Release Notification

District 1
New Mexico Oil Conservation Division
1625 N. French Drive
Hobbs, New Mexico 88240**RE: Closure Request
NM – H St. NCT - 1 #25
Remediation Permit Number 1RP-5736
Incident Number NRM1928149276
Lea County, New Mexico**

FIGURE 1
SITE LOCATION MAP
NM-H ST. NCT-1 #25
UNIT O SEC 31 T20S R37E
LEA COUNTY, NEW MEXICO
XTO ENERGY, INC.

ATTACHMENT 1: PHOTOGRAPHIC LOG

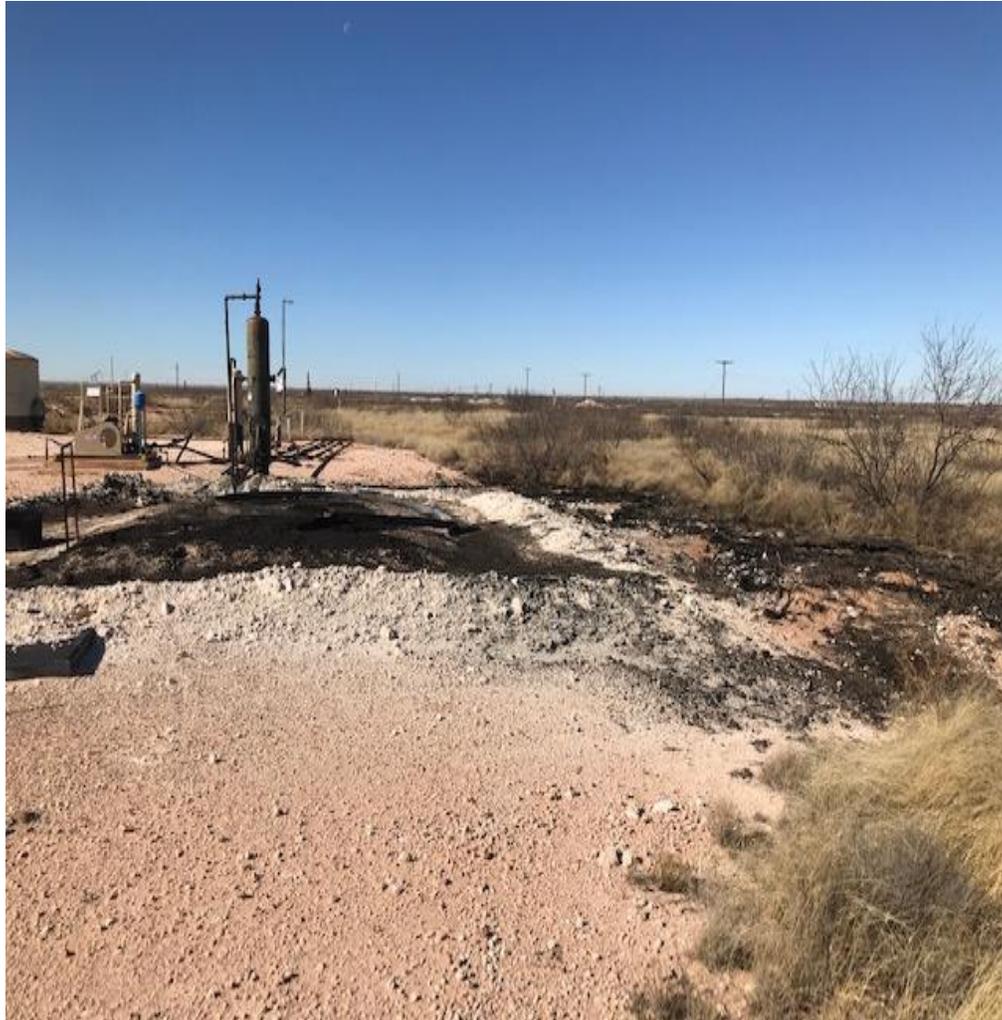
Project: 012919252	XTO Energy, Inc. NM-H St. NCT-1 #25

Western view of release area during site assessment activities.

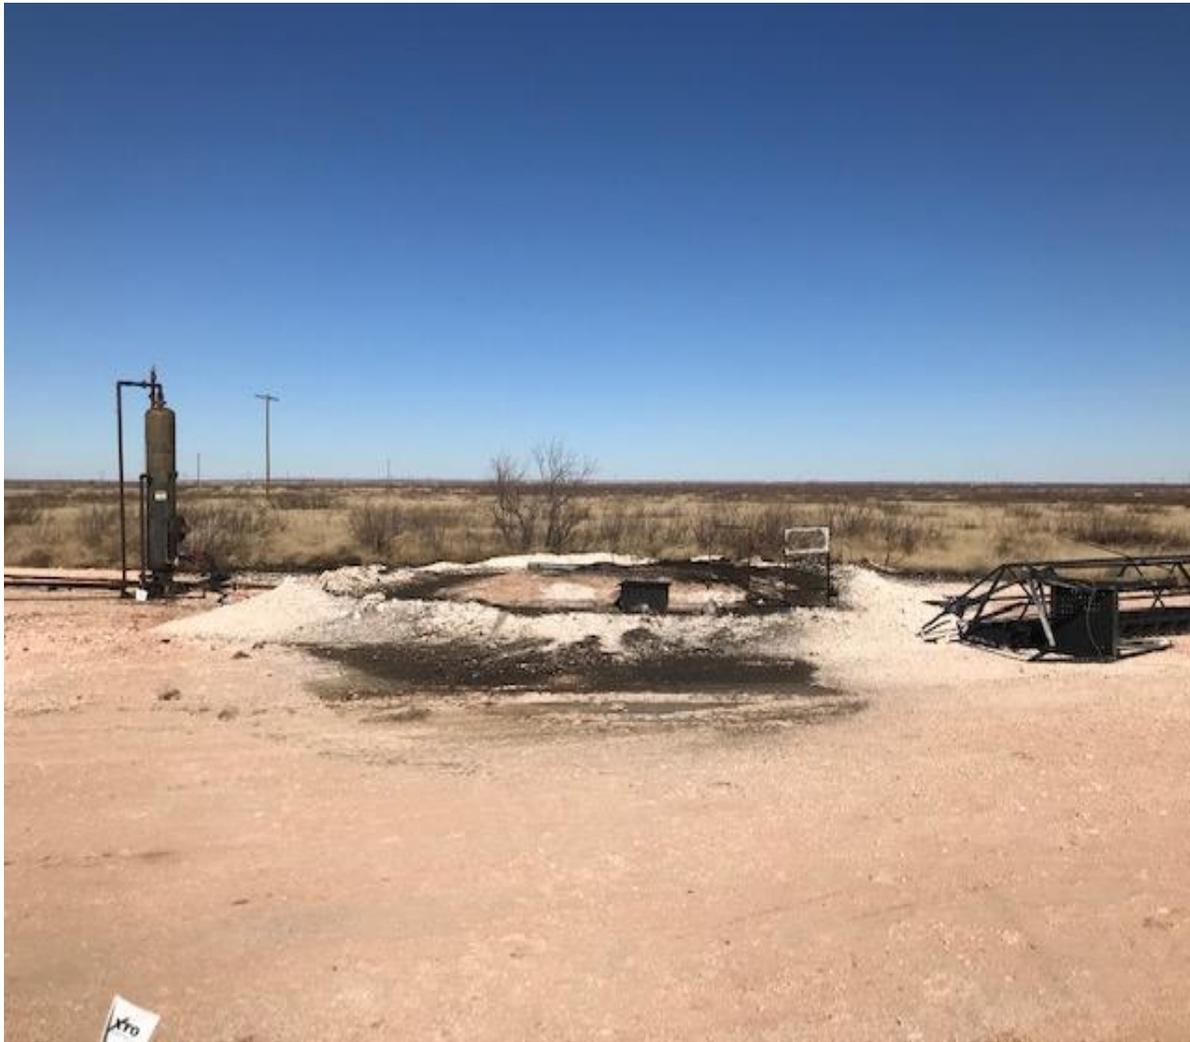
Project: 012919252	XTO Energy, Inc. NM-H St. NCT-1 #25

Eastern view of release area during delineation soil sampling activities.

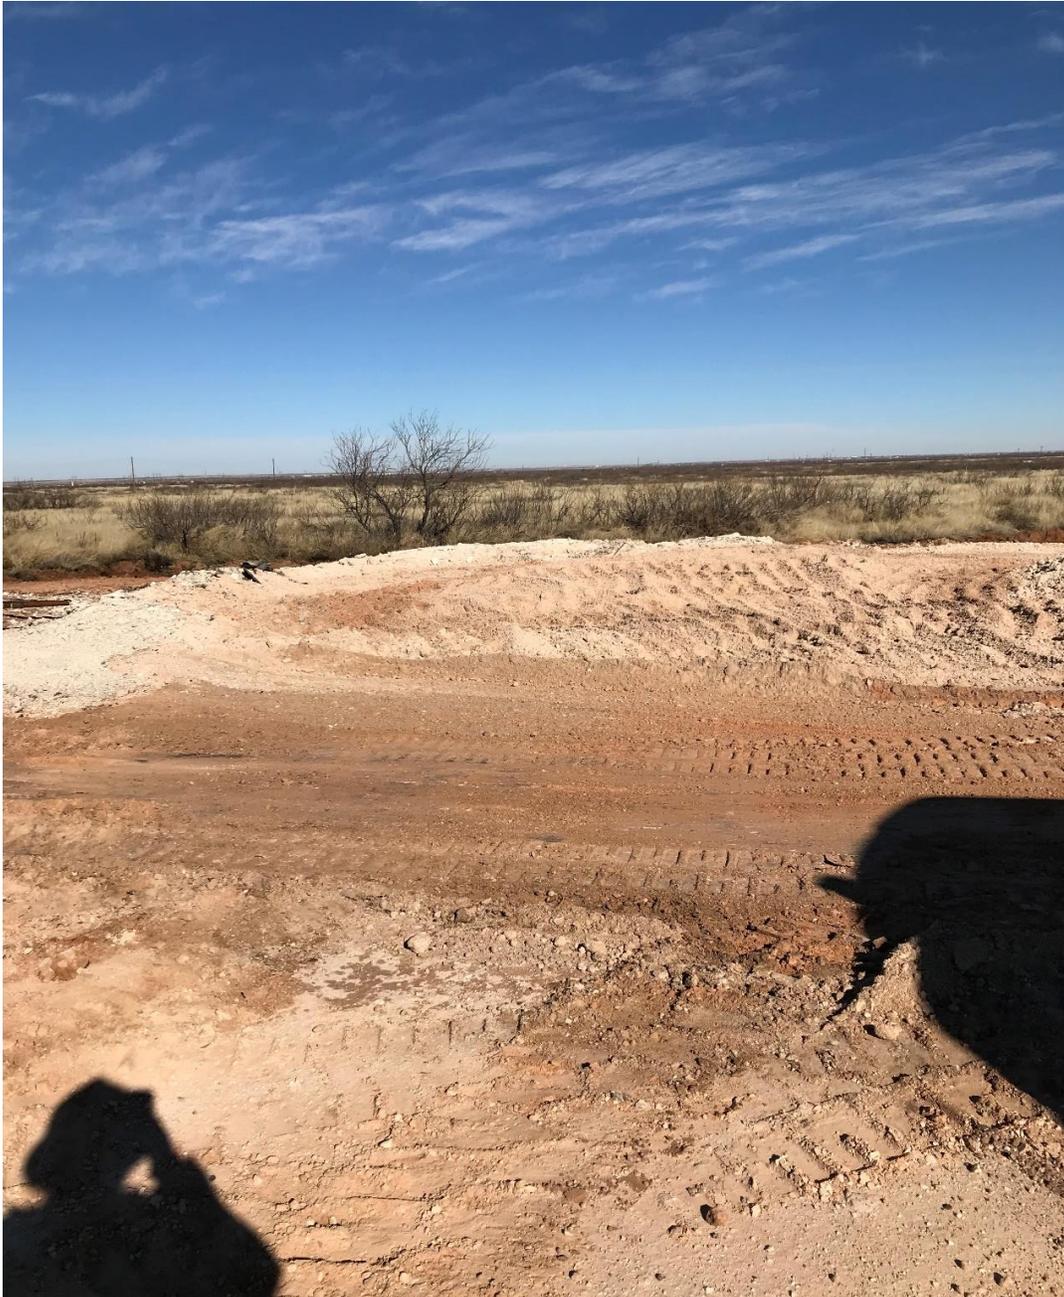
Project: 012919252	XTO Energy, Inc. NM-H St. NCT-1 #25

Eastern view of release after scraping activity on pad.

In order to address the surficial staining from the fire, LTE personnel oversaw the scraping of the pad and part of the pasture area affected by the fire with a track-mounted backhoe on December 31, 2019. Areas in the pasture that were scraped will be reseeded with Bureau of Land Management (BLM) Seed Mix #2 preceding the next rain event. Photographic documentation was conducted during the scraping activities and the photographs are included in Attachment 1.

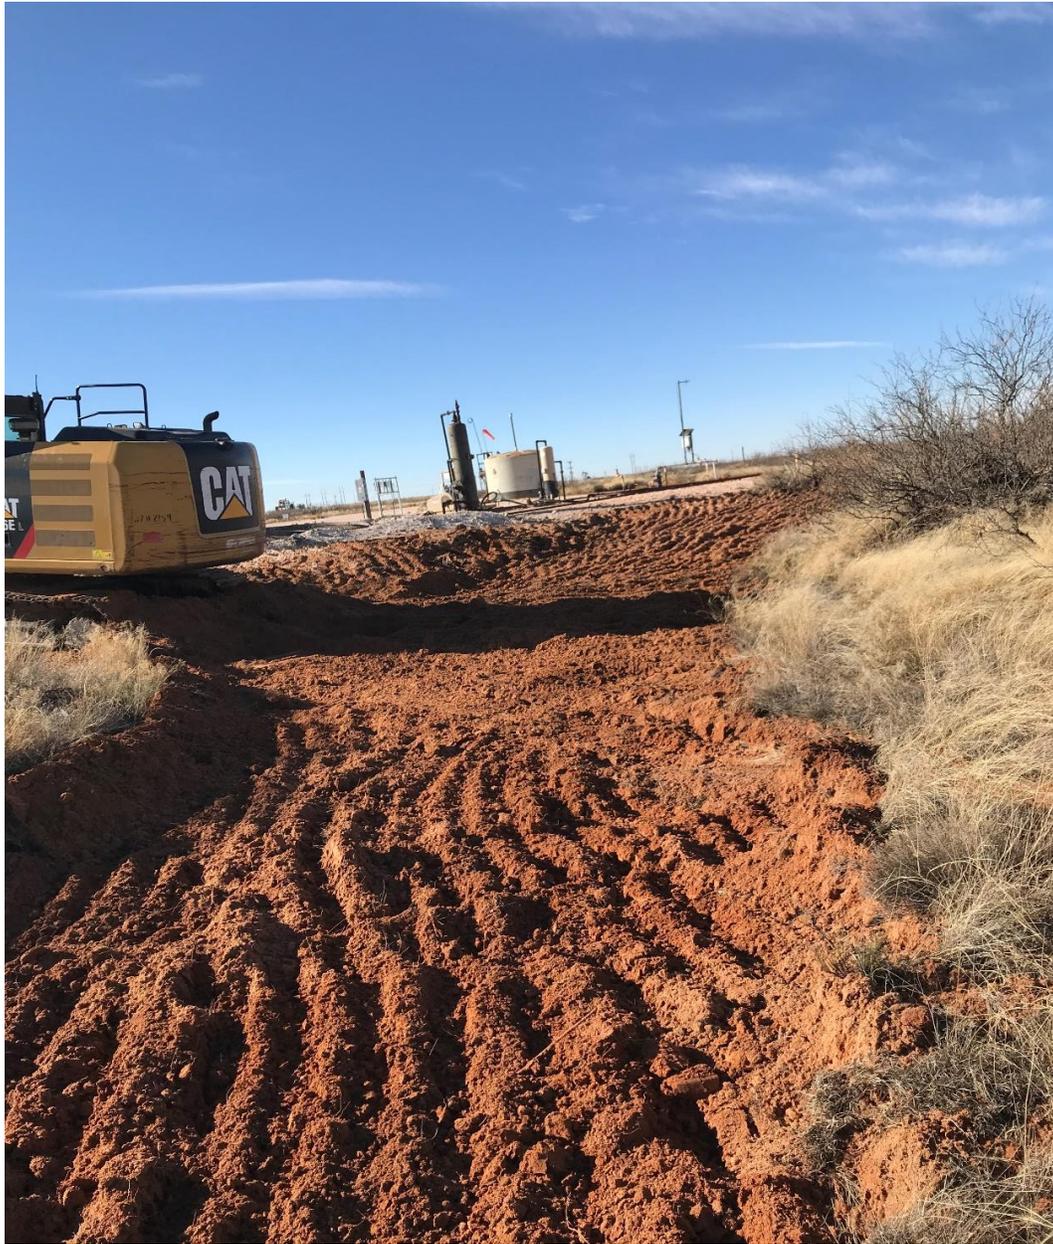
Project: 012919252	XTO Energy, Inc. NM-H St. NCT-1 #25

Southwestern view of scraping activity in pasture.
