Spill Closure Report: Boundary Raider 6 Federal #002H (Section 7, Township 23 South, Range 32 East)
API: 30-025-41884
County: Lea
Incident Report: 1RP-5564

Prepared For: **Devon Energy Corporation**
6488 Seven Rivers Highway
Artesia, New Mexico 88210

Devon Energy Corporation retained Vertex Resource Services Inc. (Vertex) to conduct a Spill Assessment for a release of produced water and crude oil at Boundary Raider 6 Federal #002H, API 30-025-41884 (hereafter referred to as “site”). This incident, 1RP-5564, was the result of the sight glass on the three-phase separator breaking due to over pressure. This letter provides a description of the Spill Assessment and includes a request for Spill Closure. The spill area is located at N 32.3256416, W -103.7059097.

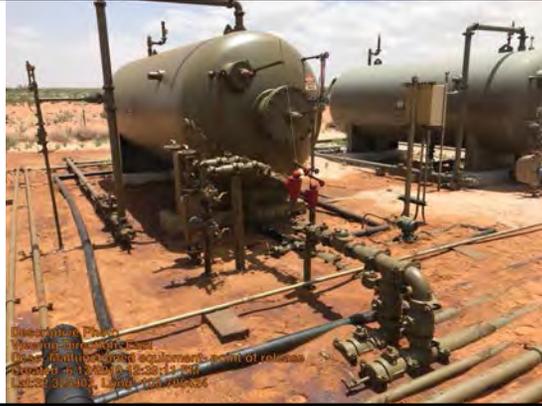
Descriptive Photo
Viewing Direction: East
Desc: Malfunctioned equipment- point of release
Created: 6/12/2019 12:38:13 PM
Lat:32.325840, Long:-103.705400

Malfunctioned equipment- point of release

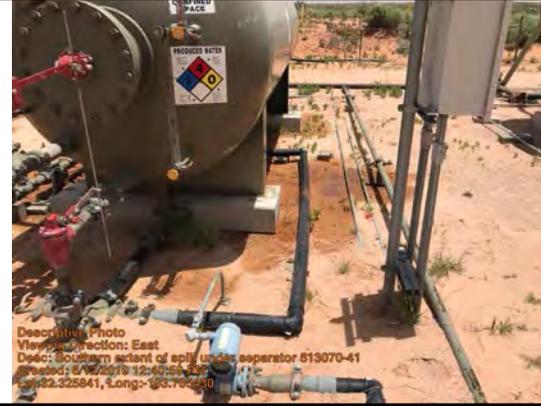
Descriptive Photo
Viewing Direction: East
Desc: Southern extent of spill under separator 613070-41
Created: 6/12/2019 12:40:56 PM
Lat:32.325841, Long:-103.705400

Southern extent of spill under separator 613070-41

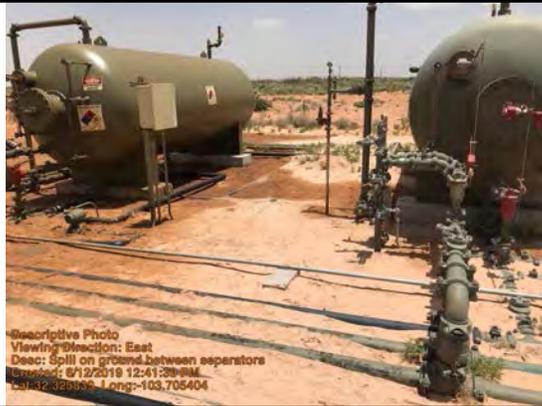
Descriptive Photo
Viewing Direction: East
Desc: Spill on ground between separators
Created: 6/12/2019 12:41:29 PM
Lat:32.325836, Long:-103.705404

Spill on ground between separators

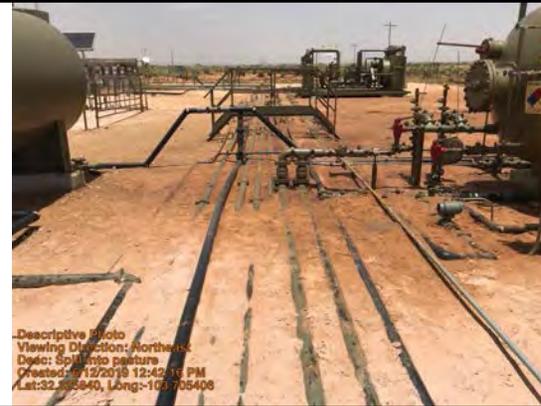
Descriptive Photo
Viewing Direction: Northeast
Desc: Spill into pasture
Created: 6/12/2019 12:42:00 PM
Lat:32.325840, Long:-103.705408

Spill into pasture

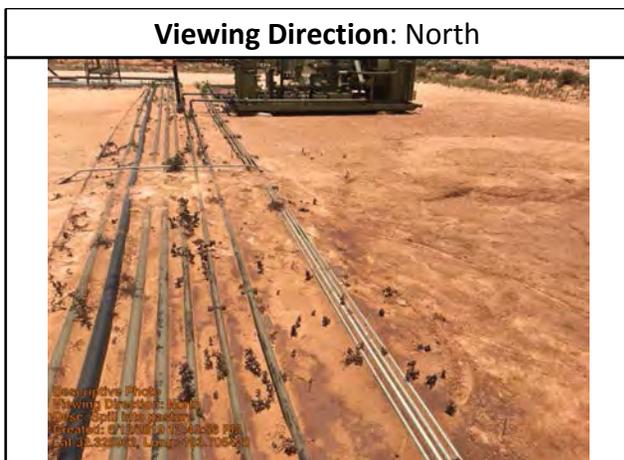
Spill into pasture

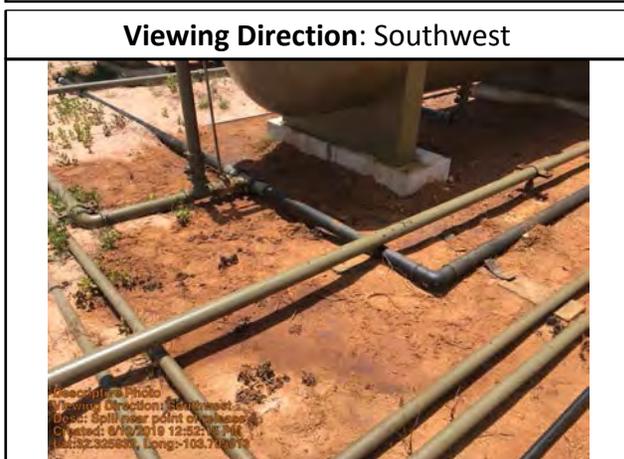
Spill near point of release

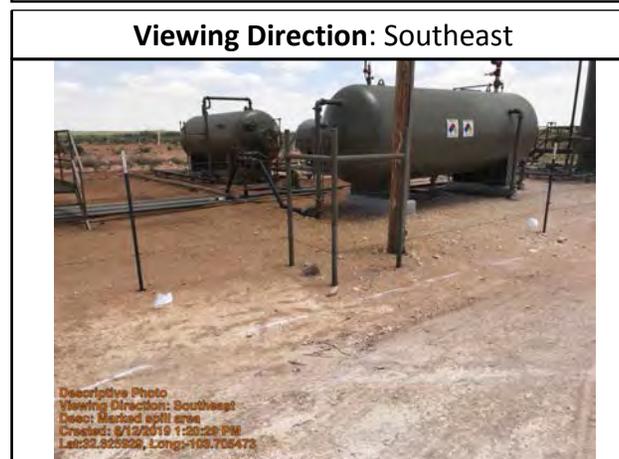
Marked spill area

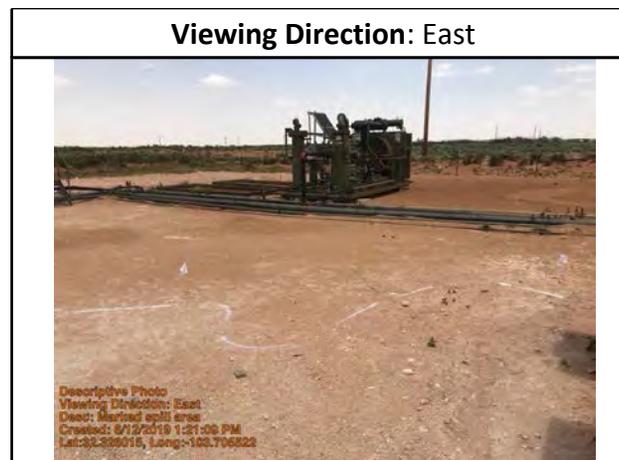
Marked spill area

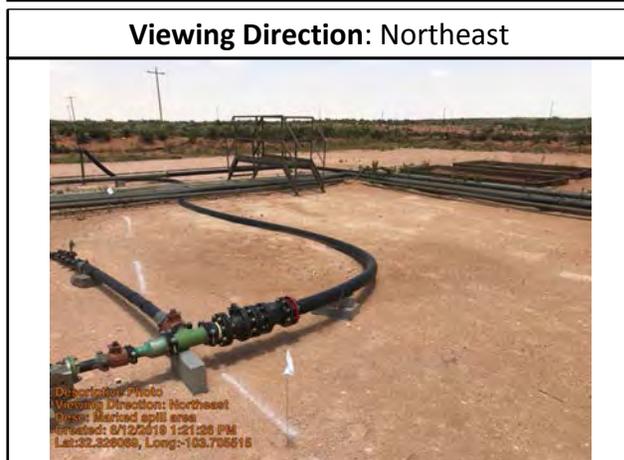
Marked spill area

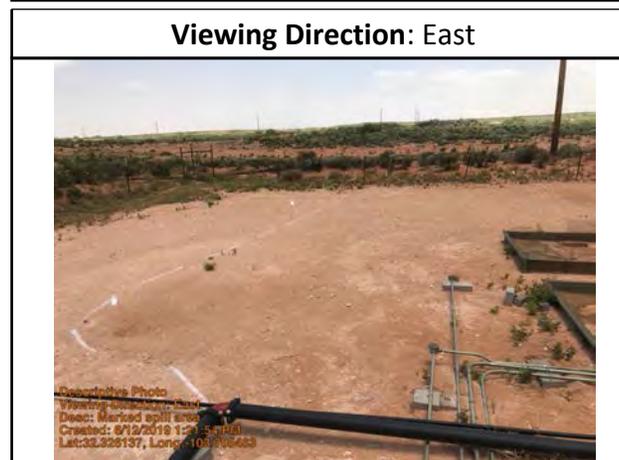
Marked spill area

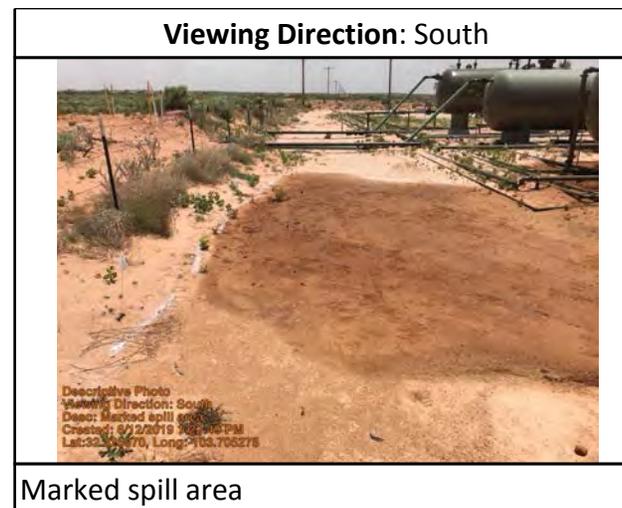
Marked spill area

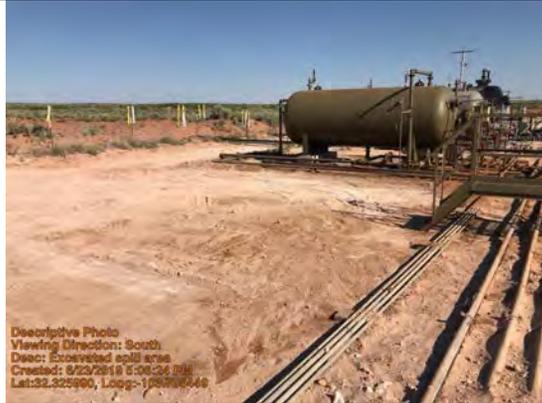
Descriptive Photo
Viewing Direction: South
Desc: Excavated spill area
Created: 6/23/2019 5:00:24 PM
Lat:32.325900, Long:-103.795479

Excavated spill area

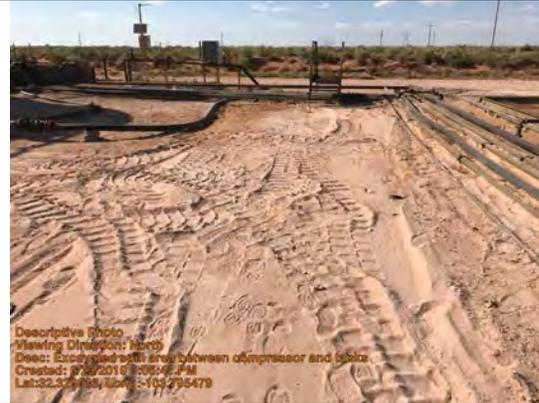
Descriptive Photo
Viewing Direction: North
Desc: Excavated spill area between compressor and tanks
Created: 6/23/2019 5:09:45 PM
Lat:32.325900, Long:-103.795479

Excavated spill area between compressor and tanks

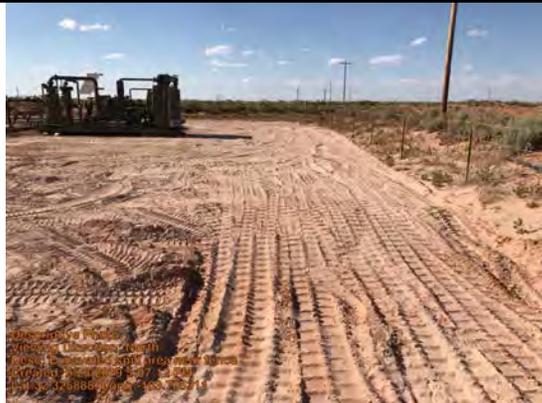
Descriptive Photo
Viewing Direction: North
Desc: Excavated spill area near fence
Created: 6/23/2019 5:17:32 PM
Lat:32.325900, Long:-103.795479

Excavated spill area near fence

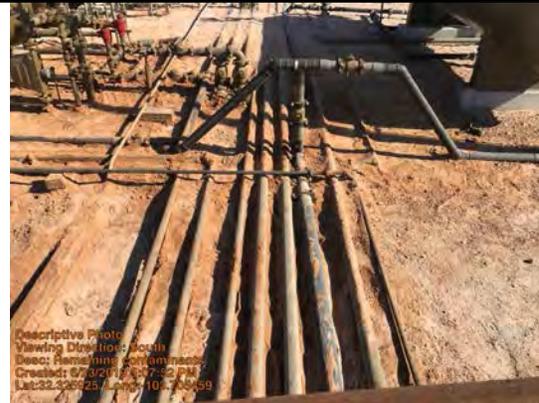
Descriptive Photo
Viewing Direction: South
Desc: Remaining contaminants
Created: 6/23/2019 5:17:32 PM
Lat:32.325900, Long:-103.795479

Remaining contaminants

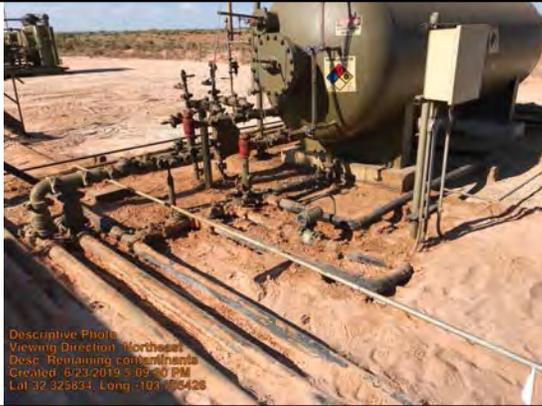
Descriptive Photo
Viewing Direction: Northeast
Desc: Remaining contaminants
Created: 6/23/2019 3:09:40 PM
Lat: 32.325834, Long: -101.705428

Remaining contaminants

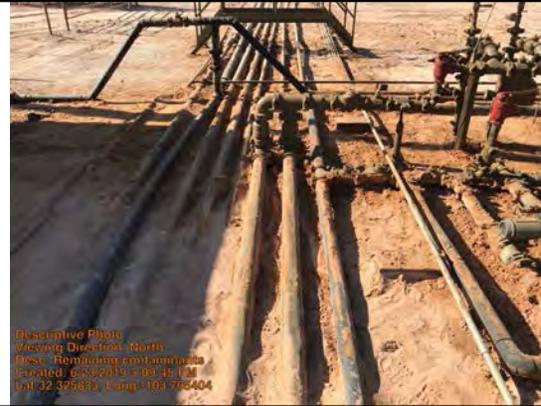
Descriptive Photo
Viewing Direction: North
Desc: Remaining contaminants
Created: 6/23/2019 3:09:45 PM
Lat: 32.325834, Long: -101.705404

Remaining contaminants

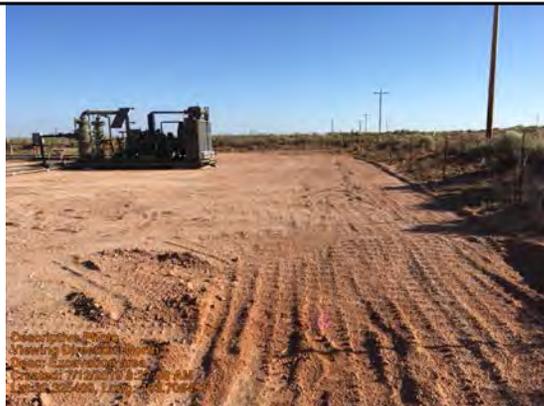
Descriptive Photo -
Viewing Direction: North
Scene: Excavation area
Created: 7/12/2019 8:27:22 AM
Latitude: 32.92426, Longitude: 103.70670

Excavation area

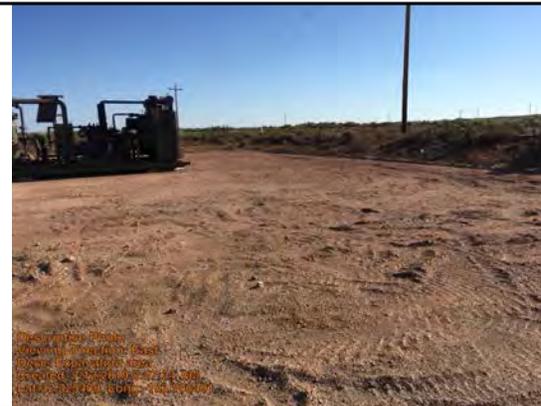
Descriptive Photo -
Viewing Direction: Northeast
Scene: Excavation area
Created: 7/12/2019 8:27:22 AM
Latitude: 32.92426, Longitude: 103.70670

Excavation area

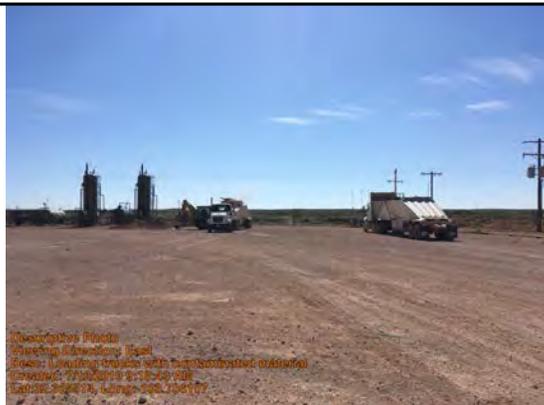
Descriptive Photo -
Viewing Direction: East
Scene: Loading trucks with contaminated material
Created: 7/12/2019 8:18:40 AM
Latitude: 32.92426, Longitude: 103.70670

Loading trucks with contaminated material

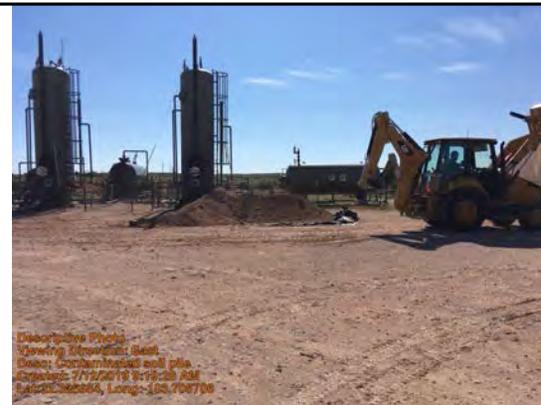
Descriptive Photo -
Viewing Direction: East
Scene: Contaminated soil pile
Created: 7/12/2019 8:18:40 AM
Latitude: 32.92426, Longitude: 103.70670

Contaminated soil pile

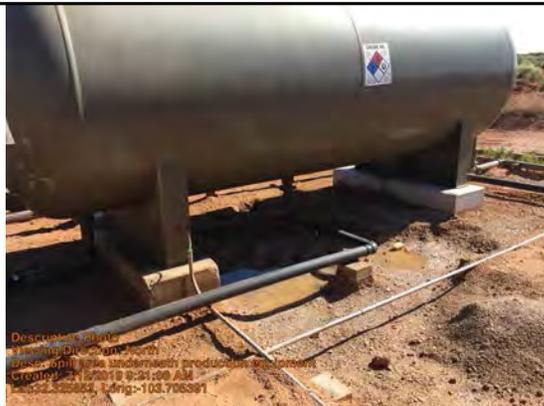
Descriptive Photo
Viewing Direction: North
Desc: Spill area underneath production equipment
Created: 7/12/2019 9:31:00 AM
Lat:32.325573, Long:-103.705391

Spill area underneath production equipment

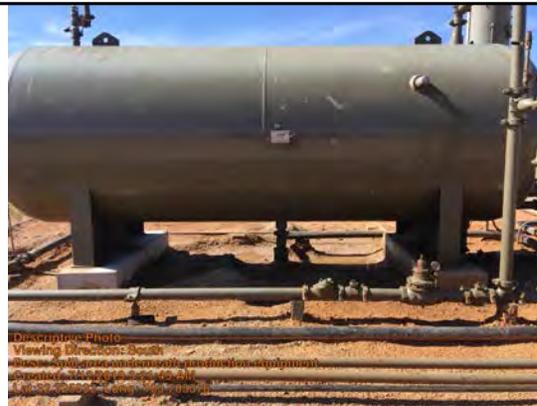
Descriptive Photo
Viewing Direction: South
Desc: Spill area underneath production equipment
Created: 7/12/2019 9:31:00 AM
Lat:32.325573, Long:-103.705391

Spill area underneath production equipment

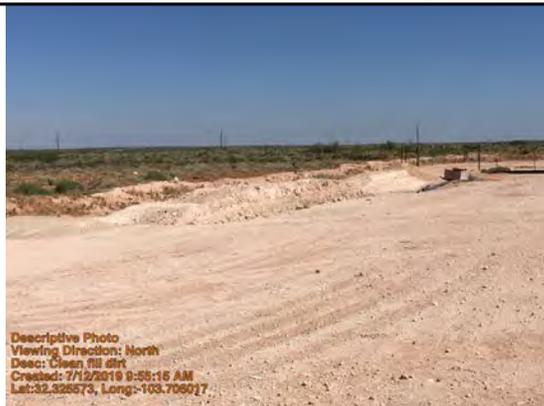
Descriptive Photo
Viewing Direction: North
Desc: Clean fill dirt
Created: 7/12/2019 9:55:16 AM
Lat:32.325573, Long:-103.705017

Clean fill dirt

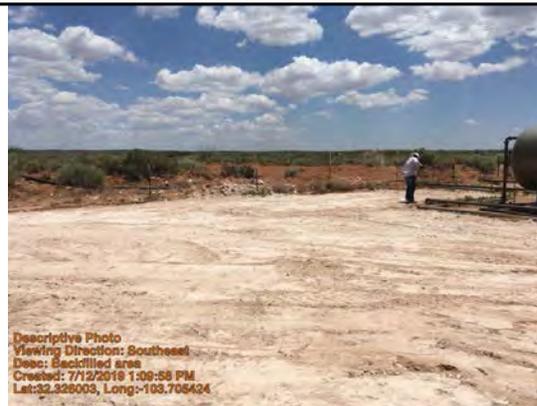
Descriptive Photo
Viewing Direction: Southeast
Desc: Backfilled area
Created: 7/12/2019 1:09:58 PM
Lat:32.326003, Long:-103.705424

Backfilled area

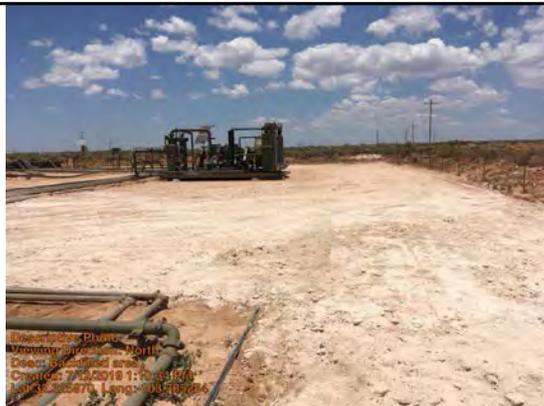
Descriptive Photo
Viewing Direction: North
Date: Backfilled area
Created: 7/12/2019 1:21:43 PM
Lat:32.328776, Long:-103.703664

Backfilled area

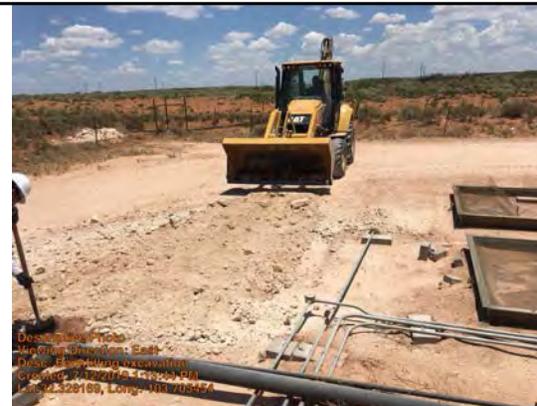
Descriptive Photo
Viewing Direction: East
Date: Backfilling excavation
Created: 7/12/2019 4:13:33 PM
Lat:32.328169, Long:-103.703474

Backfilling excavation

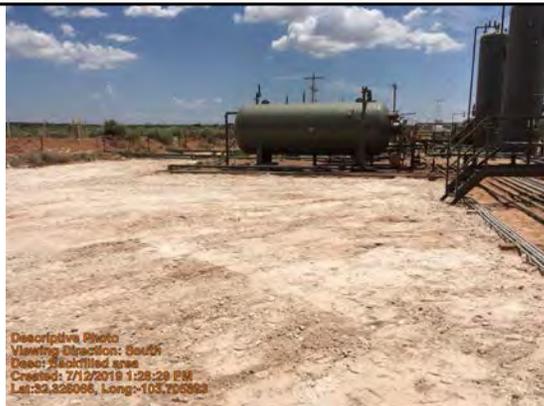
Descriptive Photo
Viewing Direction: South
Date: Backfilled area
Created: 7/12/2019 1:28:29 PM
Lat:32.328096, Long:-103.703664

Backfilled area

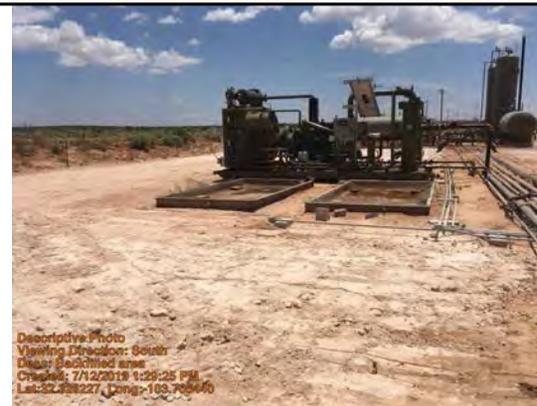
Descriptive Photo
Viewing Direction: South
Date: Backfilled area
Created: 7/12/2019 1:29:25 PM
Lat:32.328227, Long:-103.703660

Backfilled area

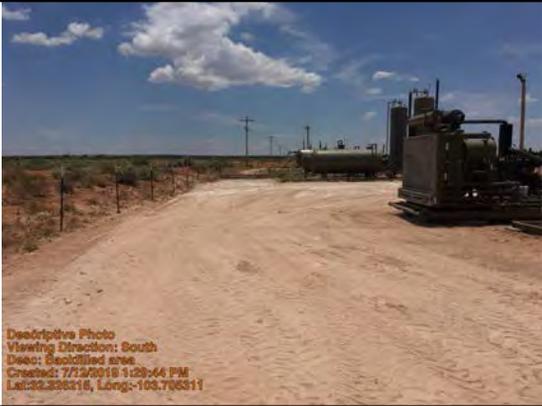
<small>Descriptive Photo Viewing Direction: South Desc: Backfilled area Created: 7/12/2019 1:23:46 PM Lat:32.236316, Long:-103.705311</small>
Backfilled area

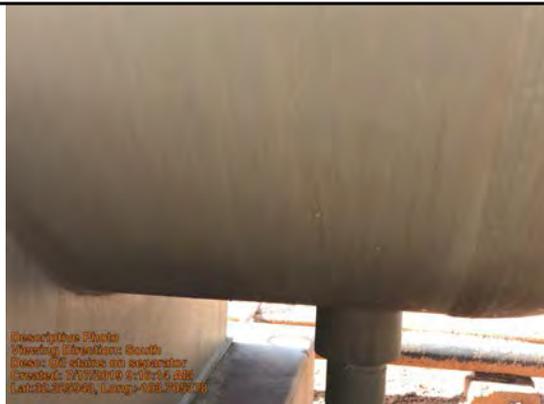
Descriptive Photo
Viewing Direction: South
Issue: Oil stains on separator
Created: 7/17/2019 4:01:16 AM
Lat:32.325853, Long:-103.705336

Oil stains on separator 6-2

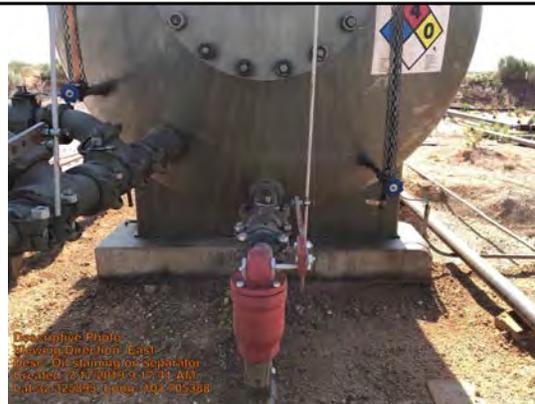
Descriptive Photo
Viewing Direction: East
Issue: Oil staining on separator
Created: 7/17/2019 4:07:41 AM
Lat:32.325853, Long:-103.705336

Oil staining on separator 6-2

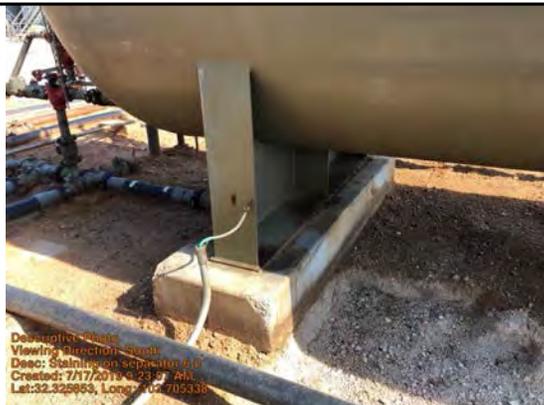
Descriptive Photo
Viewing Direction: North
Issue: Staining on separator 6-2
Created: 7/17/2019 4:23:07 AM
Lat:32.325853, Long:-103.705336

Staining on separator 6-2

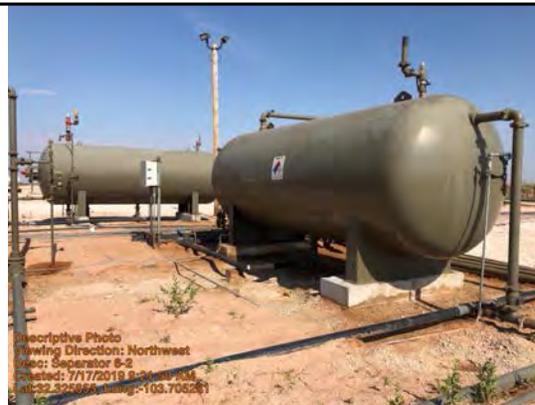
Descriptive Photo
Viewing Direction: Northwest
Issue: Separator 6-2
Created: 7/17/2019 5:24:00 AM
Lat:32.325853, Long:-103.705336

Separator 6-2
