## RJ Unit #108 (2RP-5417)

TRC Environmental Corporation (TRC), on behalf of COG Operating, LLC (COG), has prepared this *Remediation Summary and Site Closure Request* for the Release at the Site known as the RJ Unit #108 (the Site). The legal description of the Site is Unit Letter “F”, Section 27, Township 17 South, Range 29 East, in Eddy County, New Mexico. The subject property is owned by the United States Department of the Interior and administered by The Bureau of Land Management (BLM). The GPS coordinates for the Site are N32.80802°, W104.06369°. A topographical map is provided as **Figure 1**. Photographs are provided in the photolog as **Appendix B**.

On April 17, 2019, COG discovered a produced water release had occurred at the Site. The Release was caused by a fitting on the Braden head blowing out. The Release area is located on an active production pad and fluids flowed west and south toward the adjacent pastureland and Draw. The pad is shared with another production well operated by Apache Corporation located north of the COG well. COG has plugged the production well and removed the lines/equipment from the pad.

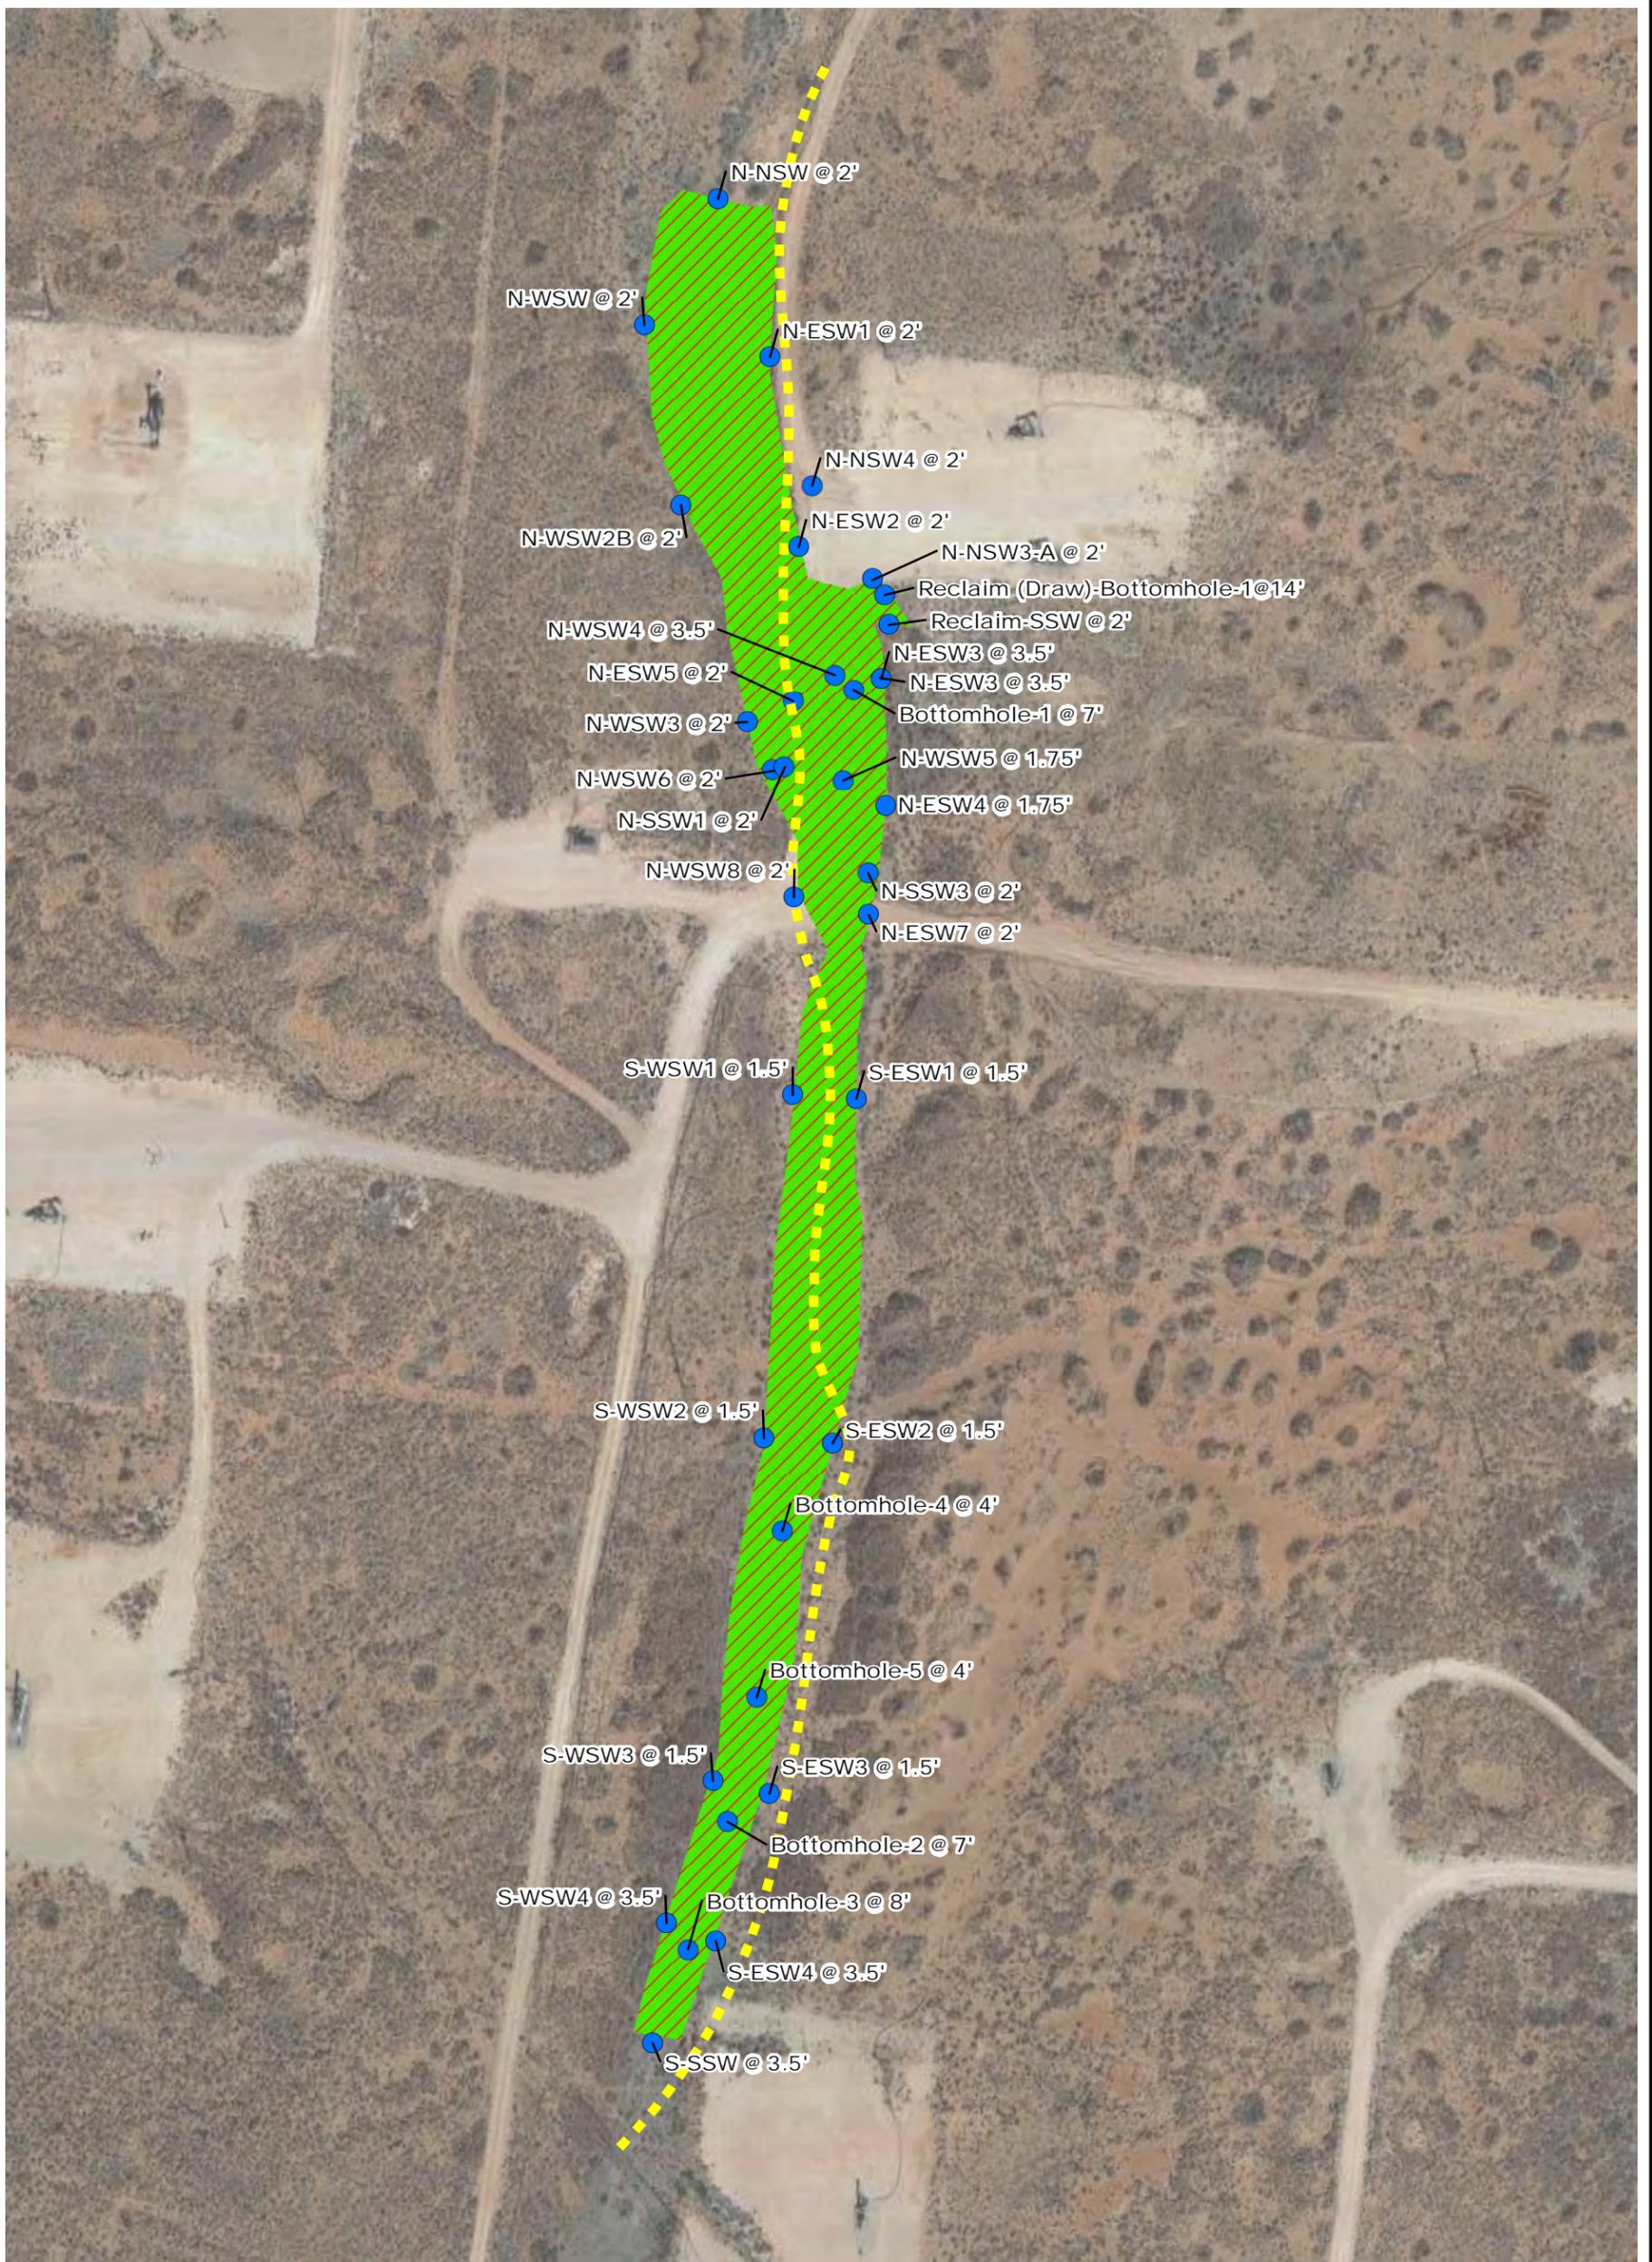
DRAWN BY:	S. RAY
CHECKED BY:	-
APPROVED BY:	-
DATE:	MARCH 2020
PROJ. NO.:	373071
FILE:	373071_4.mxd
<b>FIGURE 4</b>

<b>PROJECT:</b>	<b>CONCHO RESOURCES RJ UNIT #108 EDDY COUNTY, NEW MEXICO</b>
<b>TITLE:</b>	<b>NORTH AND SOUTH DRAW AREA</b>

- Seven (7) boreholes (BH-12, BH-13, BH-17, BH-18, BH-19, BH-20, and BH-24) were advanced along the north draw area and eight (8) boreholes (BH-5, BH-6, BH-7, BH-8, BH-9, BH-10, BH-11, and BH-22) were advanced along the south draw area.

- The impacted area represented by BH-12, BH-13, BH-17, BH-5, and BH-6 were to be excavated to an approximate depth of at least seven (7) to eight (8) ft. bgs to remove the elevated chlorides in bottom, prior to capping the area with 20 mil liner.
- Impacted soil in the area represented by boreholes BH-18, BH-19, and BH-20, was to be excavated to an approximate depth of four (4) ft. bgs.
- A 20-mil liner was to be installed and backfilled the north draw.

- The impacted area represented by BH-5 and BH-6 was to be excavated to an approximate depth of seven (7) to eight (8) ft. bgs to remove the elevated chlorides in bottom, prior to capping area with 20 mil liner.
- Impacted soil in the area represented by boreholes BH- 7, BH-8, BH-9, BH-10, BH-11, and BH-12 was to be sampled and segregated into approximately fifty (50) to seventy-five (75) cubic yard stockpiles.
- Segregated stockpiles were screened for chloride concentrations by Method E300.0.
- Chloride concentrations below 600 mg/kg were to be utilized as backfill material.
- Chloride concentrations above 600 mg/kg were transported to an NMOCD approved disposal.
- A 20-mil liner was to be installed and backfilled the south draw.

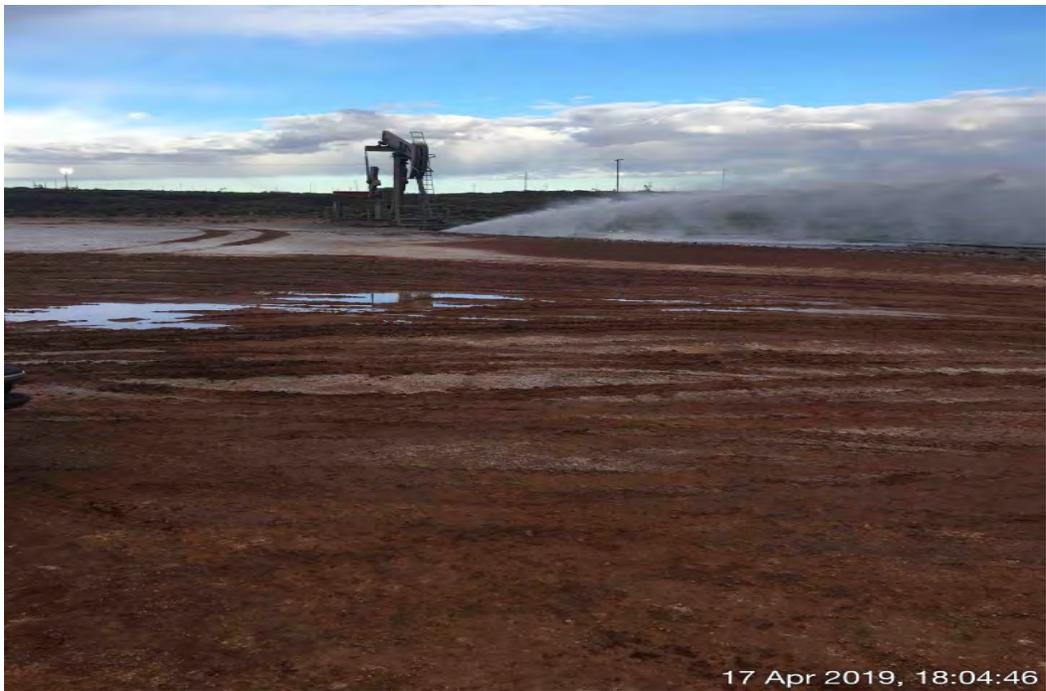
**Photograph No. 2**

**Description:**  
View of Release  
area

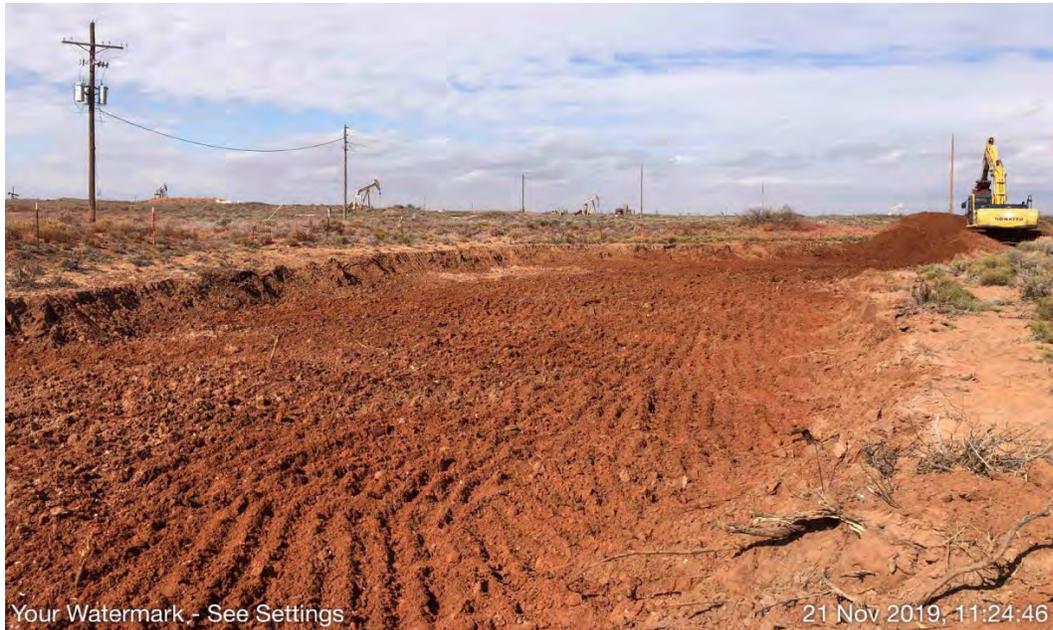
**Photograph No. 6**

**Description:**  
View of  
excavation  
activities in  
North Draw.

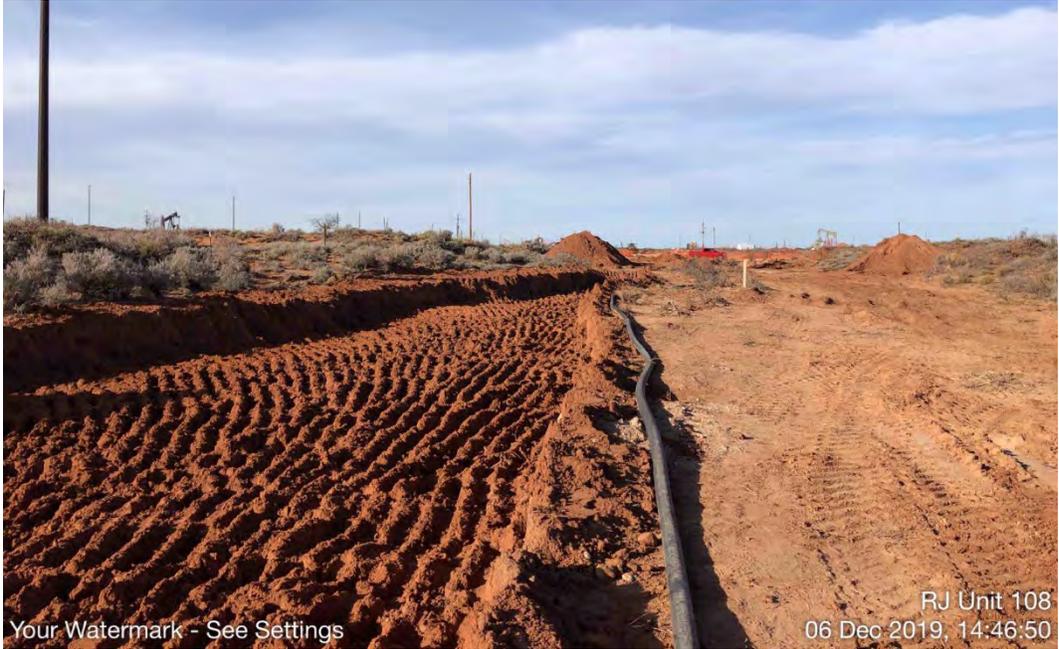
**Photograph No. 8**

**Description:**  
View of  
excavation  
activities in  
South Draw.

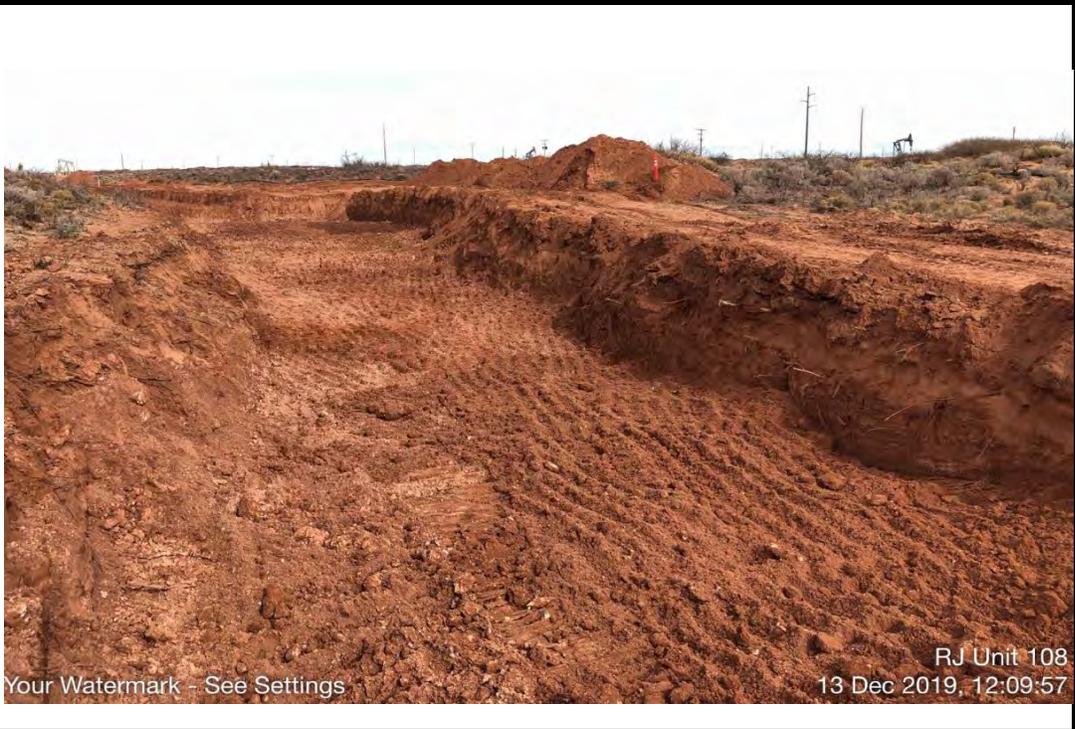
**Photograph No. 10**

**Description:**  
View of  
excavation  
activities of  
South Pad Area.

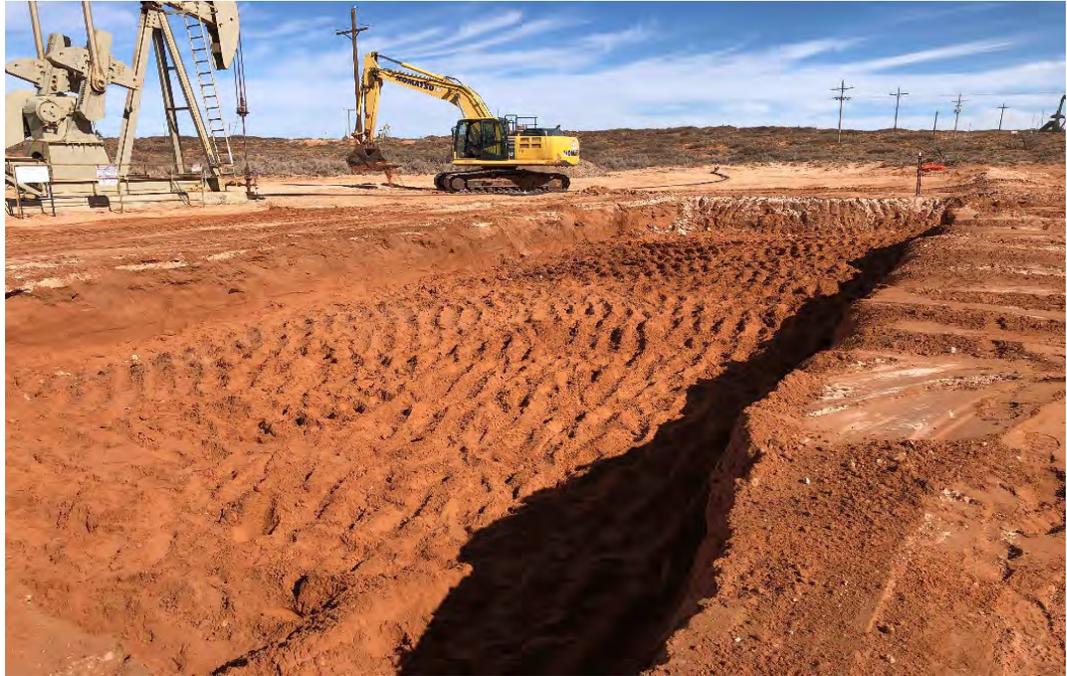
**Photograph No.  
12**

**Description:  
View of  
excavation  
activities of Pad  
Area**

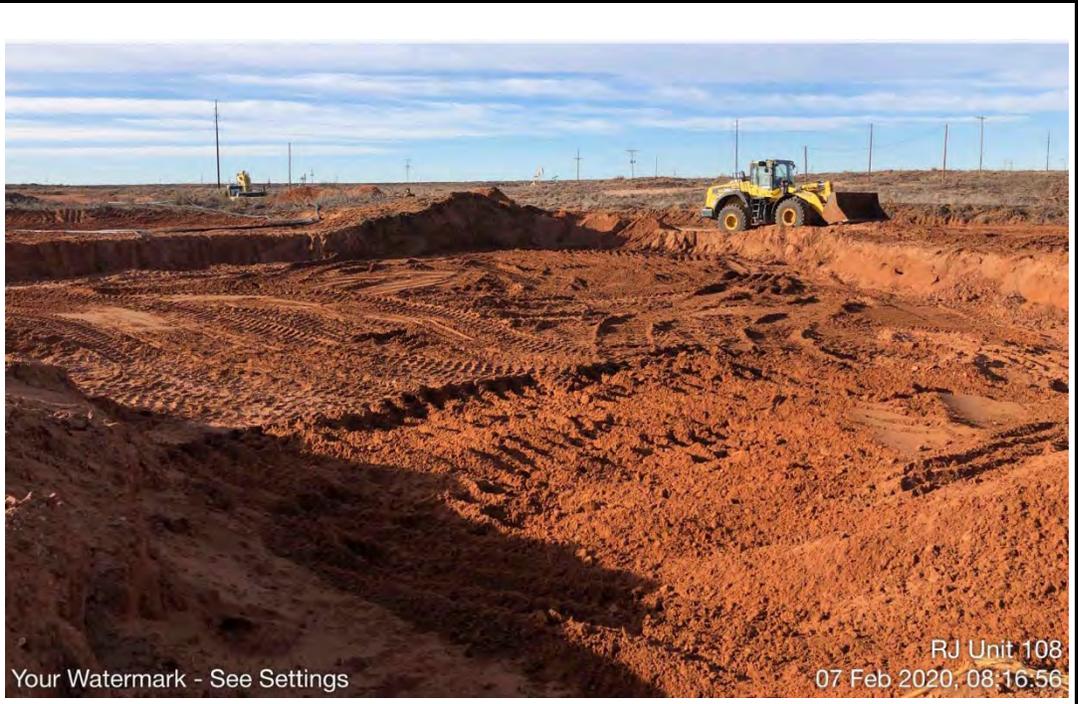
**Photograph No.  
14**

**Description:  
View of  
excavation  
activities of  
South Pad Area**

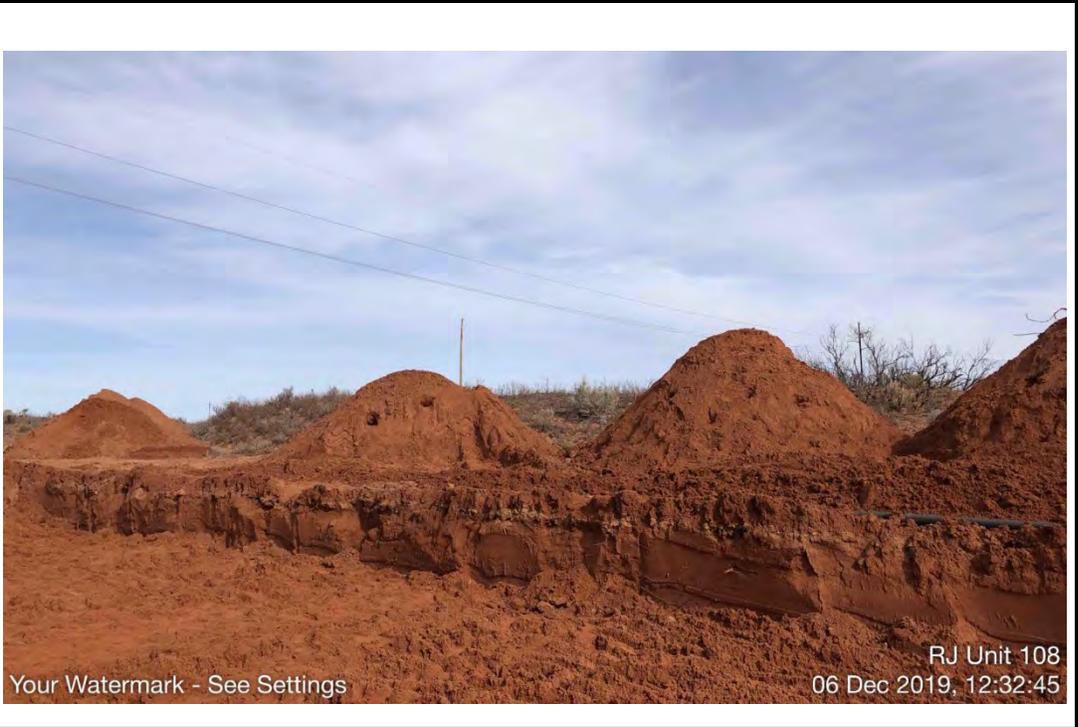
**Photograph No.**  
16

**Description:**  
View of stockpile.

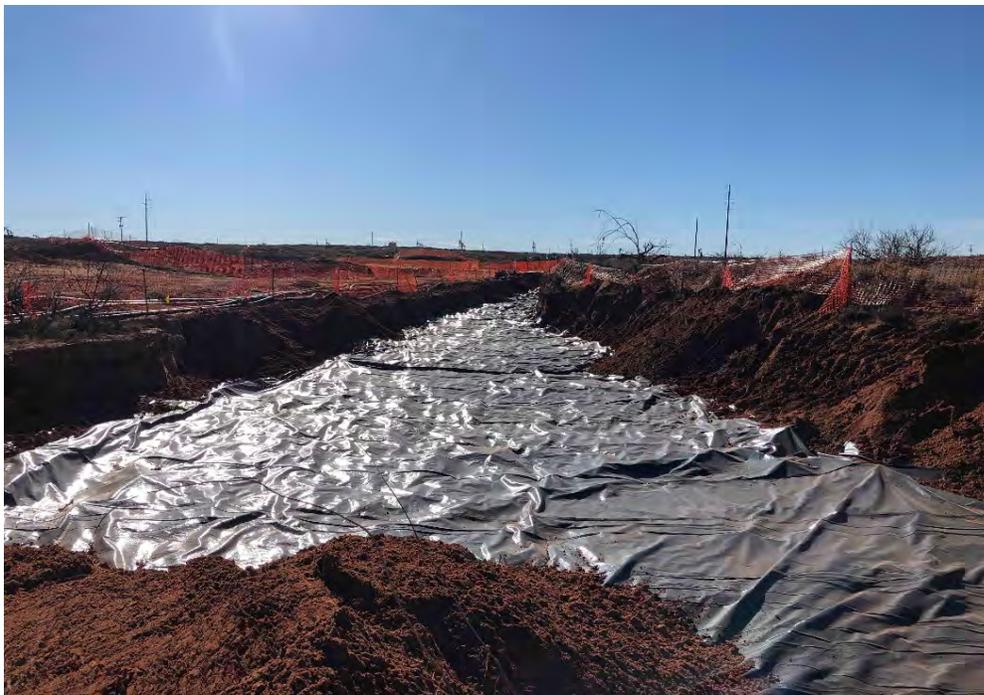
**Photograph No.**  
18

**Description:**  
View of 20-mil  
liner in South  
Draw.
