# NVV2003540716 GENERAL KEHOE TANK BATTERY @ A-02-24S-28E 0N 0E

**Spill Closure Report:** General Kehoe Tank Battery  
Unit 2, Section 2, Township 24 South, Range 28 East  
County: Eddy  
Purchase Order #:3RHP3-191118-C-1410

**Prepared For:** Matador Production Company  
5400 LBJ Freeway  
Suite 1500  
Dallas, Texas 75240

2020 Spill Assessment and Closure  
February 2020

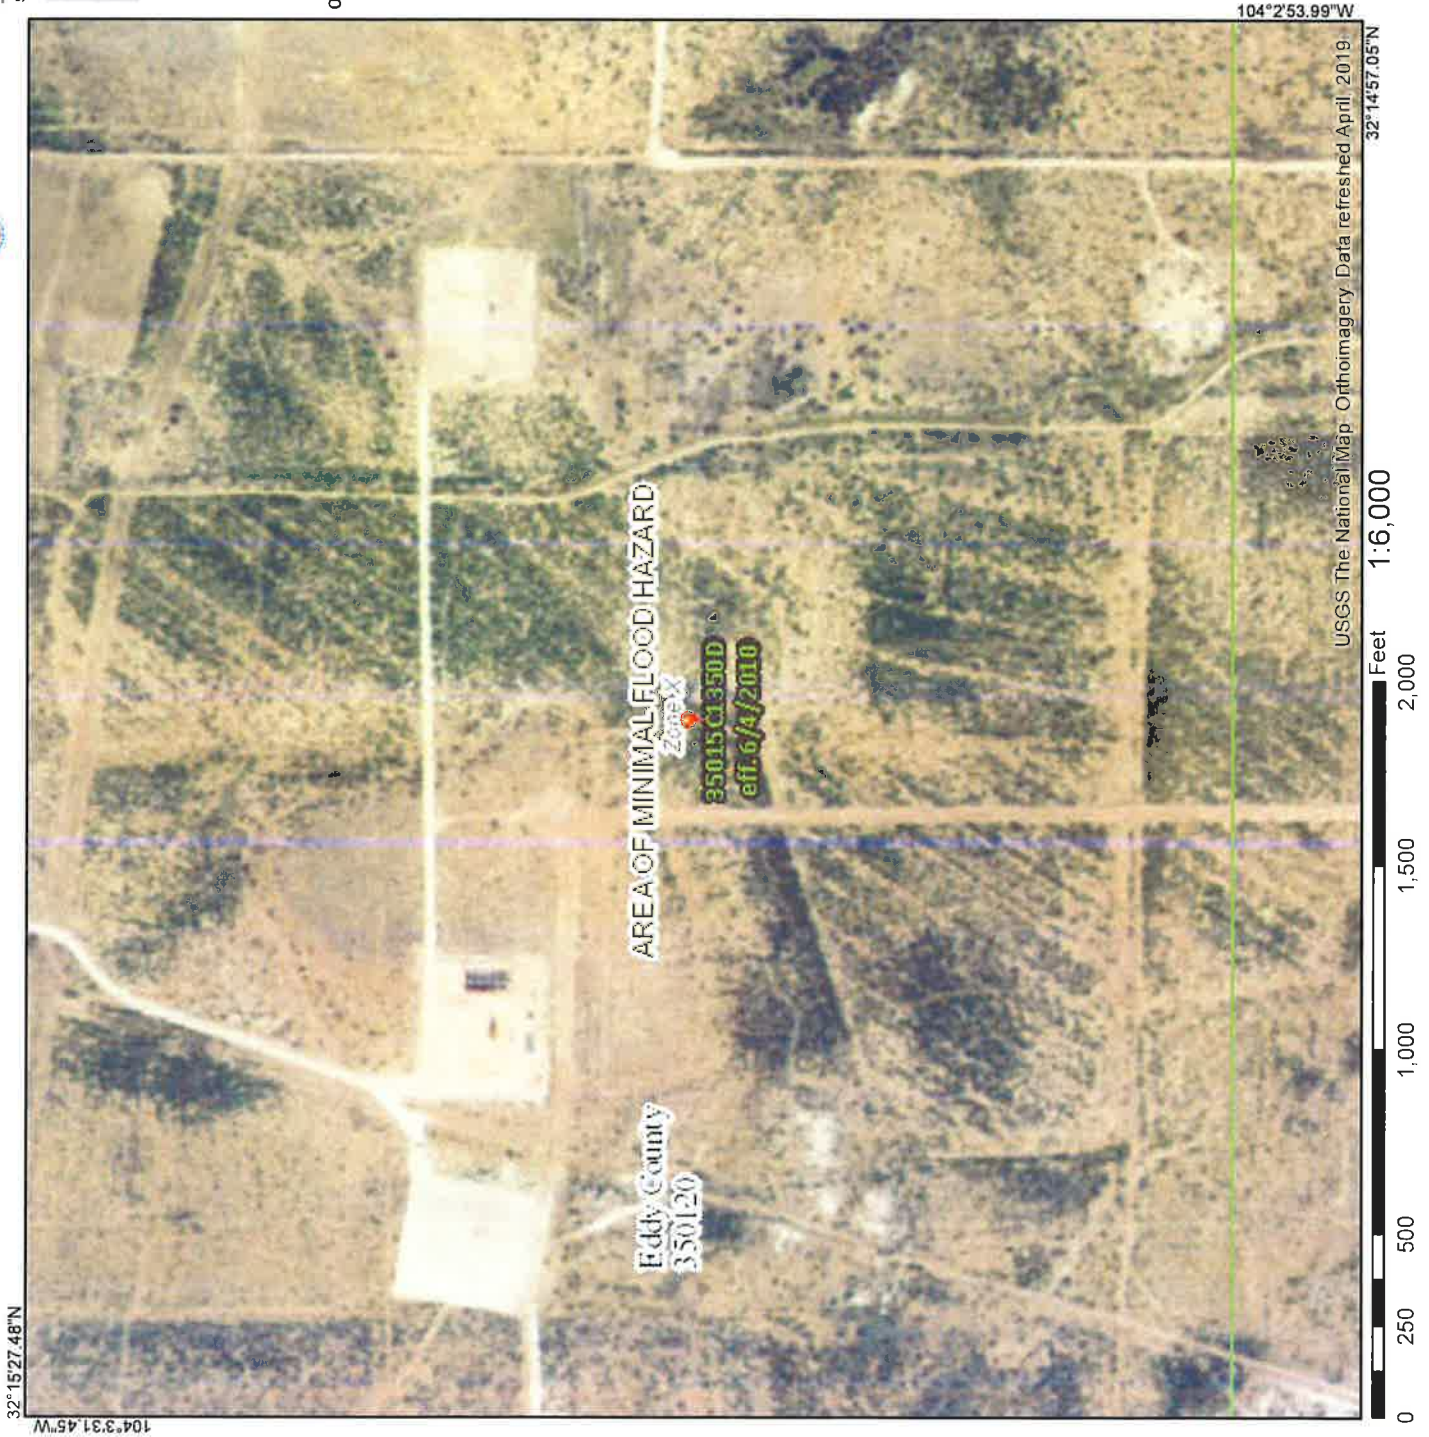
# National Flood Hazard Layer FIRMette

The flood hazard information is derived directly from the authoritative NFHL web services provided by FEMA. This map was exported on 12/16/2019 at 4:27:29 PM and does not reflect changes or amendments subsequent to this date and time. The NFHL and effective information may change or become superseded by new data over time.

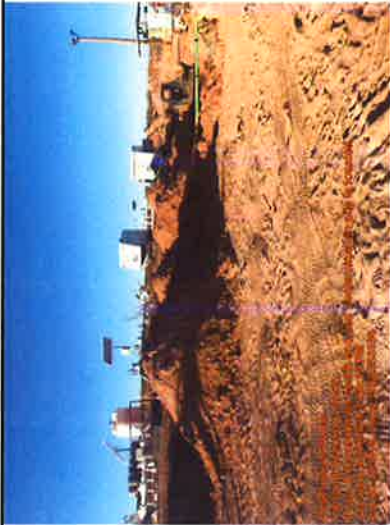
| <b>Viewing Direction: North</b><br><br>Excavation on south end and contamination pile is located | <b>Viewing Direction: East</b><br><br>Contaminated pile on north end of excavation |

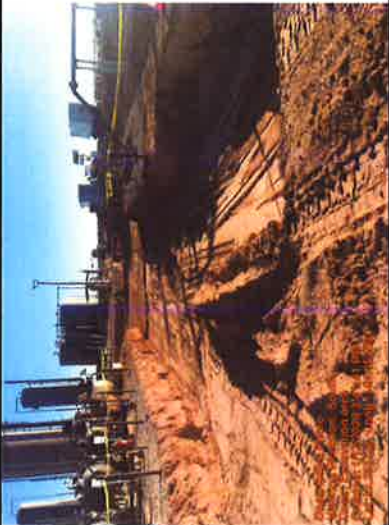
| <b>Viewing Direction: South</b><br><br>Excavation area | <b>Viewing Direction: West</b><br><br>Contamination pile |

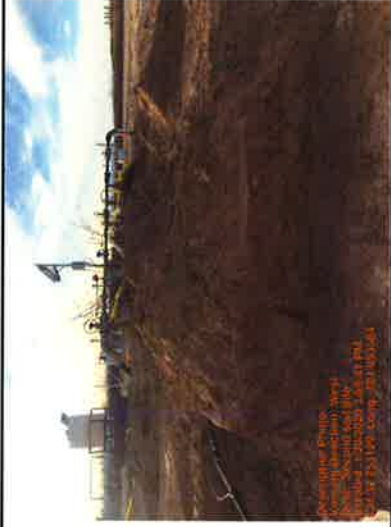
| Viewing Direction: West | <p>Second soil pile photo taken from west-facing perspective. The pile is composed of dark brown soil and is surrounded by a chain-link fence. A yellow flag is visible on the pile. The background shows a clear blue sky with some clouds.</p> |
