LT Environmental, Inc.

Mr. Bradford Billings  
New Mexico Oil Conservation Division  
1220 South St. Francis Drive, #3  
Santa Fe, New Mexico 87505**RE: Closure Request  
Nash 042 Tank Battery  
Remediation Permit Number 2RP-4823  
Eddy County, New Mexico**

LT Environmental, Inc. (LTE), on behalf of XTO Energy, Inc. (XTO), presents the following Closure Request detailing site assessment, soil sampling, and excavation activities at the Nash 042 Tank Battery (Site) in Unit E, Section 18, Township 23 South, Range 30 East, in Eddy County, New Mexico (Figure 1). The purpose of the site assessment, soil sampling, and excavation activities was to address impacts to soil after a release of crude oil and produced water at the Site.

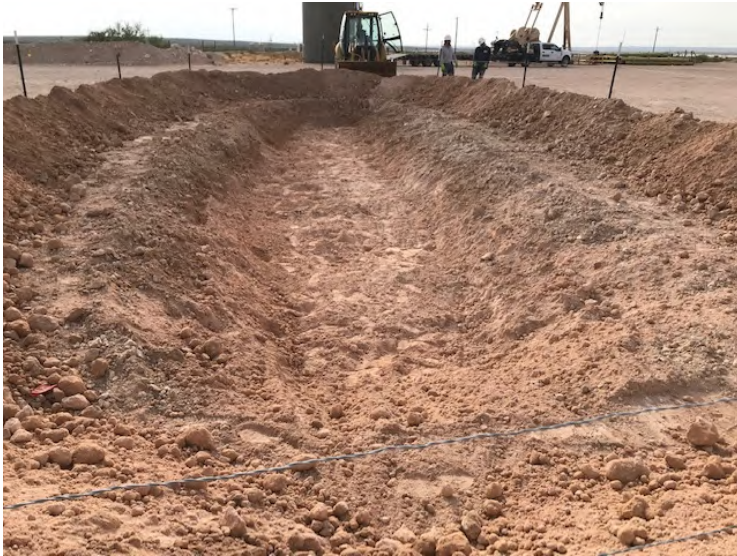
**Photograph 1:** West facing view of open excavation north of the tanks.

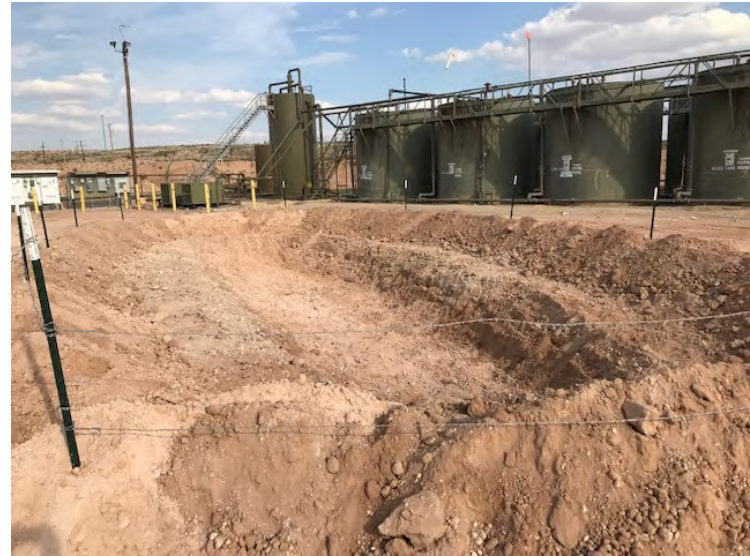
**Photograph 2:** East facing view of open excavation north of the tanks.
