LT Environmental, Inc.

RE: Closure Request
WPX Energy Permian, Inc.
Ross Draw Unit #057 (2RP-5716)
Incident ID NRM1933642770
Eddy County, New Mexico

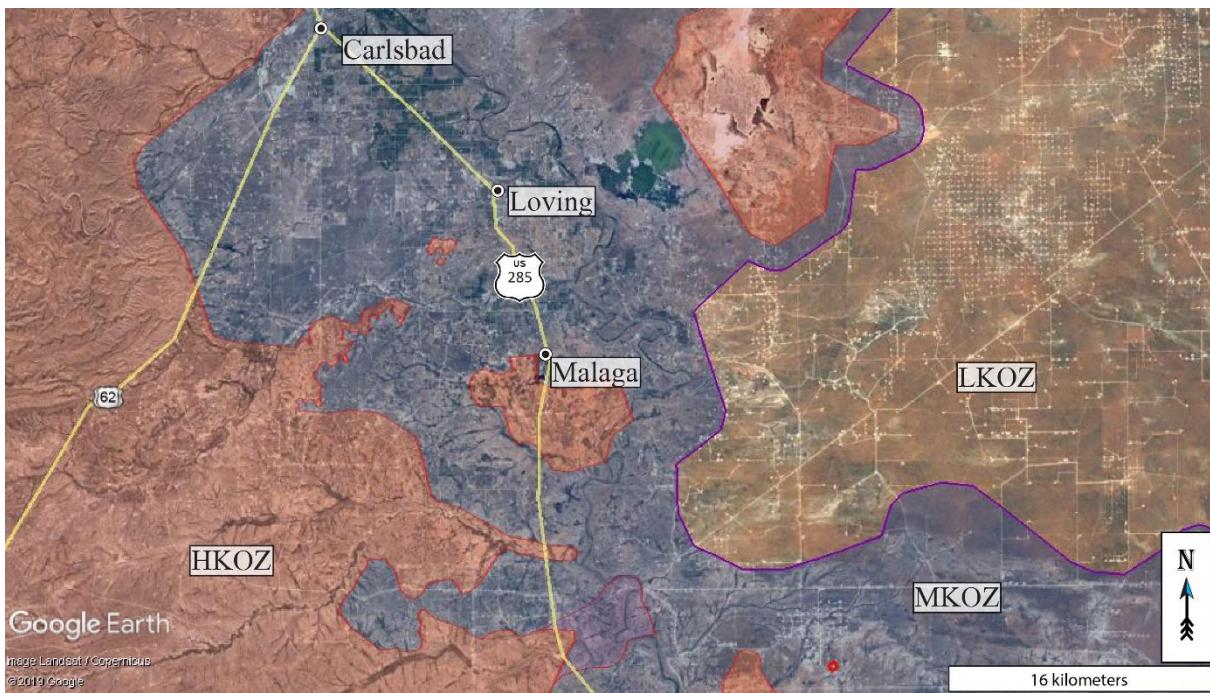
Figure 1: Karst occurrence overview. Red transparent area is a high karst occurrence zone; blue transparent area is a medium karst occurrence zone; no color indicates a low karst occurrence zone. Study area is the red outlined area in the lower-right portion of the image. Background image credit: Google Earth. Image date: February 21, 2019. Datum: WGS-84.

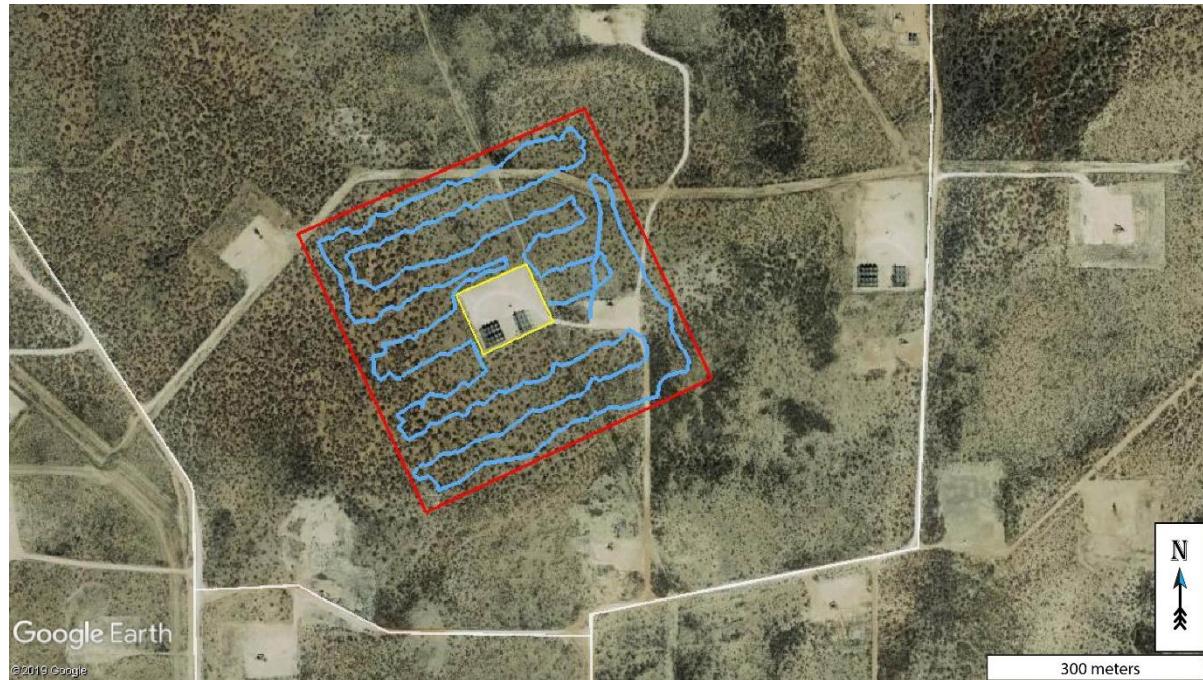
Figure 3: Survey overview. Light blue wavy lines are the actual survey lines walked. Yellow polygon is the pad site. Red polygon is the 200-meter buffer study area. Background image credit: Google Earth. Image date February 21, 2019. Datum: WGS-84.

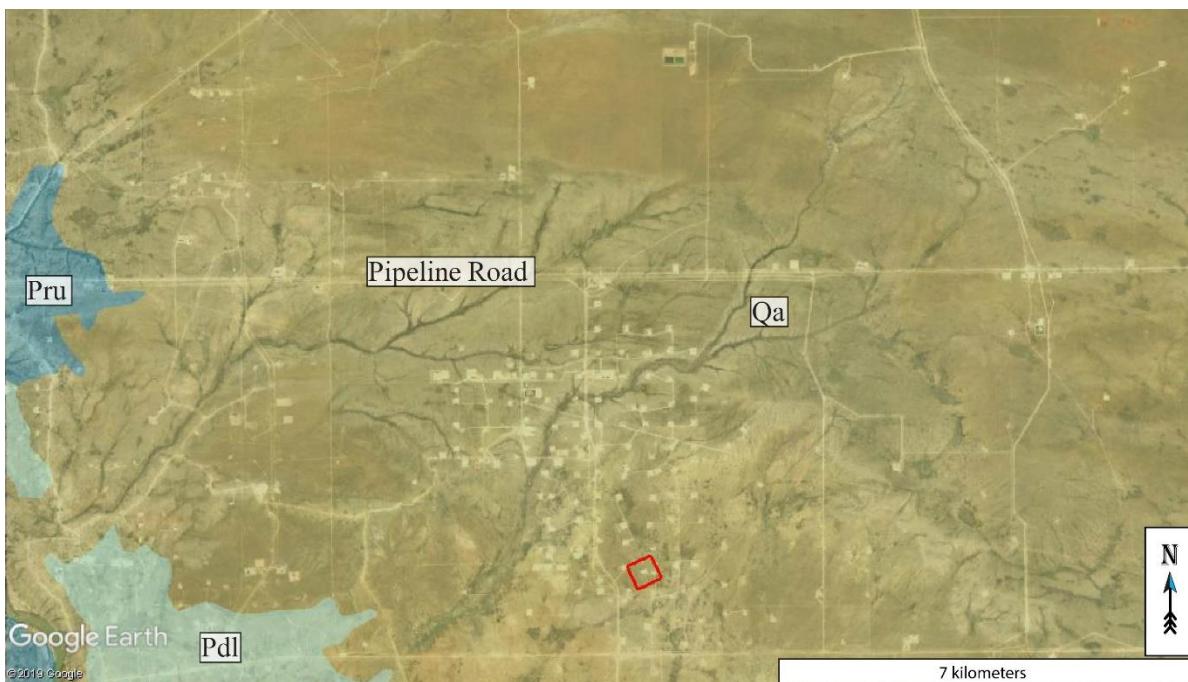
Figure 4: Geology overview. Red polygon highlights the survey area. Pru: Permian Rustler Formation. Pdl: Permian Dewey Lake Formation. Qa: Quaternary units, locally includes both Qg: Quaternary Gatuna Formation and Qs: Quaternary windblown sand. Map credit: Geologic Map of New Mexico, scale: 1:500,000 (2003), and Google Earth. Image date: February 21, 2019. Datum: WGS-84.

The area surveyed for the RDU 57 project is located at an elevation of 920 meters (3,020 feet), plus or minus 5 meters (15 feet), within the Quaternary Gatuna Formation (Qg – not shown, within Qa on map) and Quaternary windblown sand (Qs – not shown, within Qa on map). The Gatuna Formation is a conglomerate composed of calcite cemented limestone and sandstone cobble derived from the Guadalupe Mountains. The large proportion of calcite that makes up the matrix for this formation allows limited karst formation to occur. The entirety of the survey area is underlain by the Permian Dewey Lake Formation (Pdl), which outcrops in the southernmost section of the survey area, and Permian Rustler (Pru) Formation (which does not outcrop within the survey area). The Dewey Lake Formation is composed of calcite cemented, hematite stained quartz sand grains and is not known for forming karst. The Rustler Formation is composed of alternating layers of gypsum and dolomite, both of which are easily dissolved to form karst features^[3, 4]. An onsite excavation to a depth of 4 meters (12 feet) revealed fine-grained windblown sand throughout the entire depth of the excavation. Two easily accessible geologic maps that cover the survey area are the Geologic Map of New Mexico (2003) at 1:500,000 scale^[2], and the Geologic Atlas of Texas - Hobbs Sheet (1976) at 1:250,000 scale.

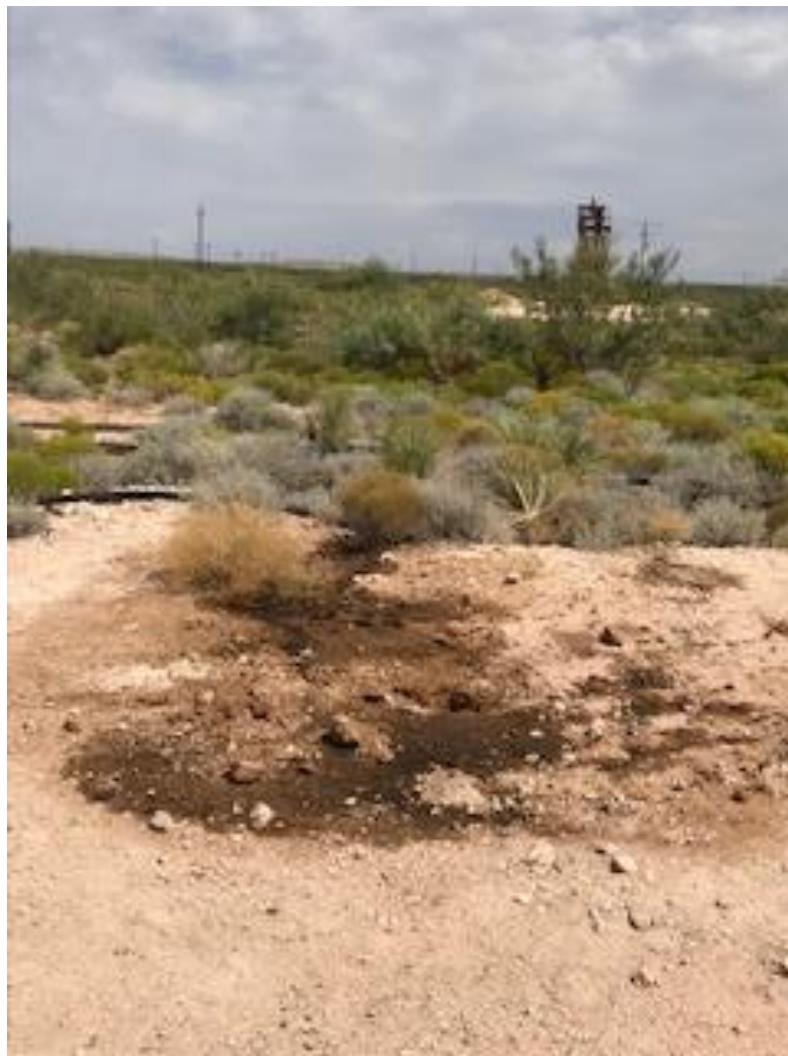
Release footprint – view north

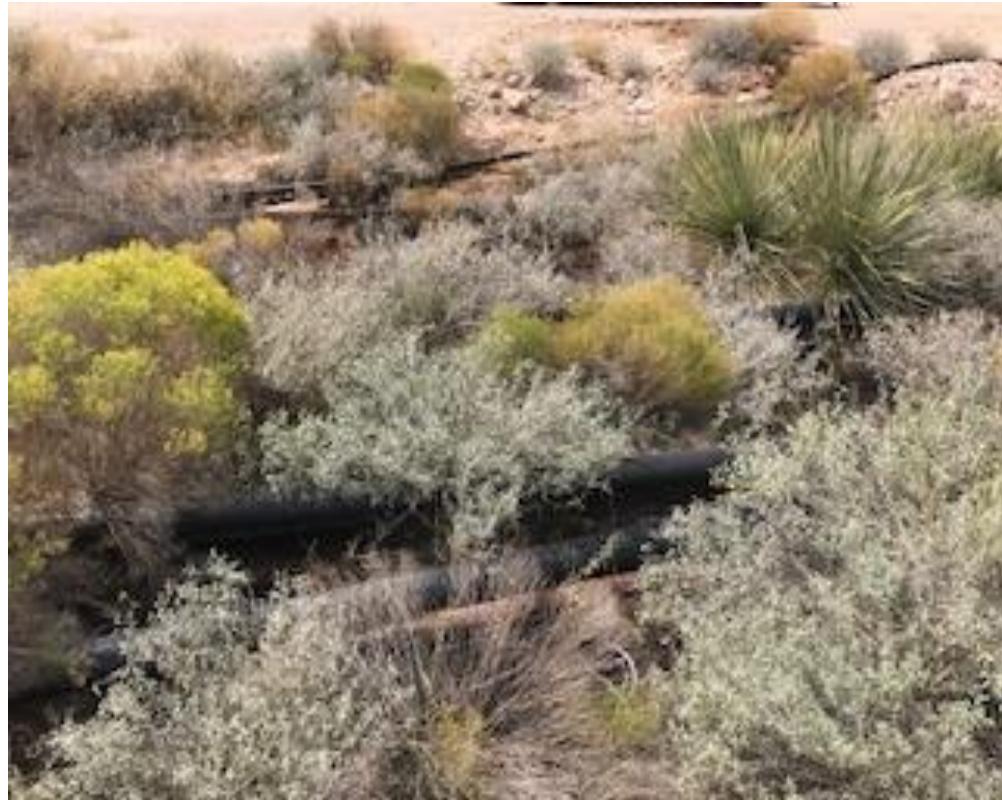
Release footprint – view south

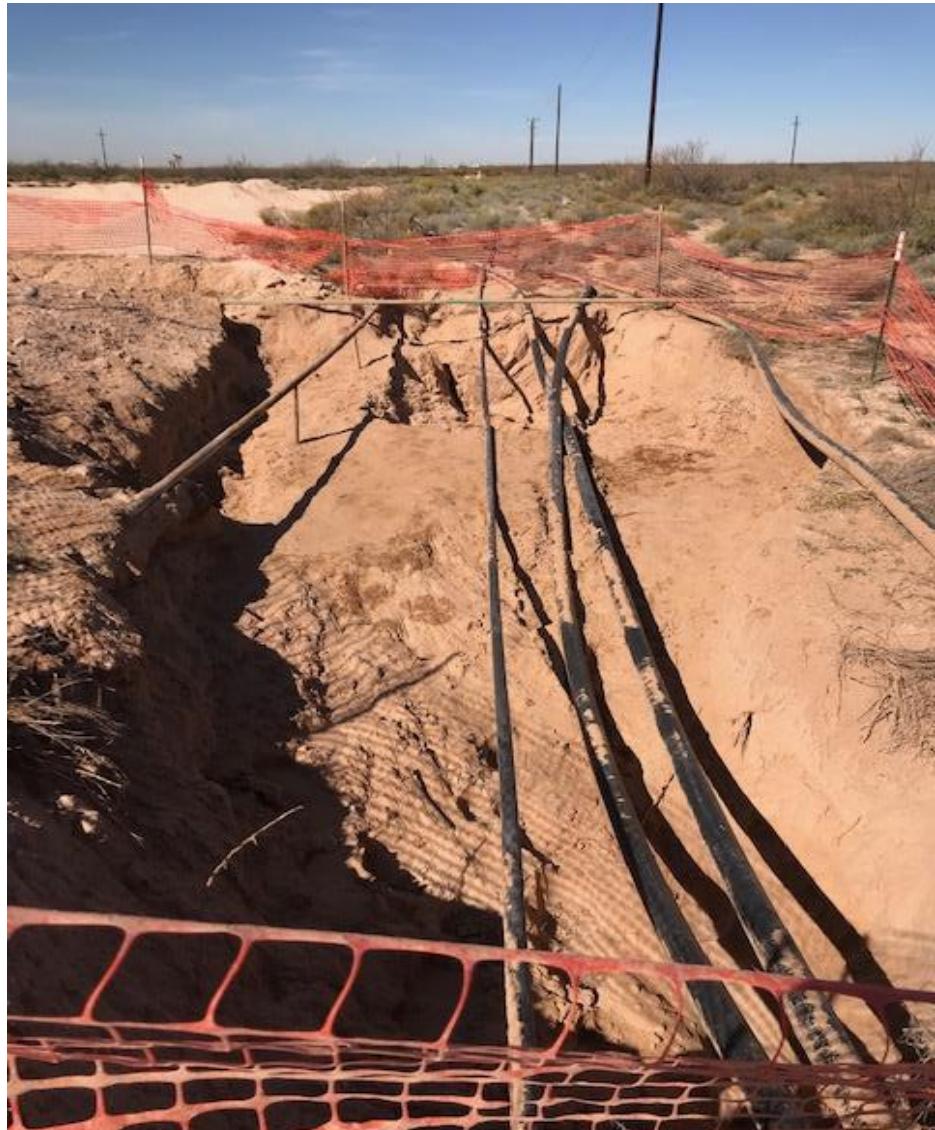
Excavation area – view north

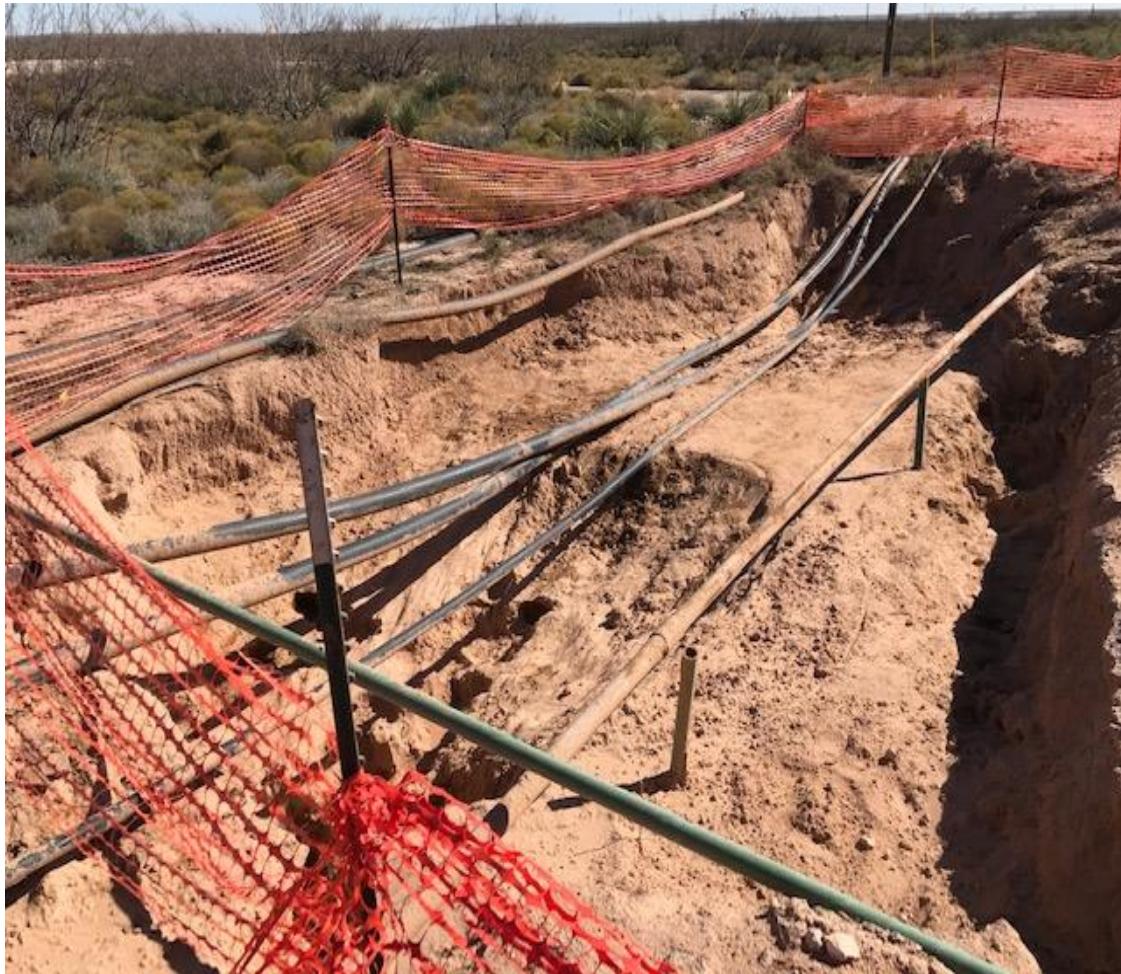
Excavation area – view southeast

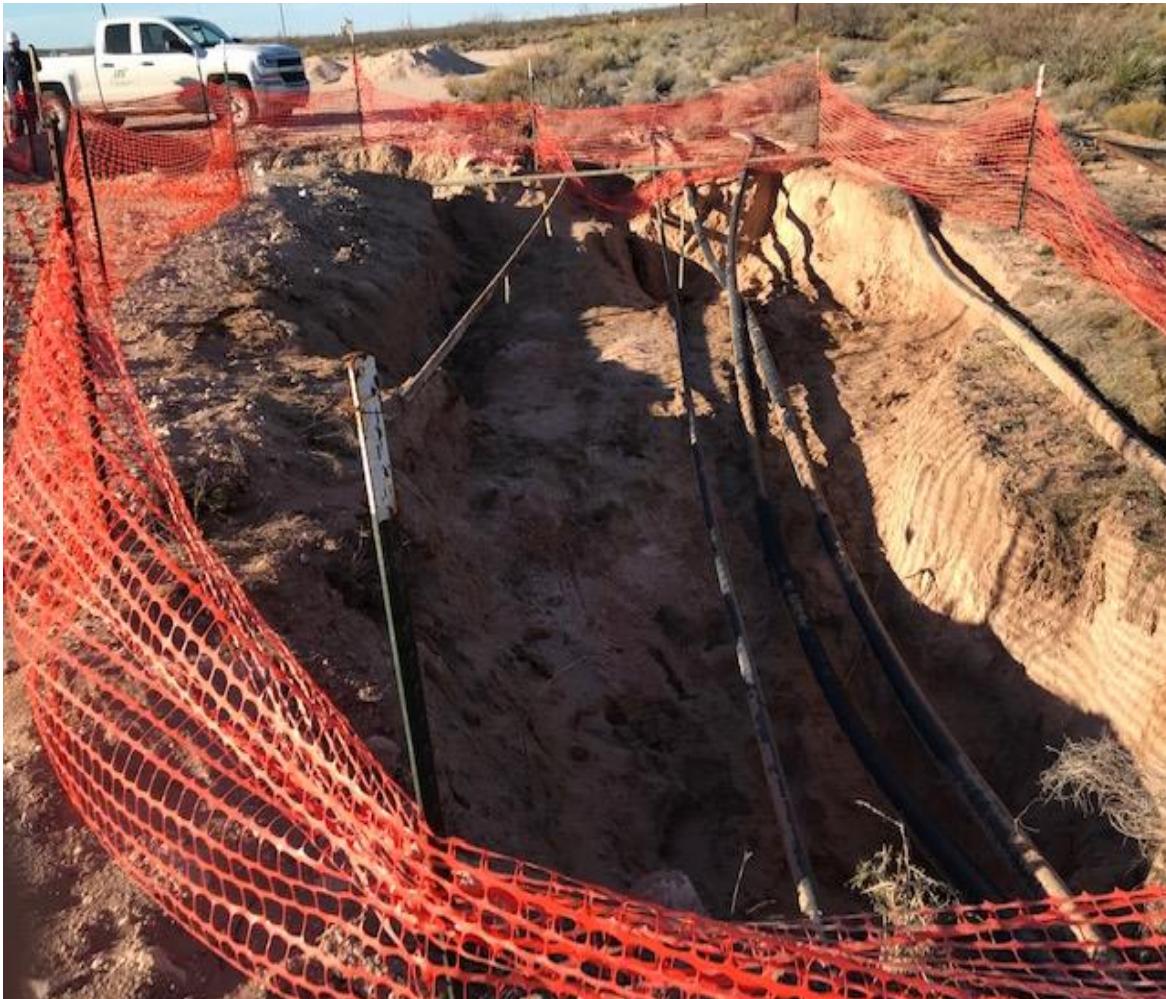
Excavation area – view north

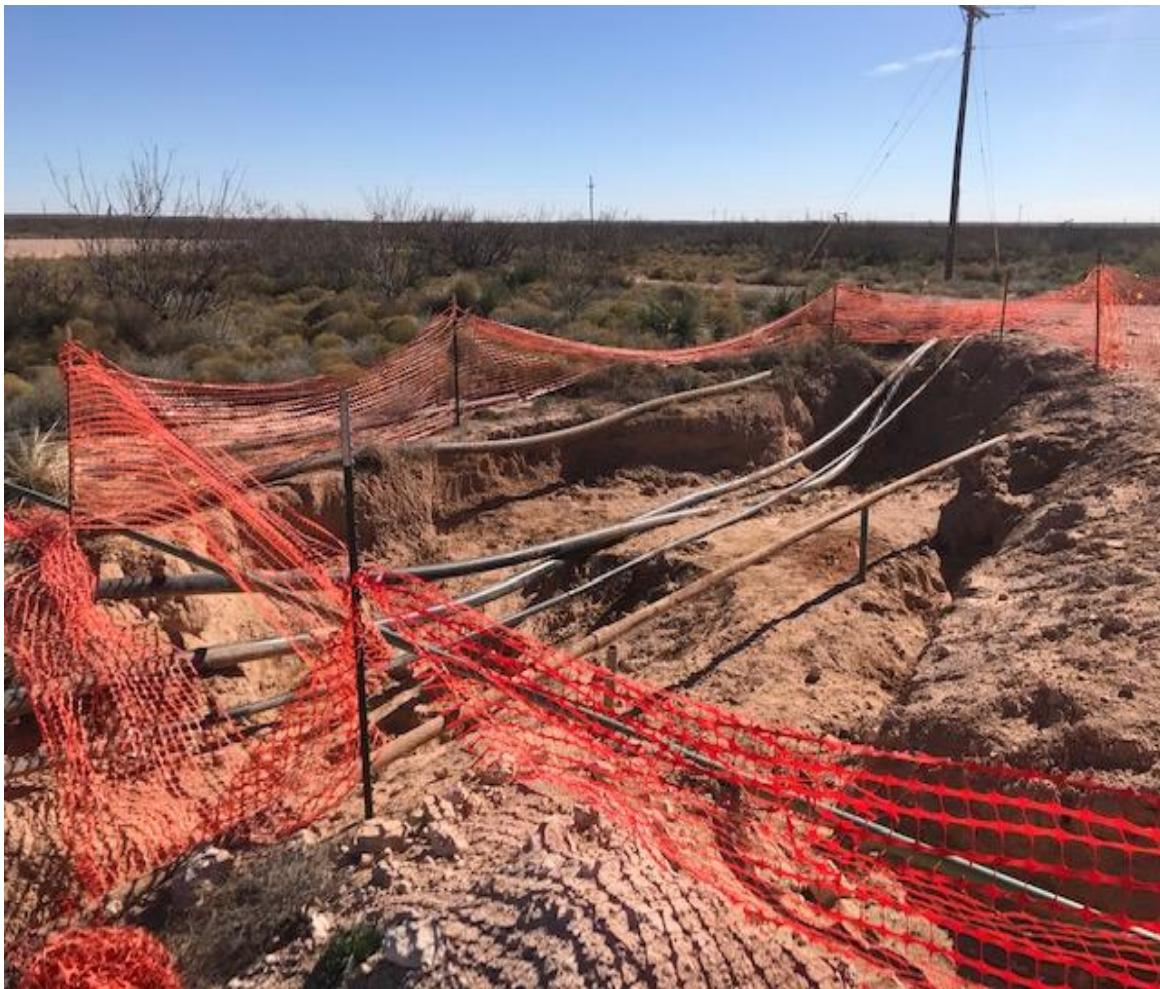
Excavation area – view southeast
