Remediation and Closure Report

COG FEZ Recycling Site
Talon Project # 701789.013.01
*1RP-5644

Subject: **Remediation and Closure Report**
COG FEZ Recycling Site
1RP-5644

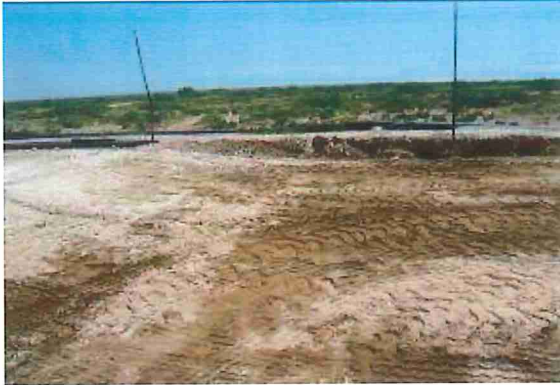
Figure 1 Pre-excavation, East edge of spill border

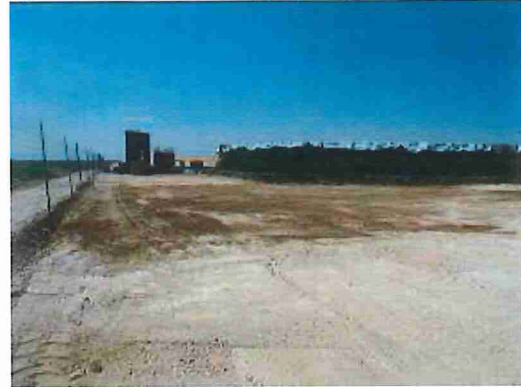
Figure 2 Pre-excavation, South-facing view of spill

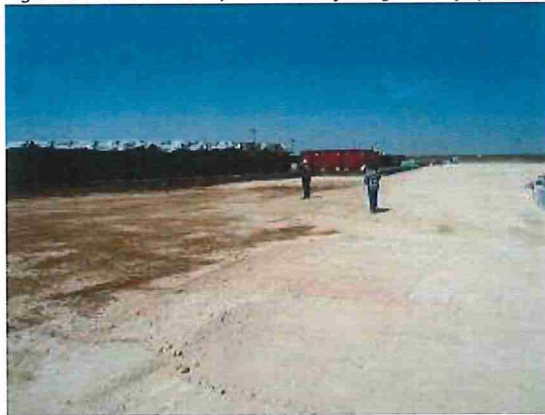
Figure 3 Pre-excavation, Southwest facing view of spill

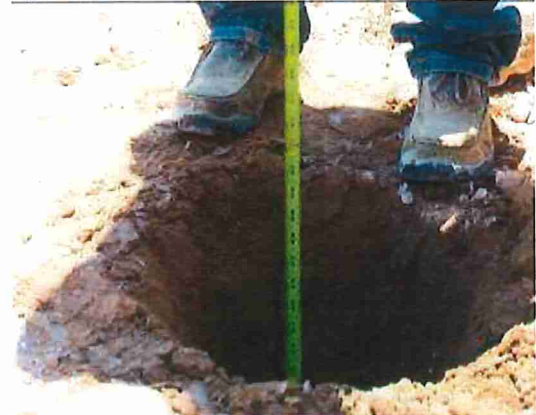
Figure 4 29-inch deep hole, South edge of spill

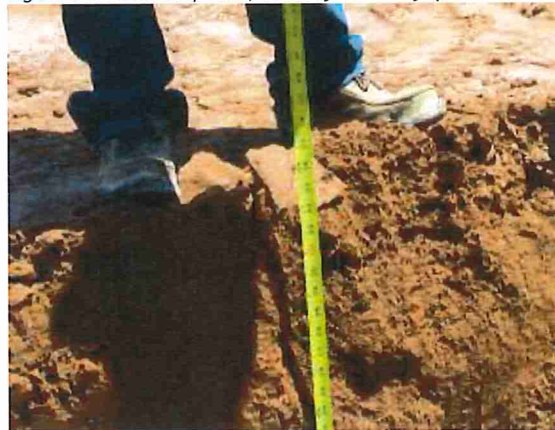
Figure 5 32-inch deep hole, West of Center of spill

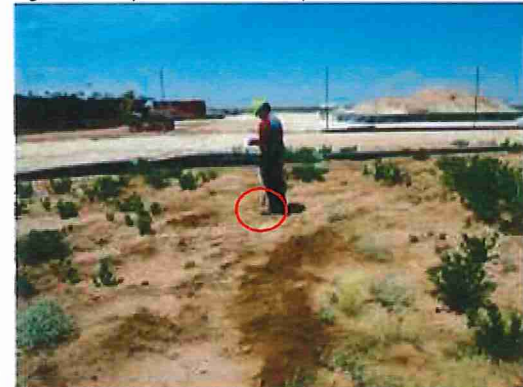
Figure 6 Sample 668 Collection point

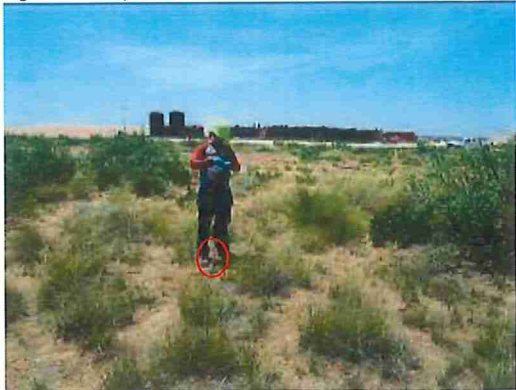
Figure 7 Sample 669 Collection point

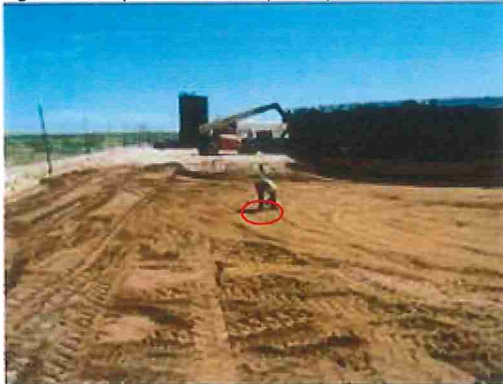
Figure 8 Sample A collection point, post-excavation

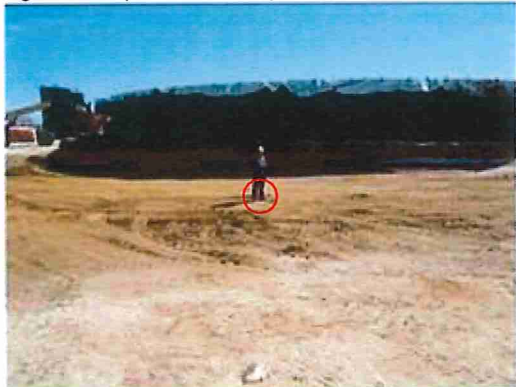
Figure 9 Sample B collection point, post-excavation

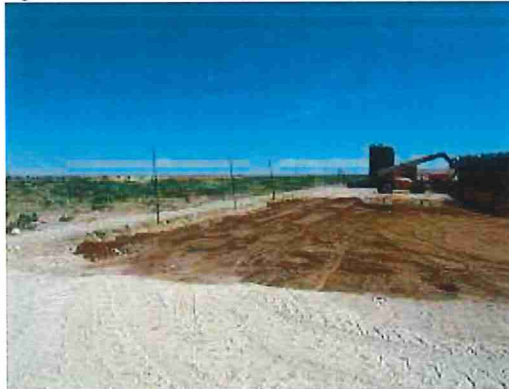
Figure 10 Post excavation, Southeast facing, spill site

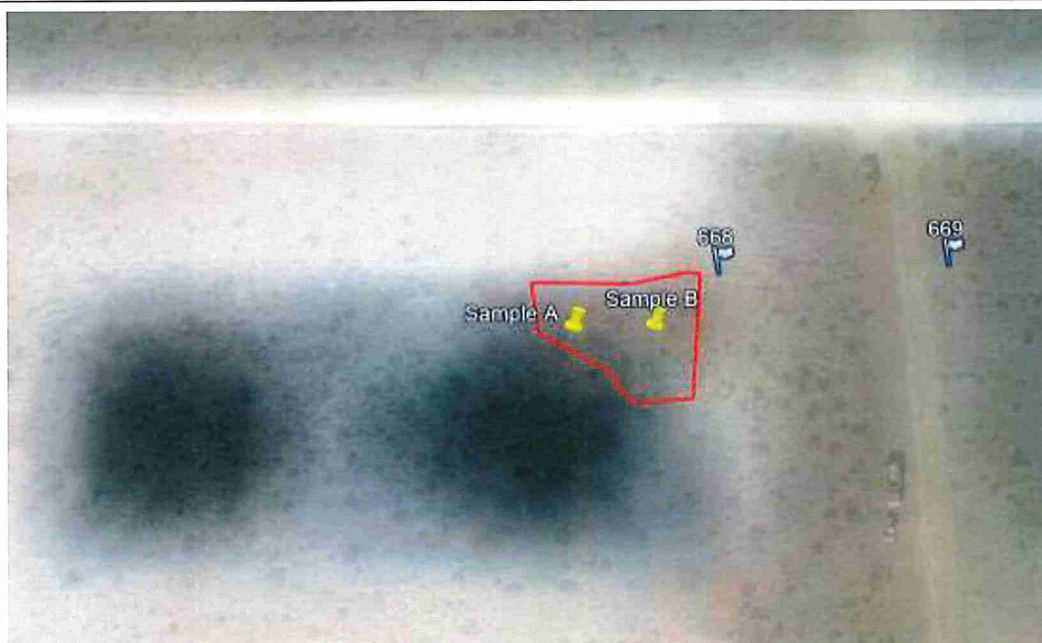
Figure 12 Zoomed satellite image, indicating spill border and sample locations
