Mojave AJY Com #1

Closure Report

30-015-26916

NRM2003033015

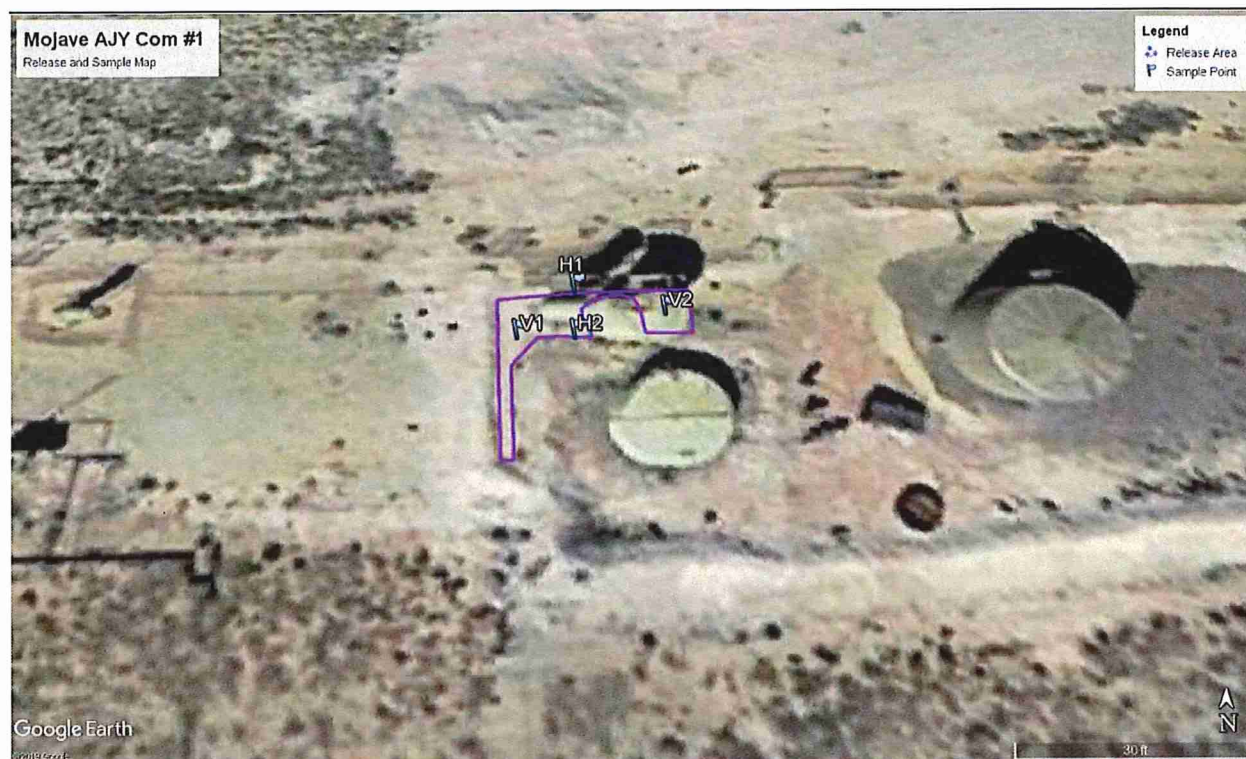
Figure 1

Site Map with Sample Points

Initial soil excavation activities removed eight (8) inches of impacted soils from the release area and hauled that impacted soil to a NMOCD approved disposal facility. Soil sample analysis conducted at the site on January 20 and February 18, 2020, affirmed that all impacted soils had been removed during initial site excavation activities with results being under the required thresholds of Table 1 closure requirements. All soil sampling was conducted by way of 5-point composite samples, with no one sample representing greater than 200 square feet.

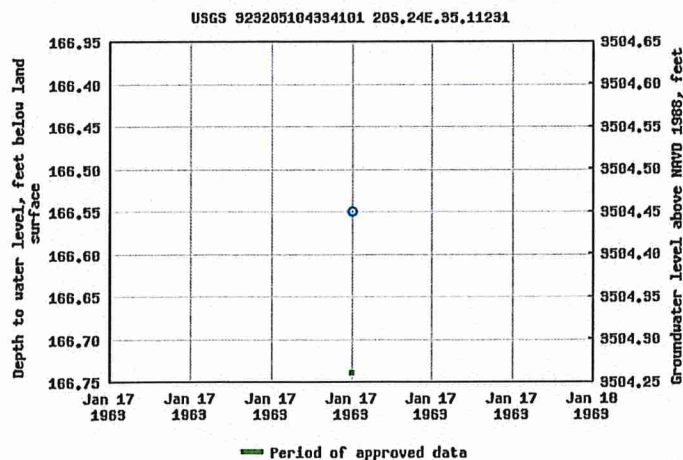
USGS 323205104334101 20S.24E.35.11231

This well is completed in the Rustler Formation (312RSLR) local aquifer.

Breaks in the plot represent a gap of at least one year between field measurements.

Area geology is Paleozoic Permian. Based on information from the United States Geological Survey National Water Information System (USGS) regarding this location (Section 35, T20H-R23E), depth to groundwater is approximately 156 feet with the nearest water wells being to the north (1.2 miles) and south (1.5 miles) with water located at depths of 166 and 146. Watercourses in the area are dry except for infrequent flows in response to major precipitation events, with the nearest body of surface water being Brantley Lake at approximately 9.4 miles away. The site is located outside of a 100 year flood plain, but is within a high karst area.
