JR47H-200305-C-1410

Site Assessment/Characterization

Based on laboratory analytical results and field activities conducted to date, Etech recommends ETC Texas Pipeline, Ltd. provide copies of this Remediation Summary and Soil Closure Request to the appropriate agencies and request closure be granted to the F-16-4 Pipeline Site.

Figure 2
 Aerial Map
 ETC Texas Pipeline, Ltd.
 F-16-4 Pipeline
 GPS: 32.401098, -103.155626
 Lea County

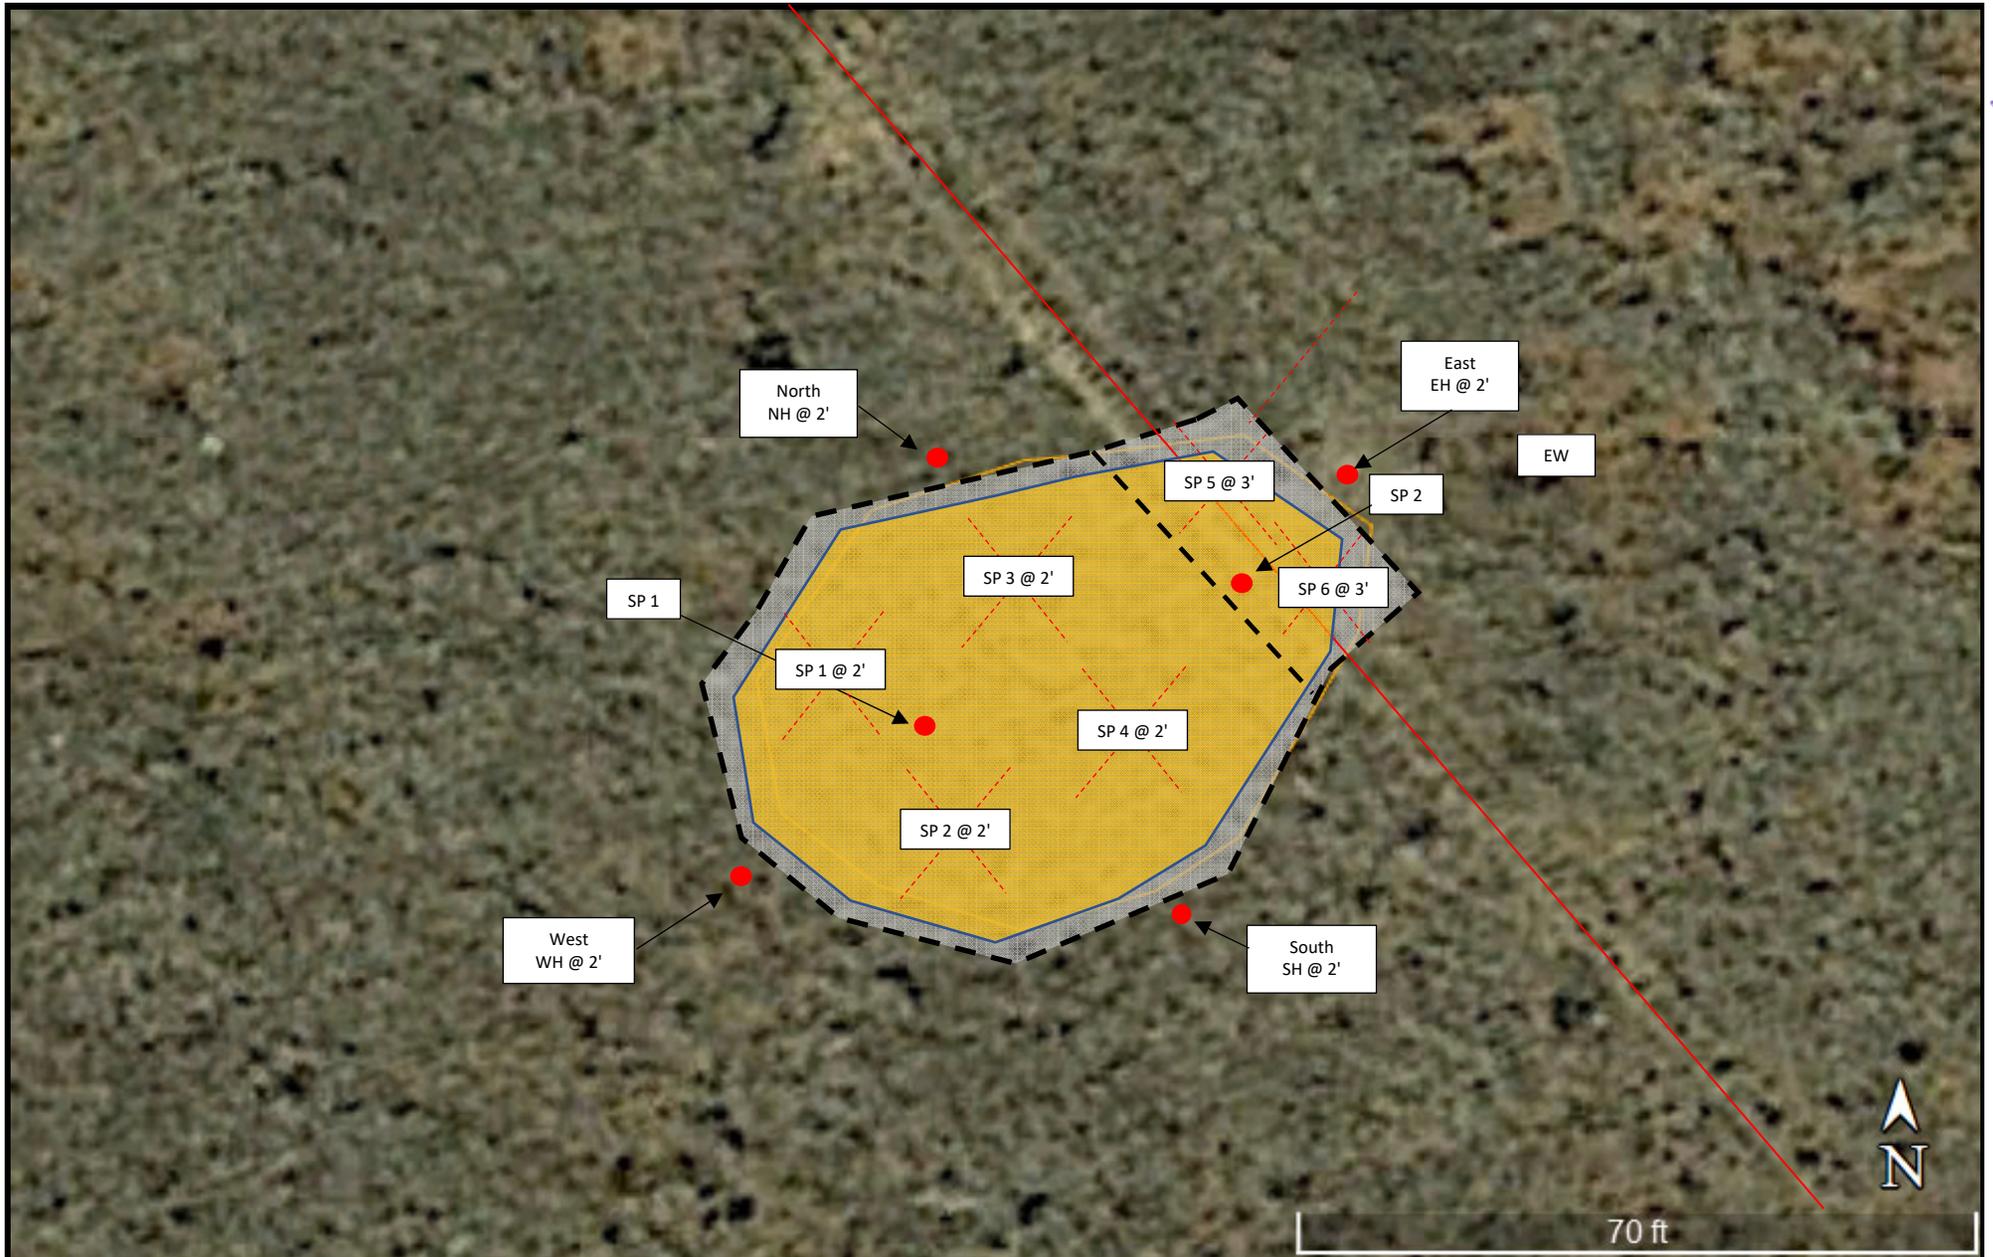
Figure 3

Site and Sample Location Map

Delineation Sample Point
	Affected Area
	Buried Pipeline
	Excavated Area

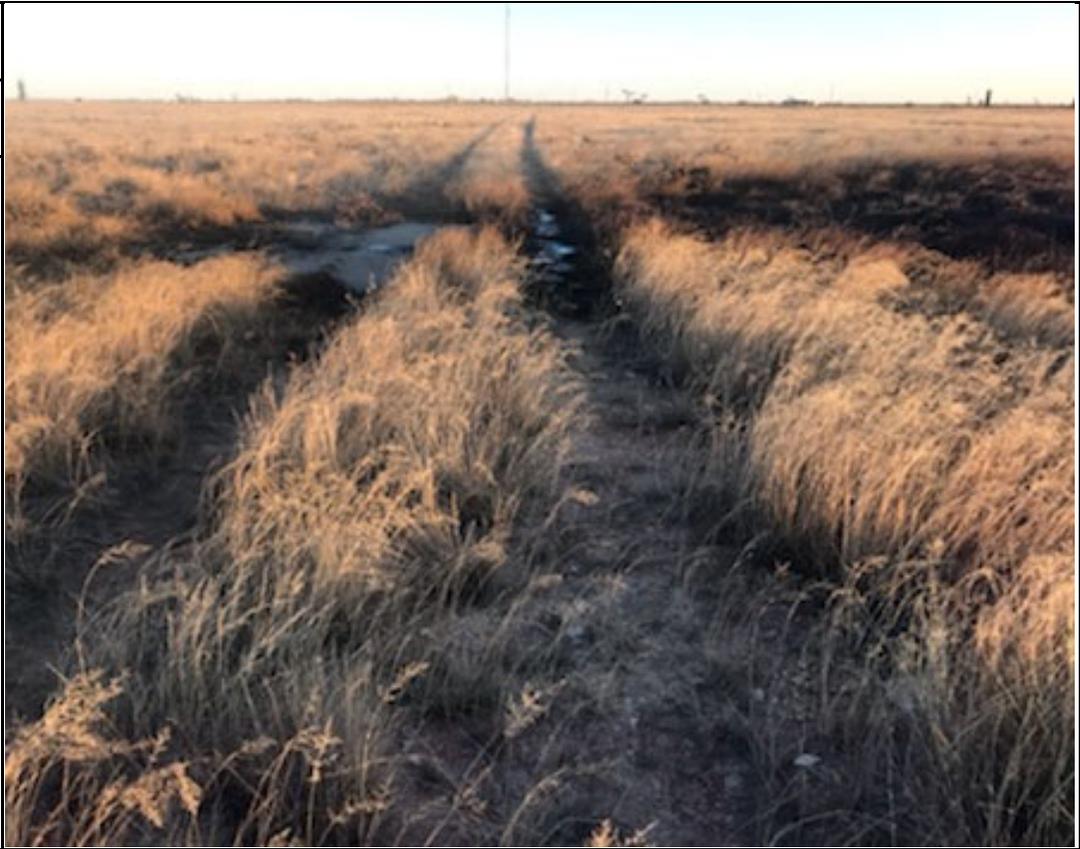
Photo Number: 1

Photo Direction: Southeast	
Photo Description: Initial release discovery.

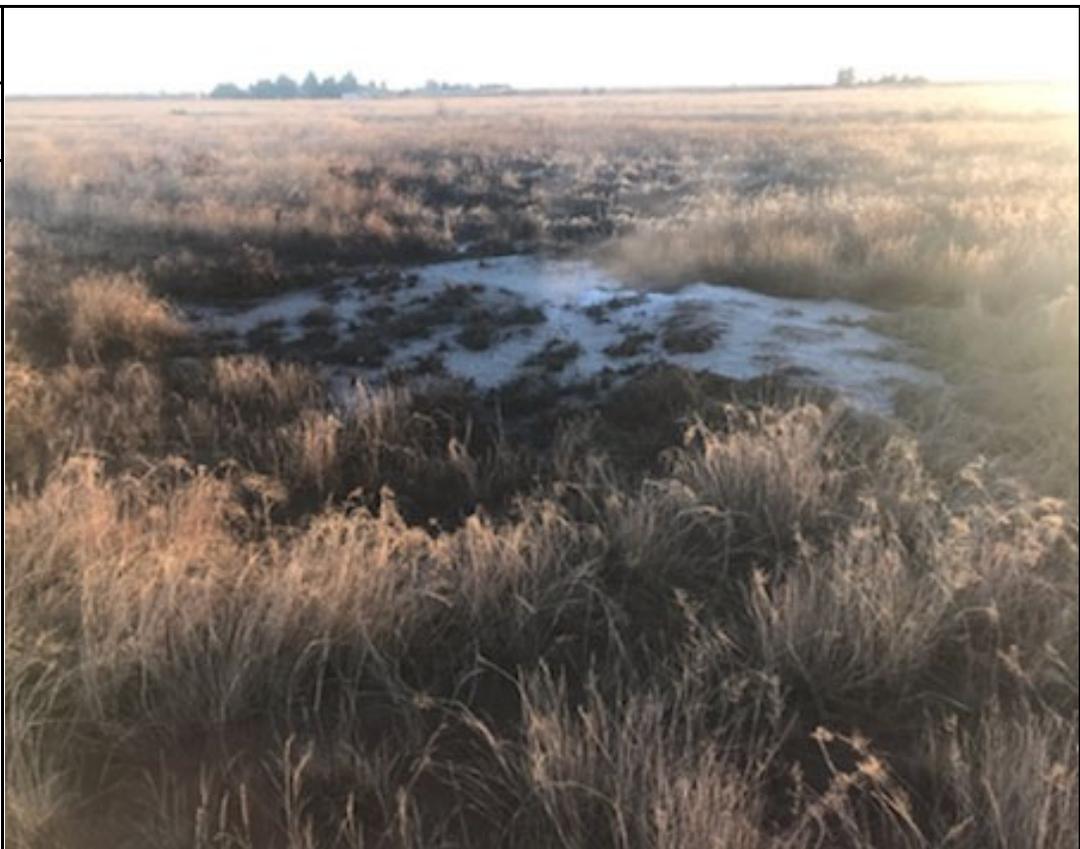
Photo Number: 2

Photo Direction: Southwest	
Photo Description: Initial release discovery.

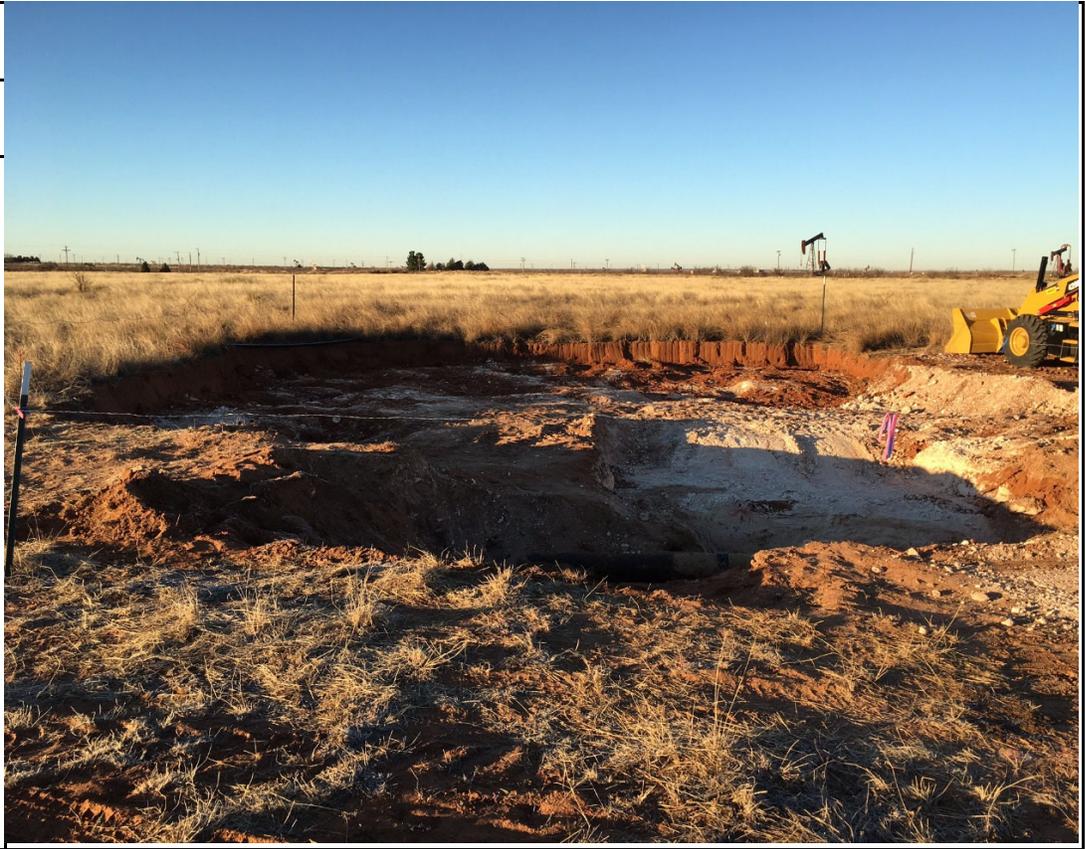
Photo Number: 3
Photo Direction: Southwest
Photo Description: Excavation in progress.

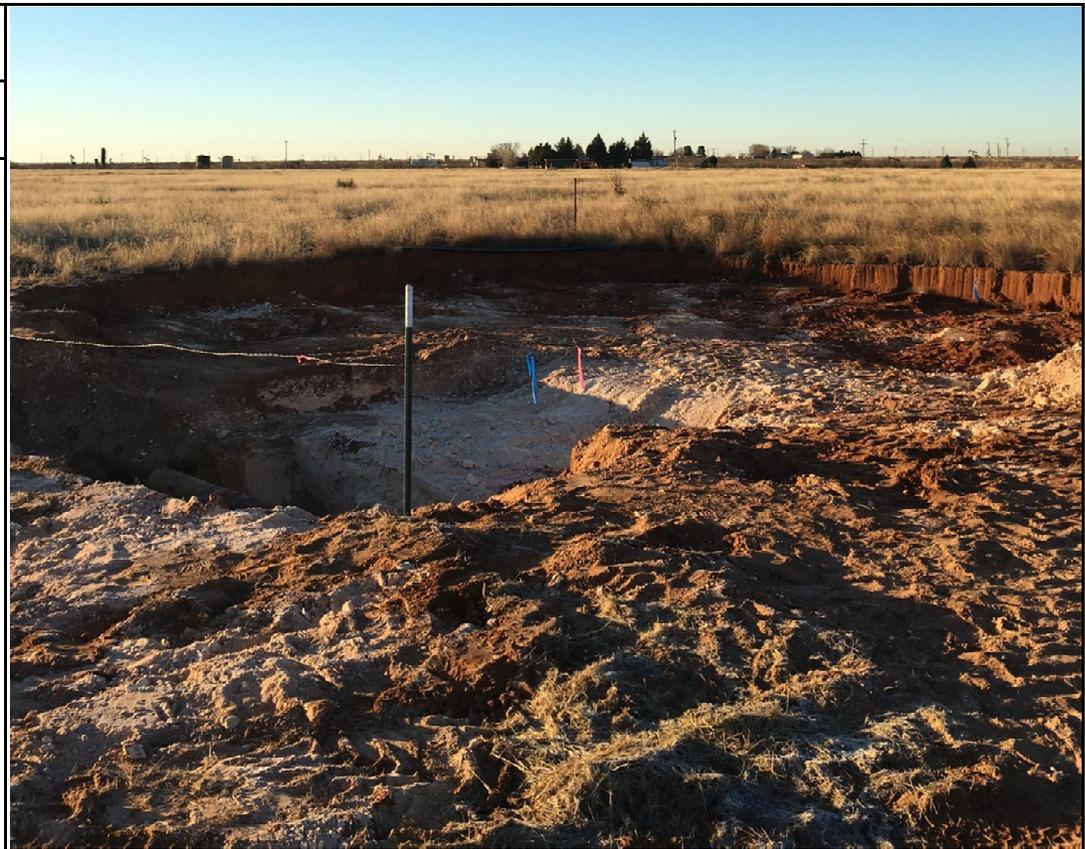
Photo Number: 4
Photo Direction: South
Photo Description: Excavation in progress.

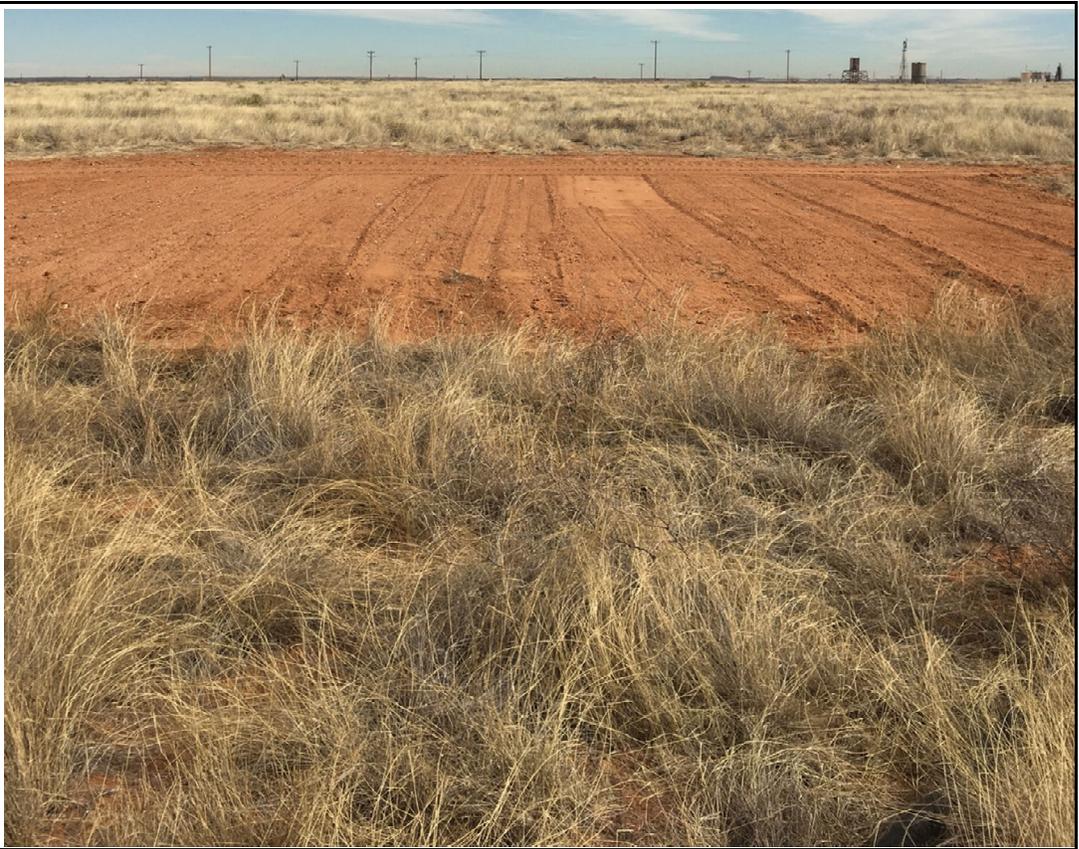
Photo Number: 5
Photo Direction: Northeast
Photo Description: Excavation backfilled and graded.

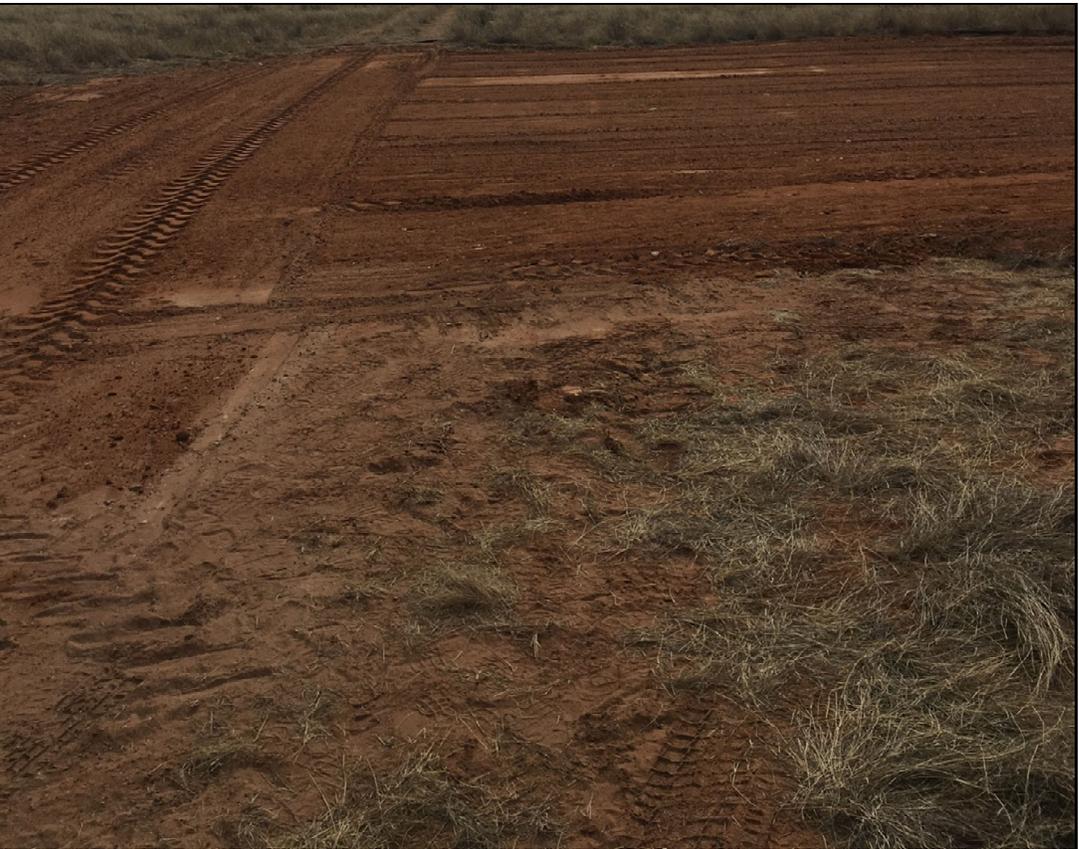
Photo Number: 6
Photo Direction: Southeast
Photo Description: Excavation backfilled and graded.
