SUBJECT: Remediation Closure Report for the Taylor Deep 12 Federal #006 Release (2RP-TBD Receipt No. Y423L-191029-C-14010), Eddy County, New Mexico

Taylor Deep 12 Federal #006 Remediation Closure Report (2RP-TBD)
January 21, 2020

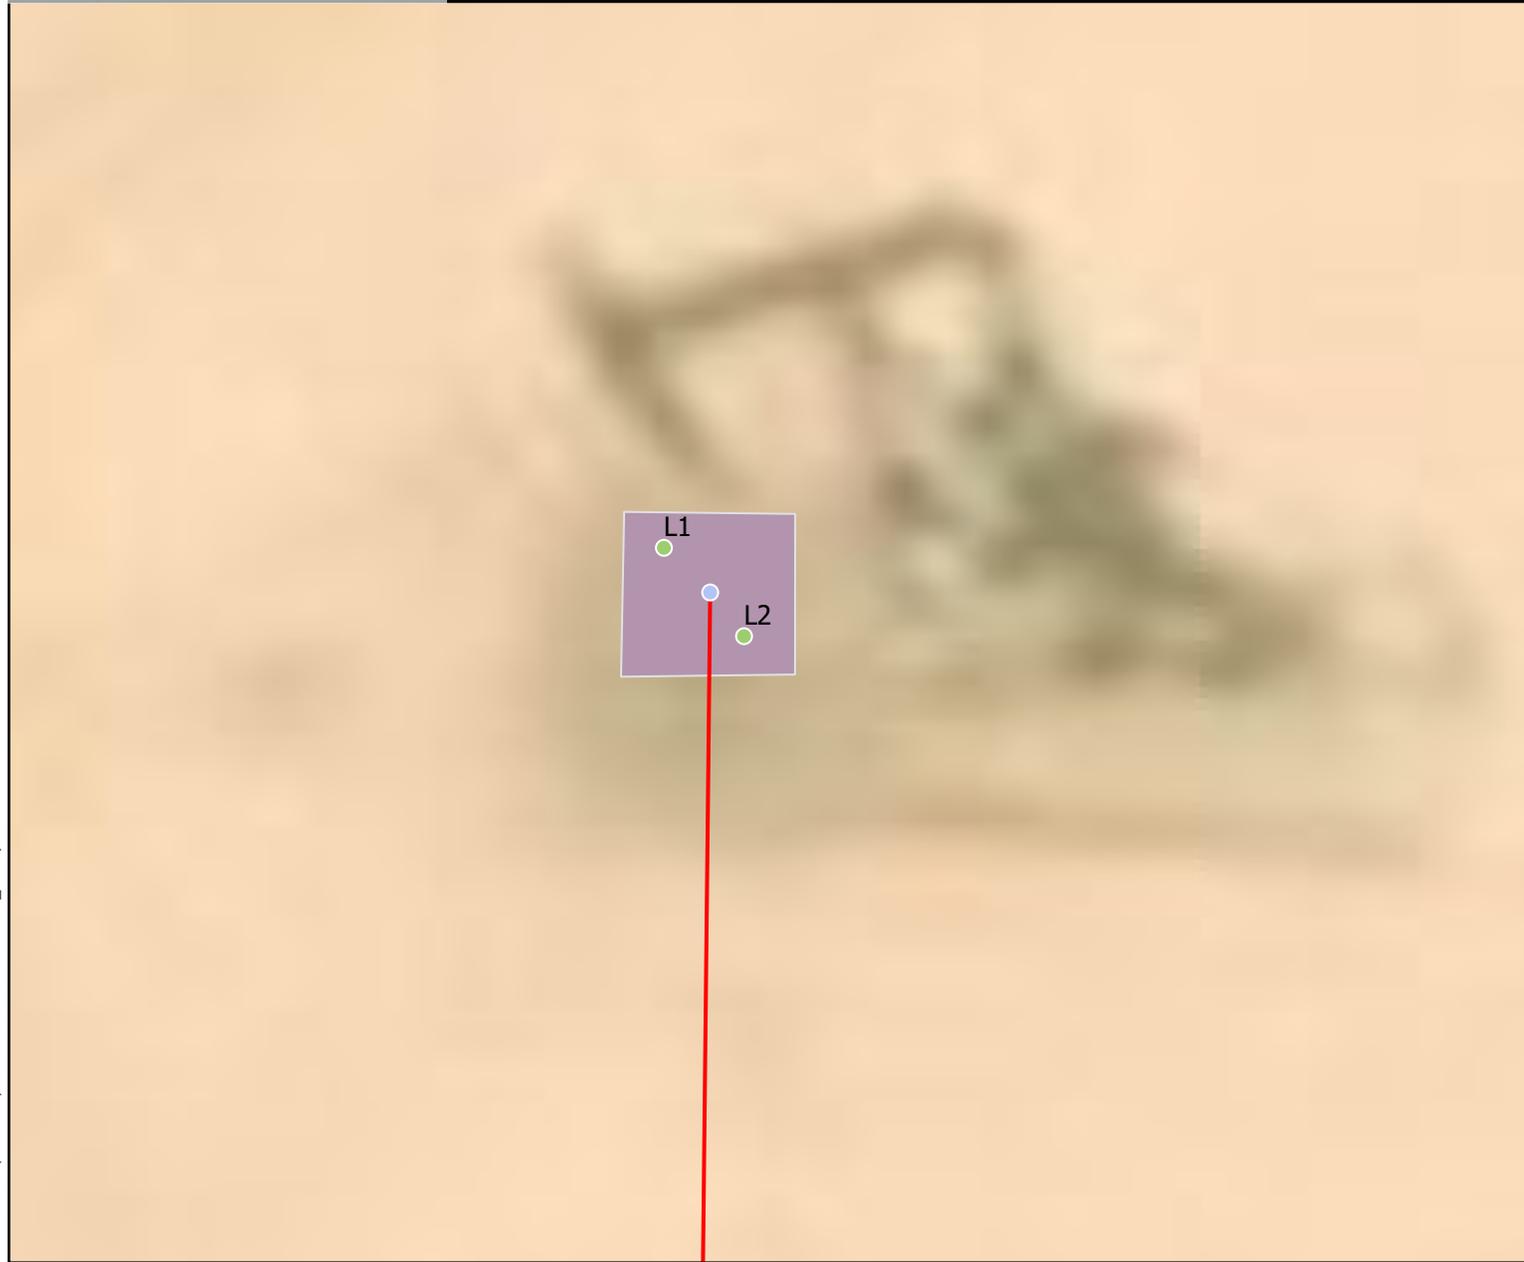
- Legend**
- Point of Release
 - Sample Locations
 - Release Area
 - Pipelines

Site and Sample Location Map
 Taylor Deep 12 Fed #6 - Marathon Oil LLC
 UL: A S: 12 T: 18S R: 31E Eddy County, New Mexico

A total of two (2) sample locations (L1,L2) were investigated using a hand-auger, to depths up to two and a half (2.5) feet bgs. Two samples were collected at each sampling location and field-screened using the methods above. A total of four (4) samples were collected for laboratory analysis for total chloride using EPA Method 300.0; benzene, toluene, ethylbenzene and total xylenes (BTEX) using EPA Method 8021B; and motor, diesel and gasoline range organics (MRO, DRO, and GRO) by EPA Method 8015D.

As summarized in Table 3, results indicated that an area approximately 10 feet by 20 feet by 2.5 feet deep had been impacted.

Figure 3 shows the initial sample locations and Figure 3A shows the extent of the excavation and closure samples. Laboratory results are summarized in Table 3. Laboratory reports are included in Appendix D.

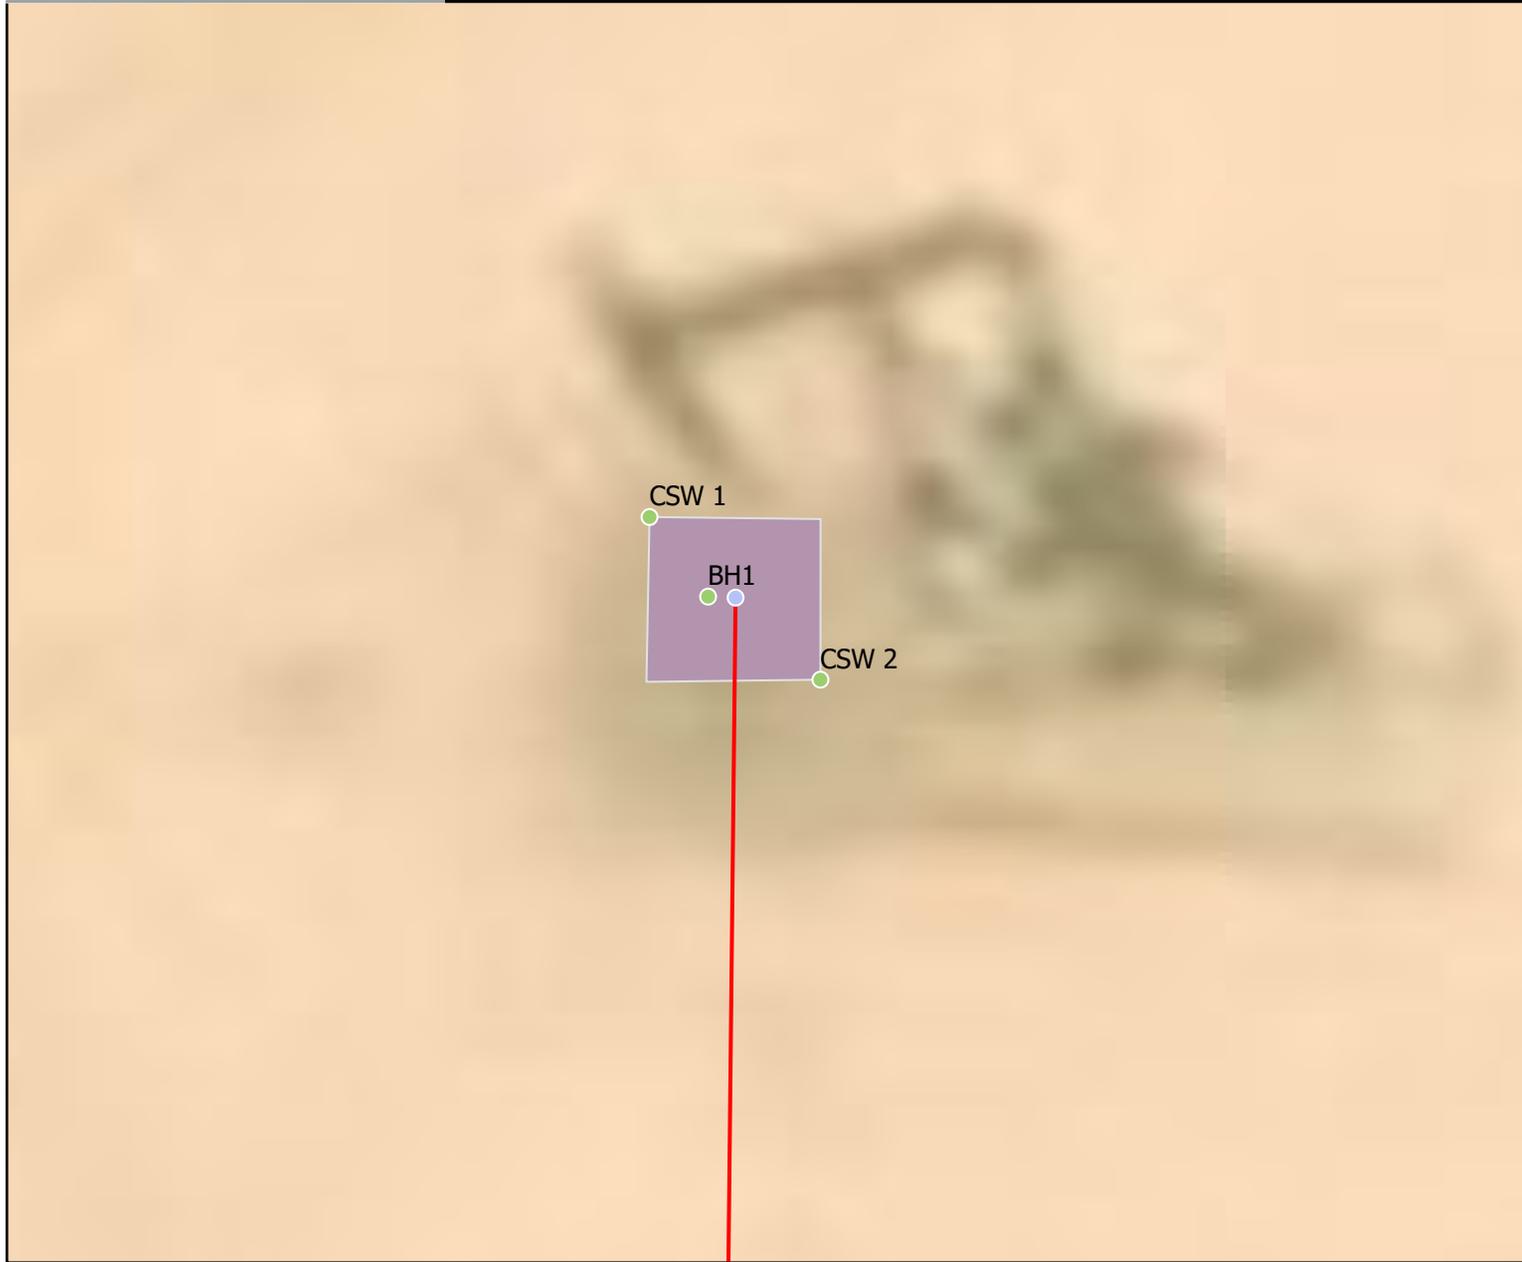
Figure 3A

- Legend**
- Point of Release
 - Sample Locations
 - Release Area
 - Pipelines

Site and Sample Location Map
 Taylor Deep 12 Fed #6 - Marathon Oil LLC
 UL: A S: 12 T: 18S R: 31E Eddy County, New Mexico

On January 6, 2020, SMA conducted confirmation sampling of the walls and base of the excavation, which measured approximately 10 X 11 X 2.5 feet deep. Confirmation samples were comprised of five-point composites of the base (BH1) and walls (CSW1 and CSW2).

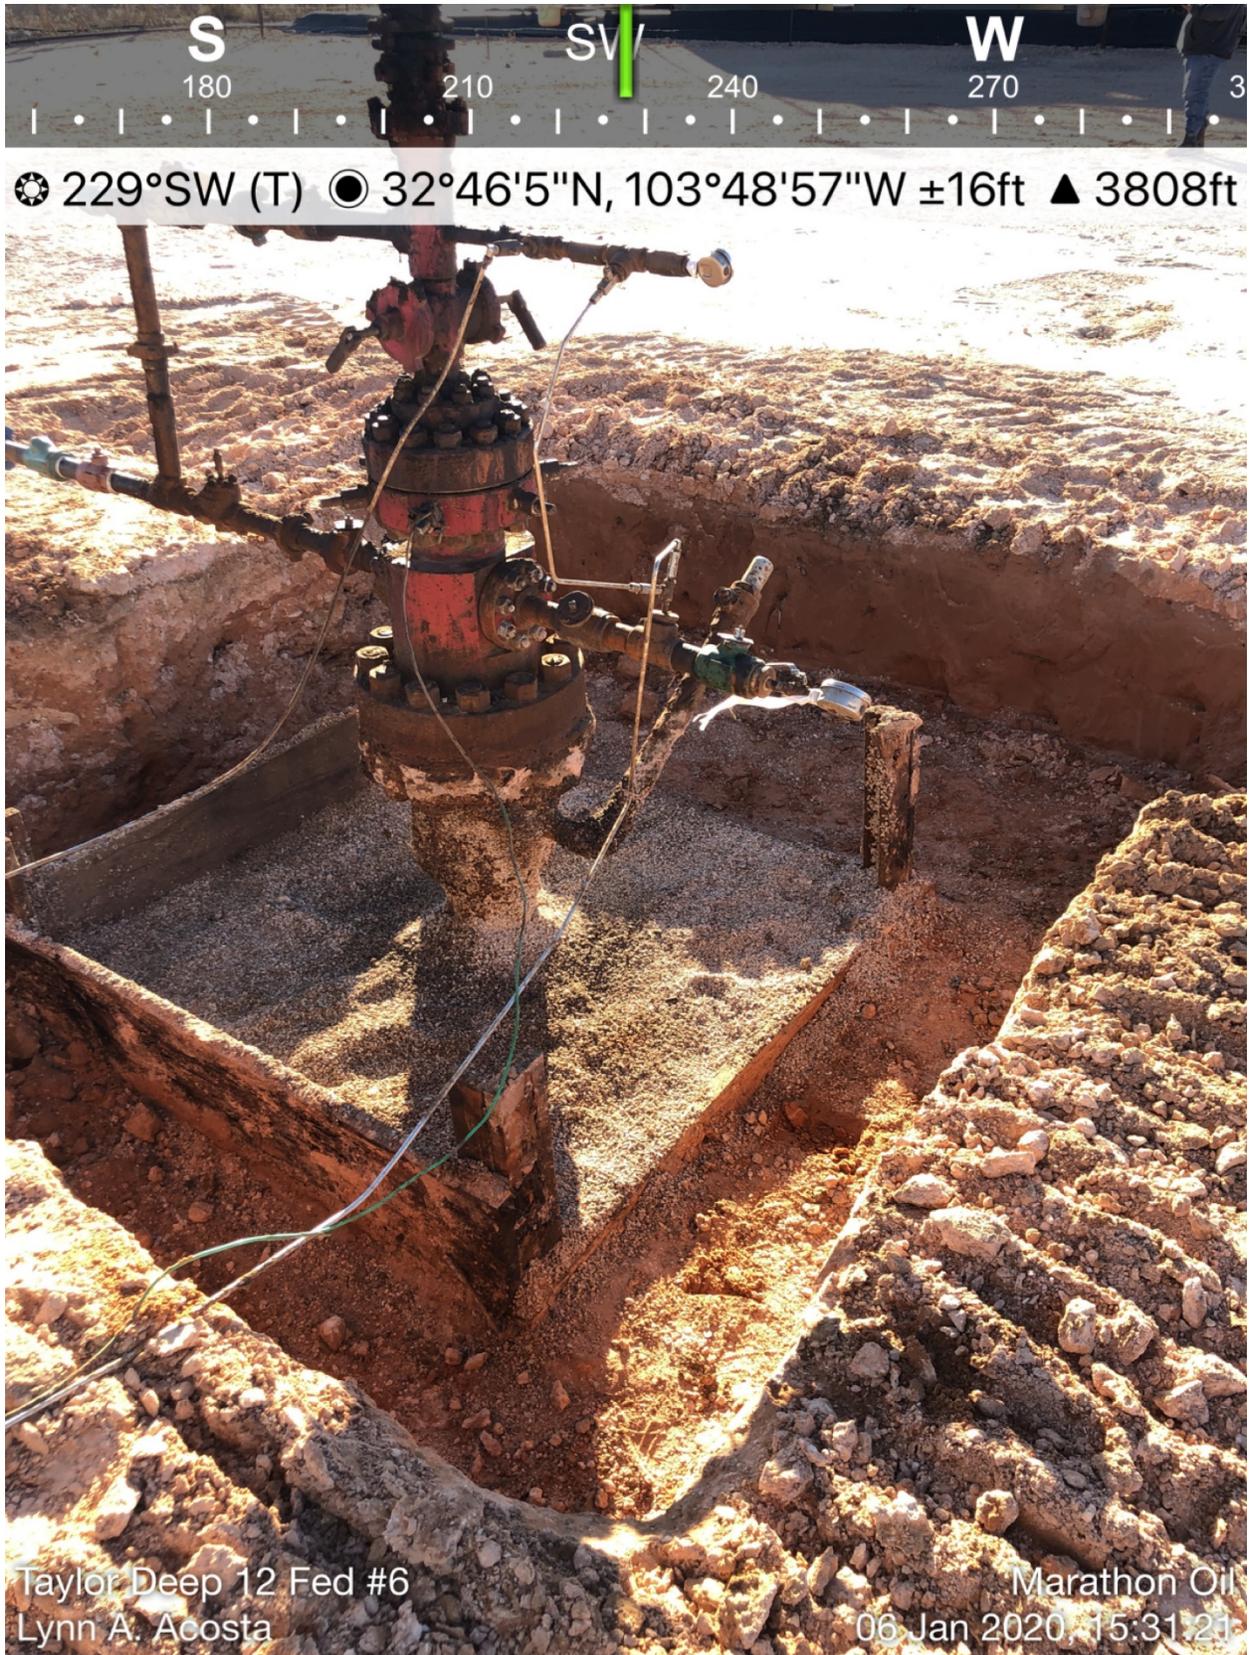
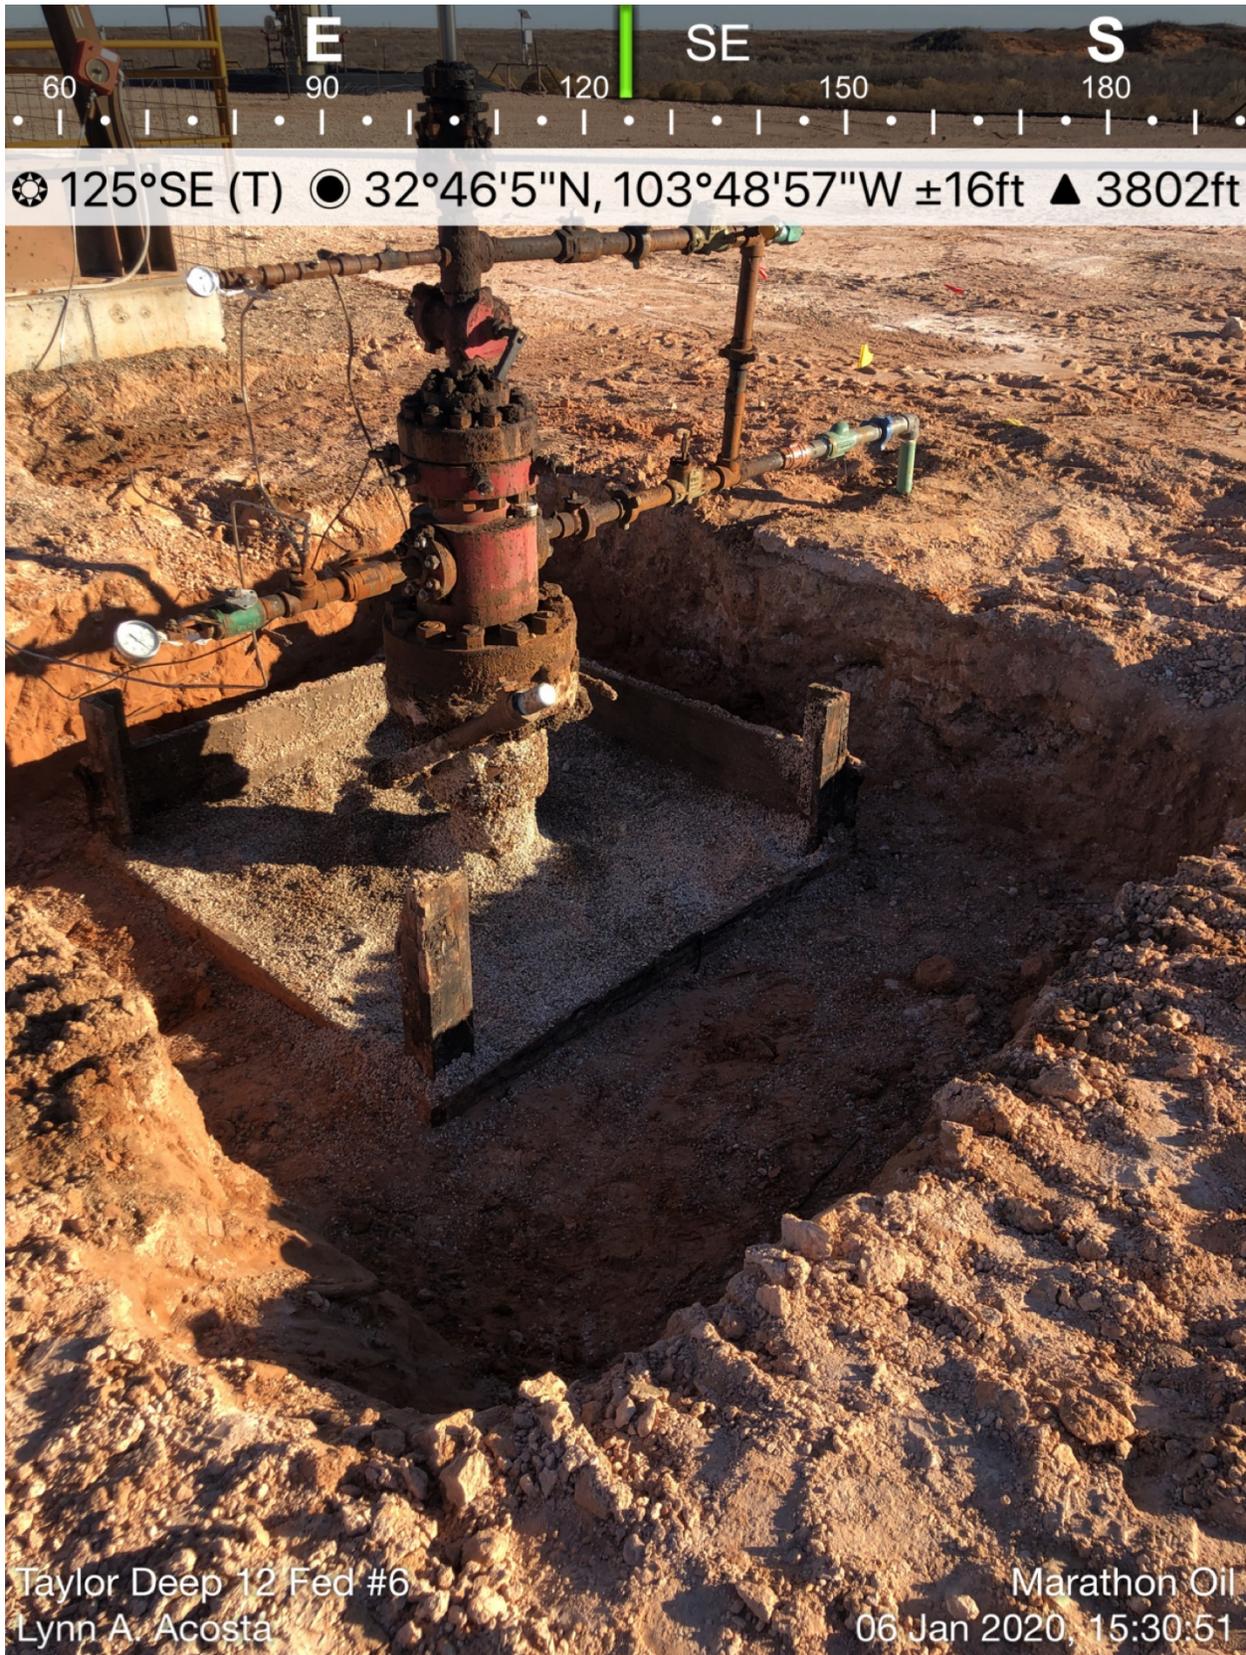
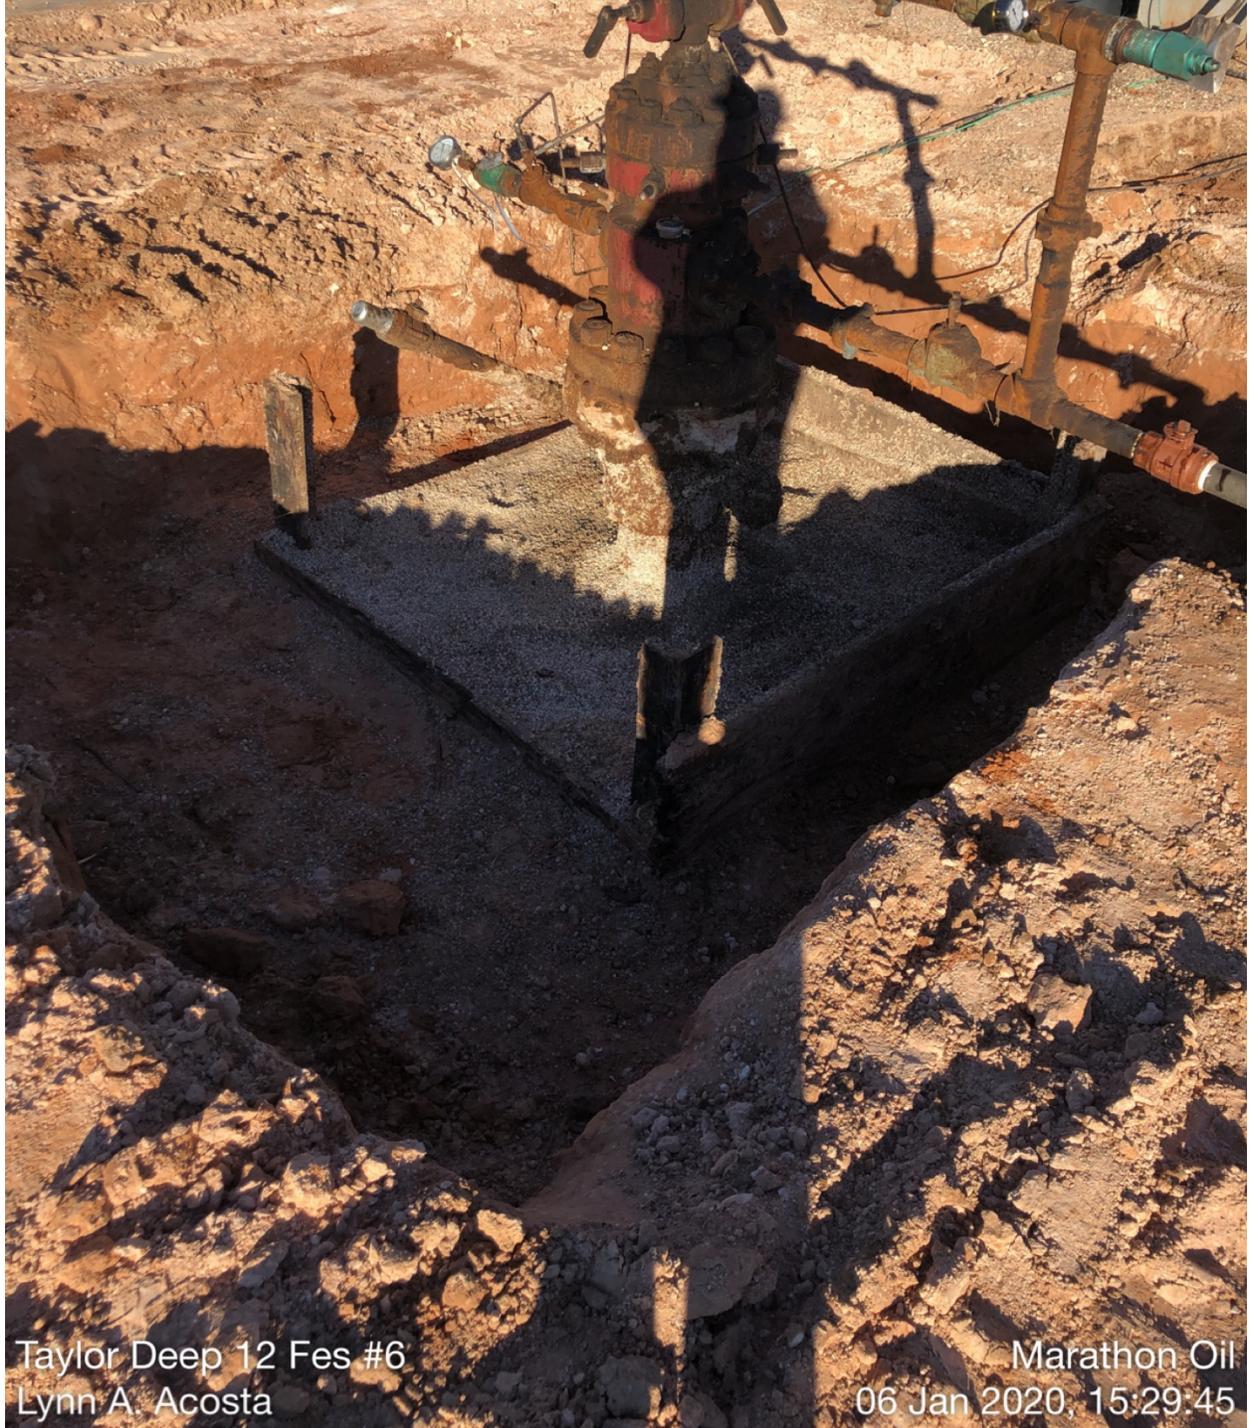
Taylor Deep 12 Fed #6
Lynn A. Acosta

Marathon Oil
06 Jan 2020, 15:30:51

Taylor Deep 12 Fes #6
Lynn A. Acosta

Marathon Oil
06 Jan 2020, 15:29:45
