Closure Report

Re: Hawk B-1 Battery

API# 30-025-35799

Case # 1RP-5252

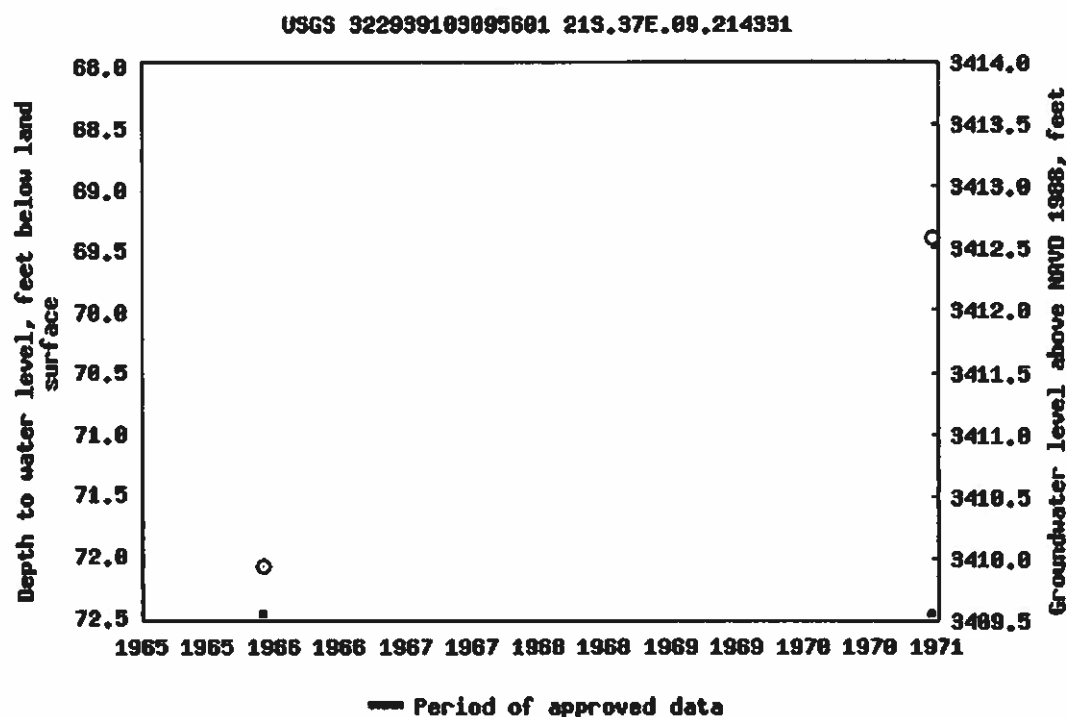
USGS 322939103095601 21S.37E.09.214331

Lea County, New Mexico
Hydrologic Unit Code 13070007
Latitude 32°29'39", Longitude 103°09'56" NAD27
Land-surface elevation 3,482 feet above NAVD88
The depth of the well is 400 feet below land surface.
This well is completed in the Chinle Formation (231CHNL) local aquifer.

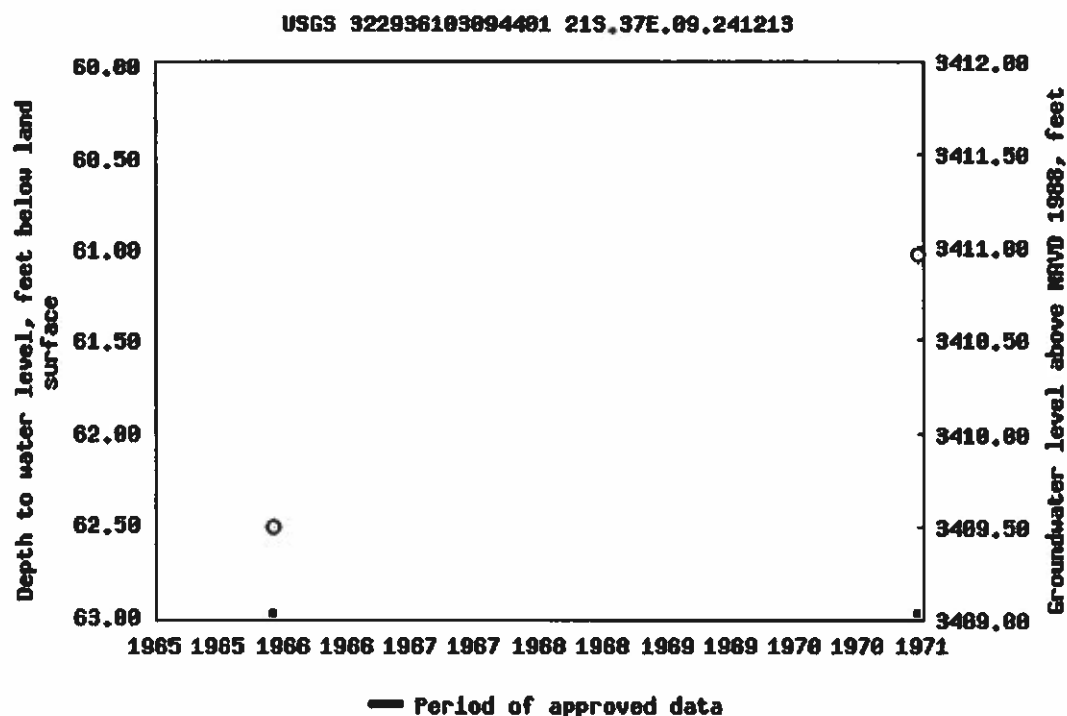
USGS 322936103094401 21S.37E.09.241213

The depth of the well is 90 feet below land surface.

This well is completed in the Alluvium, Bolson Deposits and Other Surface Deposits (110AVMB) local aquifer.

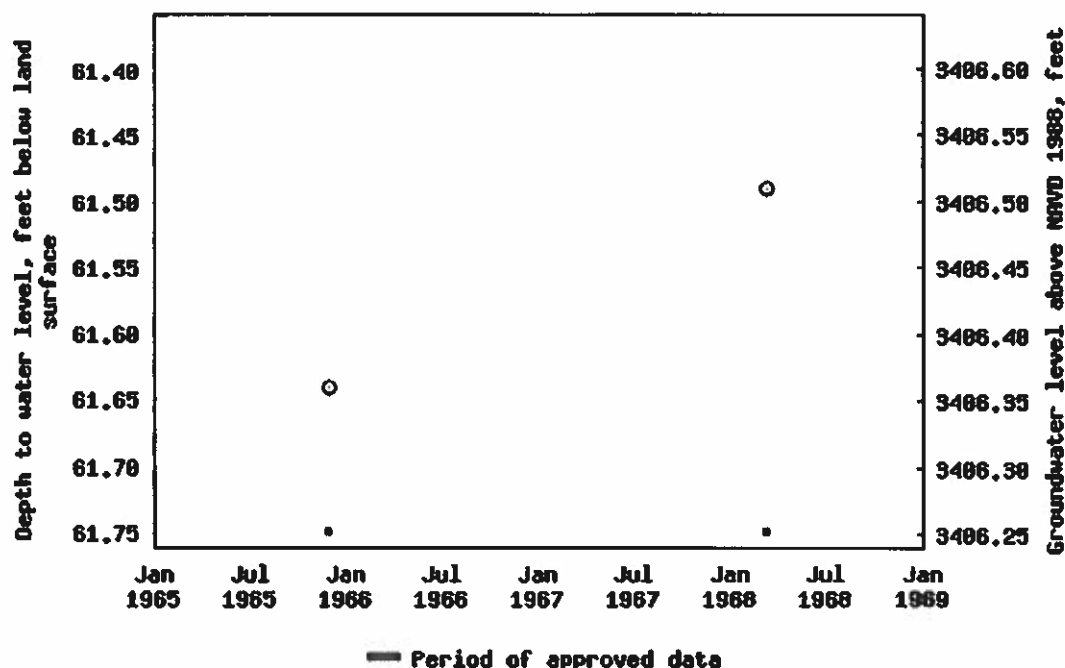
USGS 322939103093901 21S.37E.09.22430

Lea County, New Mexico
Hydrologic Unit Code 13070007
Latitude 32°29'39", Longitude 103°09'39" NAD27
Land-surface elevation 3,468 feet above NAVD88
The depth of the well is 90 feet below land surface.

This well is completed in the Alluvium, Bolson Deposits and Other Surface Deposits (110AVMB) local aquifer.

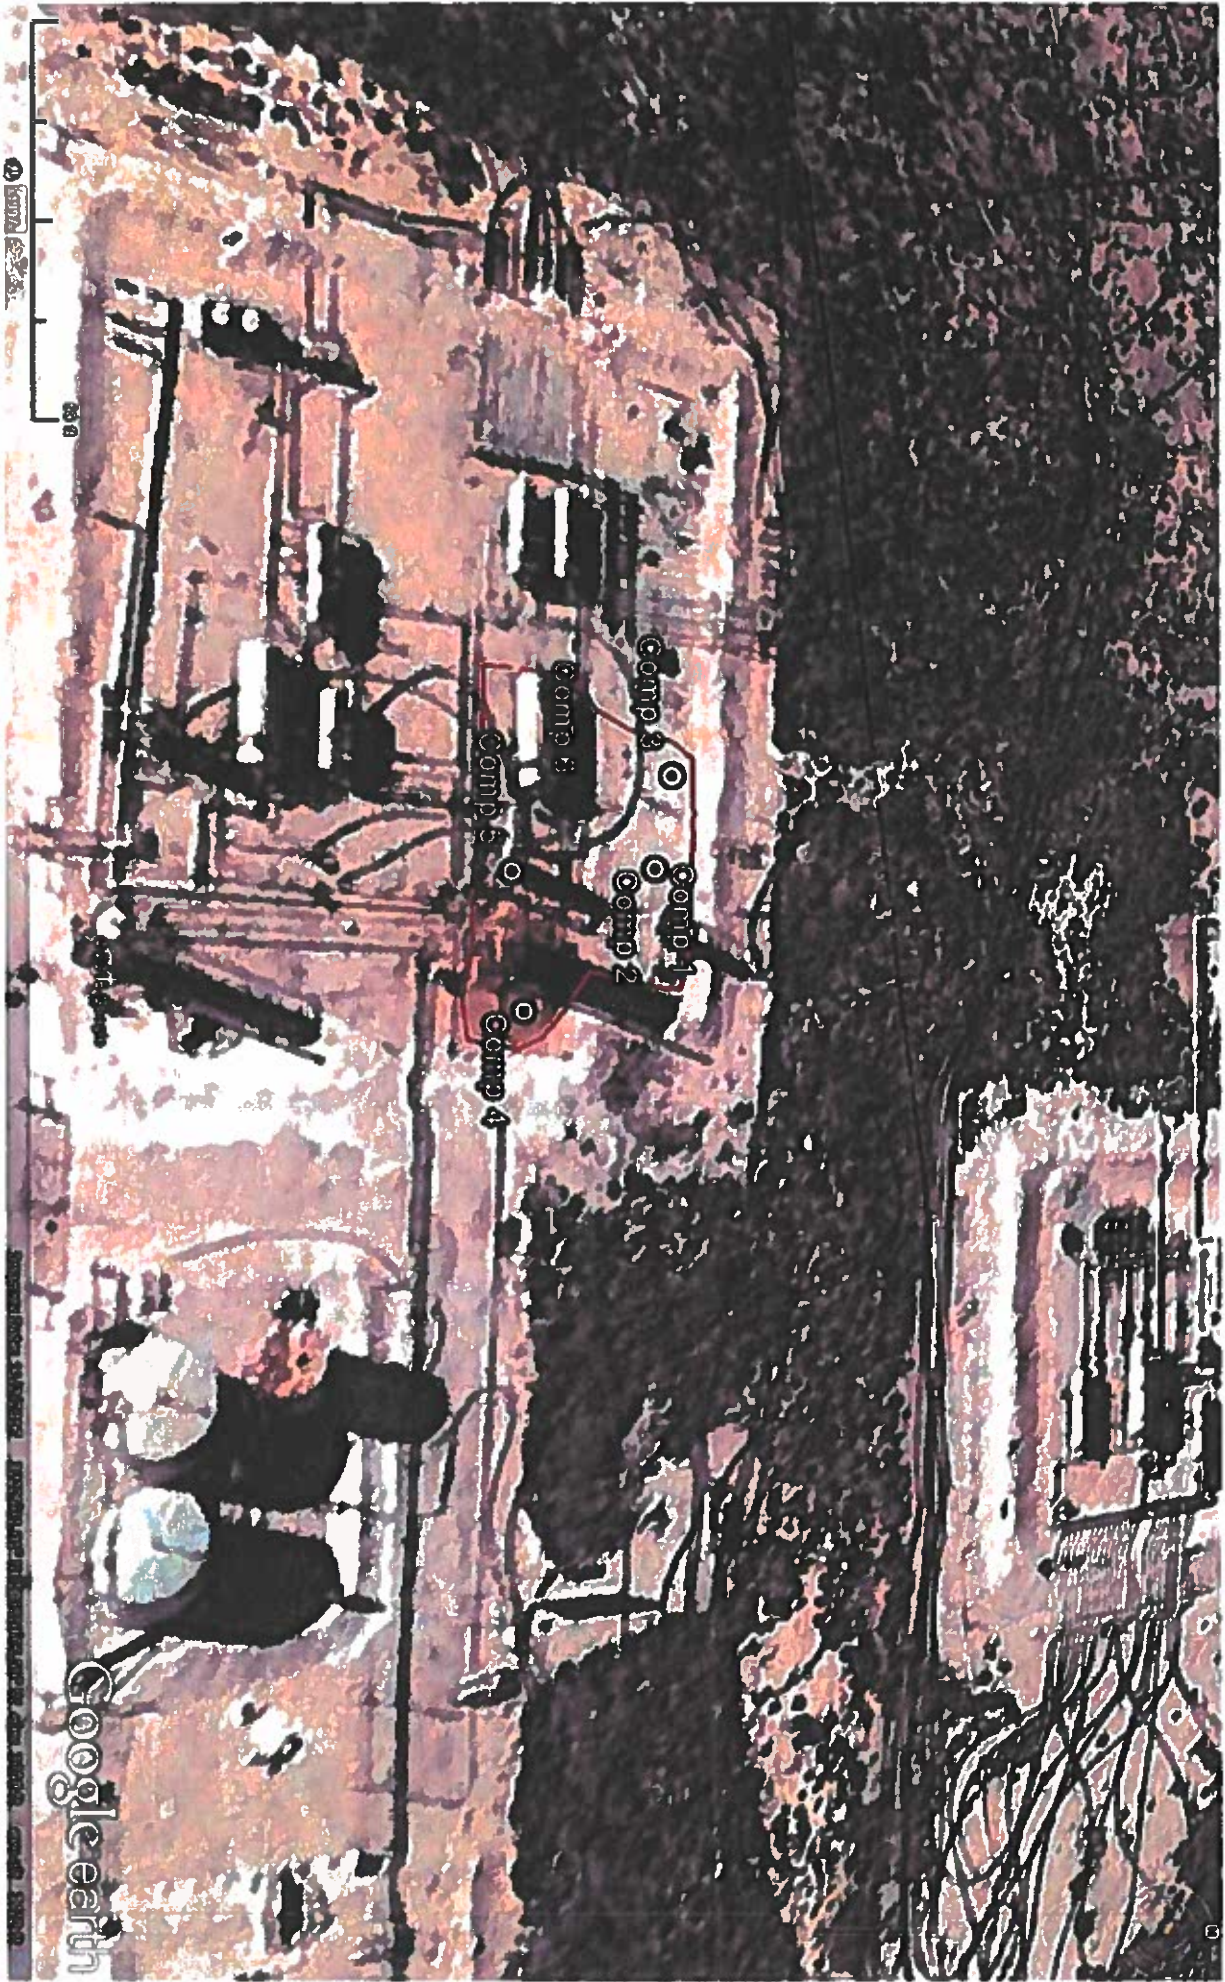
Hawk B-1 Battery

Sample Pt.	GPS	Depth	Lab CL	Benzene	Toluene	Ethylbenzene	Total Xylenes	Total BTEX	GRO	DRO	EXT DRO	Sample Date
Comp 1	32.4918205 - 103.1682405	6"	48	<0.050	<0.050	<0.050	<0.150	<0.300	<10.0	291	112	10/21/2019
Comp 2	32.4918250 - 103.1682750	6"	32	<0.050	<0.050	<0.050	<0.150	<0.300	<10.0	983	377	10/21/2019
Comp 3	32.4918329 - 103.1683219	6"	64	<0.050	<0.050	0.133	0.477	0.61	<50	112	56.9	1/29/2019
Comp 4	32.4917520 - 103.1681798	6"	64	<0.050	<0.050	<0.050	<0.150	<0.300	<10.0	41	18.5	10/21/2019
Comp 5	32.4917605 - 103.1682723	6"	80	<0.100	0.439	3.07	10	13.5	364	5270	859	1/29/2019
Comp 5		1.5	16	<0.050	<0.050	<0.050	<0.150	<0.300	<10.0	600	215	10/21/2019
SP 1	32.4917820 - 103.1683394	1'		<0.100	3.27	12.4	31.3	47	1060	16400	3430	1/29/2019
Comp 6		1.5	<16	<0.050	<0.050	<0.050	<0.150	<0.300	<10.0	374	229	10/21/2019

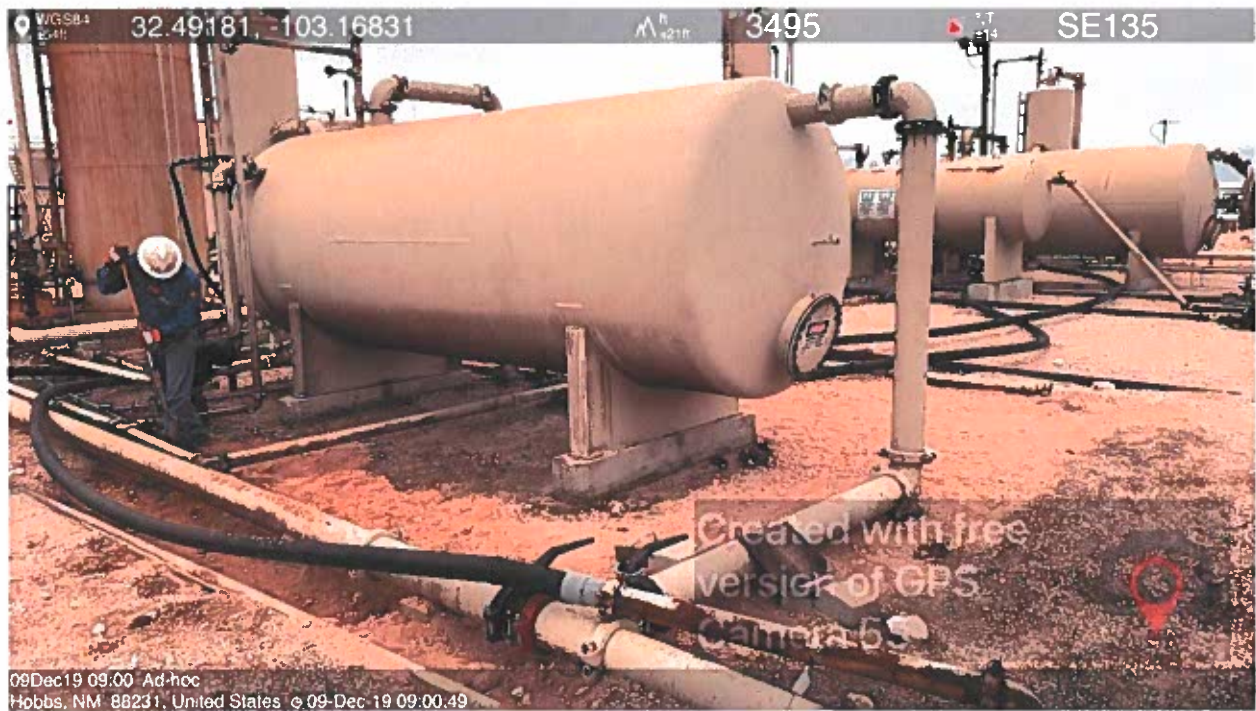
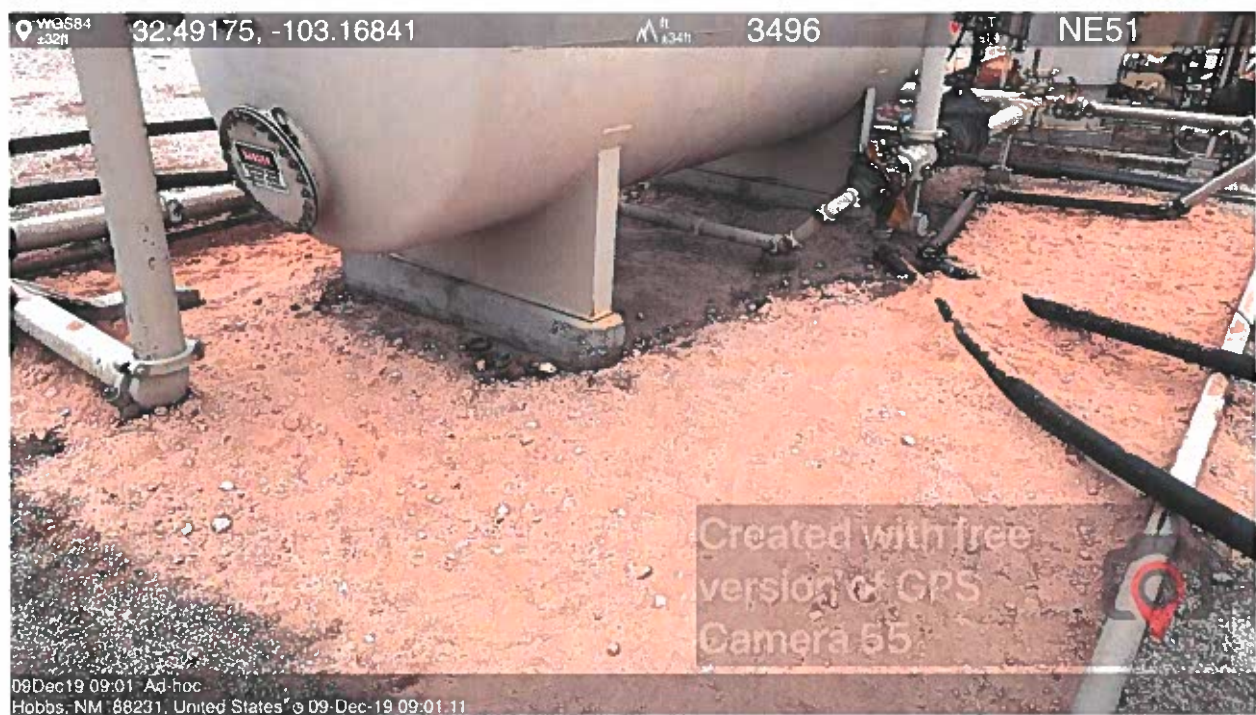
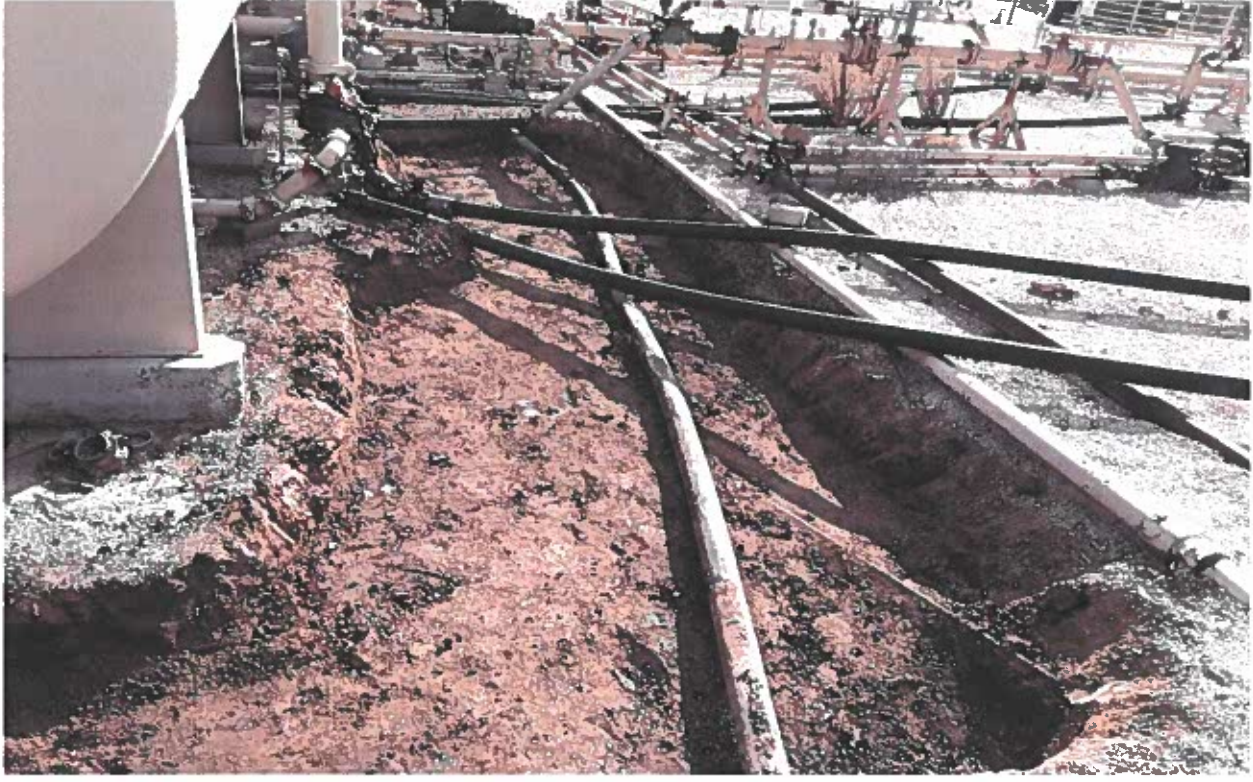
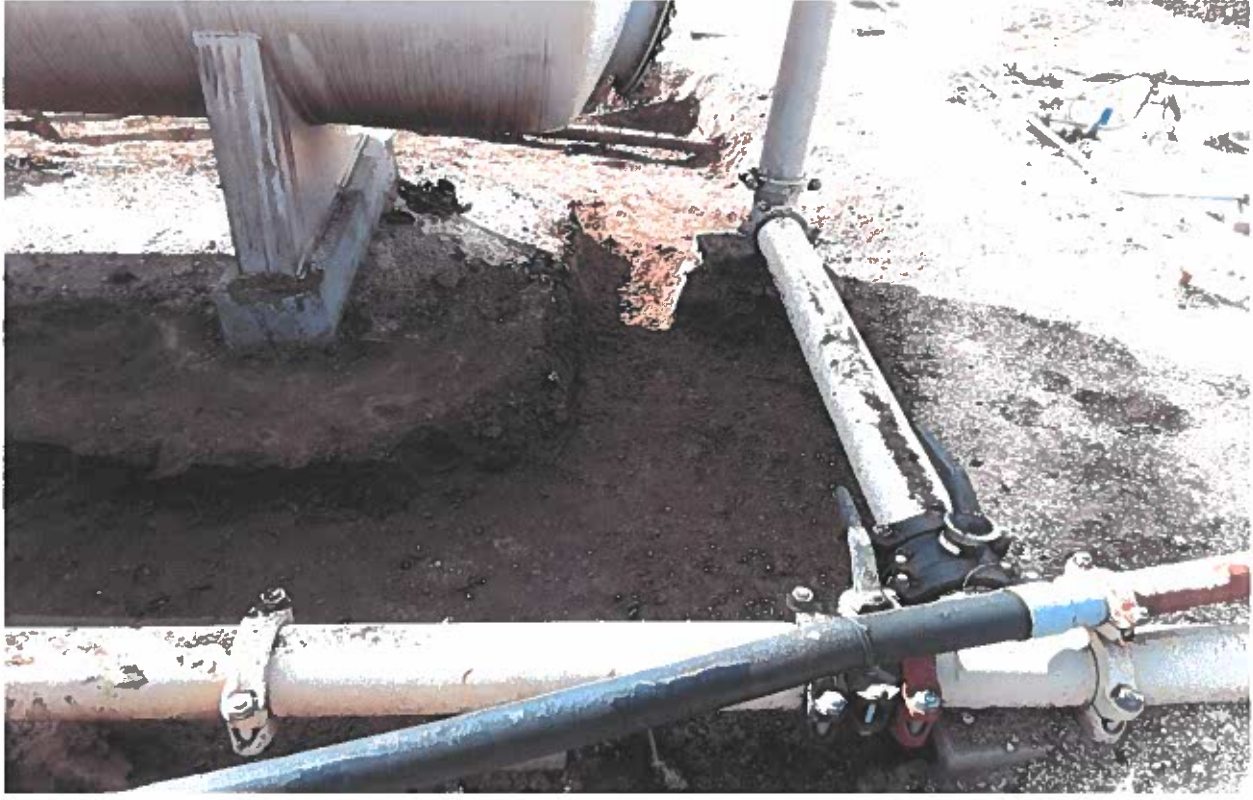
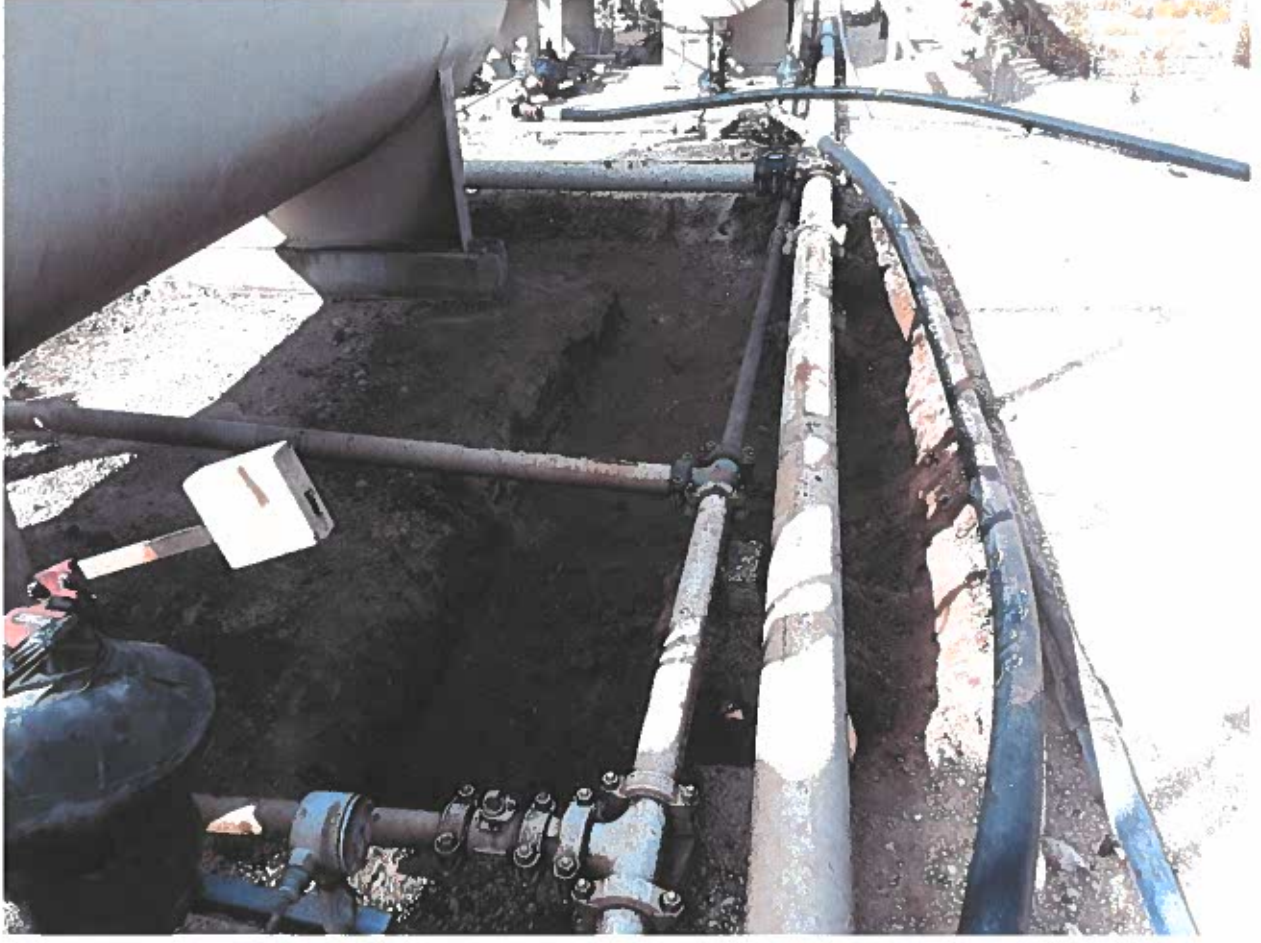
The release area was excavated to a depth of 6 inches and a remediation plan was submitted to NMOCD and denied on June 20, 2019 due to composite samples 5 and 6 were not fully delineated. Apache Corporation further excavated the composite areas for samples 5 and 6 an additional foot making the total depth of the excavation 1.5 feet. On 10/21/2019 final five point bottom and wall composite samples were collected not to exceed 200 square feet and submitted to a commercial laboratory for analysis for chloride, TPH, and BTEX. Composite sample point 3 was not sampled on 10/21/2019 due to it meet table one standards on sampling date 1/29/2019. The laboratory results were below table one standards for releases were groundwater is 51-100 feet. All excavated soil was hauled to an NMOCD approved disposal facility. The deeper excavation was backfilled with clean imported caliche.
