Release Notification

Site Name James Ranch Unit DI2 Central Tank Battery	Site Type Bulk Storage and Separation Facility
Date Release Discovered 6/8/2019	API# (if applicable) 30-015-39793 (JRU DI2 #139H)

A 6" flowline between VRT and LACT units failed. Fluid was released to lined tank containment and to the well pad. All wells were immediately shut in. A vacuum truck recovered fluids from the containment and from the well pad. Fluids were returned to production. The line was repaired and the facility was returned to operation. Additional third party resources have been retained to assist with remediation.

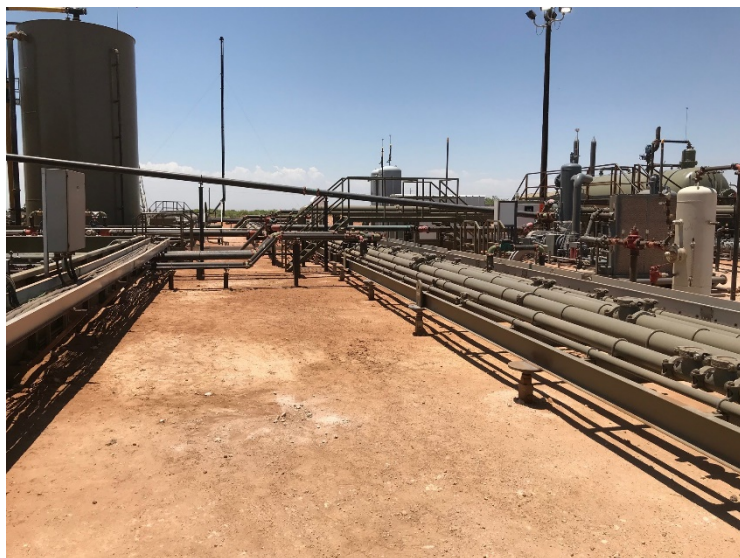
Photograph 1: View west of release staining between equipment.

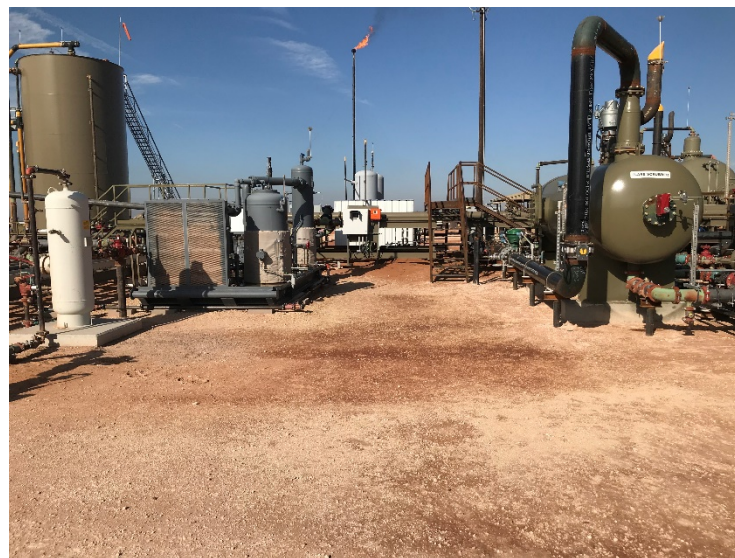
Photograph 2: Western view of northernmost edge of the release extent.

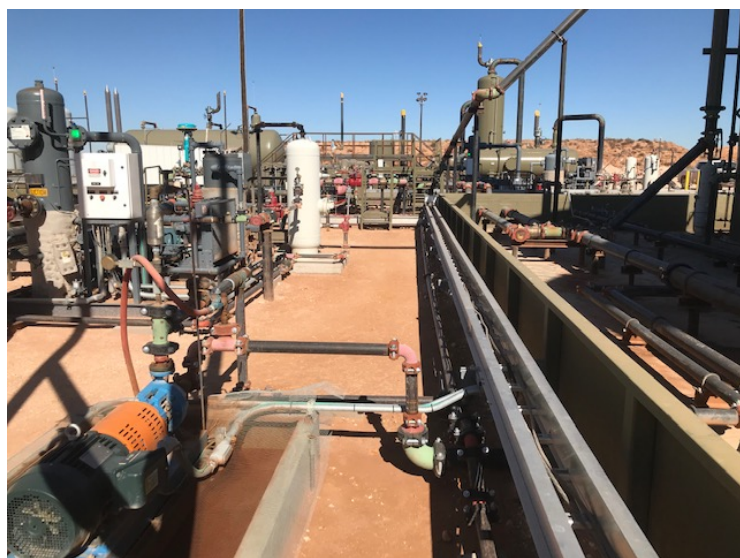
Photograph 3: View north of the release extent between tank batteries.

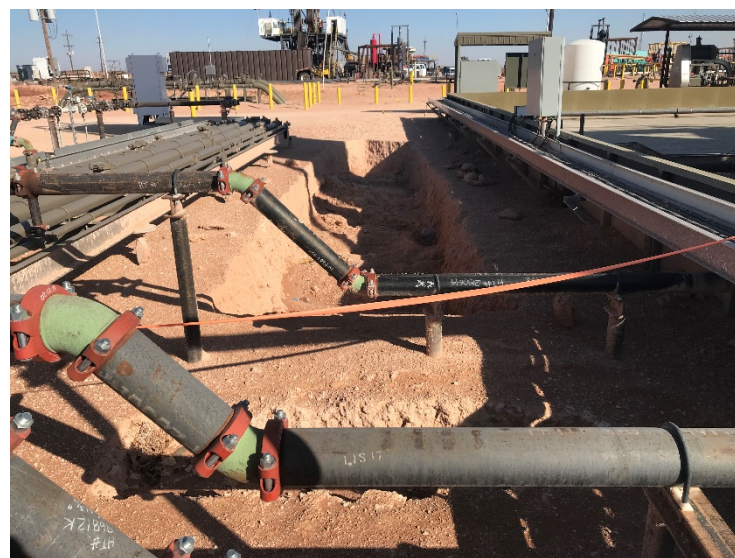
Photograph 4: View east of the southern excavation.

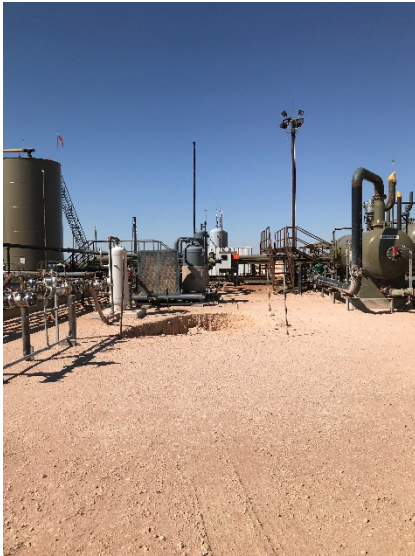
Photograph 5: View west of northern excavation.

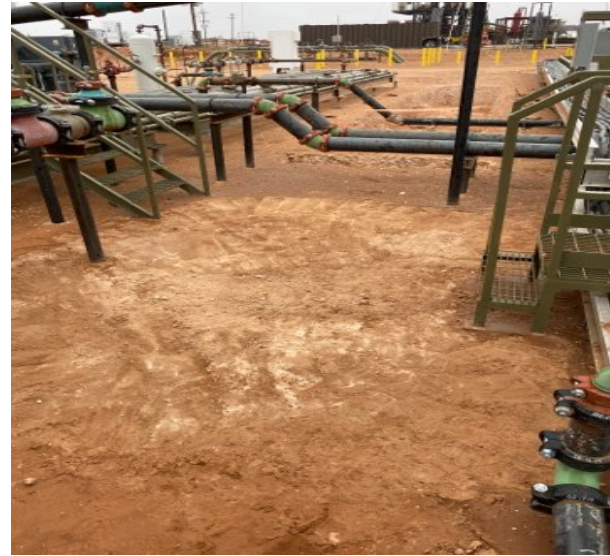
Photograph 6: View east of hand shoveled excavation.

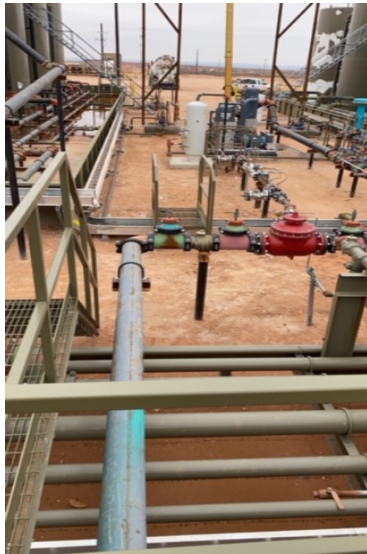
Photograph 7: View south of area after MicroBlaze® treatment.

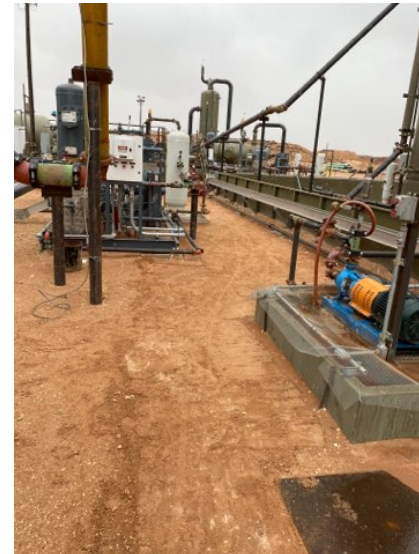
Photograph 8: View north of area after MicroBlaze® treatment.
