Republic Backhoe Service, LLC
 47 E. Dickens
 Lovington, NM 88260
 (575) 631-0131

Subject: Soil Remediation/Closure for the Saragossa 10 State #2, Eddy County, New Mexico

On behalf of Read & Stevens, Inc. Republic Backhoe Service, LLC (RBS) has prepared this Soil Remediation/Closure Report associated with Saragossa 10 State #2. The site is located in Unit B, Section 10, Township 23 South, and Range 26 East, NMPM, Eddy County, New Mexico, on NM State land. Attachment #1 and #2 illustrates the vicinity and location of the site. Piedmont alluvial deposits from the Holocene to Pleistocene age make up the subsurface of the area (mrddata.usgs.gov, Attachment #3). The subsurface is comprised of Regan Upton soils which consist of loamy deposits of quaternary age that are moderately dark colored and loamy. Hard caliche is encountered at 3-4 feet below the loamy surface (Soil Survey Eddy Area, NM 1971). The soil is generally dry except in times of rain. The site is not within a 100-year floodplain (FEMA FIRMette Map Attachment #9). The vegetation consists of black grama, blue grama, tobosa, side-oats, bush muhly, tarbush, creosote bush, vine mesquite, and yucca. The state of New Mexico own

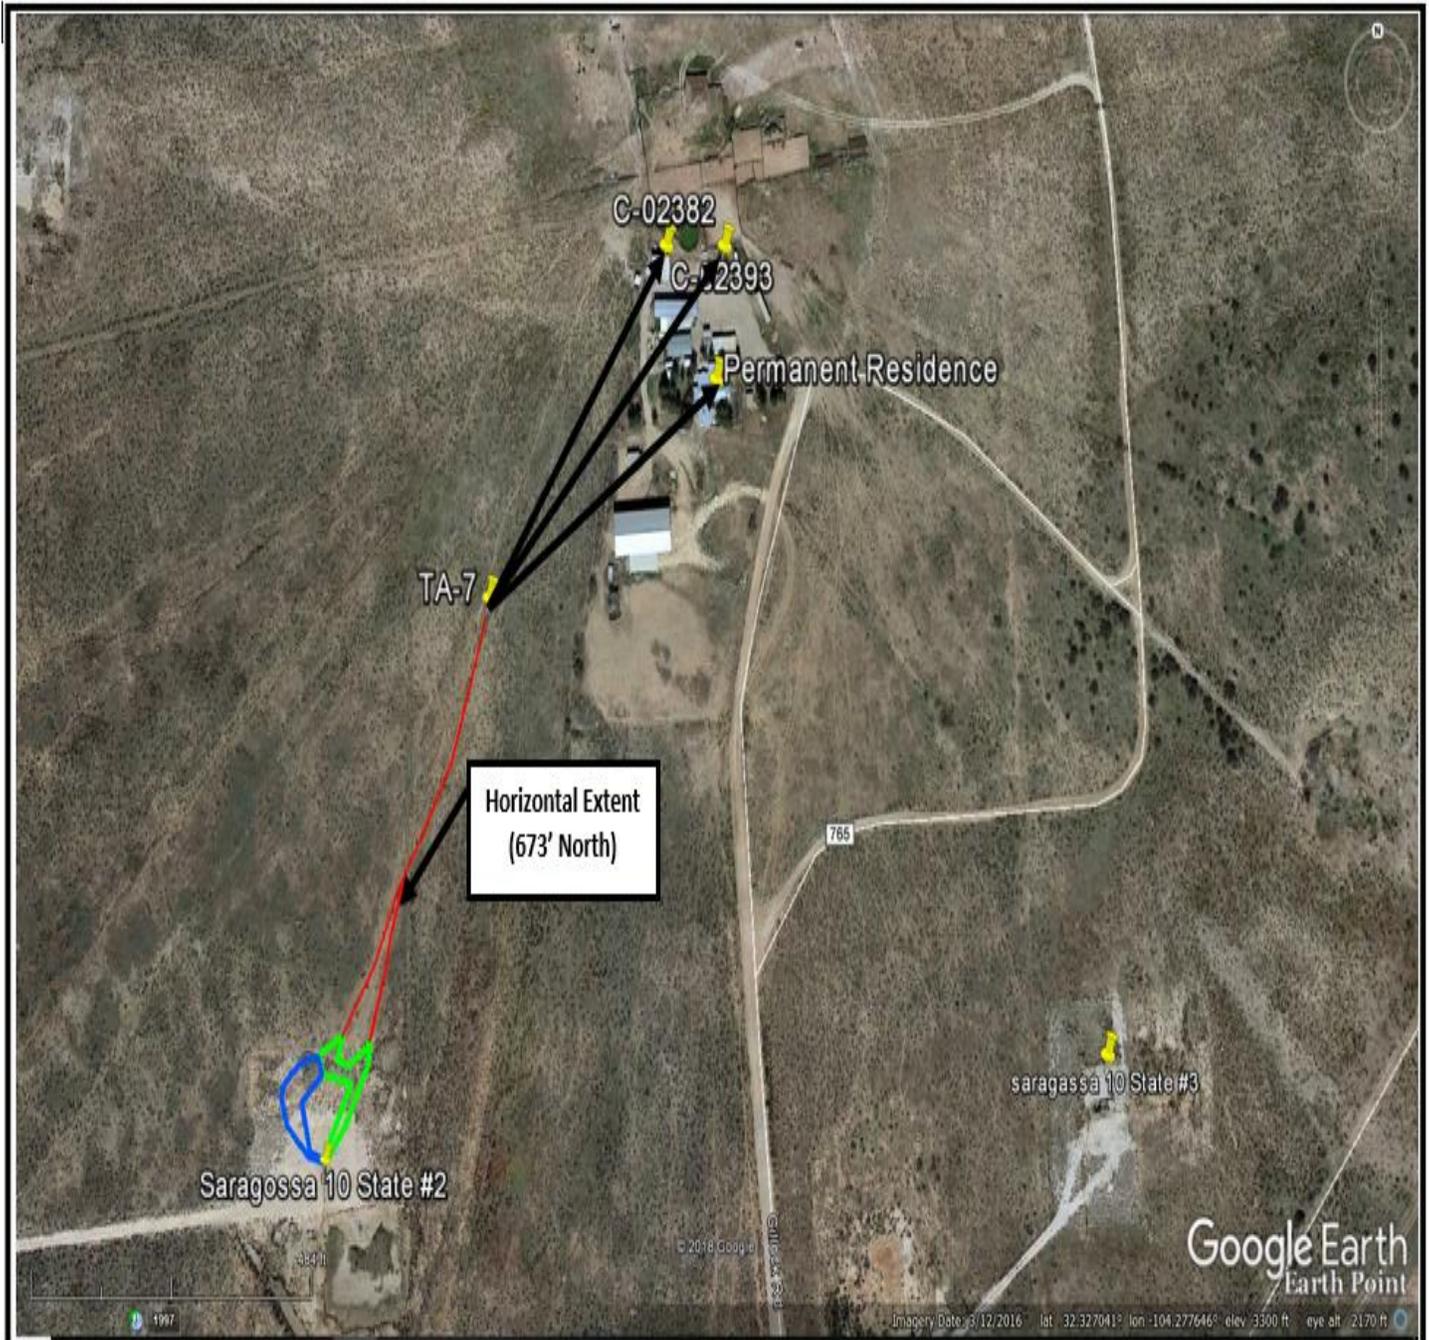
Attachment #7

**NMOSE Water Well Search
At North Extent of Spill
Sample Point TA7**
C-02382-518'
C-02393-588'
Permanent Residence-482'

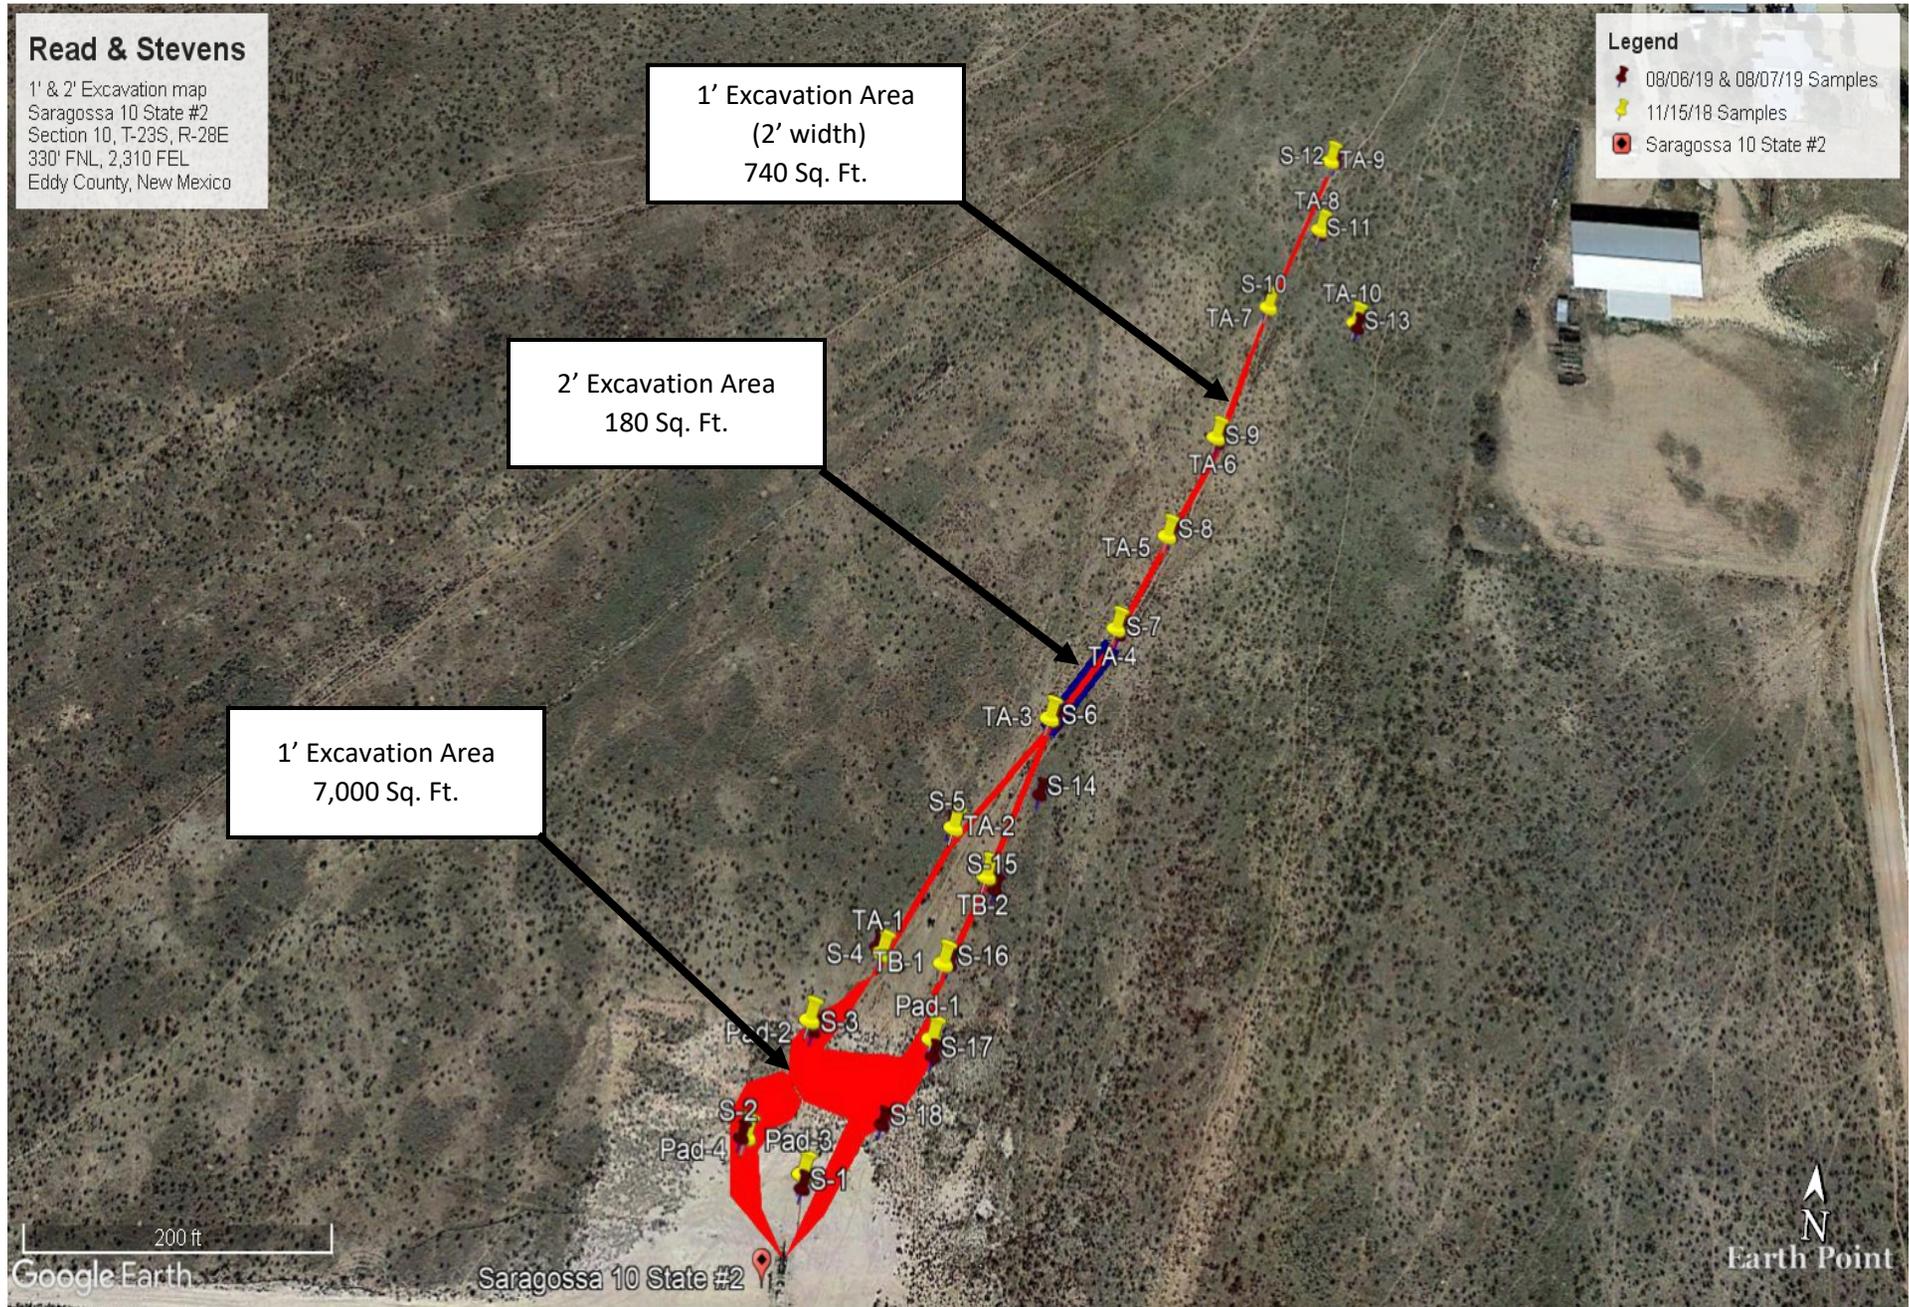
Attachment #10
Spill and Excavation Map

On November 15, 2018, RBS went to the location to delineate the site. According to the Spill Calculations (See Attachment 13) 89% of the release stayed on the well pad. The additional 11% of the release travelled along a compacted cattle path for approximately 825 feet to the north of the location (See Attachment 10). The release poses no threat to ground water as laboratory results conclude that no contamination was found at or below 2' (bgs). Furthermore, soil samples collected and analyzed at 5' (bgs) show constituents level significantly lower than NMOCD permissible levels. A backhoe was used to dig a total of 16 trenches at the site (See Attachment #8). Samples were collected from the surface, 2 feet (bgs), and 5 feet (bgs). The following table summarizes the laboratory analytical results from the soil samples collected during the site assessment:

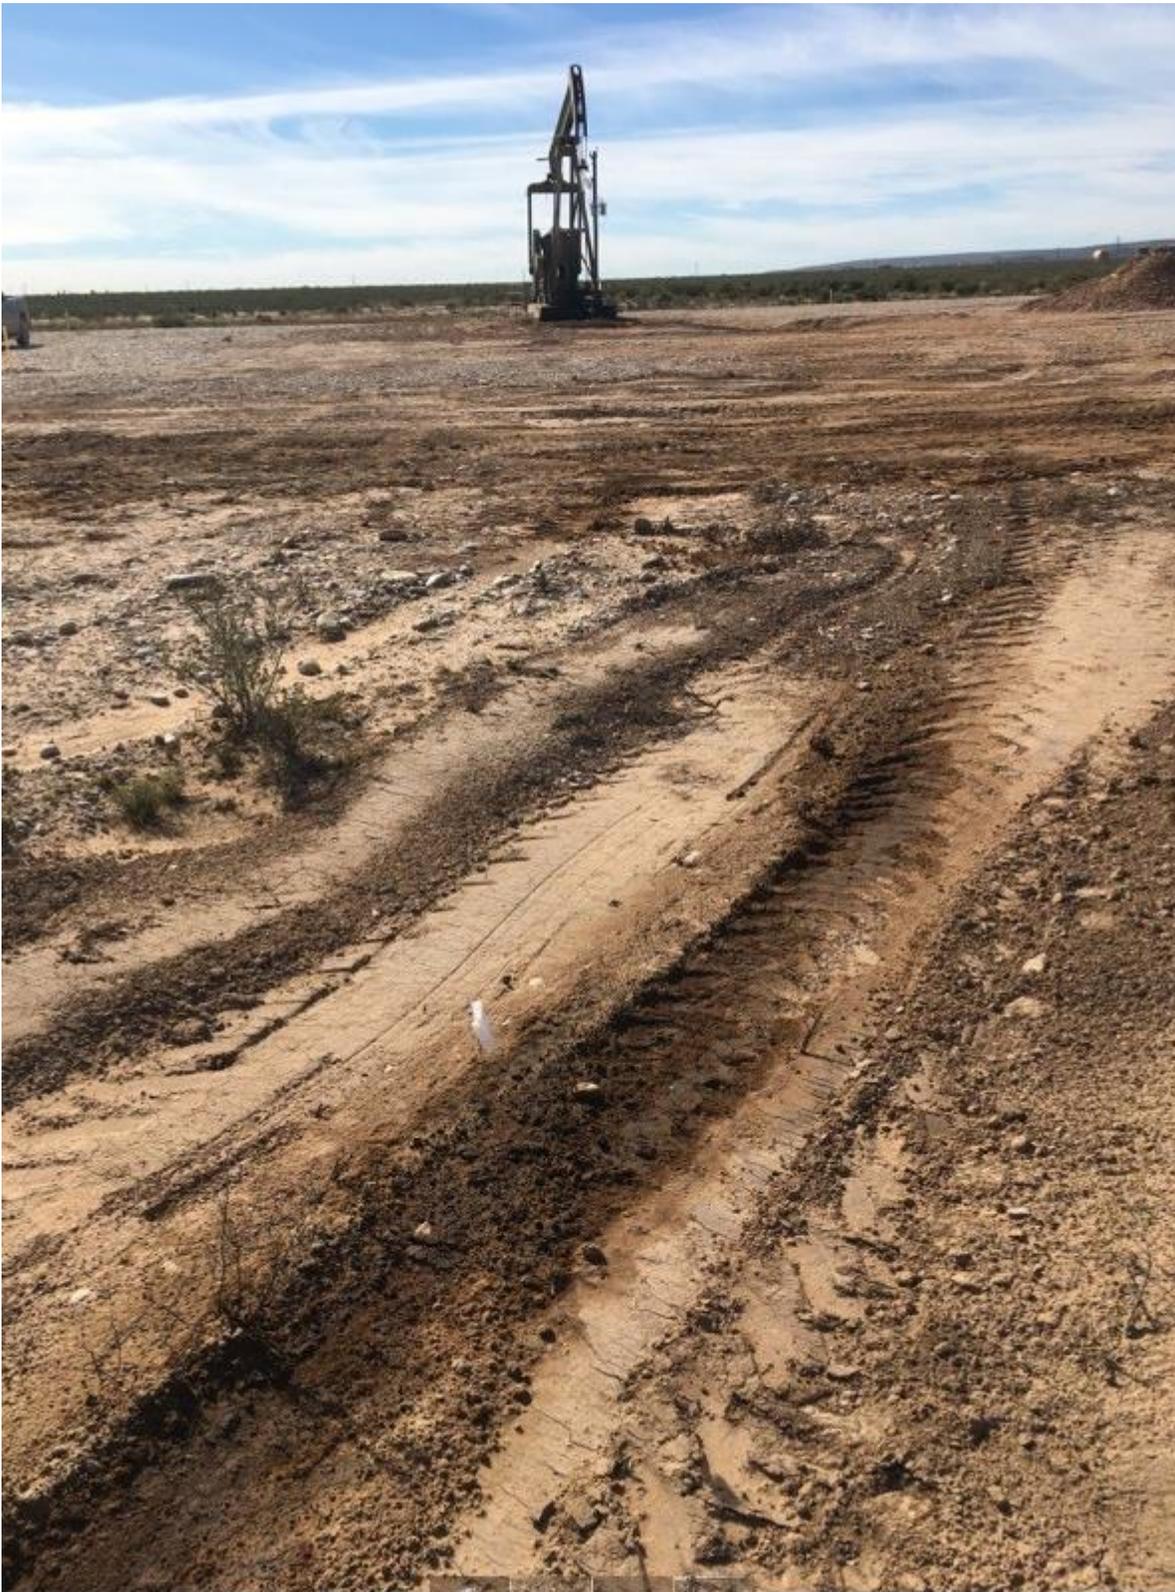
Sample Location TA1-Looking South towards the source of release.

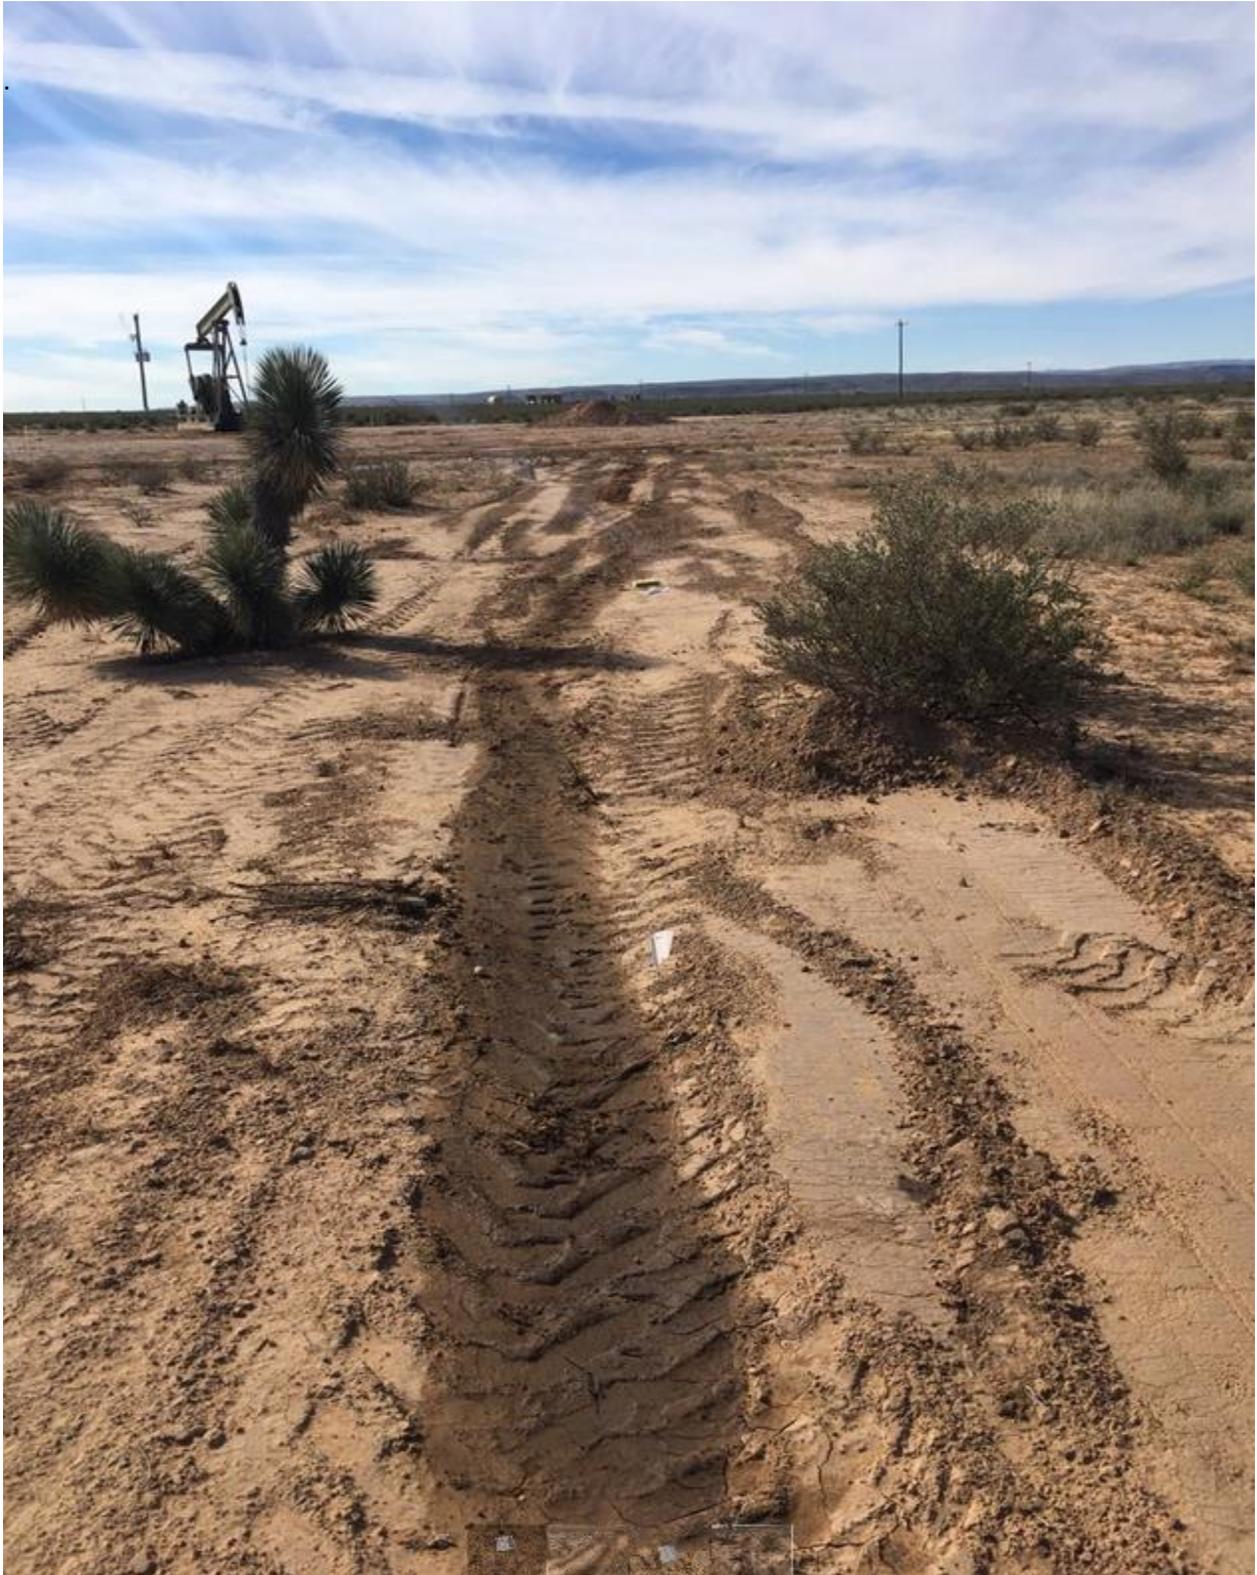
Sample Location TA2-Looking South towards the source of release.

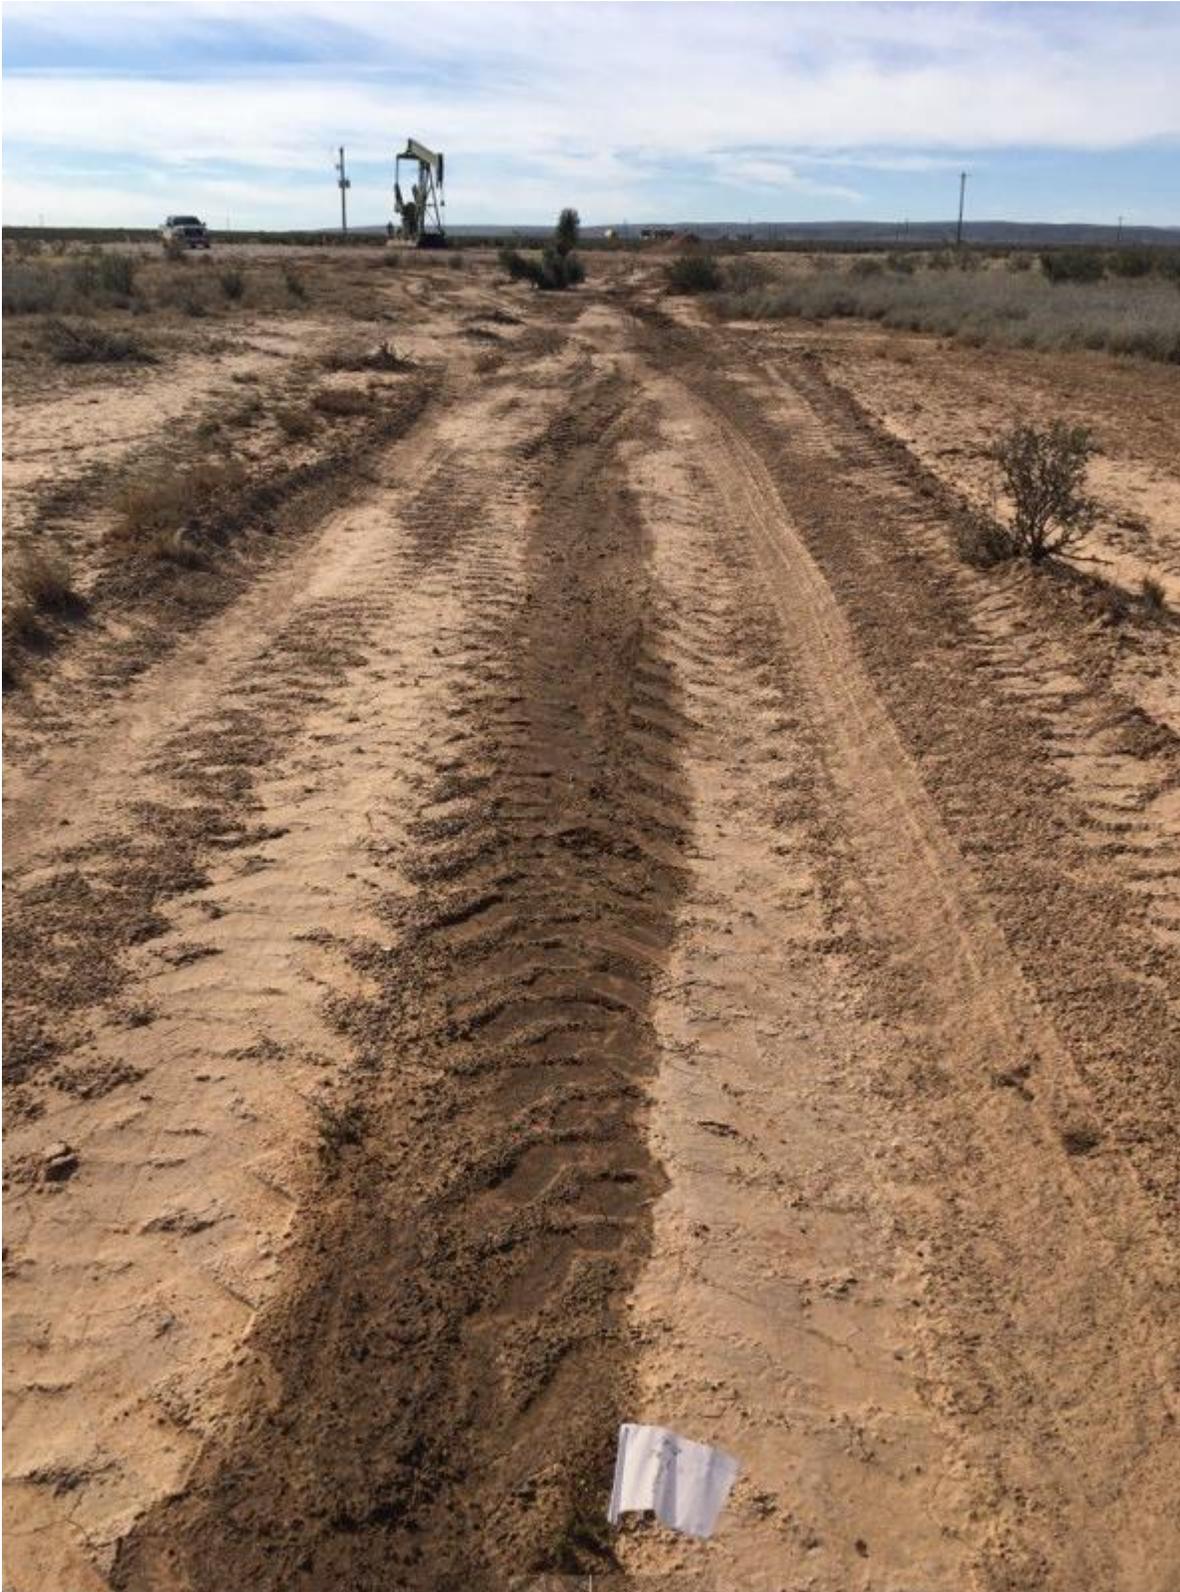
Sample Location TA3-Looking South towards the source of release.

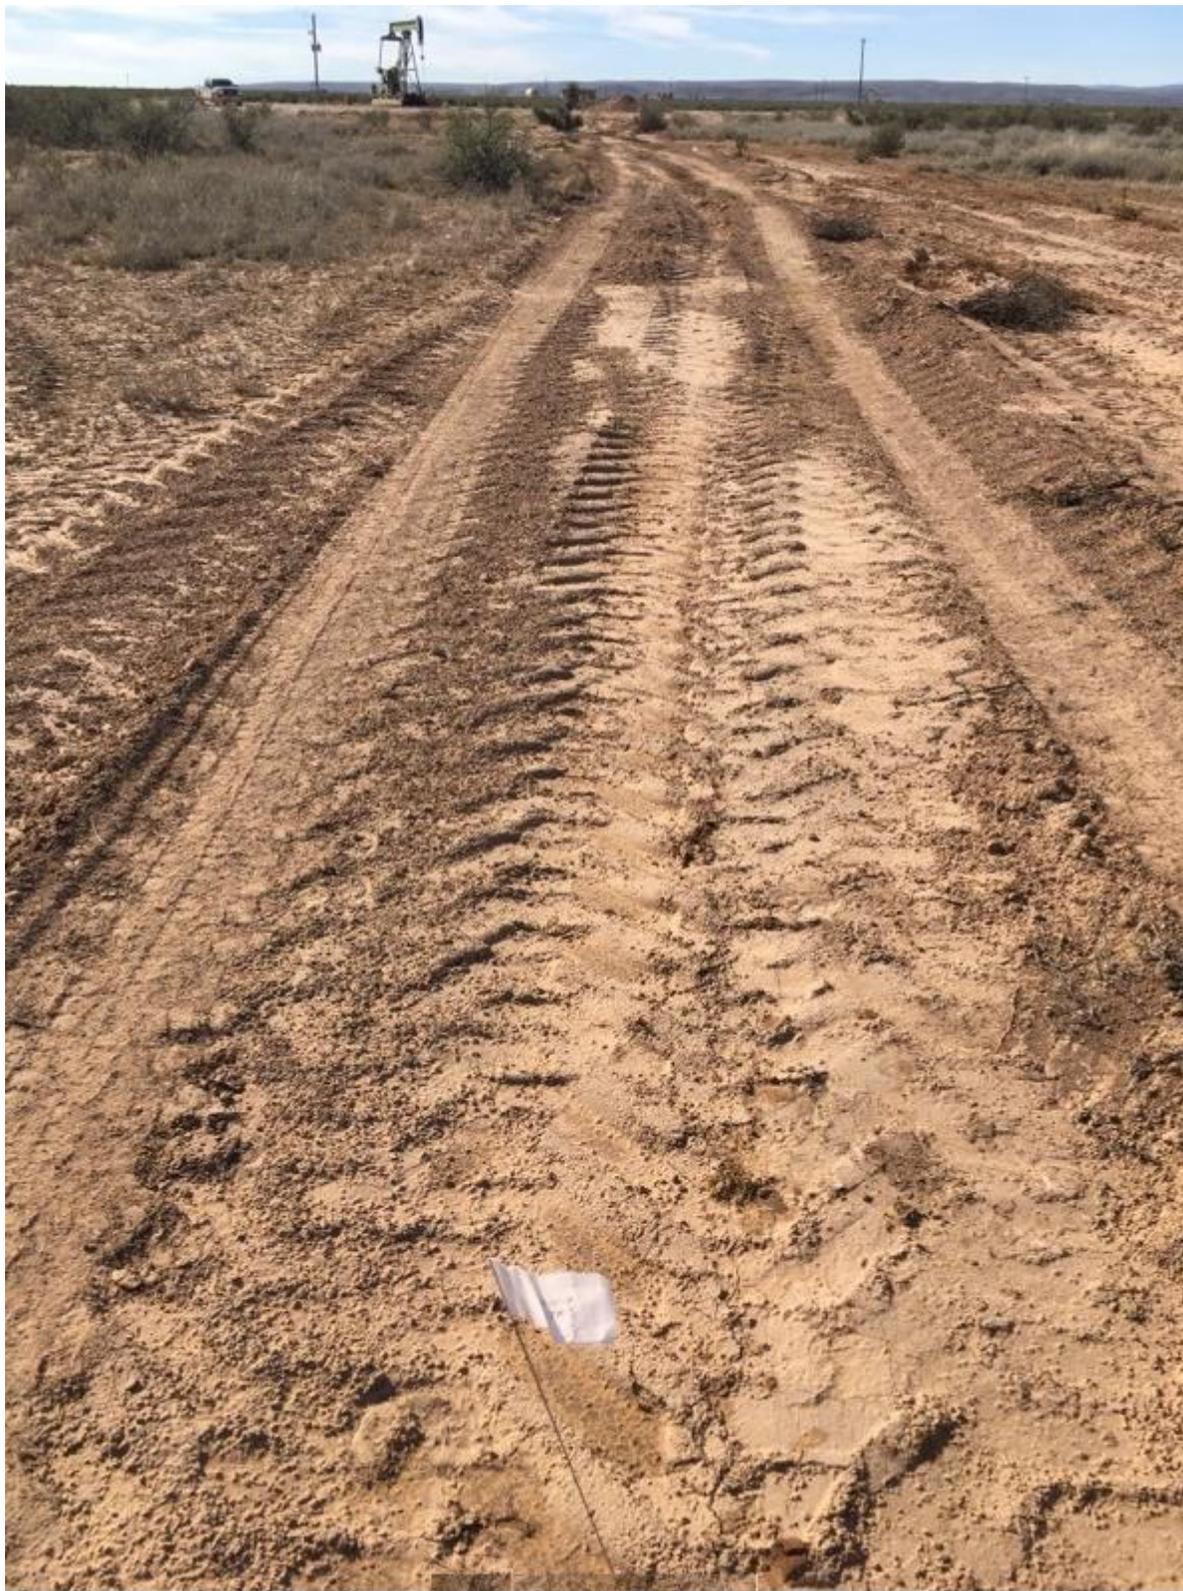
Sample Location TA4-Looking South towards the source of release.

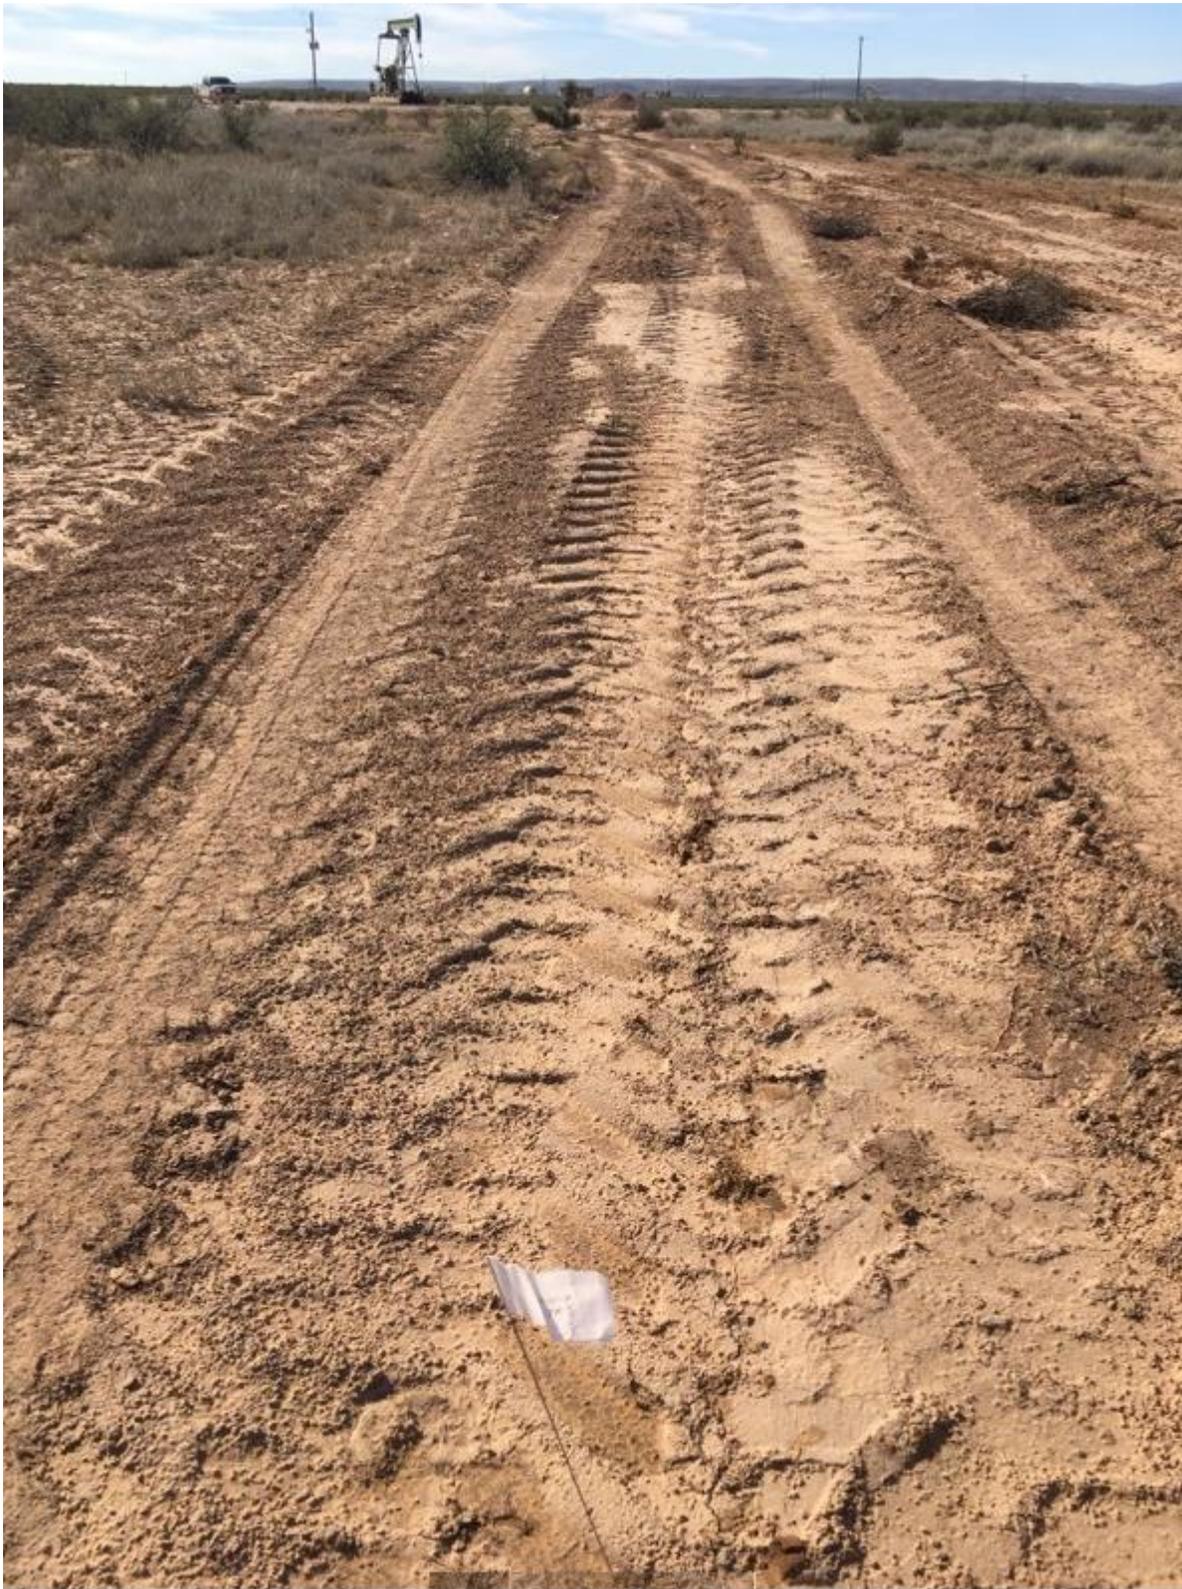
Sample Location TA5-Looking South towards the source of release.

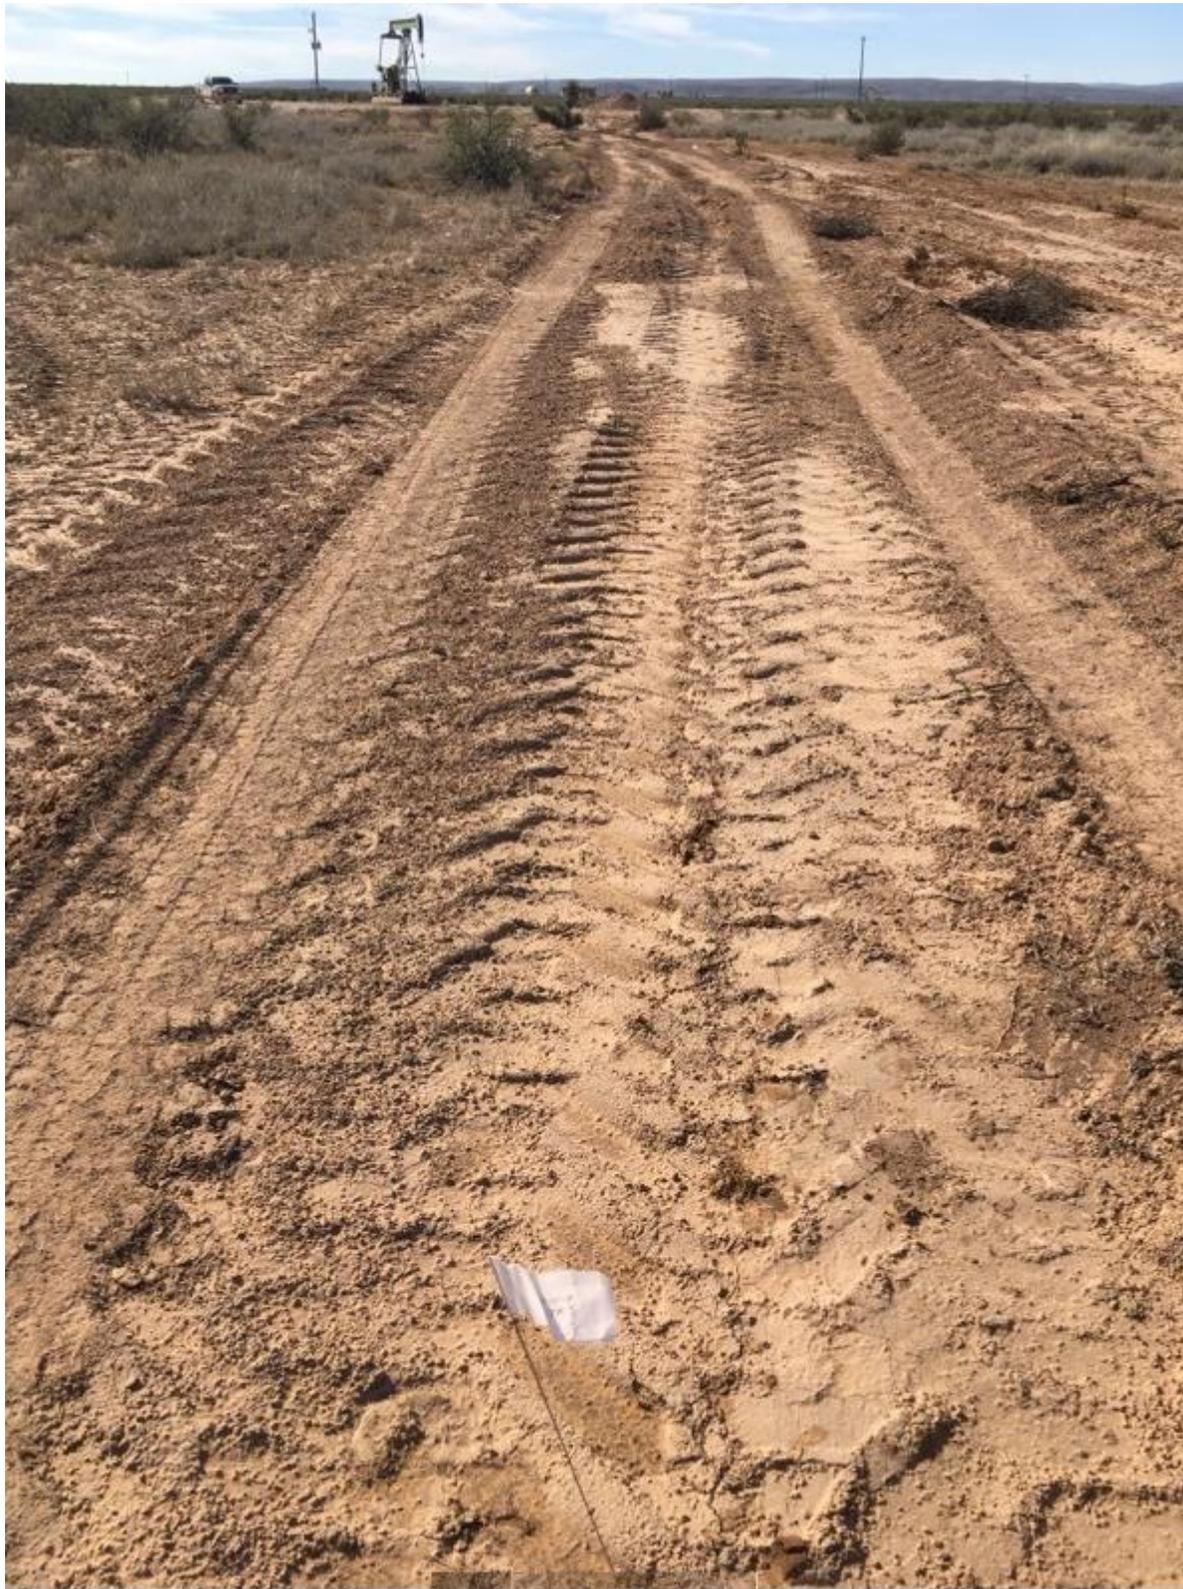
Sample Location TA6-Looking South towards the source of release.

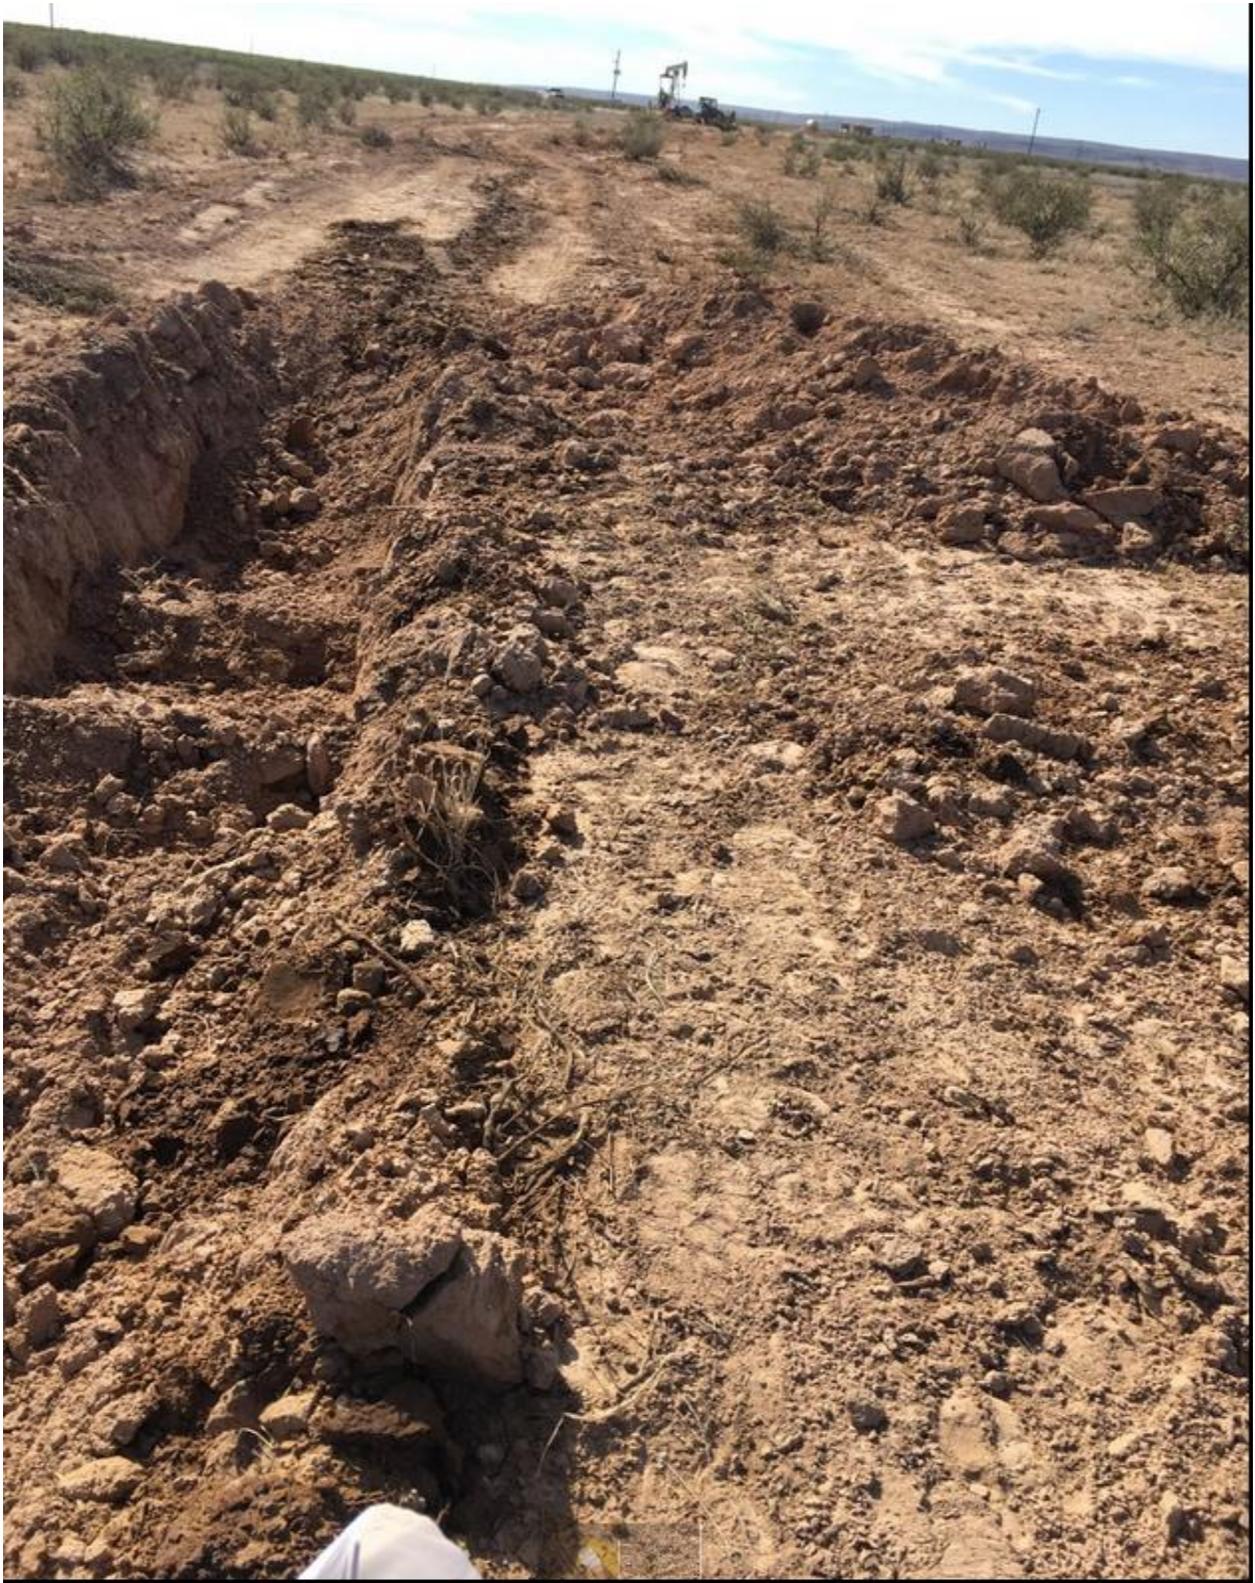
Sample Location TA7-Looking South towards the source of release.

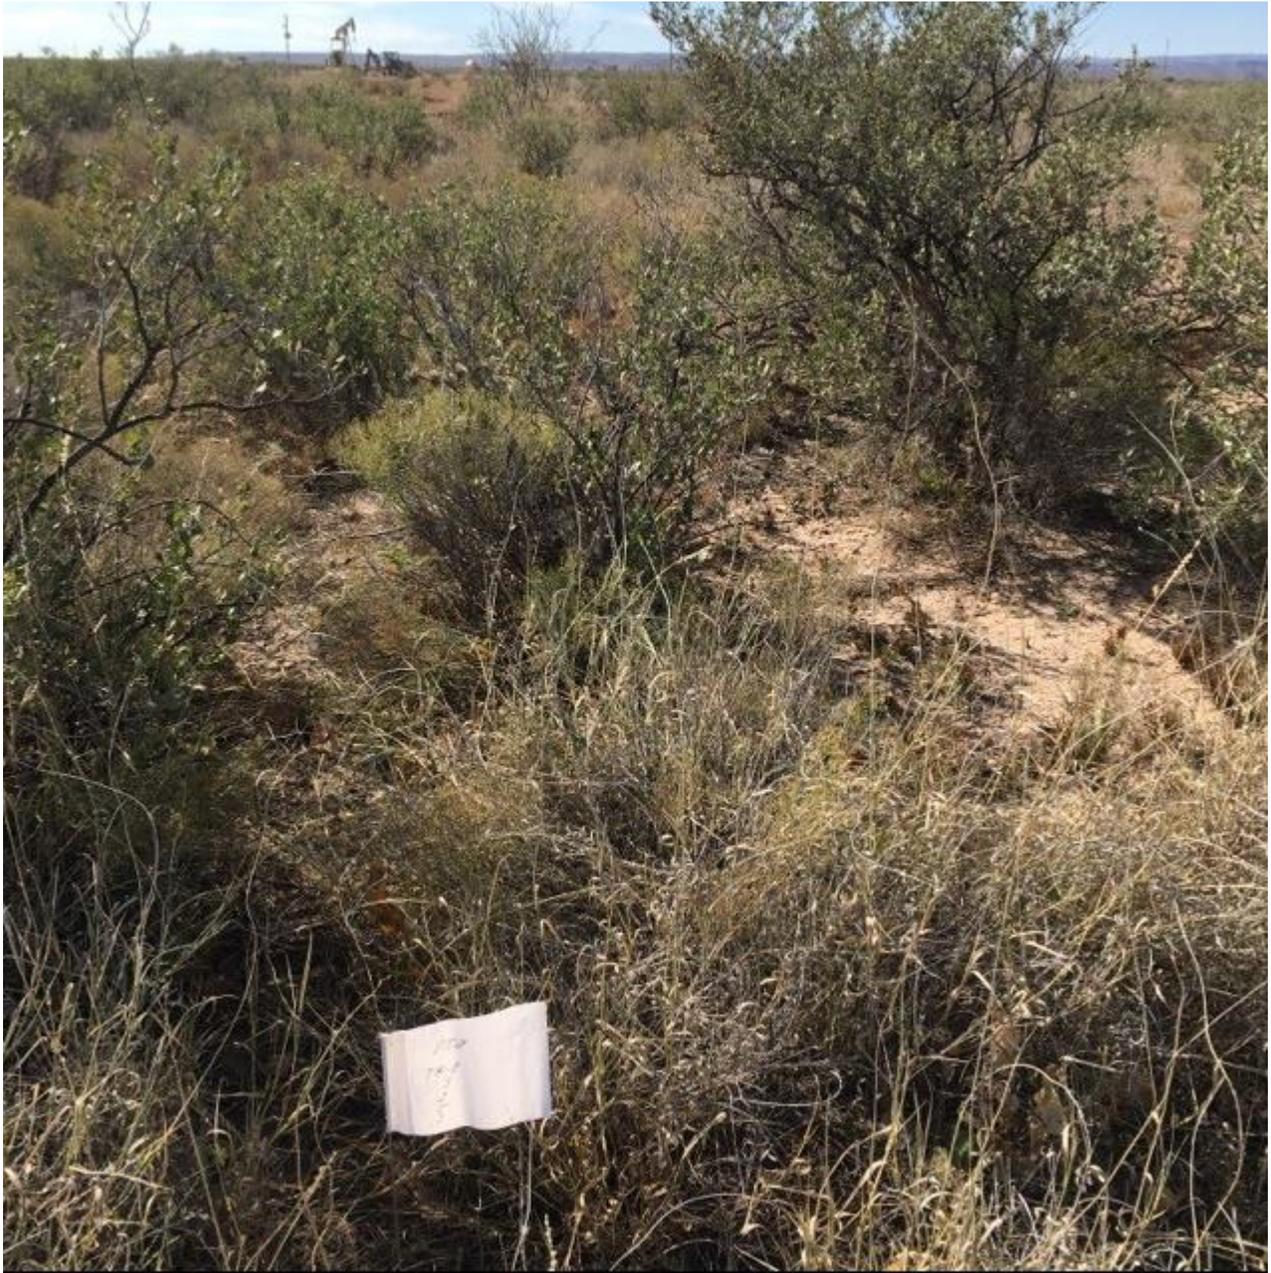
Sample Location TA8-Looking South towards the source of release.

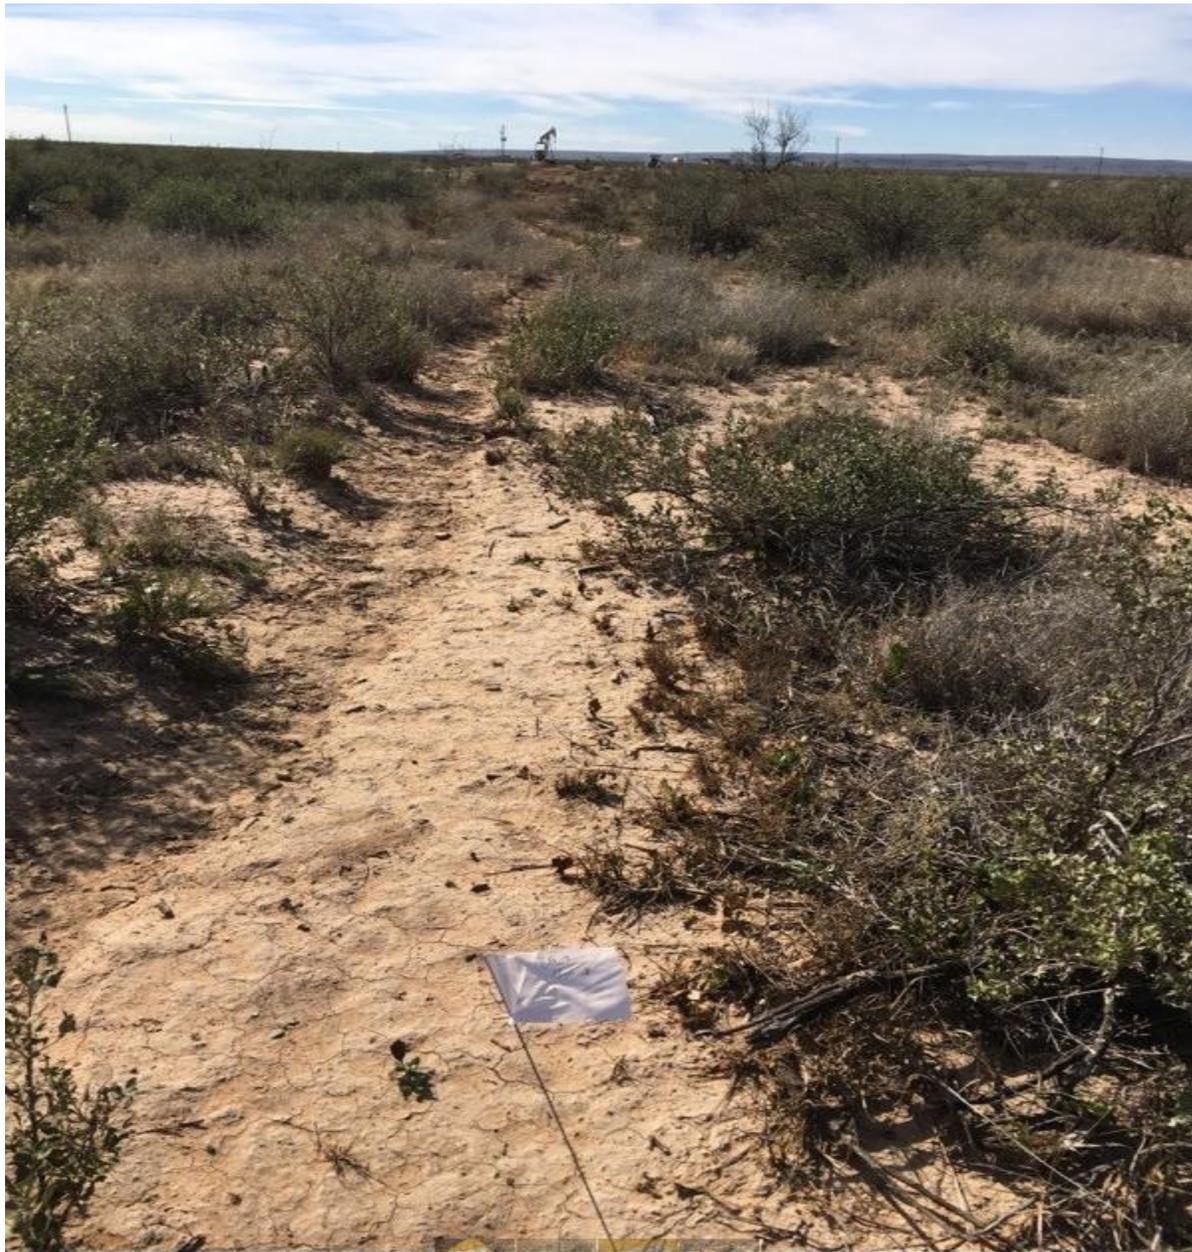
Sample Location TA9-Looking South towards the source of release.
