Republic Backhoe Service, LLC
 47 E. Dickens
 Lovington, NM 88260
 (575) 631-0131

Subject: Soil Remediation/Closure for the Saragossa 10 State #2, Eddy County, New Mexico

On behalf of Read & Stevens, Inc. Republic Backhoe Service, LLC (RBS) has prepared this Soil Remediation/Closure Report associated with Saragossa 10 State #2. The site is located in Unit B, Section 10, Township 23 South, and Range 26 East, NMPM, Eddy County, New Mexico, on NM State land. Attachment #1 and #2 illustrates the vicinity and location of the site. Piedmont alluvial deposits from the Holocene to Pleistocene age make up the subsurface of the area (mrddata.usgs.gov, Attachment #3). The subsurface is comprised of Regan Upton soils which consist of loamy deposits of quaternary age that are moderately dark colored and loamy. Hard caliche is encountered at 3-4 feet below the loamy surface (Soil Survey Eddy Area, NM 1971). The soil is generally dry except in times of rain. The site is not within a 100-year floodplain (FEMA FIRMette Map Attachment #9). The vegetation consists of black grama, blue grama, tobosa, side-oats, bush muhly, tarbush, creosote bush, vine mesquite, and yucca. The state of New Mexico own

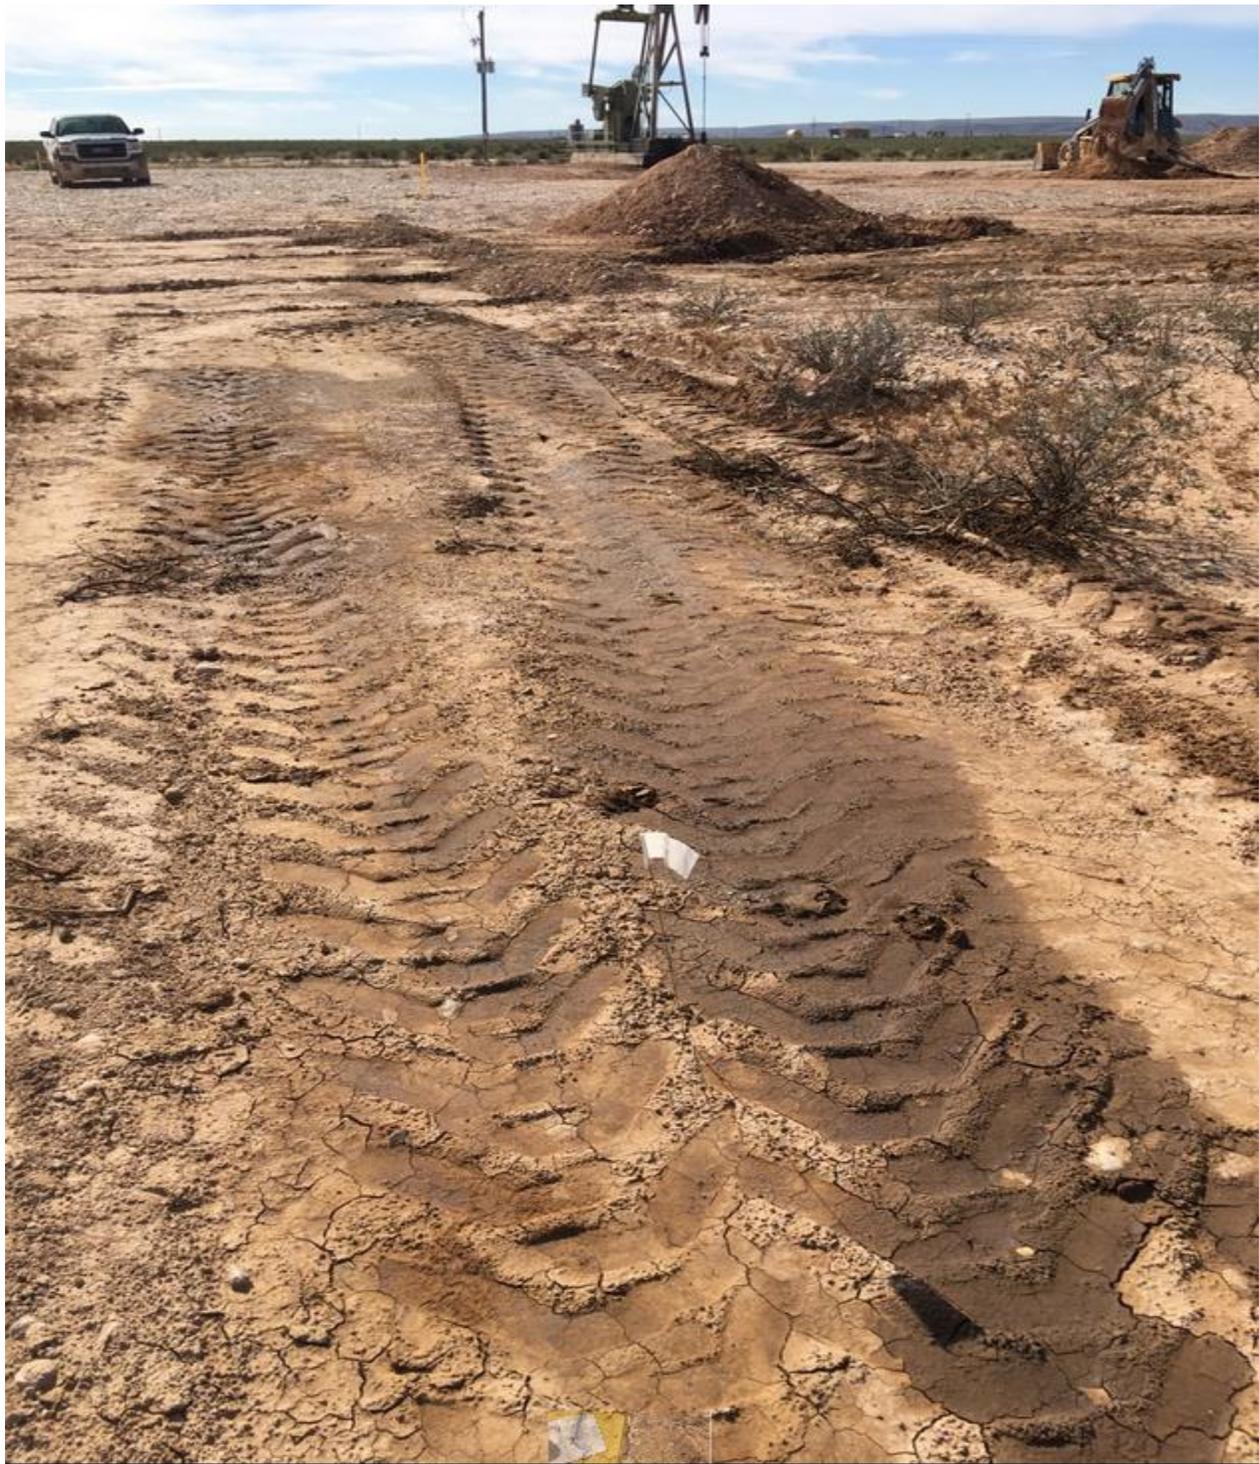
Sample Location TB1-Looking South towards the source of release.

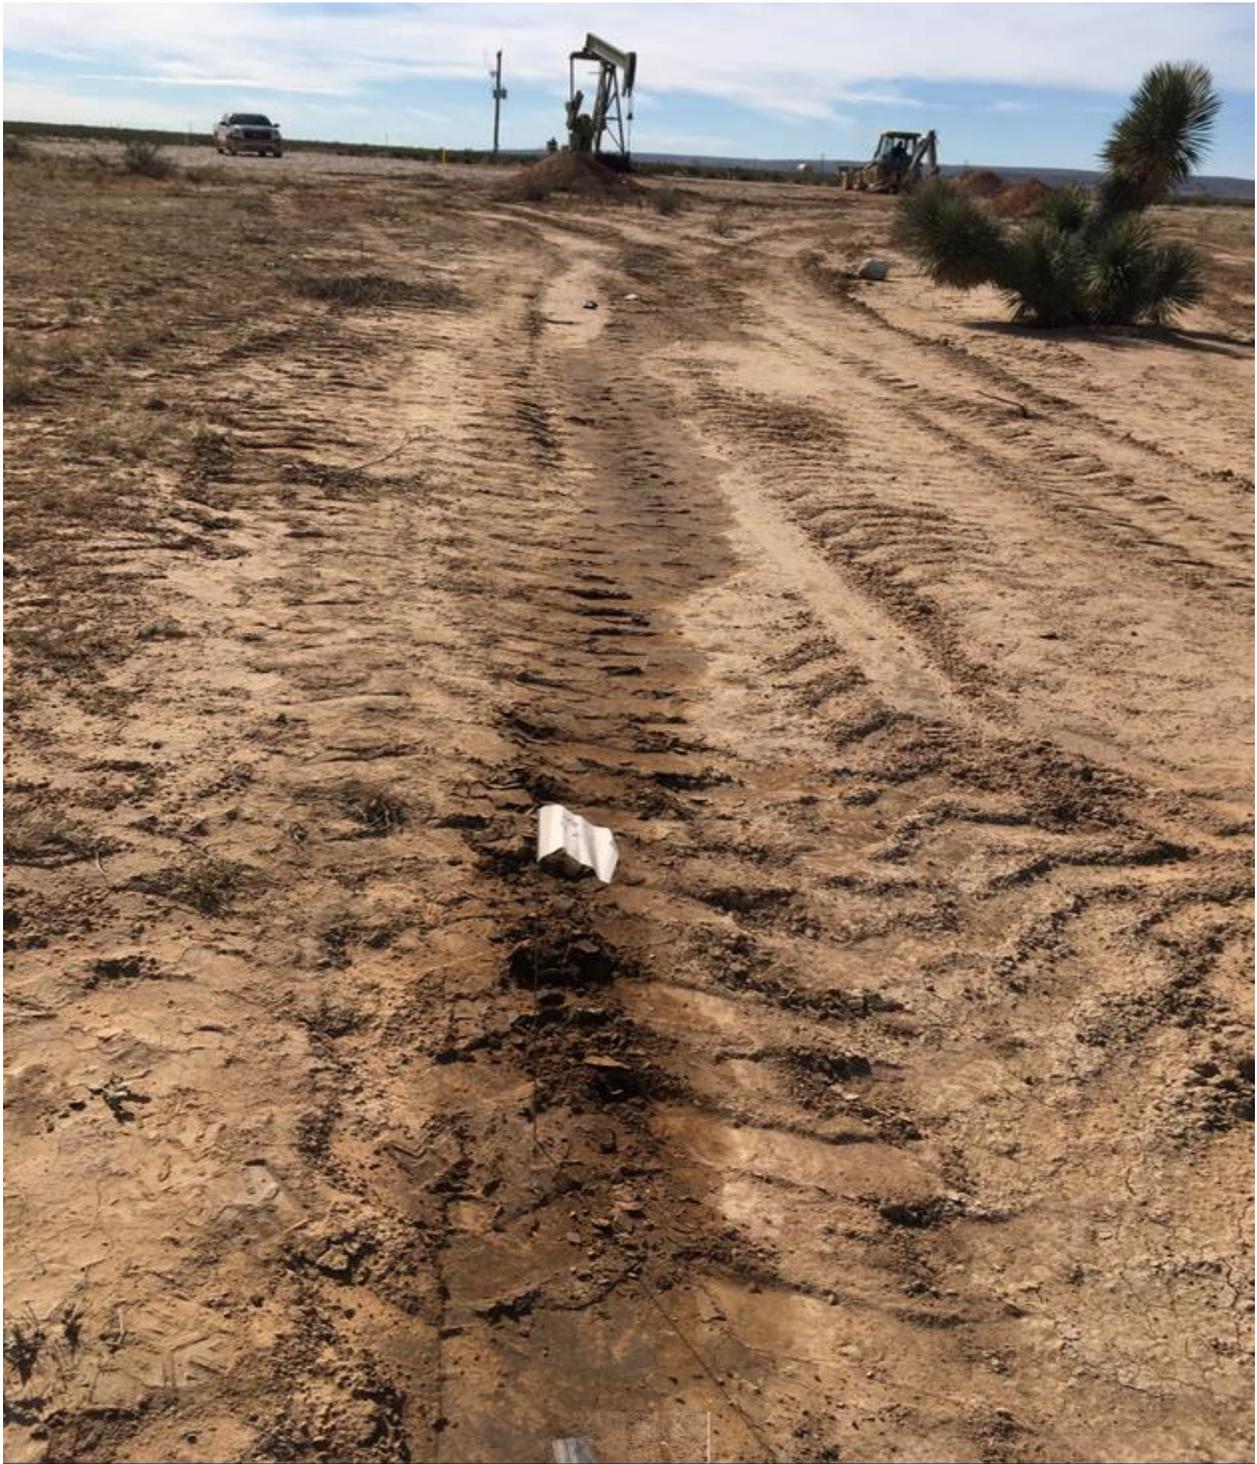
Sample Location TB2-Looking South towards the source of release.
