CLOSURE REPORT

MILLMAN SB STATE #2

2RP – 4983

RE: CLOSURE REPORT REQUEST
GRIZZLY ENERGY – MILLMAN SB STATE #2
API NO. 30-025-05430

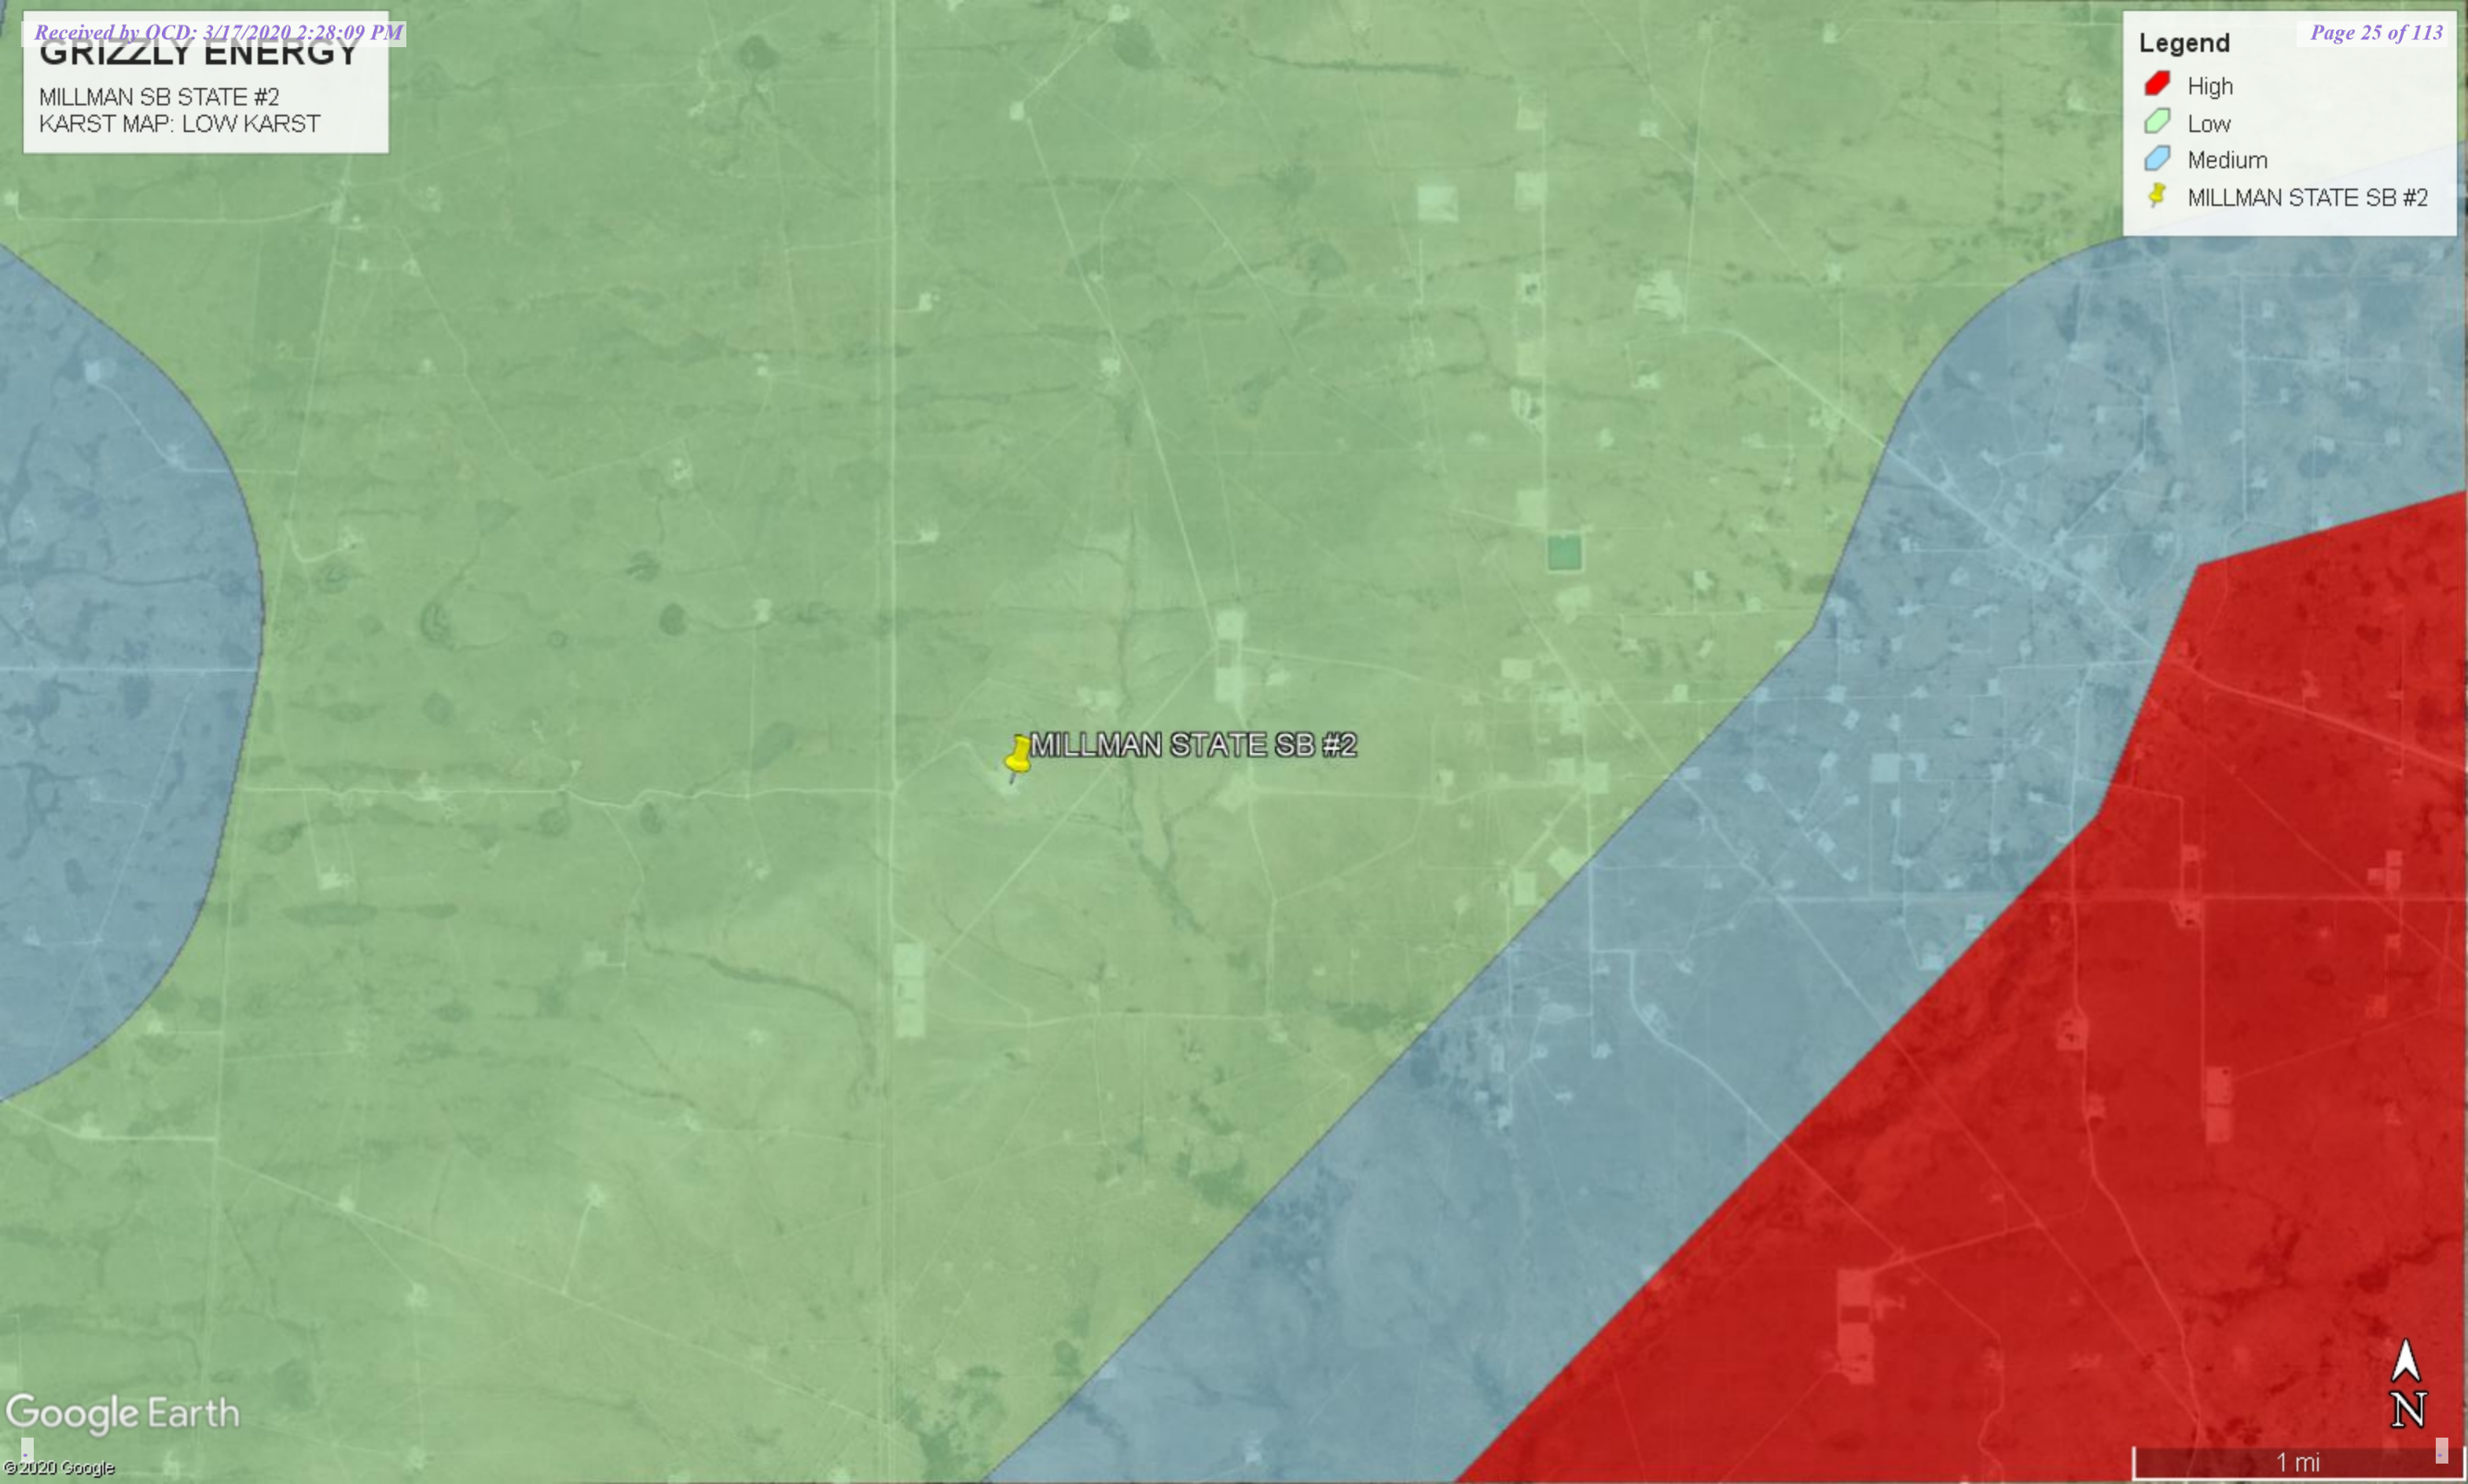
VANGUARD - MILLMAN SB STATE #2

Sample ID	Ft	Field Chl	Titration	PID	Lab-Chl	Lab-BTEX	Lab-GRO	Lab-DRO	Lab-MRO	TPH	Soil	Notes
SP1	SUR	<30										
	2'	252	94		384	<0.300	<10	<10	<10	<10	CAL	
SP2	SUR	<30										
	2'		64		320	<0.300	<10	<10	<10	<10	CAL	
SP3	SUR	<30										
	2'	<30	70		32	<0.300	<10	<10	<10	<10	CAL	
SP4	SUR	<30										
	2'		84		768	<0.300	<10	<10	<10	<10	CAL	
SP5	SUR	<30										
	2'		84		352	<0.300	<10	<10	<10	<10	CAL	
SP6	SUR	<30										
	2'	<30	62		48	<0.300	<10	<10	<10	<10	CAL	
SP7	SUR	<30										
	2'		138		1140	<0.300	<10	<10	<10	<10	CAL	
SP8	SUR	<30										
	2'		58		128	<0.300	<10	<10	<10	<10	CAL	
SP9	SUR	<30										
	2'	<30	46		16	<0.300	<10	<10	<10	<10	CAL	
SP10	SUR	<30										
	2'	<30	44		48	<0.300	<10	<10	<10	<10	CAL	
SP11	SUR	<30										
	2'	<30	46		32	<0.300	<10	11.4	<10	11.4	CAL	
SP12	SUR	<30										
	2'	<30	50		48	<0.300	<10	<10	<10	<10	CAL	
SP13	SUR	<30										
	2'	<30	42		32	<0.300	<10	<10	<10	<10	CAL

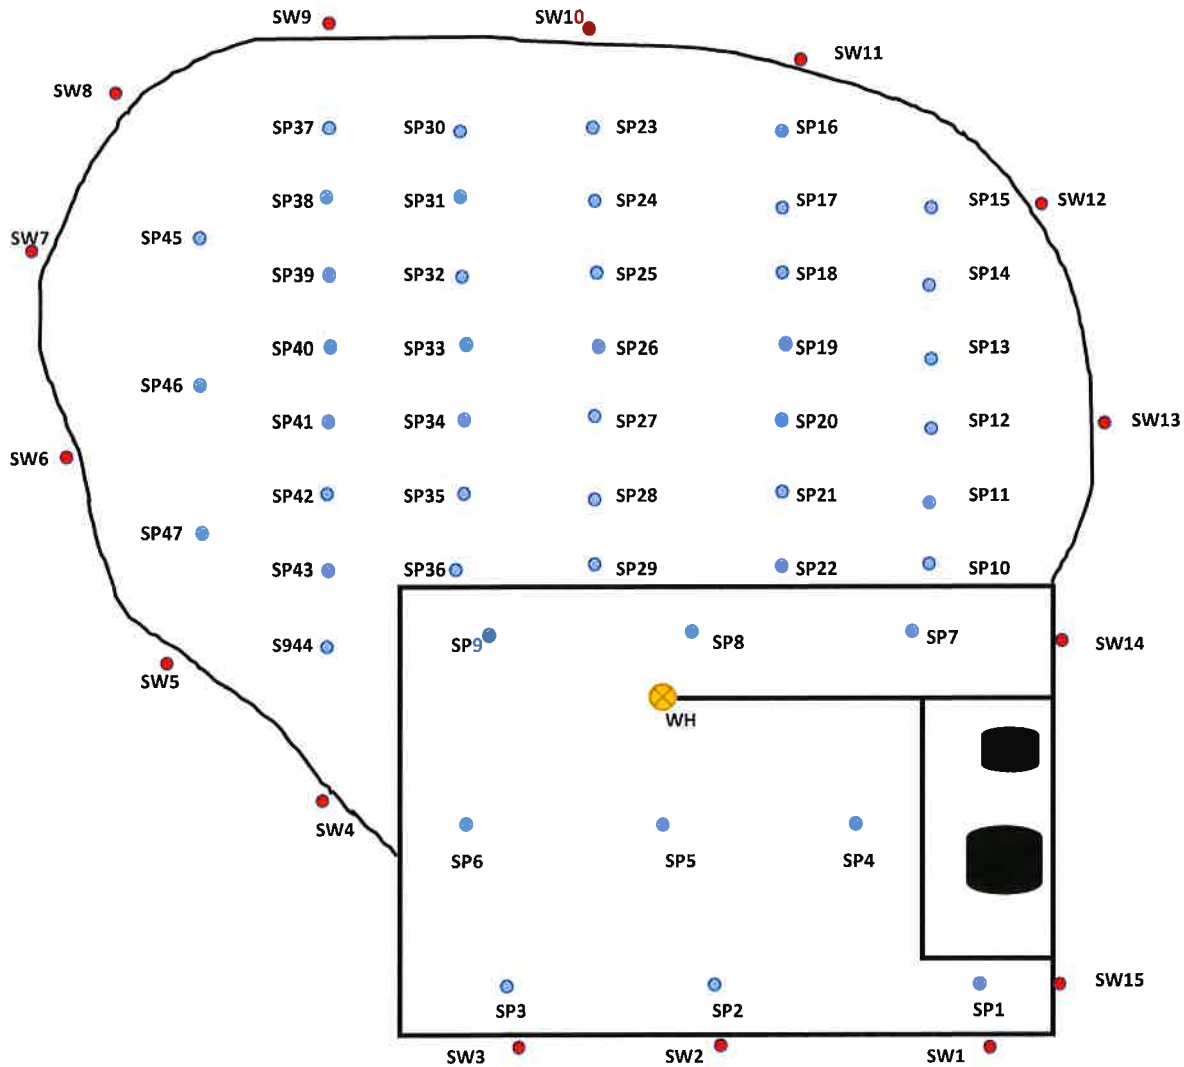
Vanguard Natural Resources
Millman SB State #2
Release date 9-11-18
2RP-4983

- Sample Points
- Side Wall Sample Points

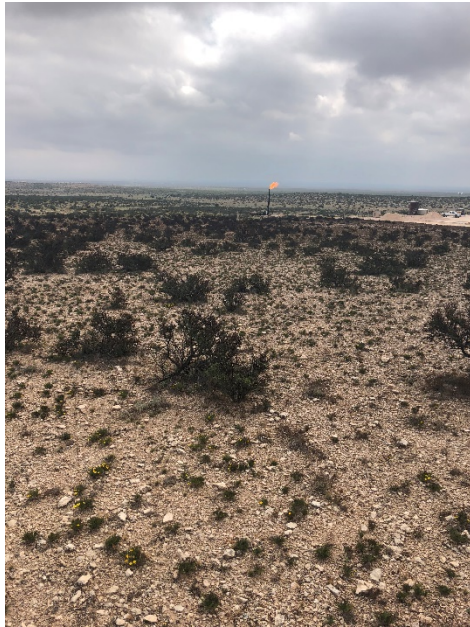
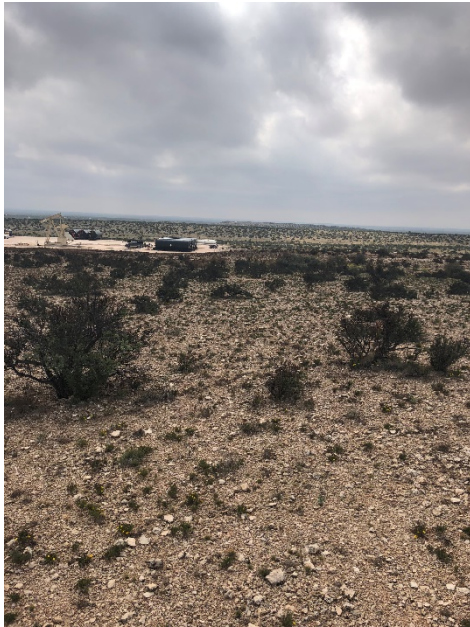
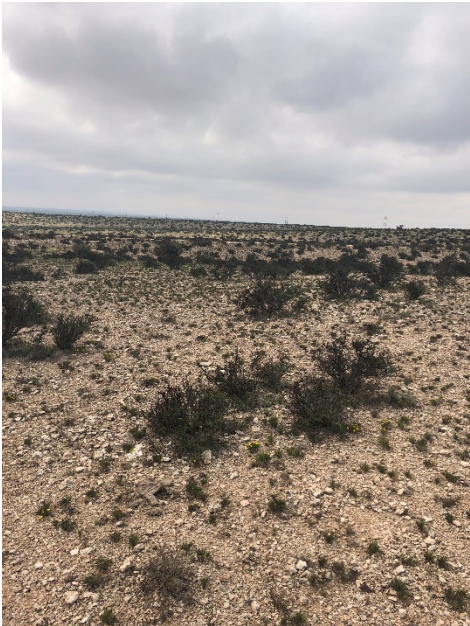
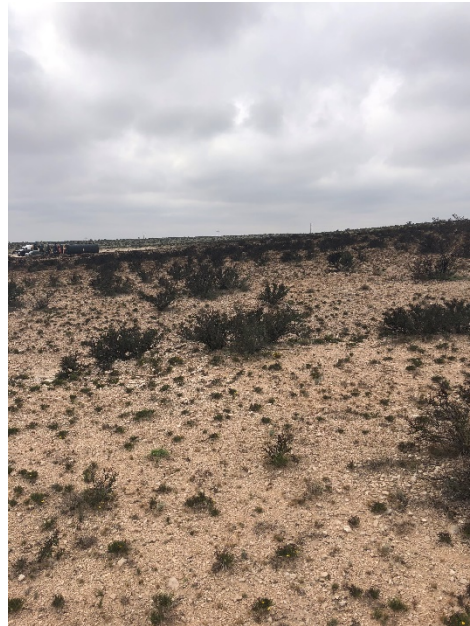
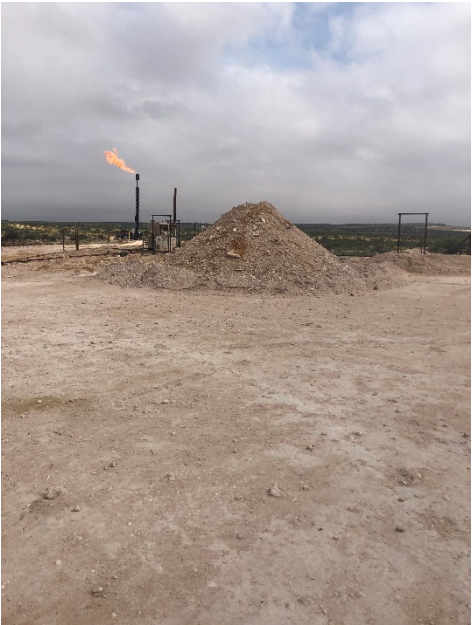
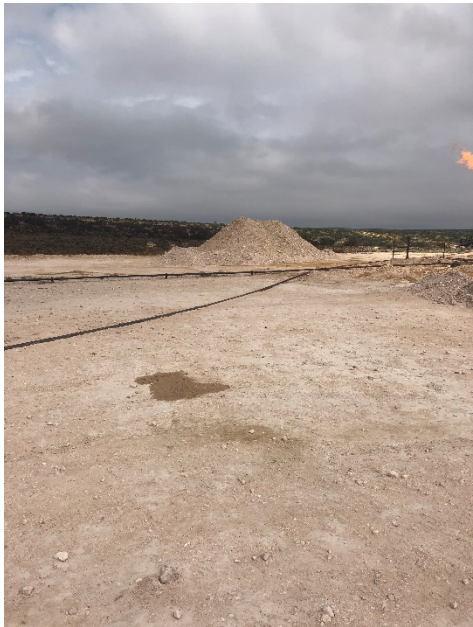
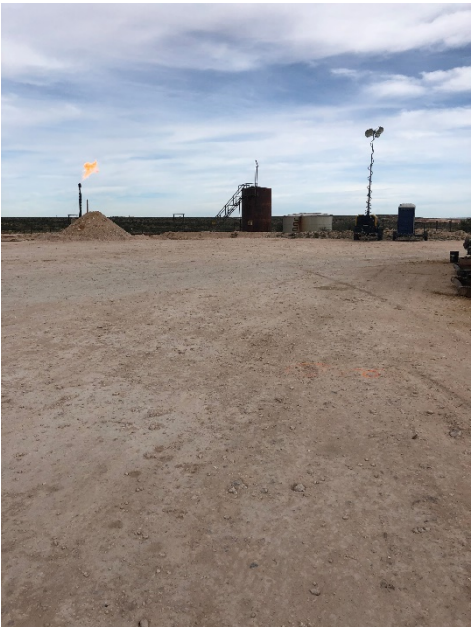
BEFORE PHOTOS

The site is located in Eddy County, New Mexico. The incident occurred due to an offset frac on a nearby well, that caused the separator to overpressure and release through the relief valve. A large area was sprayed by oil that covered approximately 304,920 Sq. Ft. of pasture and pad area. The release occurred on or before September 11th of 2018.
