Remediation and Closure Report

Tomb Raider 1 Central Tank Battery 3
Eddy County, New Mexico
2RP-5346
Talon Project #700794.322.01

Subject: **Remediation and Closure Report**
Tomb Raider 1 CTB 3
Eddy County, New Mexico
2RP-5346

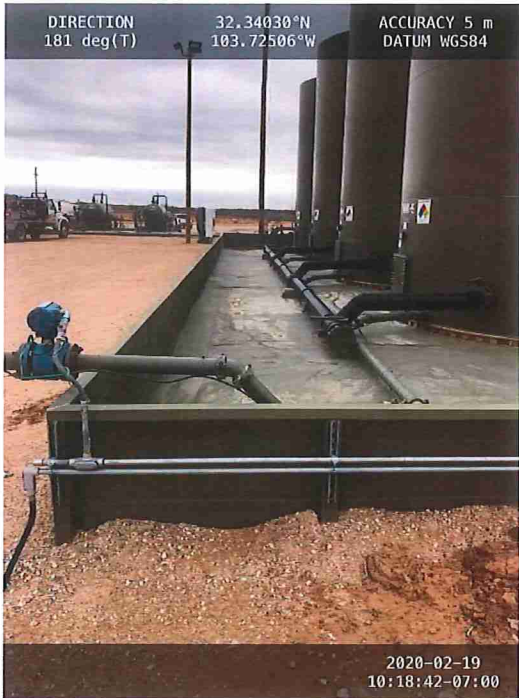
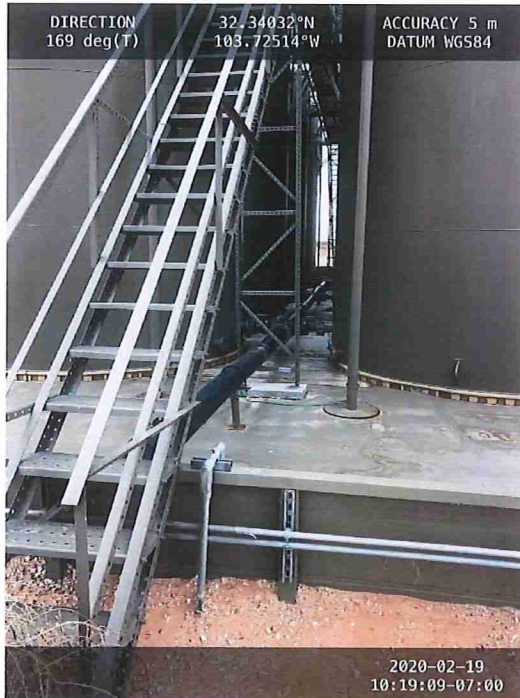
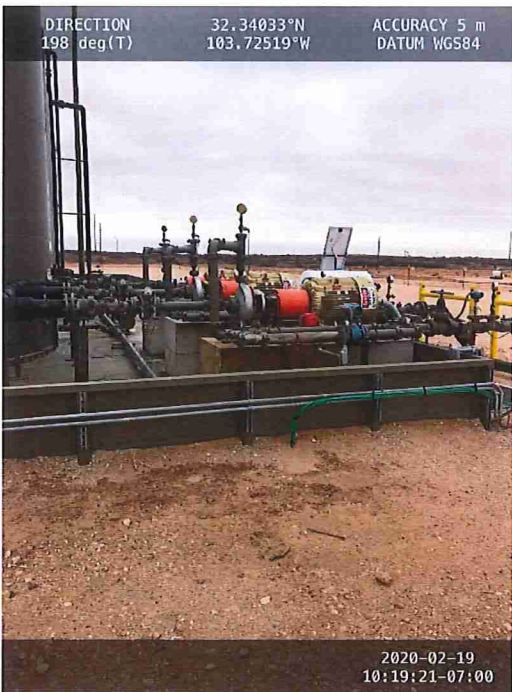
Geotagged Liner Inspection Photos

On February 19, 2020, Talon mobilized personnel to the site and conducted the liner inspection, taking photos for the record. Background samples around the battery were collected to ensure the integrity of the liner was not breached. Sample locations are shown on the attached site plan and the results of our sampling event are presented in the following data table.

Based on this site characterization, liner inspection, and analytical results, we request that no further actions be required, and that closure with regard to the attached incident be granted.
