Re: North Brushy Draw Federal 35 #001H Release Closure Request (NRM2003458859)

Subject: Closure Report
North Brushy Draw Federal 35 #001H
API #: 30-015-39753
Eddy County, New Mexico

HRL Compliance Solutions, Inc. (HRL) is pleased to present this closure report for the release and subsequent remediation at the North Brushy Draw Federal 35 #001H production facility (Site). The Site is located in Eddy County, New Mexico (Figure 1). Photographs of the Site can be found in Attachment A.

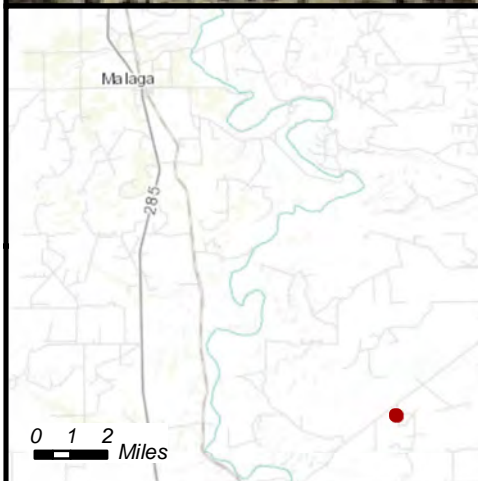
Figure 2: Impacted Area Map

On December 30, 2019, HRL mobilized to the Site to evaluate the release. HRL utilized a Trimble GeoXT global positioning system (GPS) unit to map the surficial extent of the release (Figure 2). Based on visual staining, the release impacted an approximate area of 590-square feet.

The impacted area covers an extent of roughly 590.76 square feet.

Additional excavation was conducted on January 31, 2020 following the results of analytical data exceeding NMOCD closure standards. Upon completion of remediation activities, HRL observed the total area of the excavation to be approximately 590-square feet (Figure 2) and 3 feet deep (Photographs, Attachment B).

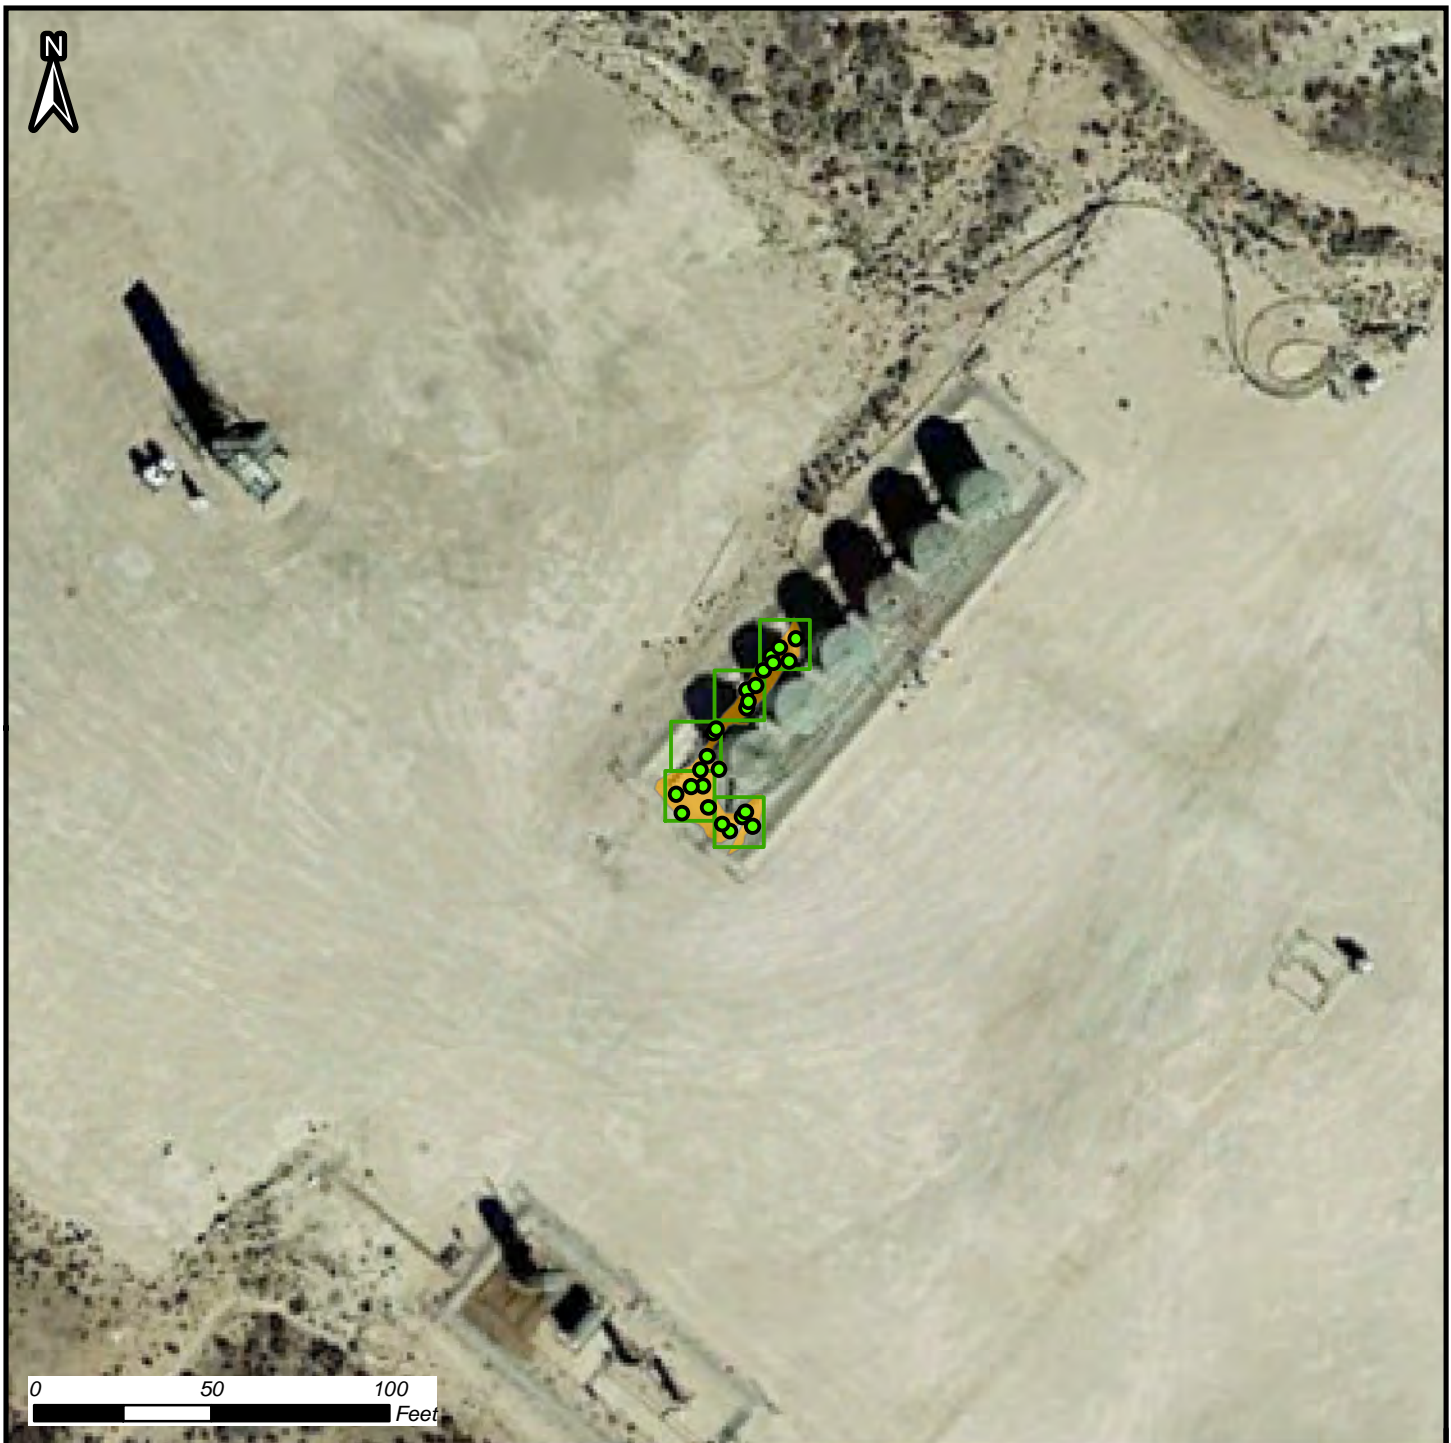
Figure 5: Confirmation Sample Map

A confirmation sample plan was implemented utilizing a five-point composite sample strategy that represented areas less than 200-square feet, in accordance with 19.15.29.12 NMAC. Confirmatory soil samples were collected on January 16, 2020. Sample locations where initial confirmation samples exceeded NMOCD closure standards were resampled on February 11, 2020, following the completion of additional excavation (Figures 4 and 5). The confirmation samples were submitted to Hall Environmental Analysis Laboratory Inc., Albuquerque, New Mexico. The soil samples were analyzed for:

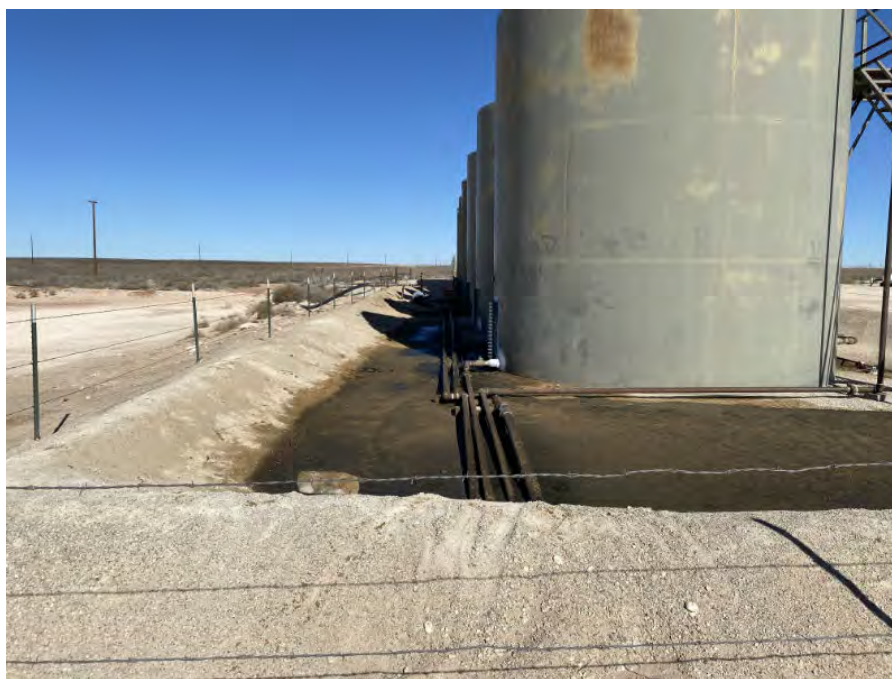
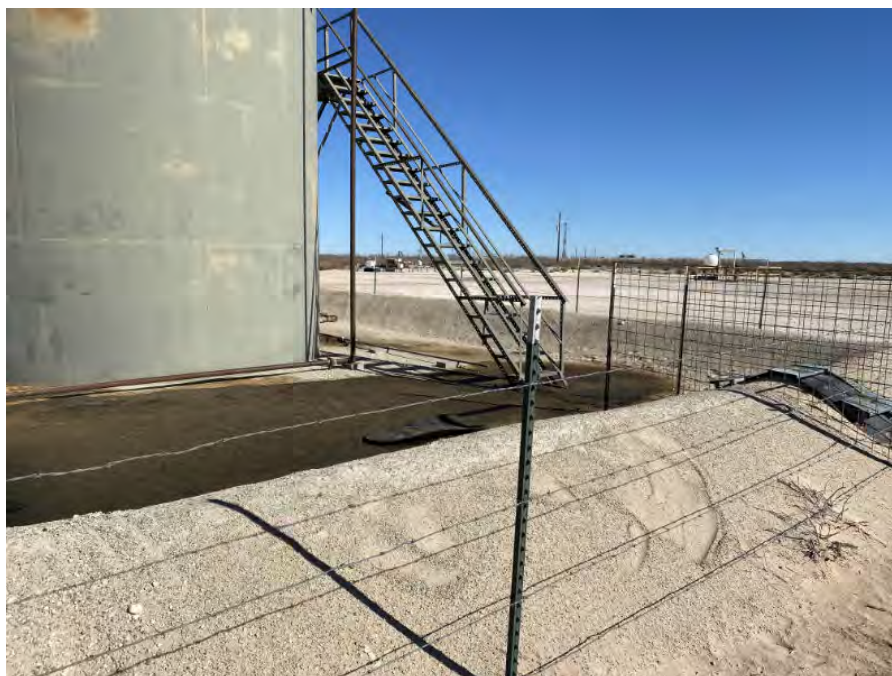
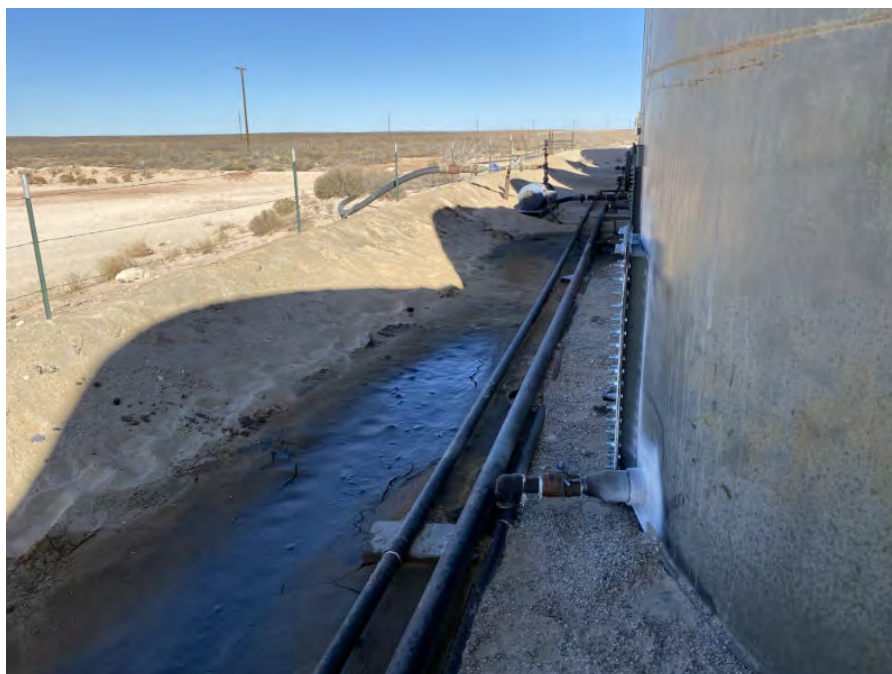
On December 28, 2019, a release of eight barrels of crude oil was observed at the Site. This release occurred when a weld on the outlet of the oil tank failed. The crude oil impacted the area within secondary containment adjacent to the oil tank. A liner was not present within the secondary containment.

Impacted Area
December 30, 2019

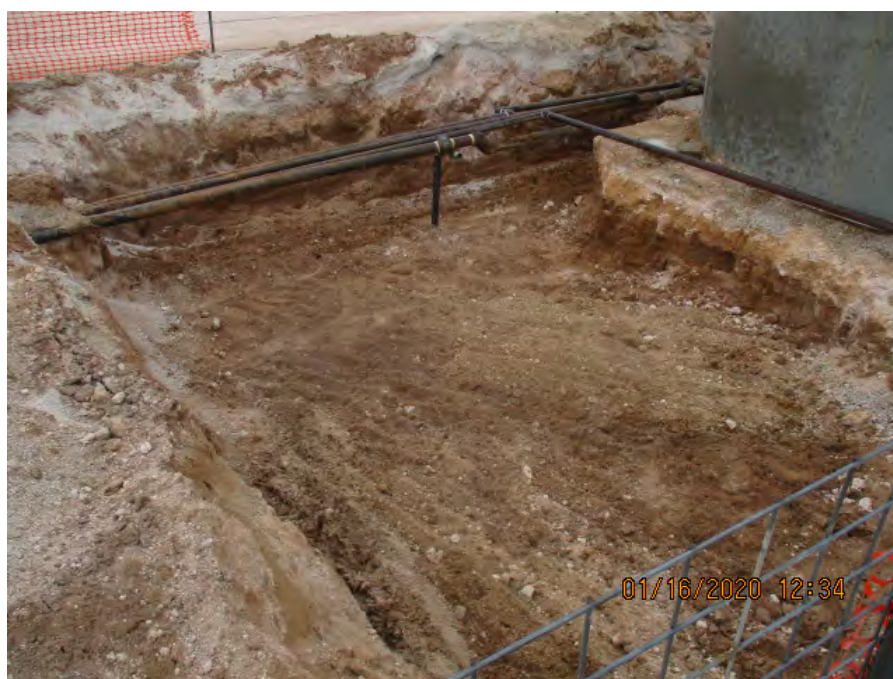
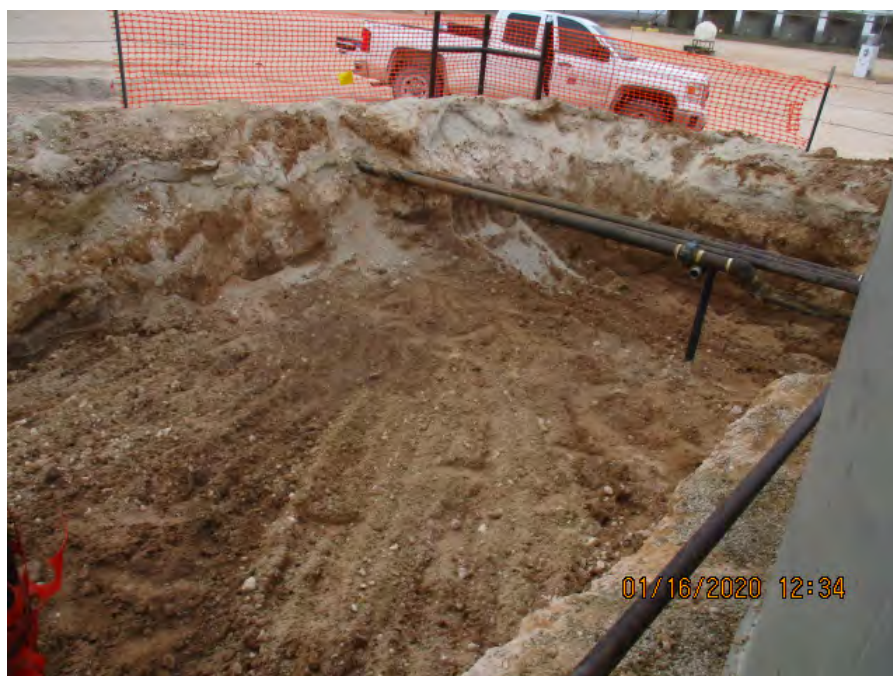
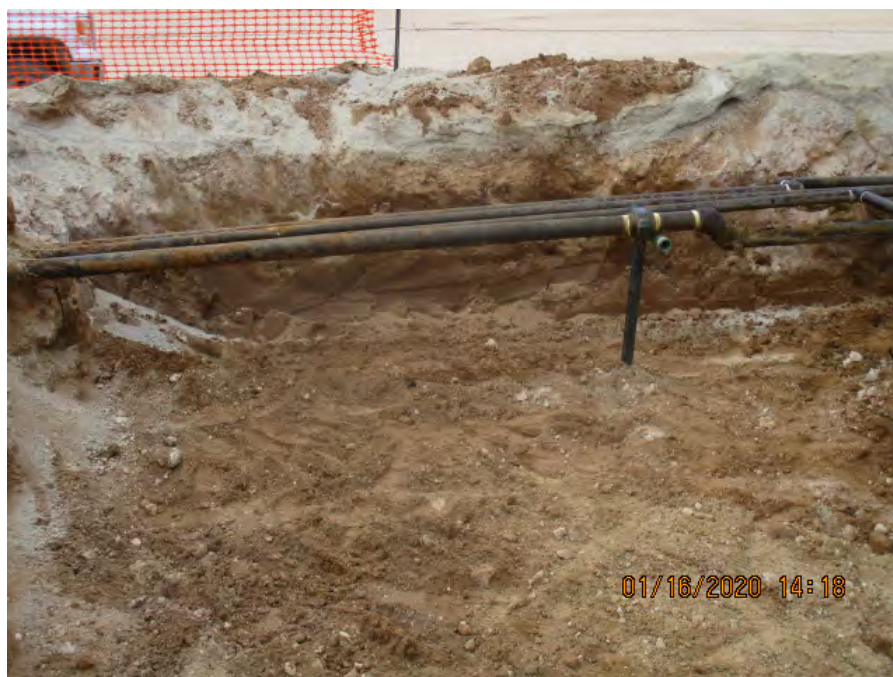
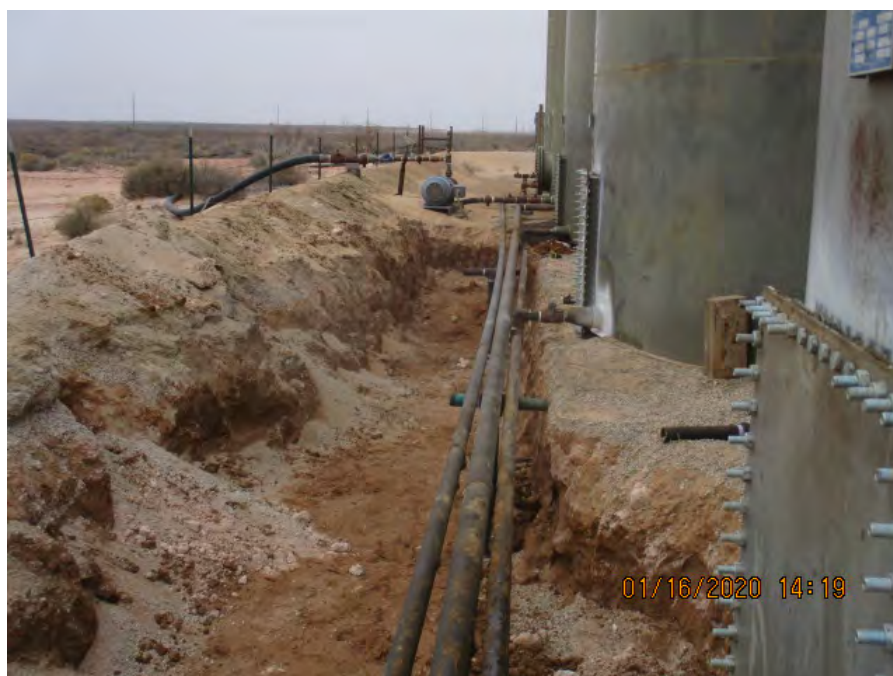
Remediated Area
January 16, 2020

Based on the presence of free liquids in the soil, it was determined that remediation of the impacted soil was necessary. WPX retained Kelley Oilfield Services to conduct the excavation of impacted soil. Remediation activity at the Site consisted of the excavation of impacted soil and off-site disposal at R360 Red Bluff, an exploration and production waste disposal facility located in Orla, Texas. Excavation activities began on January 9, 2020. HRL provided guidance for excavation activities based on collection of soil samples for analysis in the field (field screening) using field instrumentation. Field screening activities were conducted for:

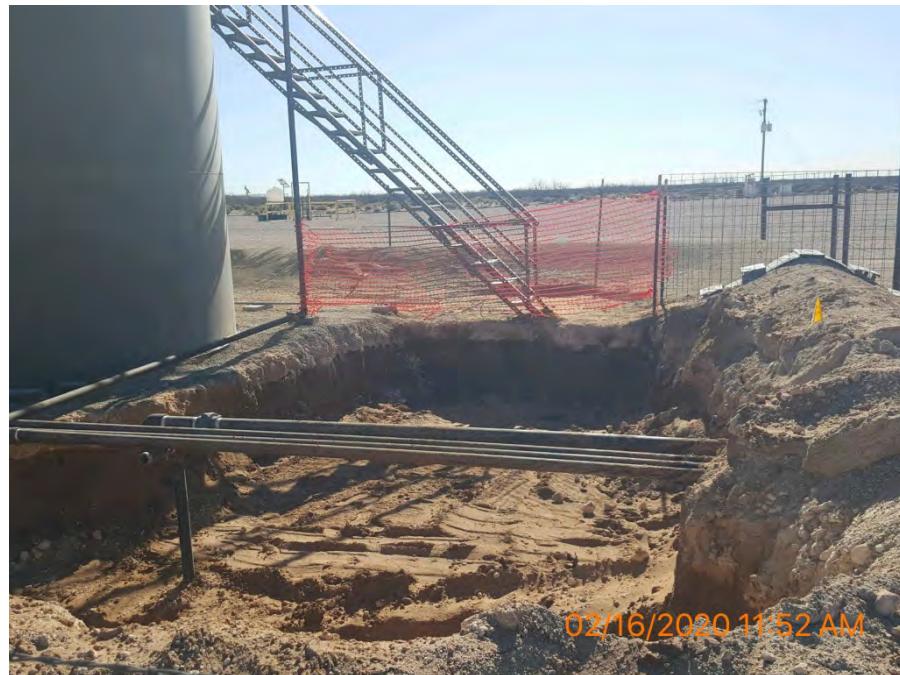
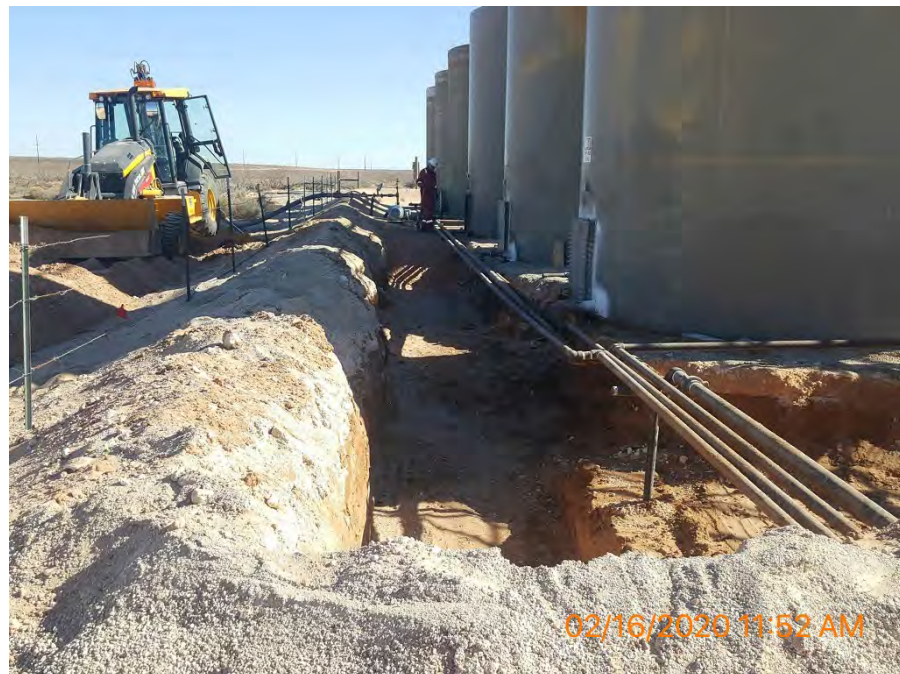
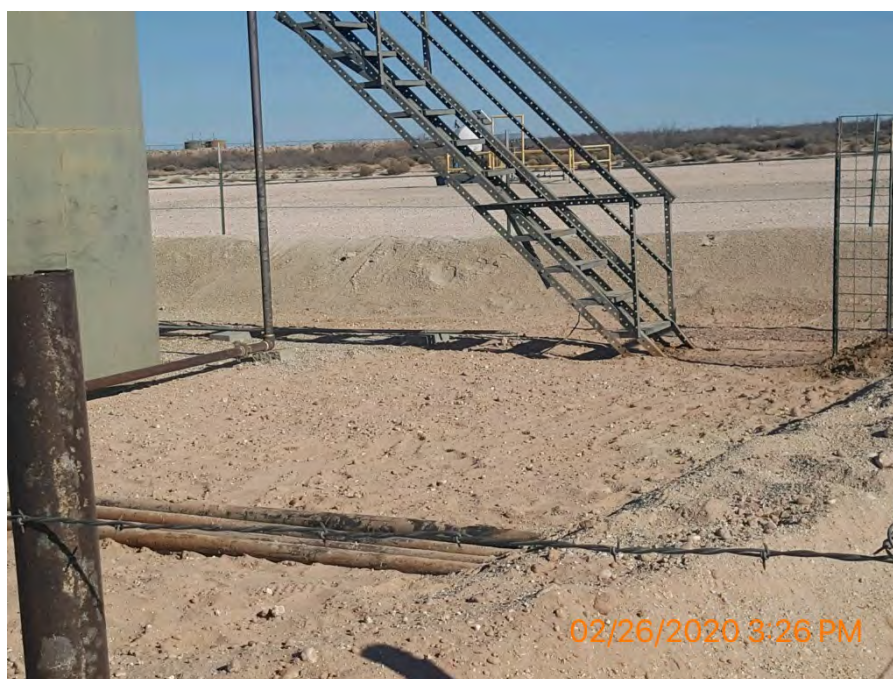
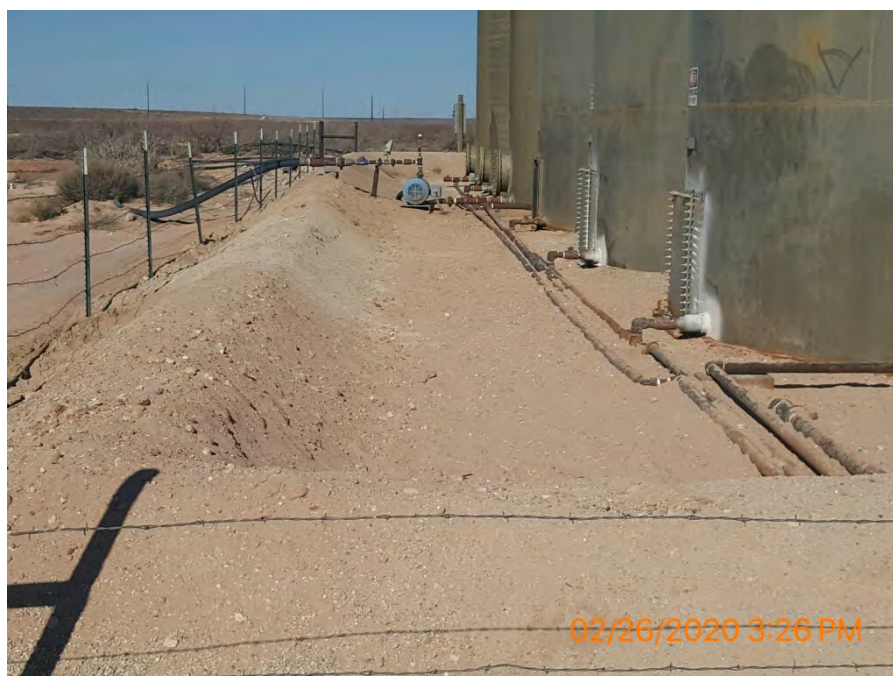
Remediated Area
February 16, 2020

Remediated Area
February 26, 2020
