Humble Yates Battery Closure March 30, 2020

Maverick Natural Resources Humble Yates Battery NAB1912635236 2RP-5384 Closure Report Section 16, Township 18S, Range 28E Eddy County, New Mexico Revised March 30, 2020

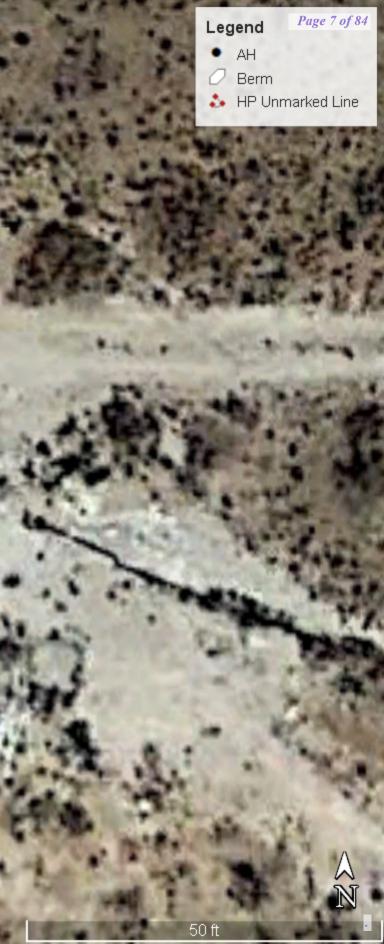
Battery Sample Positions

AH 3 AH 1 AH 2

Test Trench

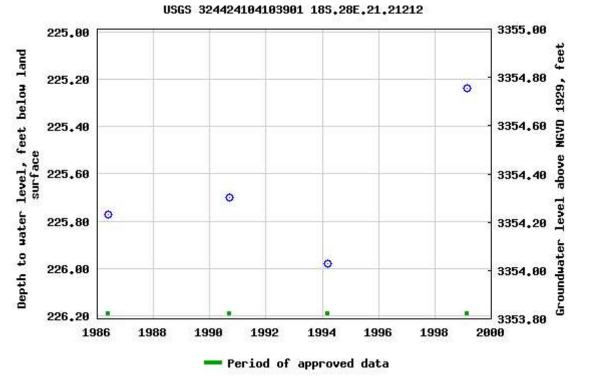
The depth of the well is 250.00 feet below land surface.

Breaks in the plot represent a gap of at least one year between field measurements. <u>Download a presentation-quality graph</u>

According to the NM Oil and Gas Hydrology map, there is no record of groundwater in the immediate vicinity of this location. The depth to groundwater for this location is 225 feet according to the USGS web interface map. The Office of the State Engineer records indicate depth to groundwater to be 300 feet at the nearest well. Furthermore, the trend map reveals depth to groundwater at 150-200 feet. Based on the information from these three sources, we believe depth to groundwater to be between 150 feet and 250 feet.

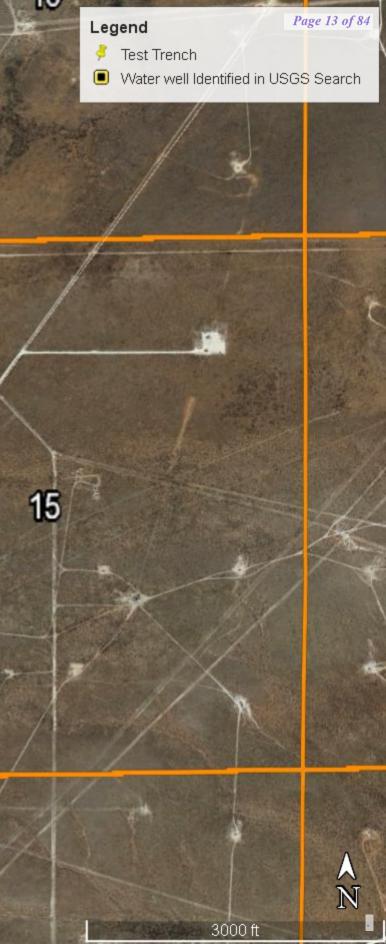
Water well Identified in USGS Search
