SUBJECT: Remediation Closure Report for the State 36 #001 Release (NCE2002851831), Eddy County, New Mexico

On behalf of Ridge Runner Resources (RRR), Atkins Engineering Associates INC. (AEA) has prepared this Remediation Closure Report that describes the remediation of a release related to oil and gas production activities at the State 36 #001. The site is in Unit L, Section 36, Township 21S, Range 27E, Eddy County, New Mexico, on Private land. Figure 1 illustrates the vicinity and site location on an USGS 7.5-minute quadrangle map.

State 36 #001 Remediation Closure Report (2RP-TBD)
February 17, 2020

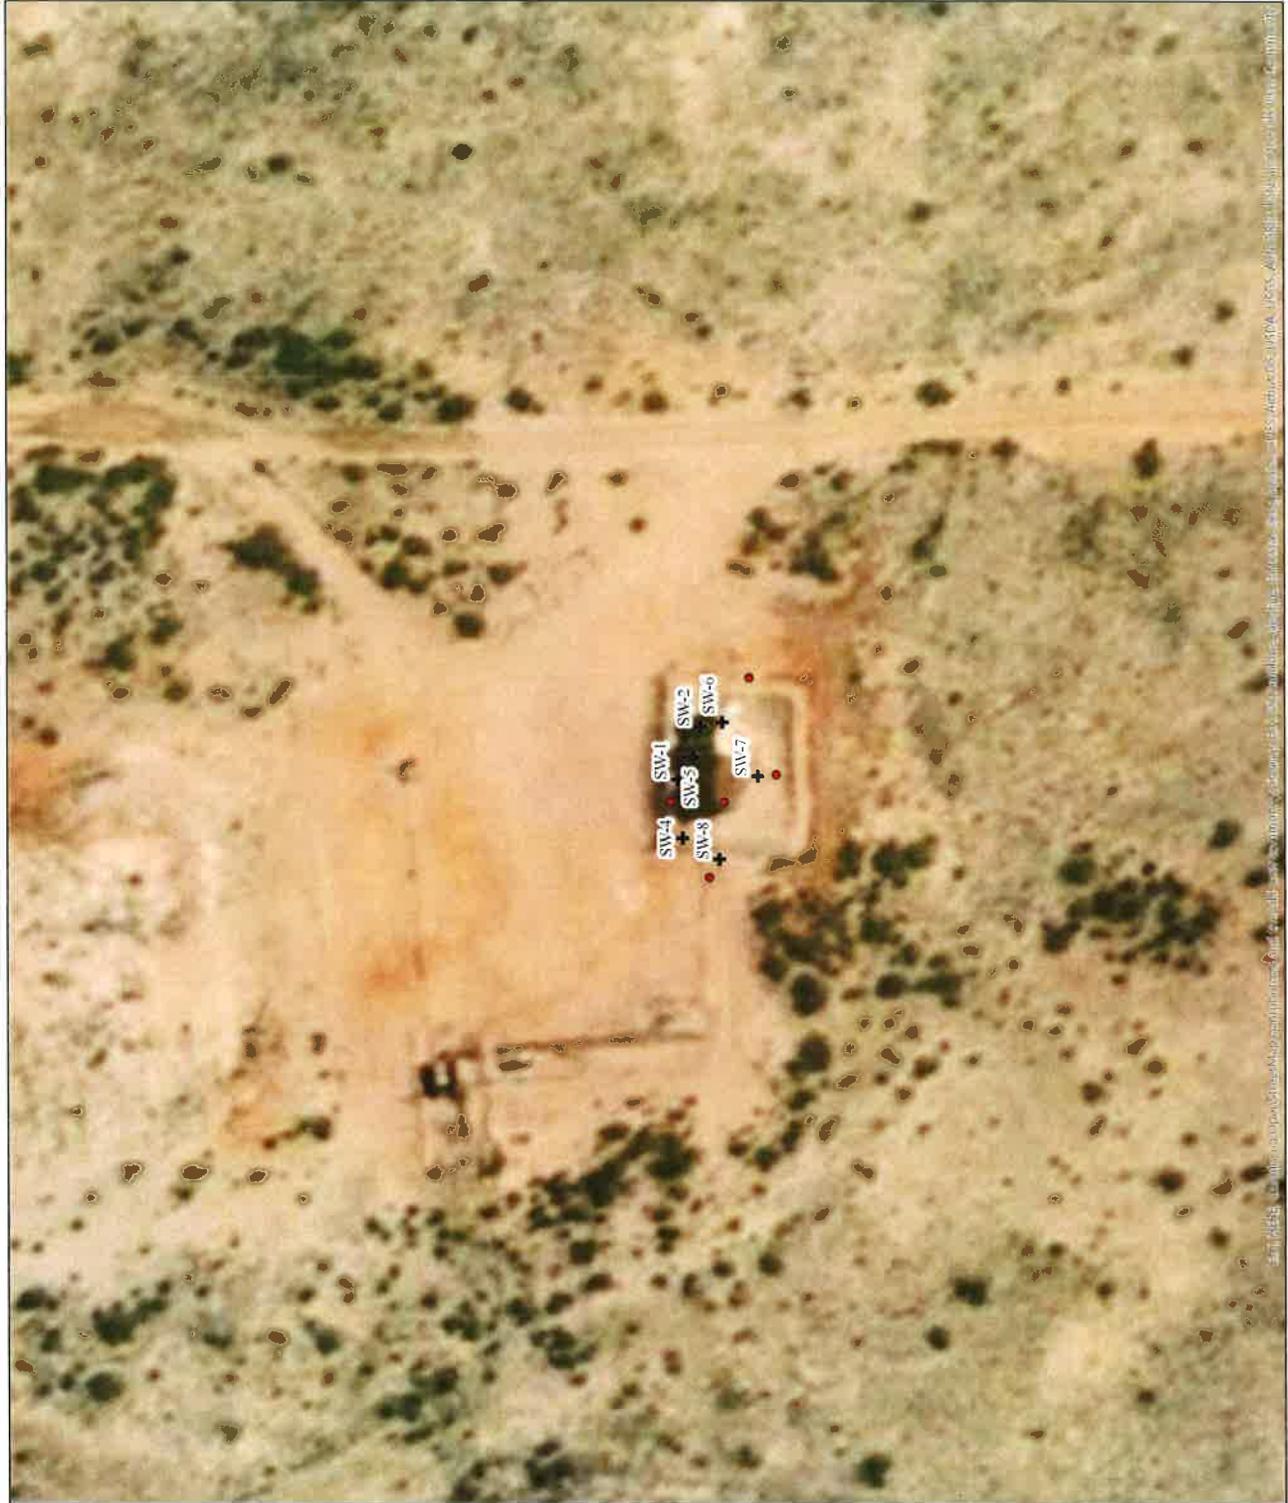
State 36
Sec 36, T 21S, R 27E,
N.M.P.M.

Figure 3 shows the extent of the excavation and sample locations. All laboratory results are summarized in Table 3. Laboratory reports are included in Appendix D.

As summarized in Table 3, results indicated that most of the old battery had hydrocarbon contamination (TPH) from depths of four (4) to six (6) feet. an area approximately 50feet wide and 60 feet long was found to be impacted. The area is located directly under the old production tank battery.

AEA returned to the site to oversee the excavation of contaminated soil directly beneath the old tank battery. AEA guided the excavation activities by collecting soil samples for field screening. The walls and base were excavated until field screening results indicated that the NMOCD Closure Criteria would be met or as close to production equipment as could be safely allowed.

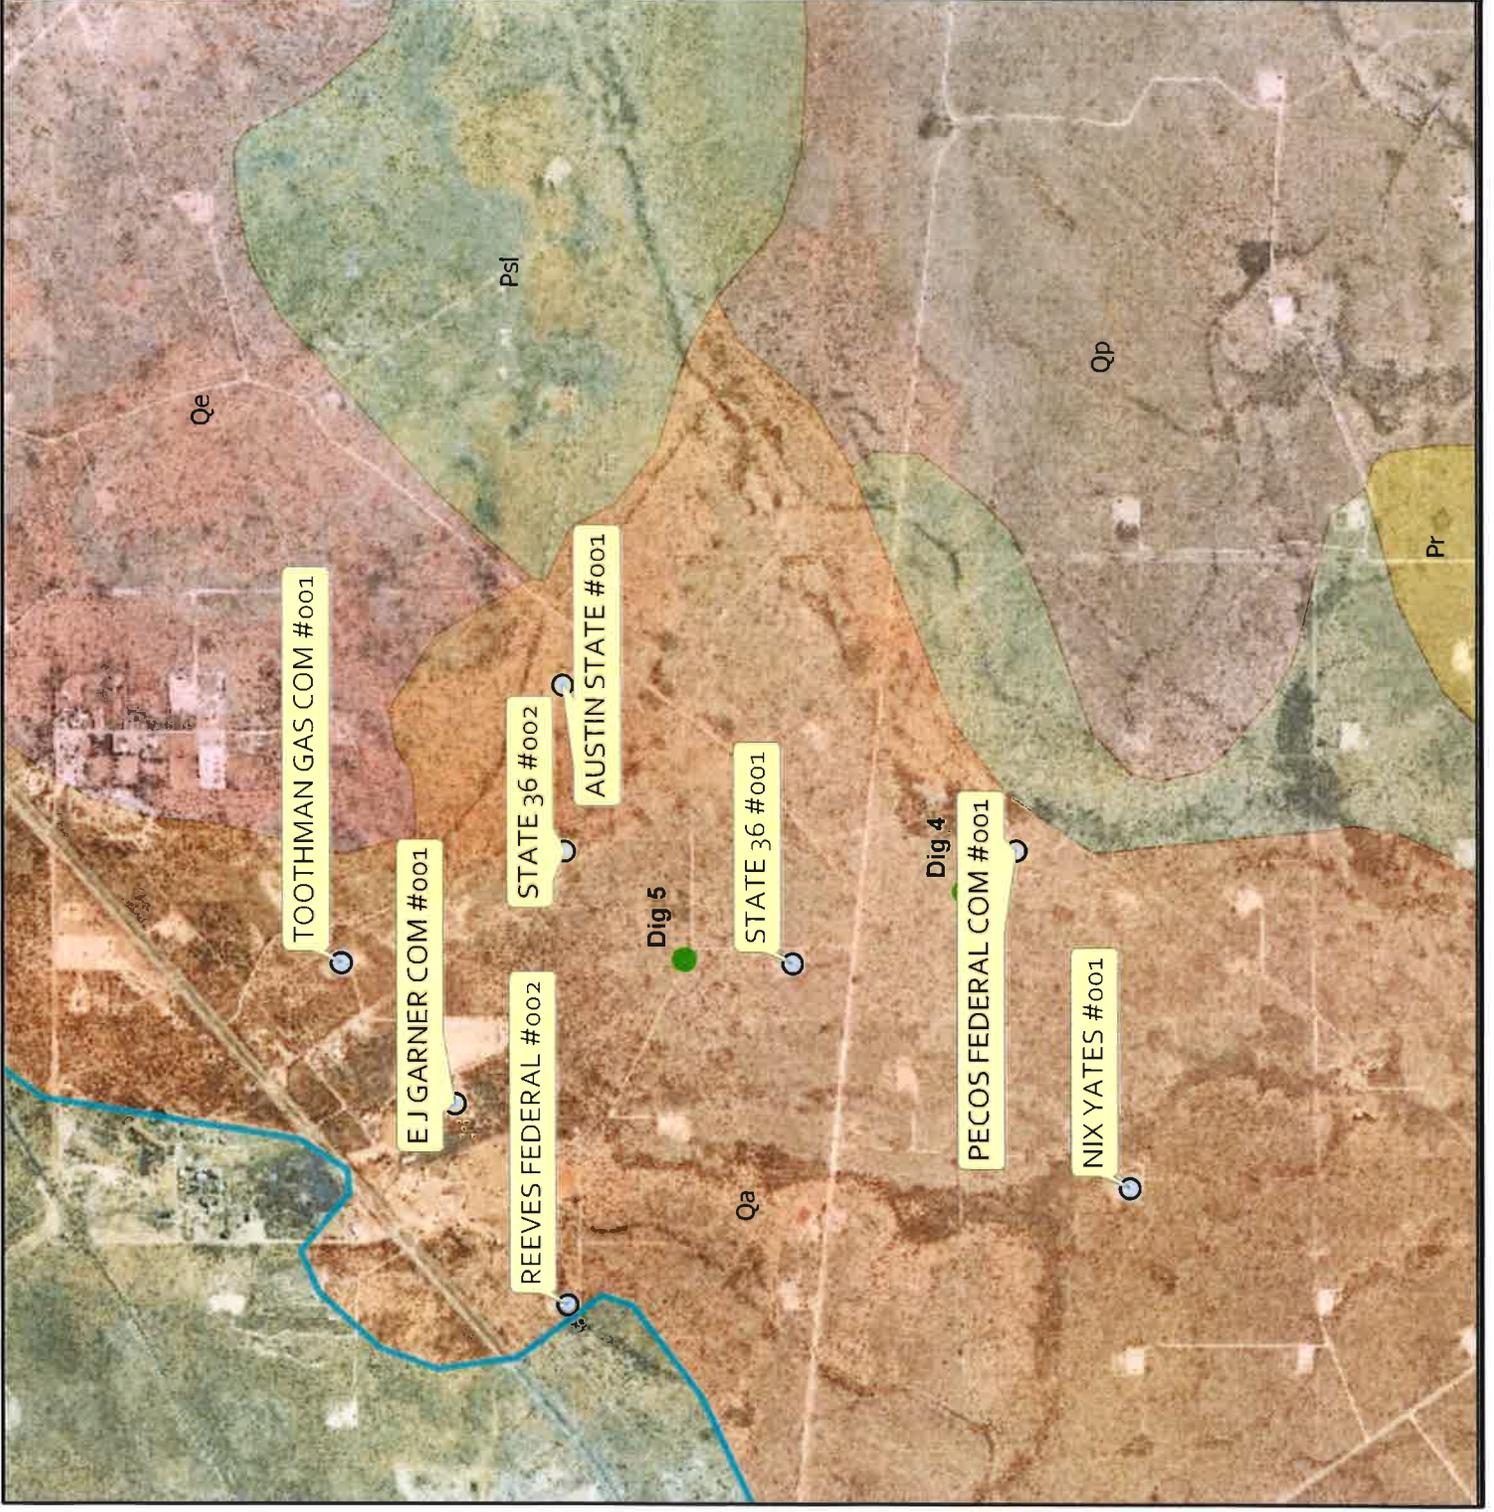
FIGURE 1
Ridge Runner
East Carlsbad

AEA found several temporary monitoring wells that had been drilled in the northernmost RRR production area prior to RRR purchasing the area assets. The most relevant were in response for a NMOCD reportable release at the Finley Station on August 21, 2015 and was closed by NMOCD on December 2016 (three monitoring wells were drilled). The groundwater monitoring well MW-1 was installed approximately 150 feet north of the excavation source area, in an apparent up-gradient location relative to the well site see Figure #1.

Three (3) soil borings were advanced to approximately 30 feet bls utilizing a Mobile B58 Hollow Stem Auger with an inside diameter of 3.25 inches. Groundwater when present was located approximately eleven to twenty seven (11-27) feet bls; therefore, soil borings were terminated at 30 feet bls. Each of the boreholes where logged using the Universal Soil Classification System (USCS) method. Field assessment of soil and water samples were accomplished by the NRCS 1:1 EC method with use of Deionized Water (DI). The soil bores that did not encounter ground water were plugged to surface with bentonite pellets. This was the case for Dig 1 and Dig 4. Both soil bores where advanced to 30ft allowed to develop, but no water was detected.

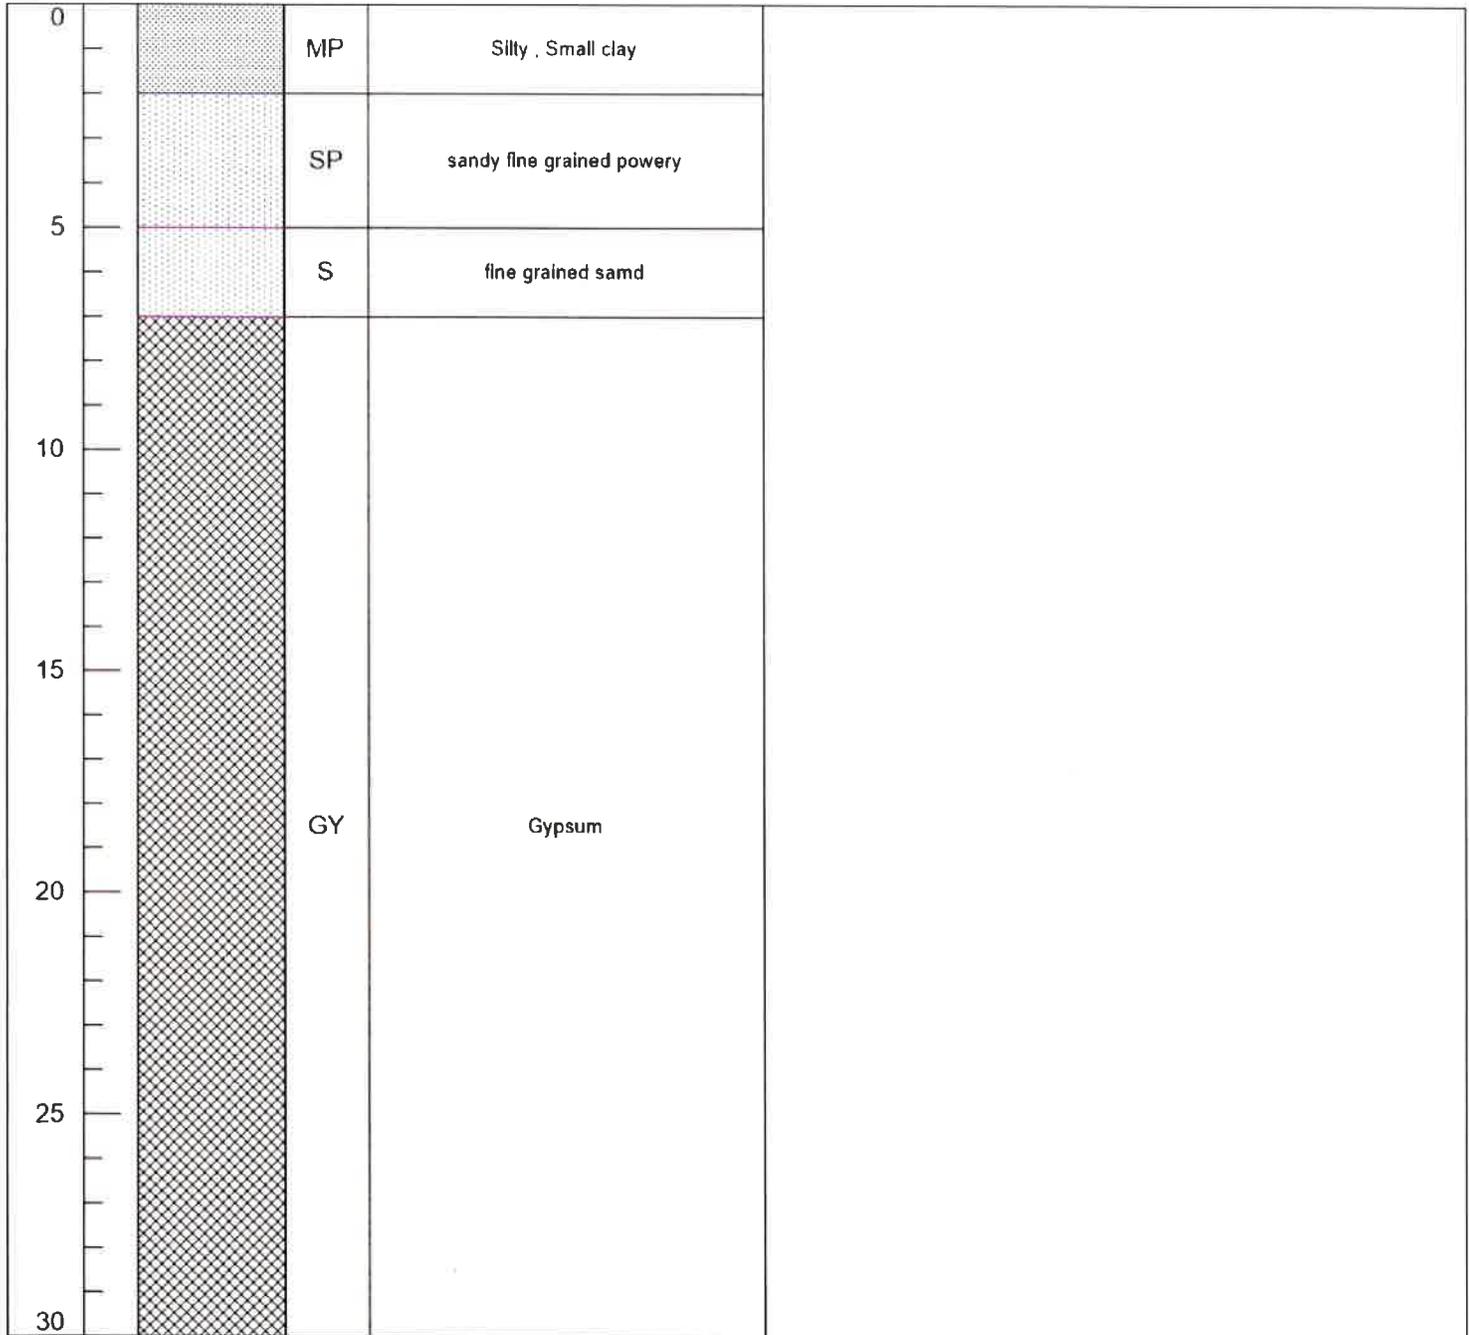
10ft of Bentonite Hole Plug 3/8 with backfill to surface
 No Water was Reached

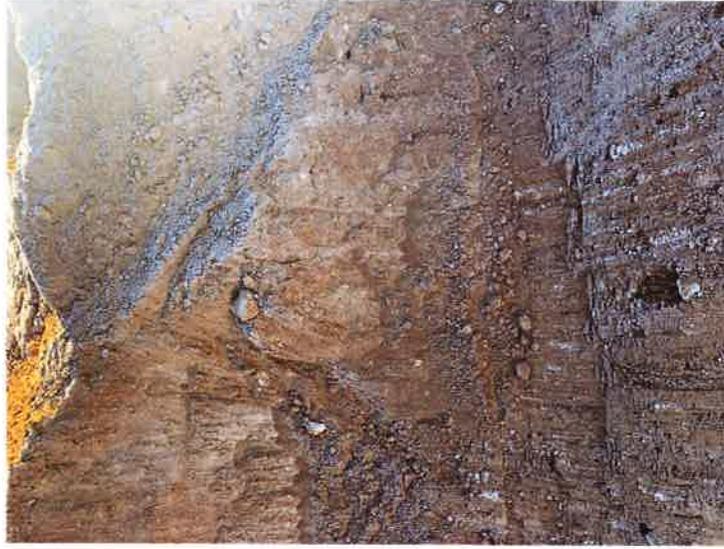
SW3 Geo- Reference photo

Lab analysis showed that sample locations SW3 and SW5 are still elevated in TPH compared to background concentrations. No further excavation was attempted because SW3 and SW5 are comprised of solid rock. All additional samples collected where no-detectable (ND) or below the NMOCD standards of Table I of 19.15.29.12 NMAC.

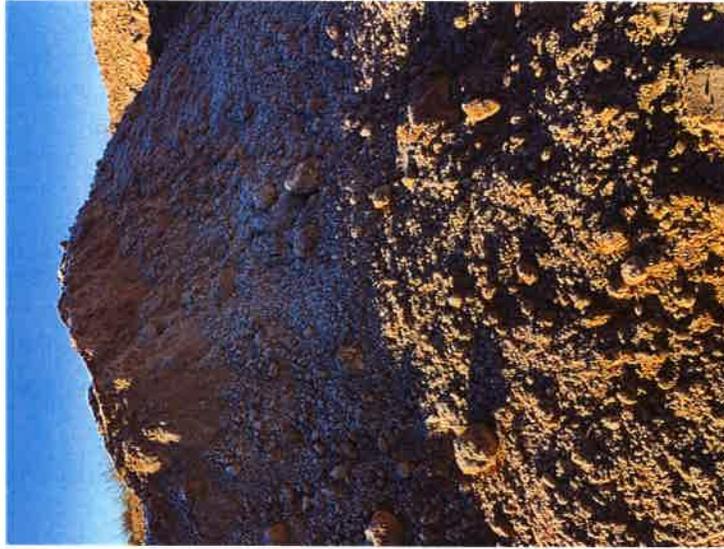
Excavation and Dolomite Reference photo

The center of the contaminated area is dominated by a large continuous vein of dolomite measuring approximately fifteen (15) feet wide and longer than the excavation. The solid rock vein began at four (4) to six (6) feet bgs and continued past the bottom of the excavation at ten (10) feet.

On December 4, 2019 AEA met with NMOCD district 2 personal on the presence of the solid rock vein. NMOCD guided AEA to pressure wash the rock and hydro excavate any contaminated soil from the surface and sides of the rock. On December 18, 2019 AEA field personal pressure washed the rock face with 330 gallons of (Liquid Remediate) a bio-degradable soap and hydrocarbon ingesting bacteria amendment (see attached SDS). All associated leachate and soil from the washing event was collected and disposed. The impacted soil staging location on site was also sampled at the completion of excavation hauling activities (SP1).
