Re: Pinnacle State #009 Release Closure Request (NVV2002829022)

Subject: Closure Report
 Pinnacle State #009
 API #: 30-015-27201
 Eddy County, New Mexico

HRL Compliance Solutions, Inc. (HRL) is pleased to present this closure report for the release and subsequent remediation at the Pinnacle State #009 Production Facility (Site). The Site is located in Eddy County, New Mexico (Figure 1). Photographs of the Site can be found in Attachment A.

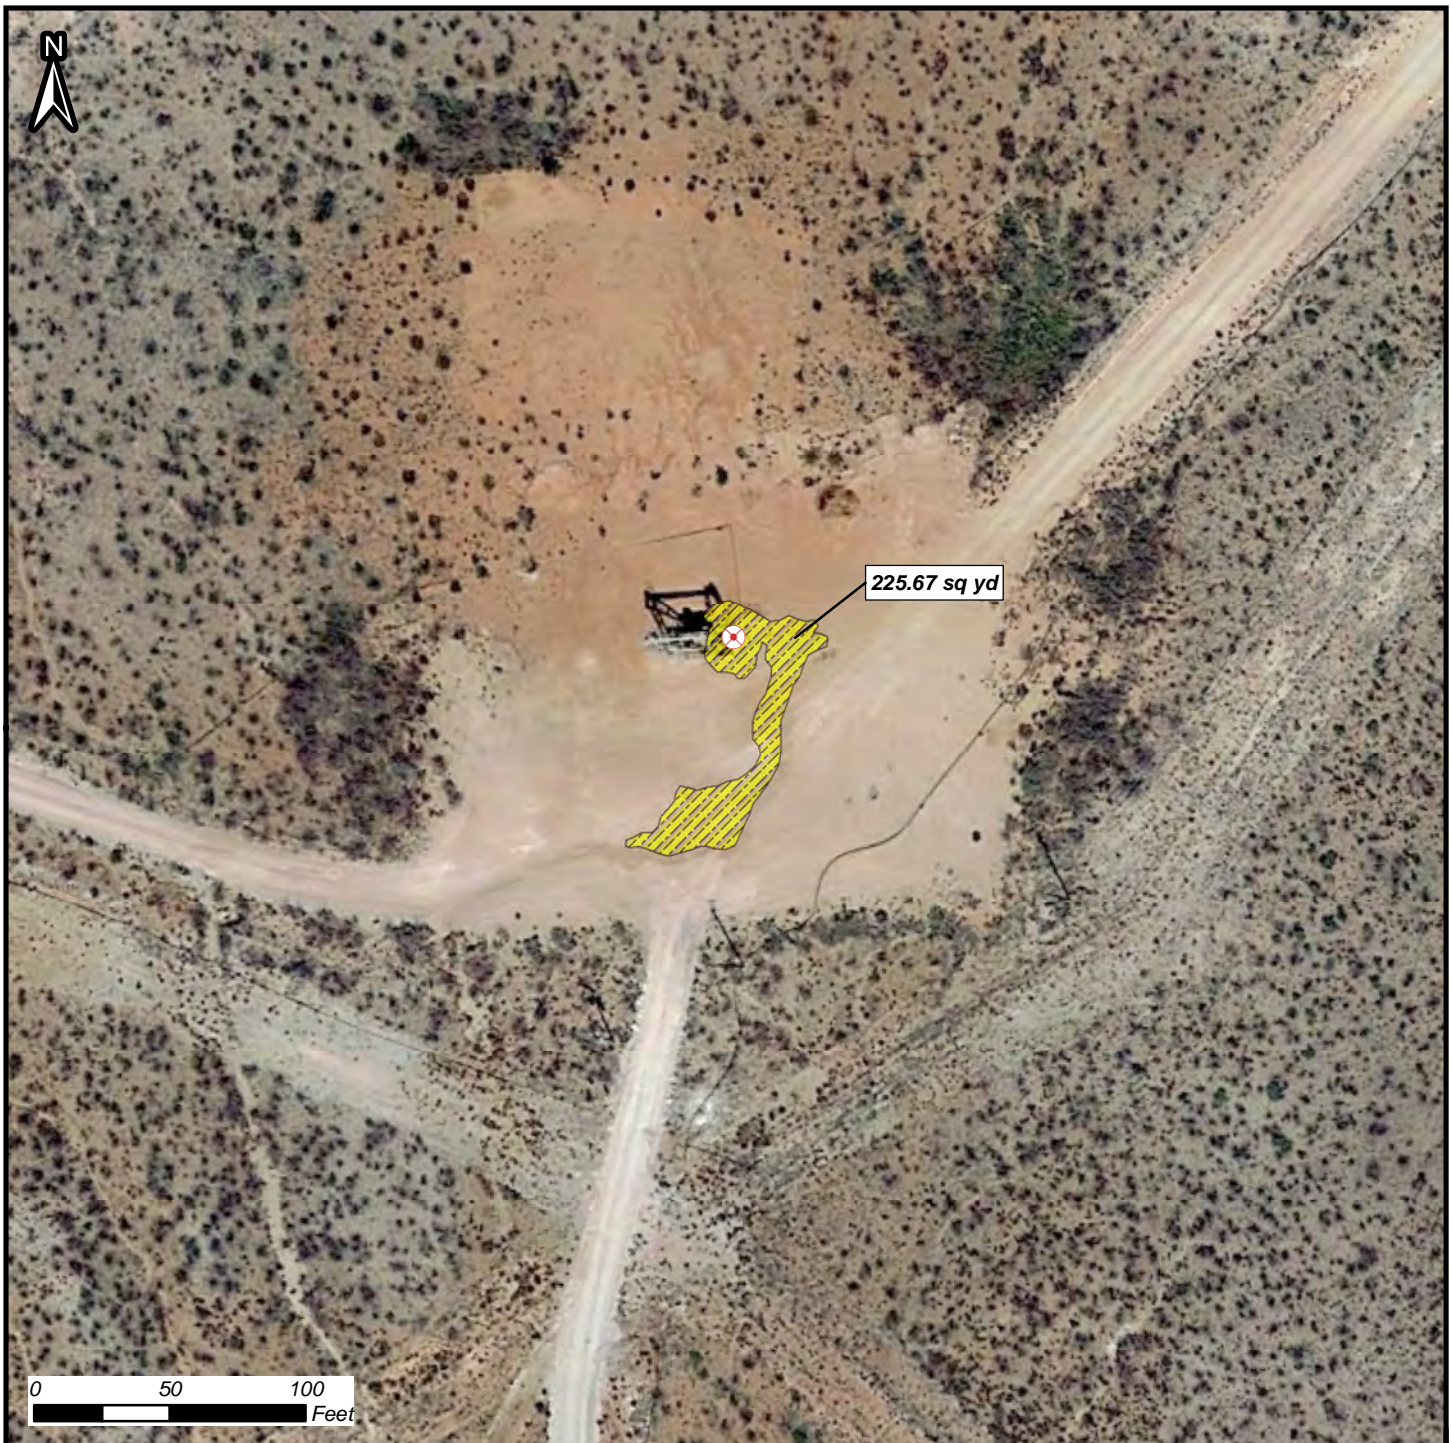
Figure 2: Impacted Area Map

On January 15, 2020, HRL mobilized to the Site to evaluate the release. HRL utilized a Trimble GeoXT global positioning system (GPS) unit to map the surficial extent of the release (Figure 2). The release impacted an approximate area of 2,025 square feet (225.67 square yards).

The impacted area covers an extent of roughly 225.67 square yards.

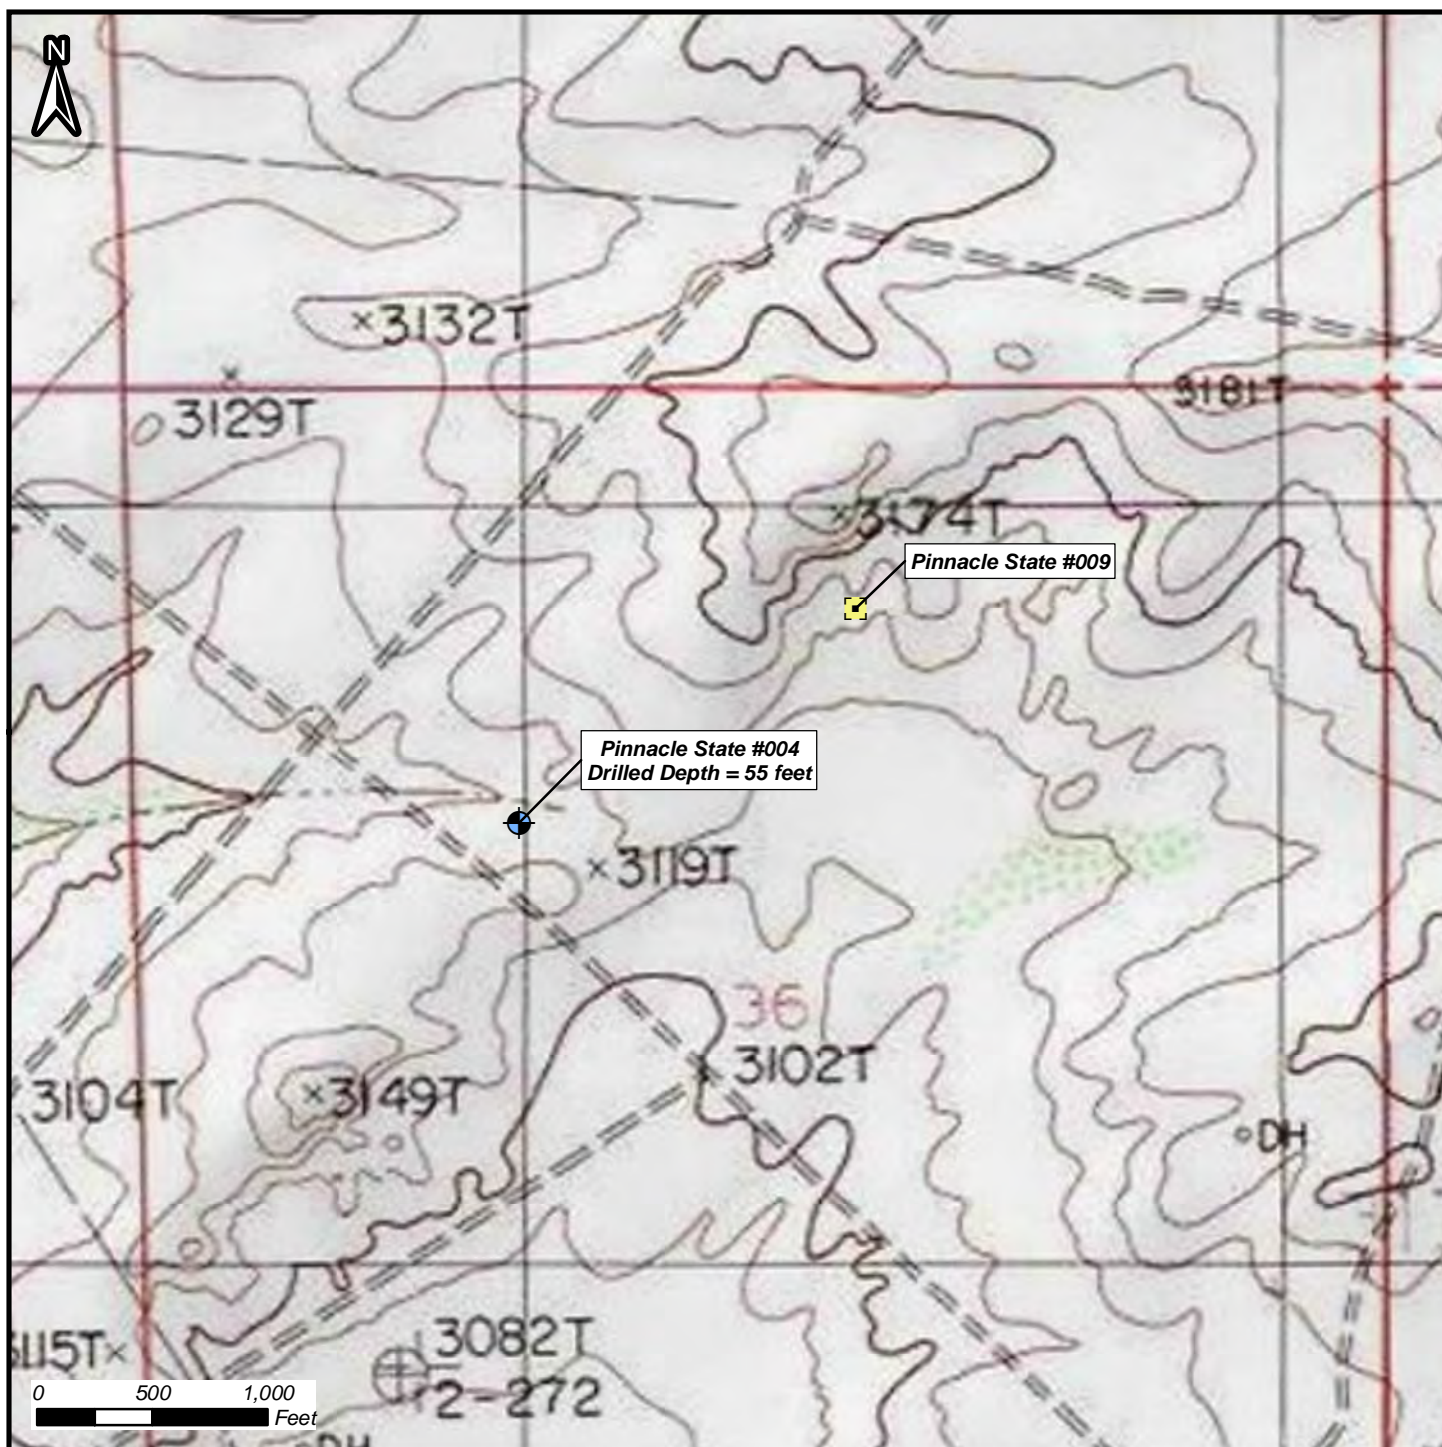
Figure 3: Depth to Groundwater Map

HRL drilled one groundwater monitoring well at the Pinnacle State #004 well pad (latitude 32.351316, -104.044205), approximately 1,700 feet southwest of the Site. The well was drilled using hollow-stem auger to a total depth of 55 feet below ground surface (bgs). The well was completed with two-inch polyvinyl chloride (PVC) factory slotted screen from 55 to 45 feet bgs and blank casing from 45 feet bgs to ground surface. The well was left undisturbed for 48-hours, at which time WPX returned to gauge the depth to water. Water was not encountered in this well; therefore, HRL has determined that the depth to groundwater is greater than 55 feet below ground surface. (Figure 3).

The depth to groundwater at this newly drilled well is greater than 55 feet.

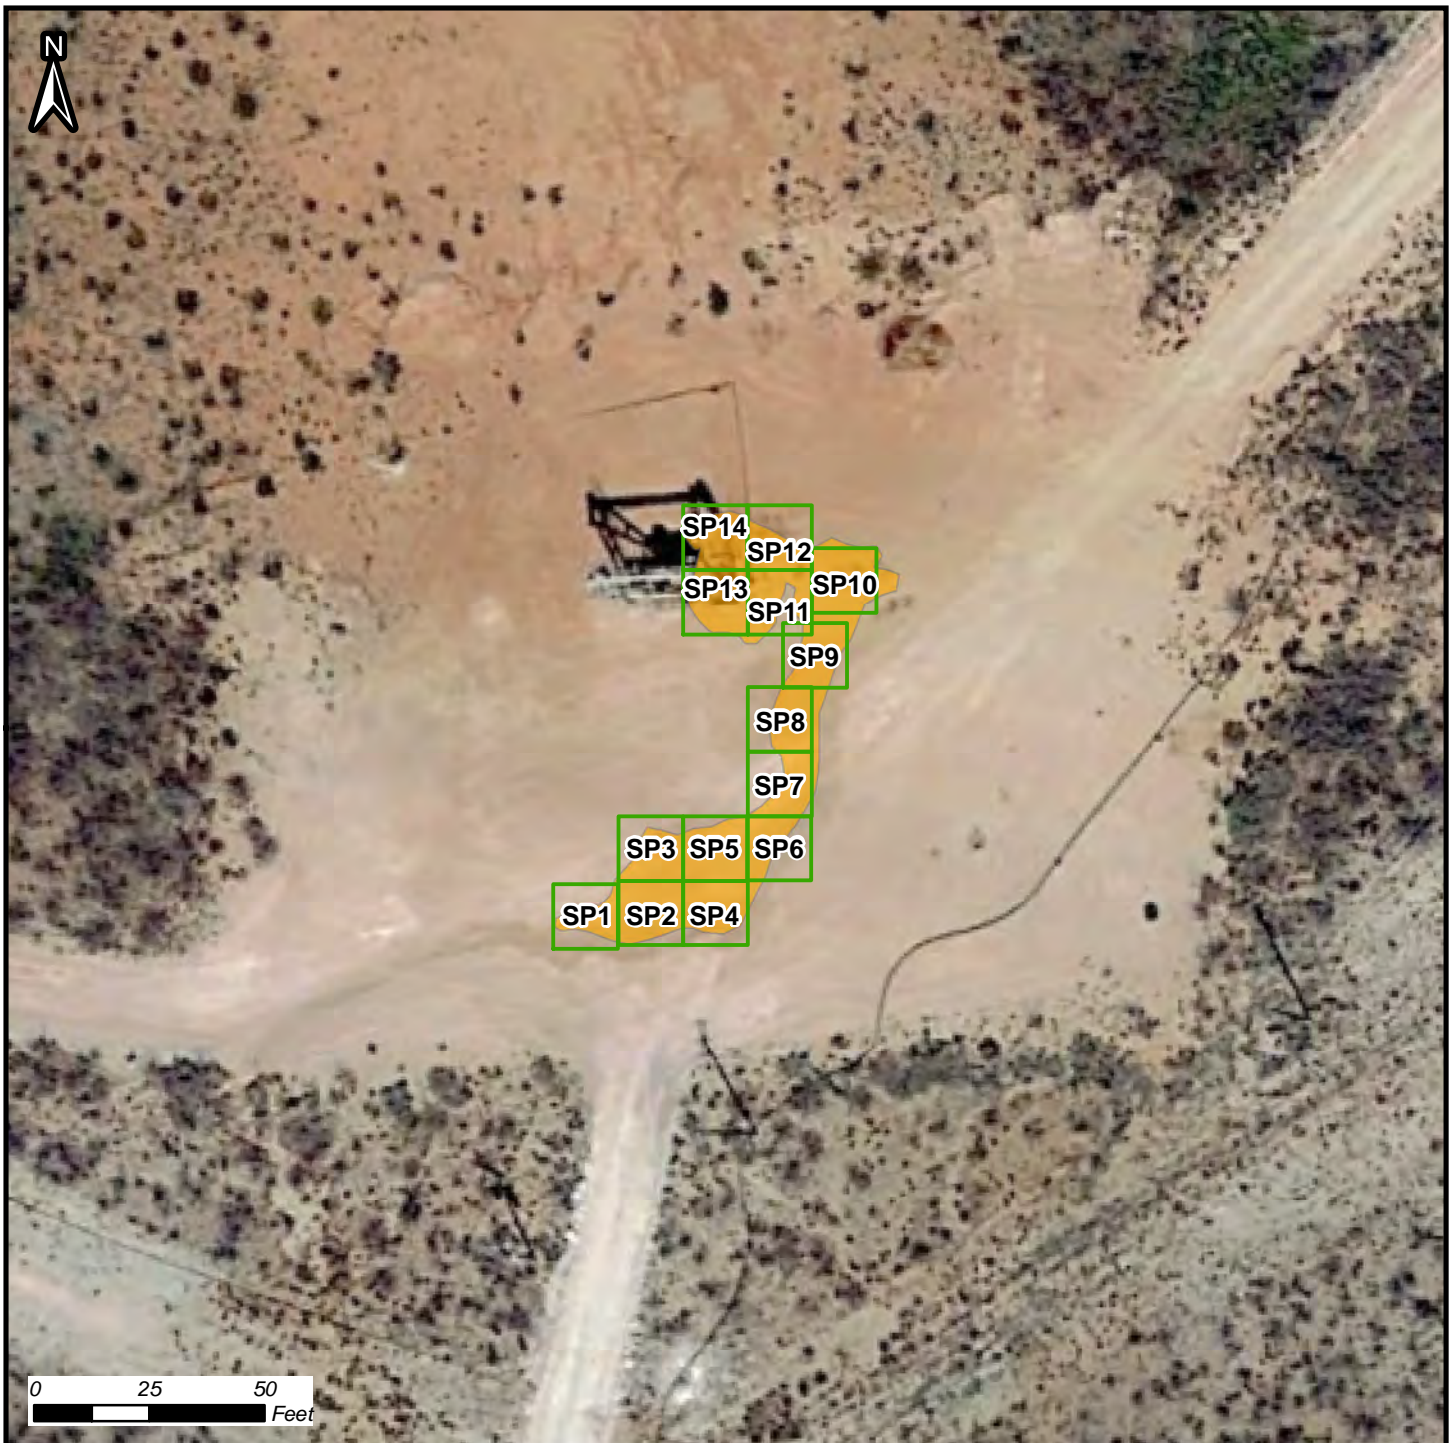
Figure 4: Confirmation Sample Grid

A confirmation sample plan was implemented utilizing a five-point composite sample strategy that represented areas less than 200-square feet, in accordance with 19.15.29.12 NMAC. On January 27, 2020, sixteen confirmation soil samples (FP1 through FP14 and SW1 and SW2) were collected from the final excavation footprint (Figures 4, 5, and 6). The confirmation samples were submitted to Hall Environmental Analysis Laboratory Inc., Albuquerque, New Mexico. The soil samples were analyzed for:

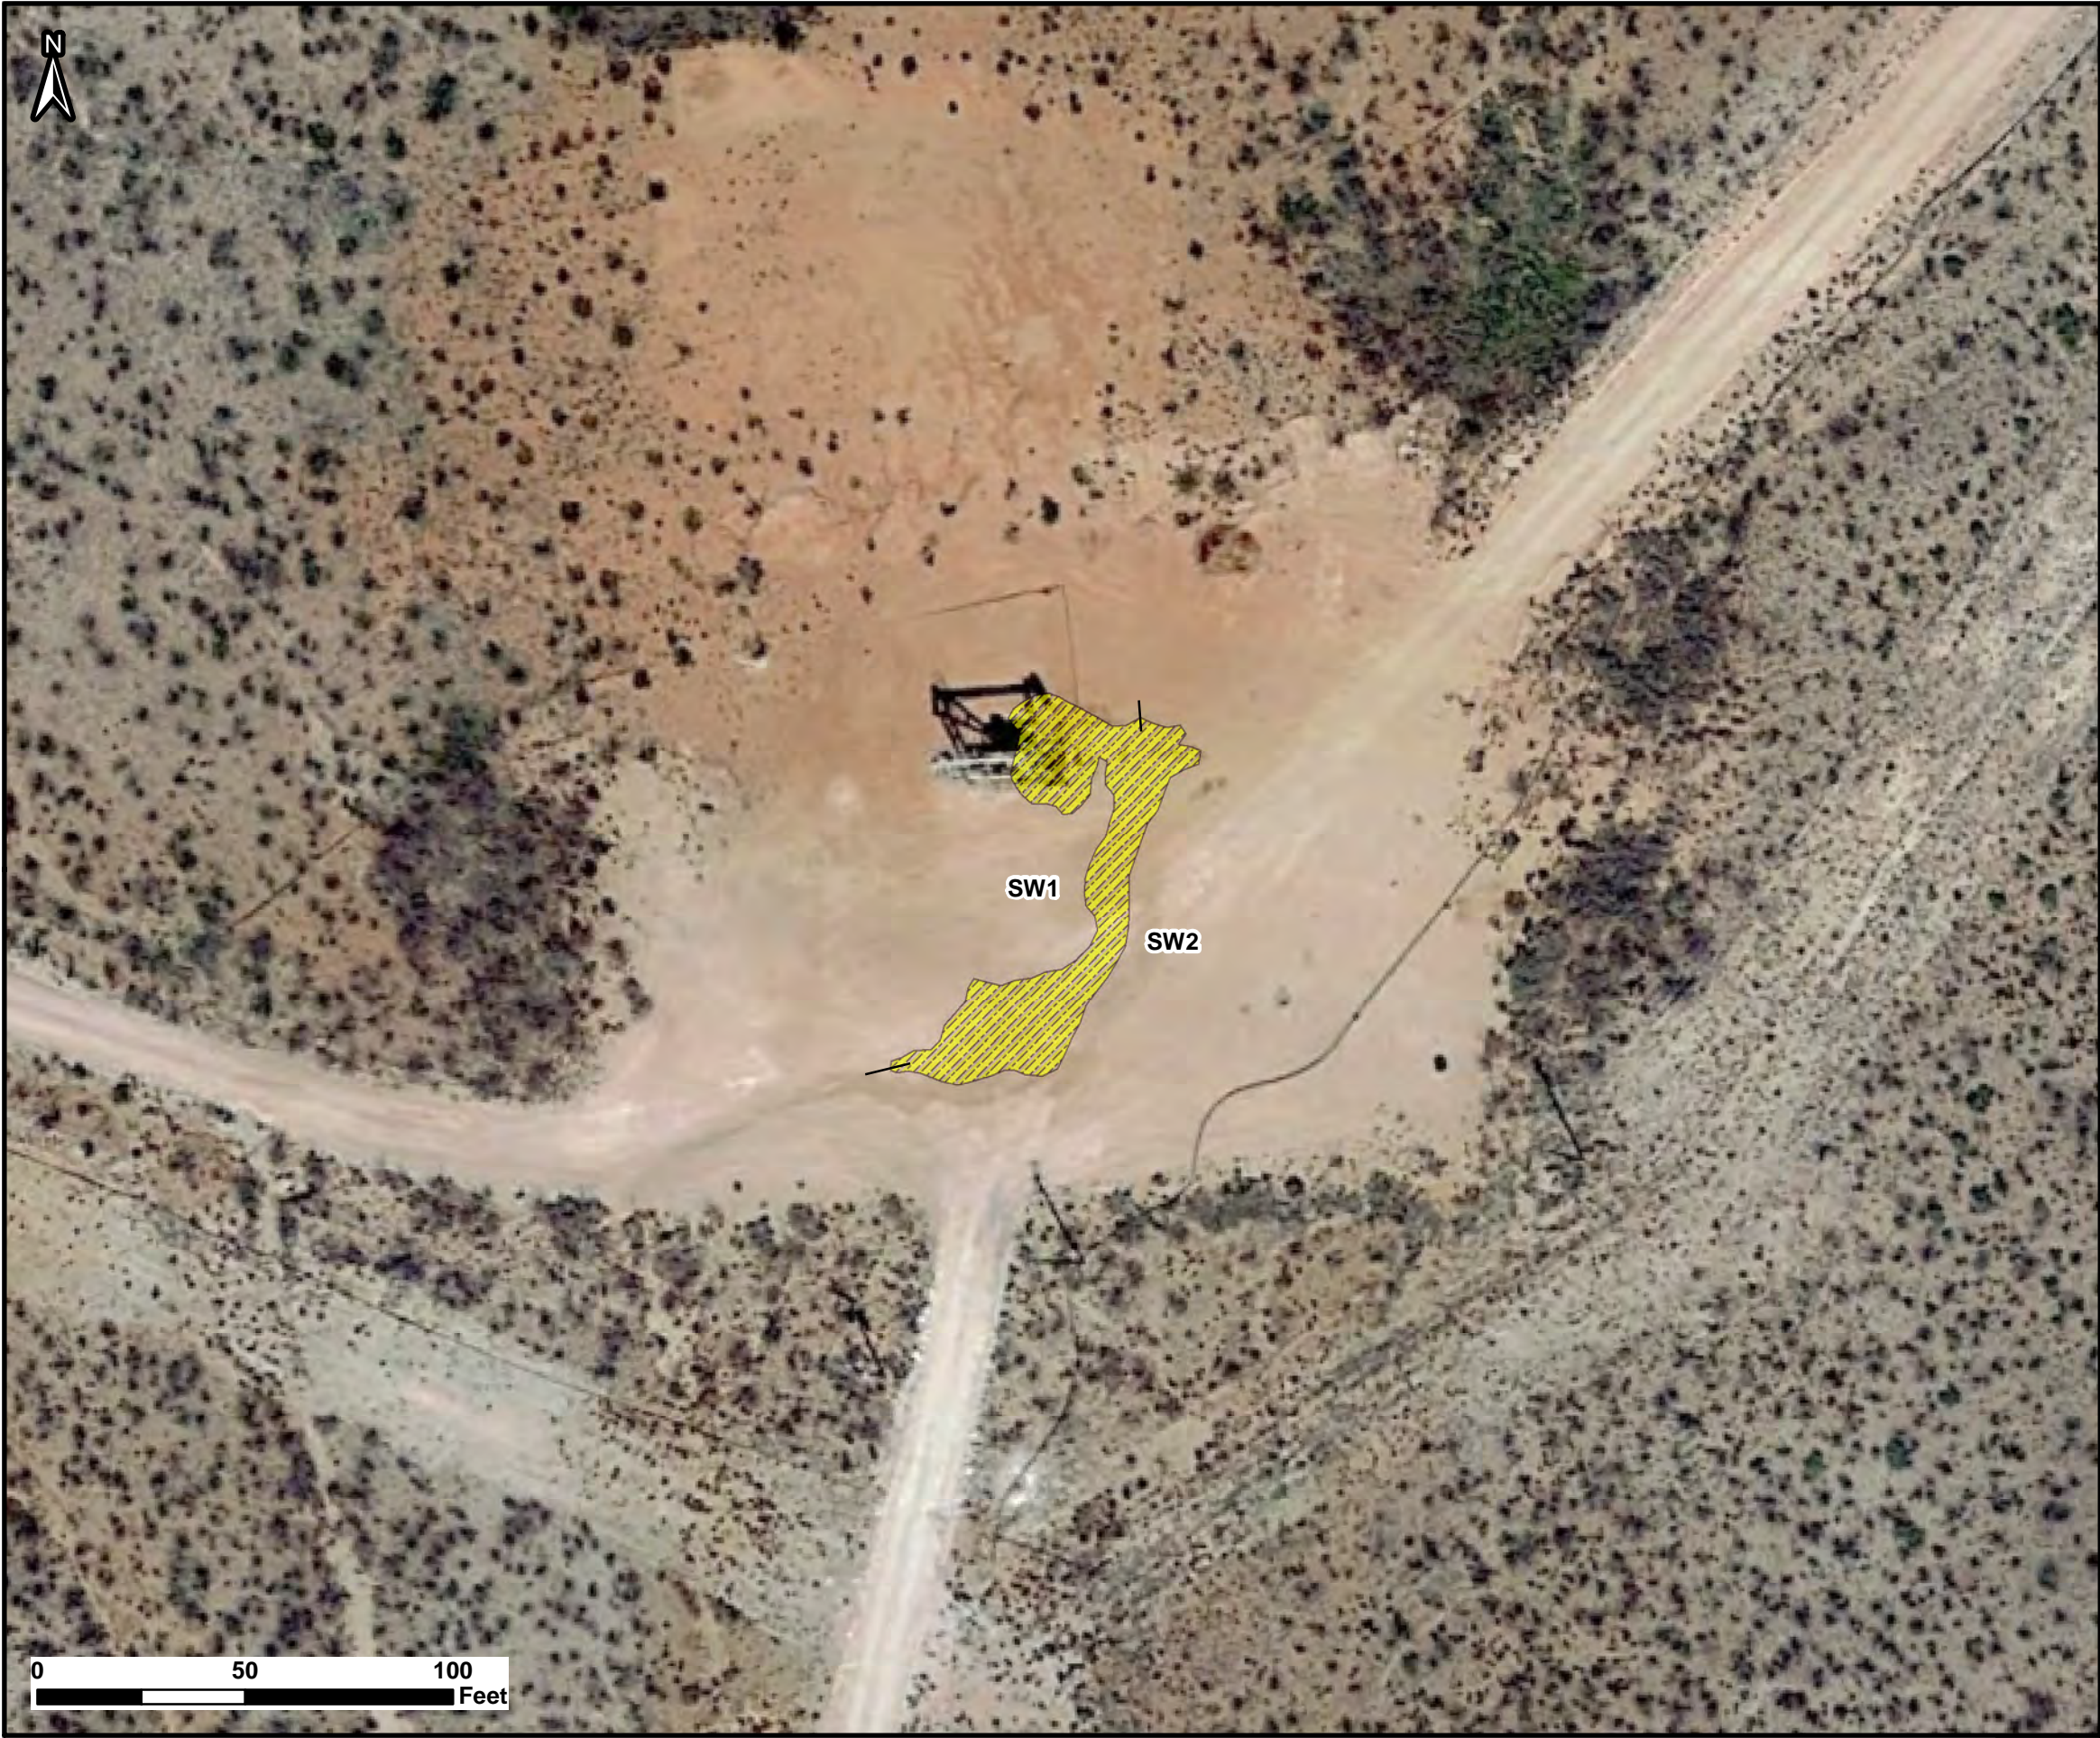
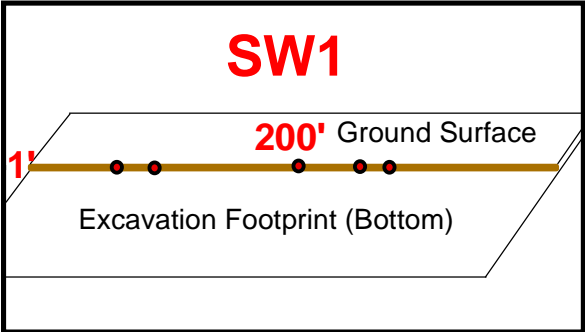
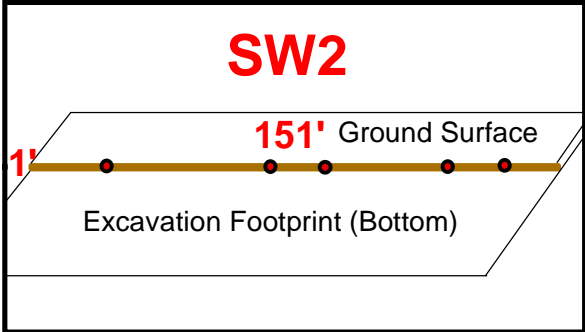
Figure 6:
Sidewall Confirmation
Sample Diagrams

Composite Sample Diagrams

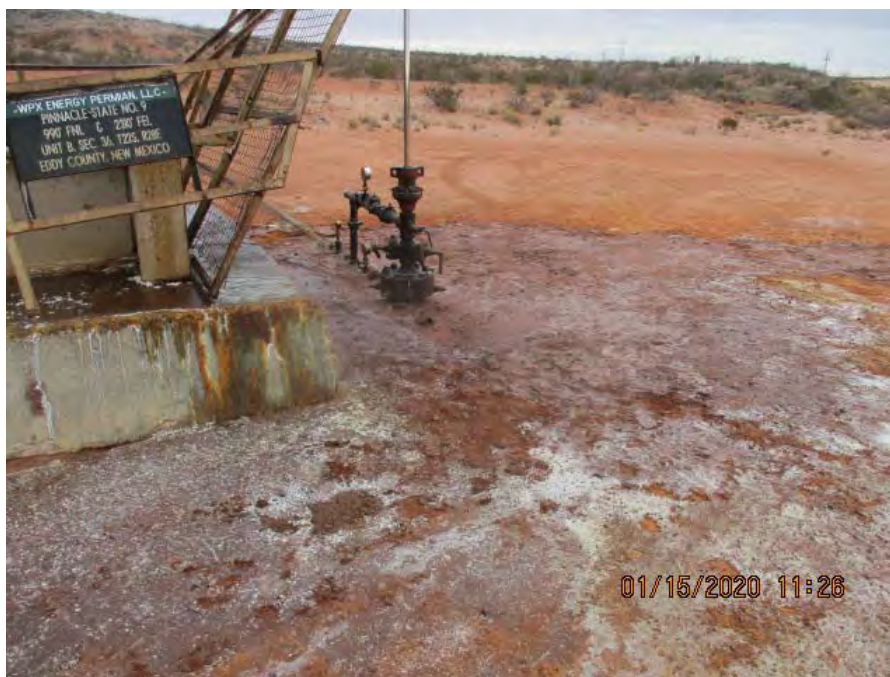
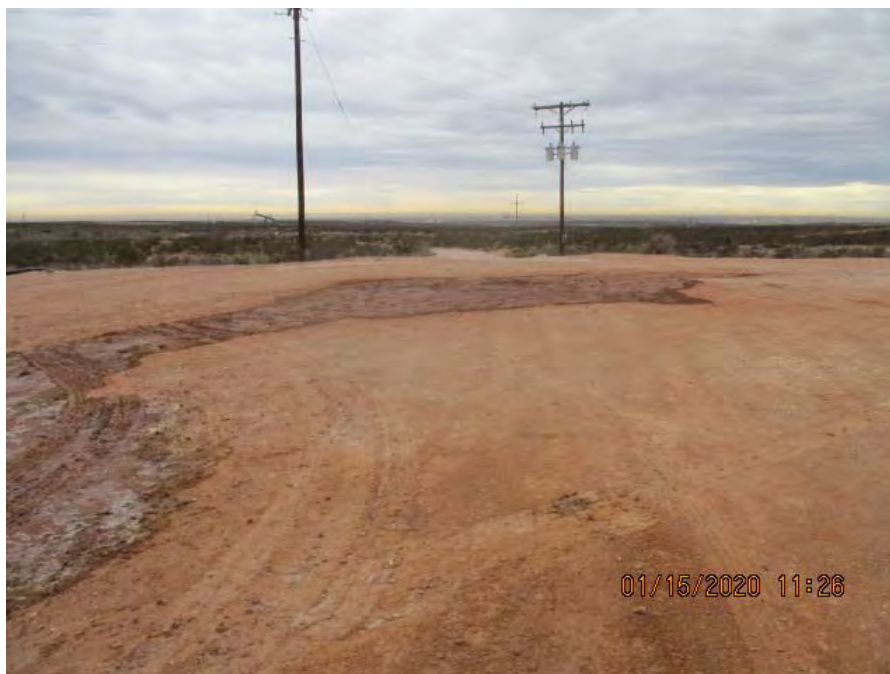
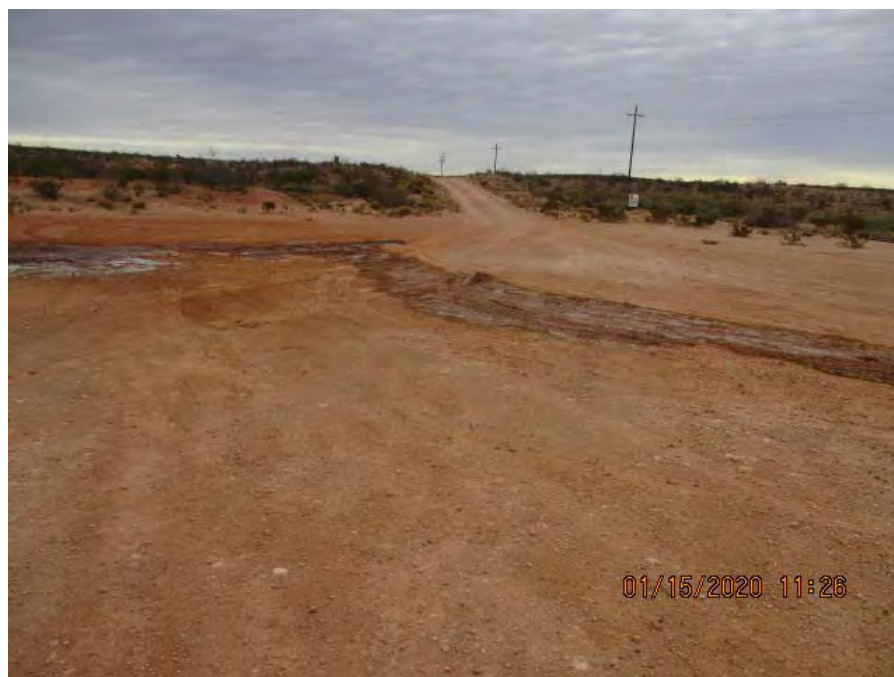
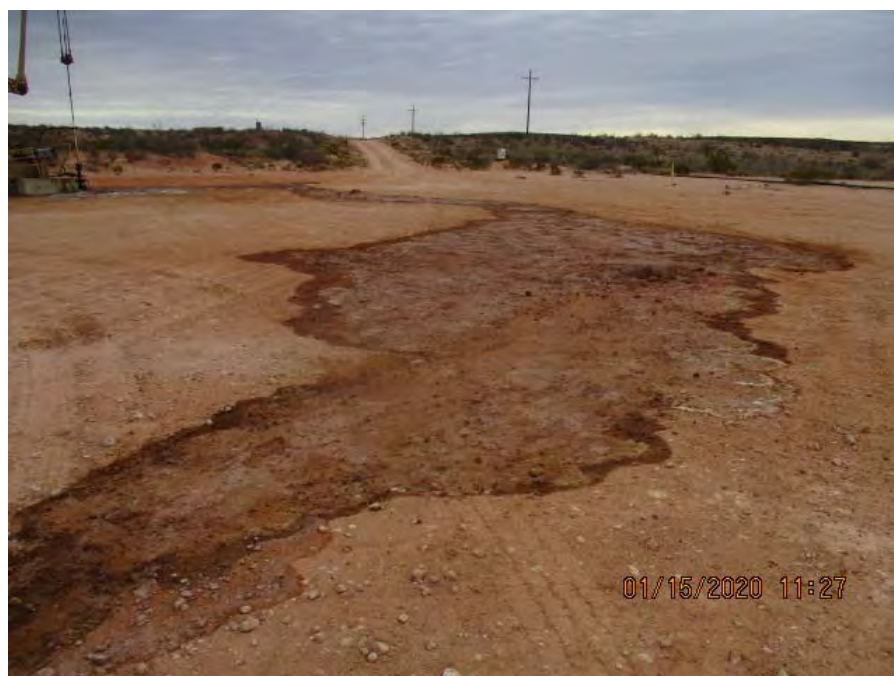
On January 14, 2020 a release of eight barrels of produced water was observed at the Site. The release was due to a polish rod casing leak. The produced water impacted the well pad surface. Initial response activities included the removal of the free liquids located within the impacted area.

Impacted Area
January 15, 2020

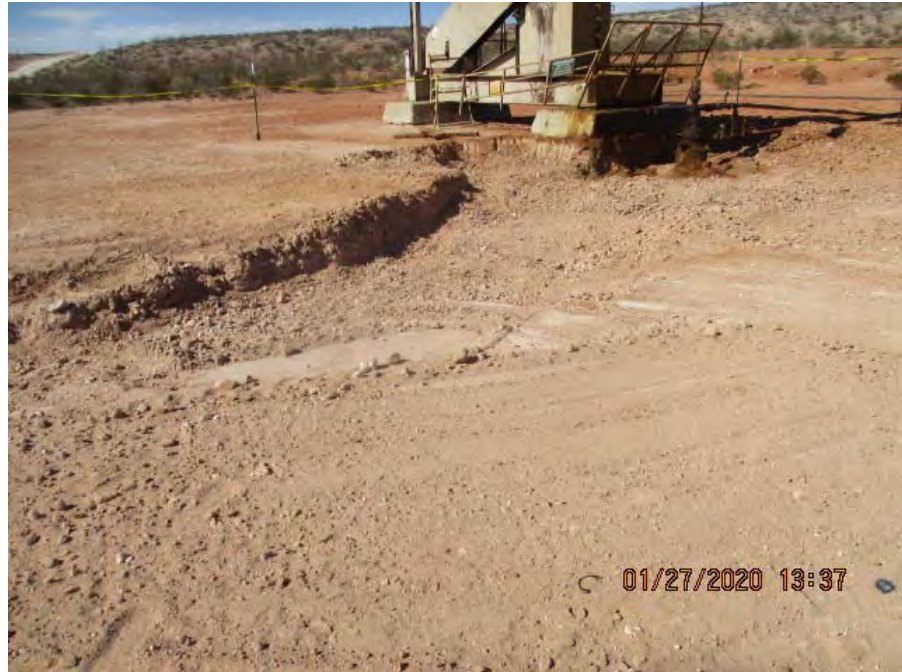
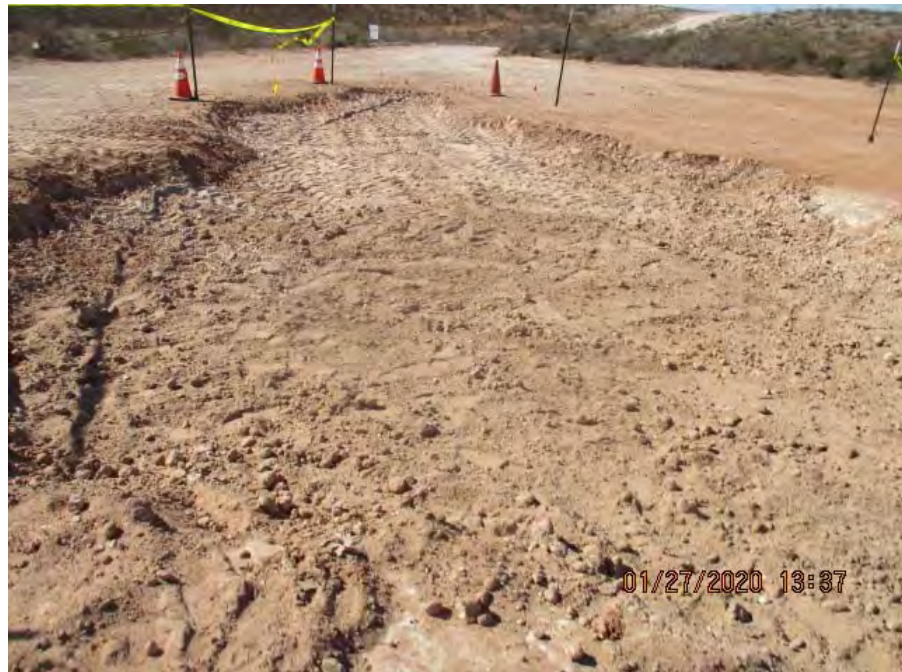
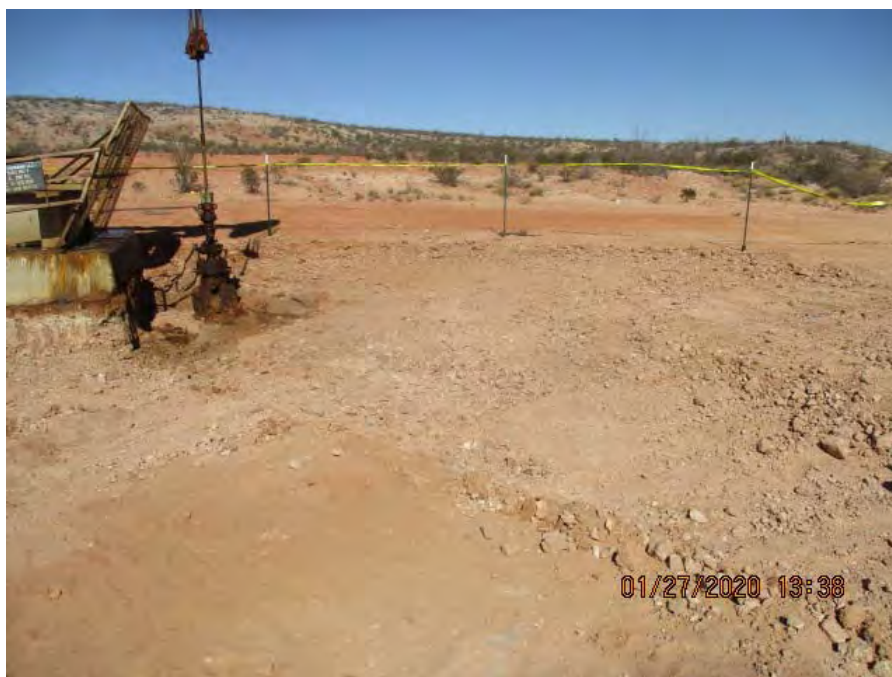
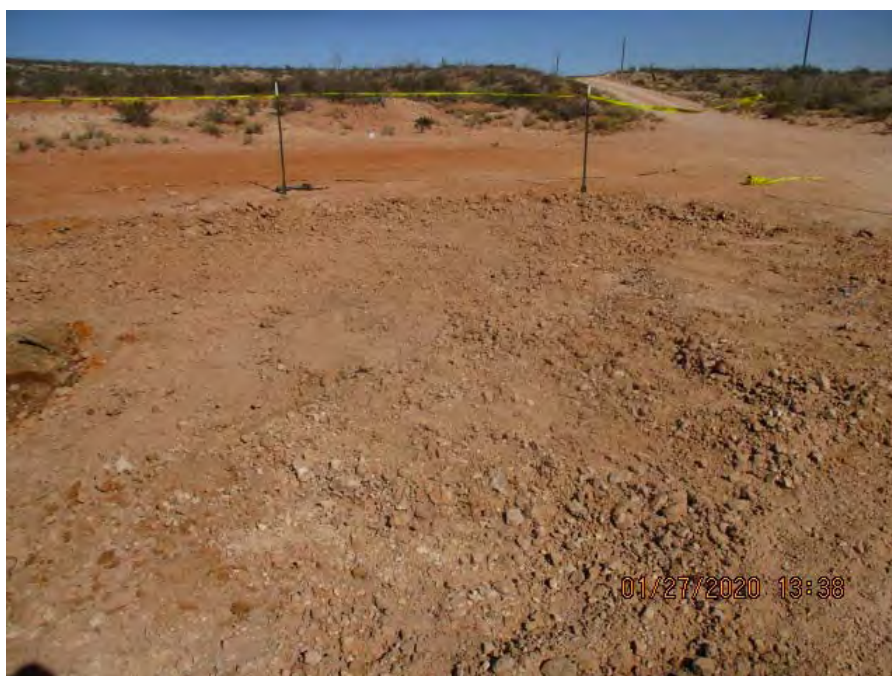
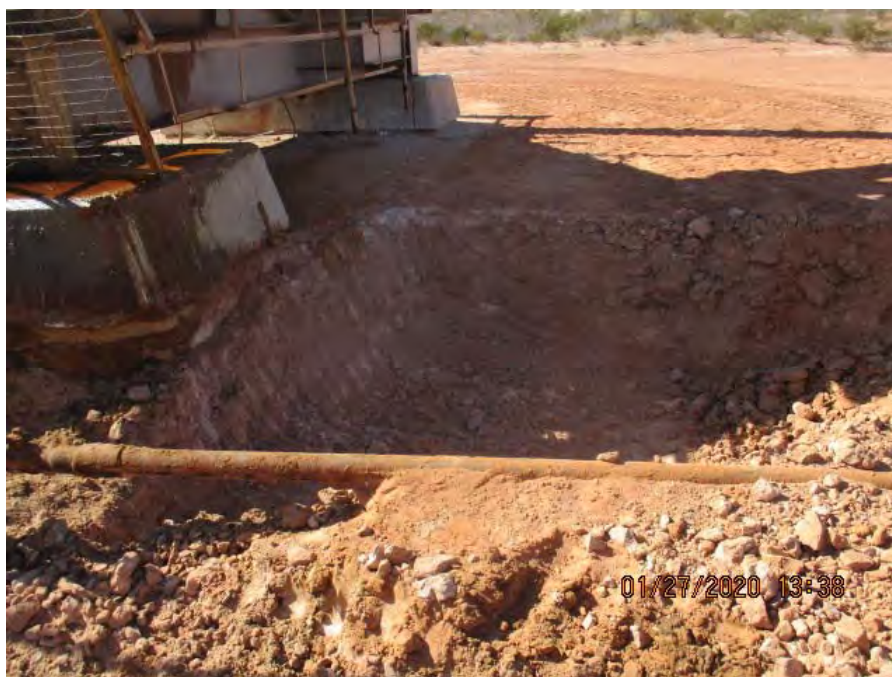
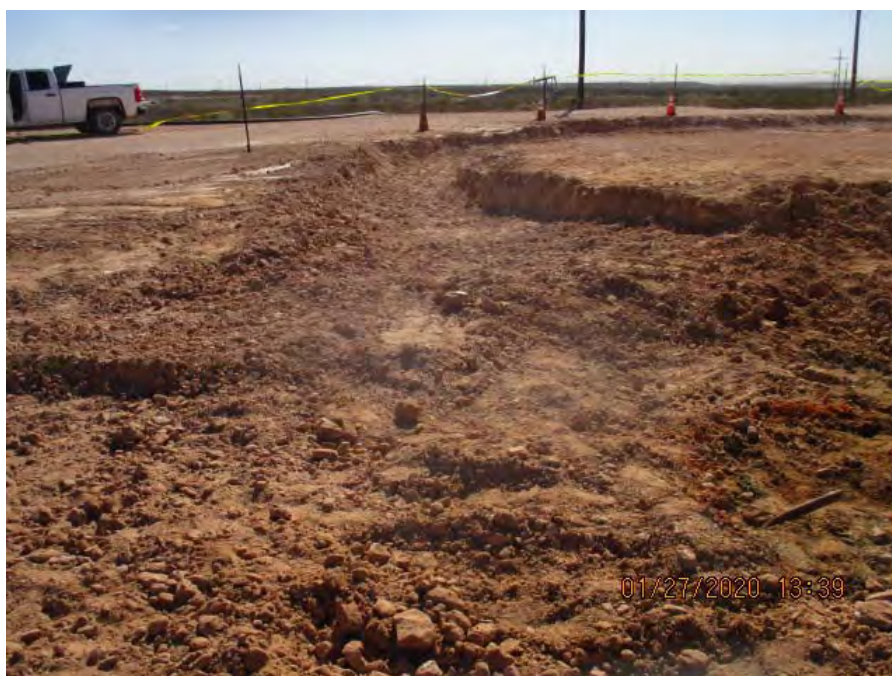
Halo Services completed the excavation of the impacted soil to a total depth of one to two feet below ground surface (Appendix B, Photographs). All excavated soil was transported to R360 Halfway Site, an exploration and production waste disposal facility located in Hobbs, New Mexico. A total of 80-cubic yards of impacted soil were removed from the Site.

Excavation
January 27, 2020

Due to the presence of free liquids on the soil, remediation was necessary to meet cleanup standards specified in 19.15.29.12 NMAC. Remediation included excavation of impacted soil and off-site disposal. Analytical results indicate the impacted area had been remediated to cleanup standards.
