Subject: Soil Remediation/ Closure Report for the Saragossa 10 State #3, Eddy County, New Mexico.

On behalf of Read & Stevens, Inc. Republic Backhoe Service, LLC (RBS) has prepared this Soil Remediation/Closure Report associated with Saragossa 10 State #3. The site is located in Unit A, Section 10, Township 23 South, and Range 26 East, NMPM, Eddy County, New Mexico, on NM State land. Attachment #1 illustrates the vicinity and location of the site. Piedmont alluvial deposits from the Holocene to Pleistocene age make up the subsurface of the area (mrdata.usgs.gov, Attachment #3). The subsurface is comprised of Regan Upton soils which consist of loamy deposits of quaternary age that are moderately dark colored and loamy. Hard caliche is encountered at 3-4 feet below the loamy surface (Soil Survey Eddy Area, NM 1971). The soil is generally dry except in times of rain. The site is not within a 100-year floodplain (FEMA FIRMetMap Attachment #8). The vegetation consists of black grama, blue grama, tobosa, side-oats, bush muhly, tarbush, creosote bush, vine mesquite, and yucca. The state of New Mexico owns the surface and is overseen by the State Land Office and leased out for grazing.

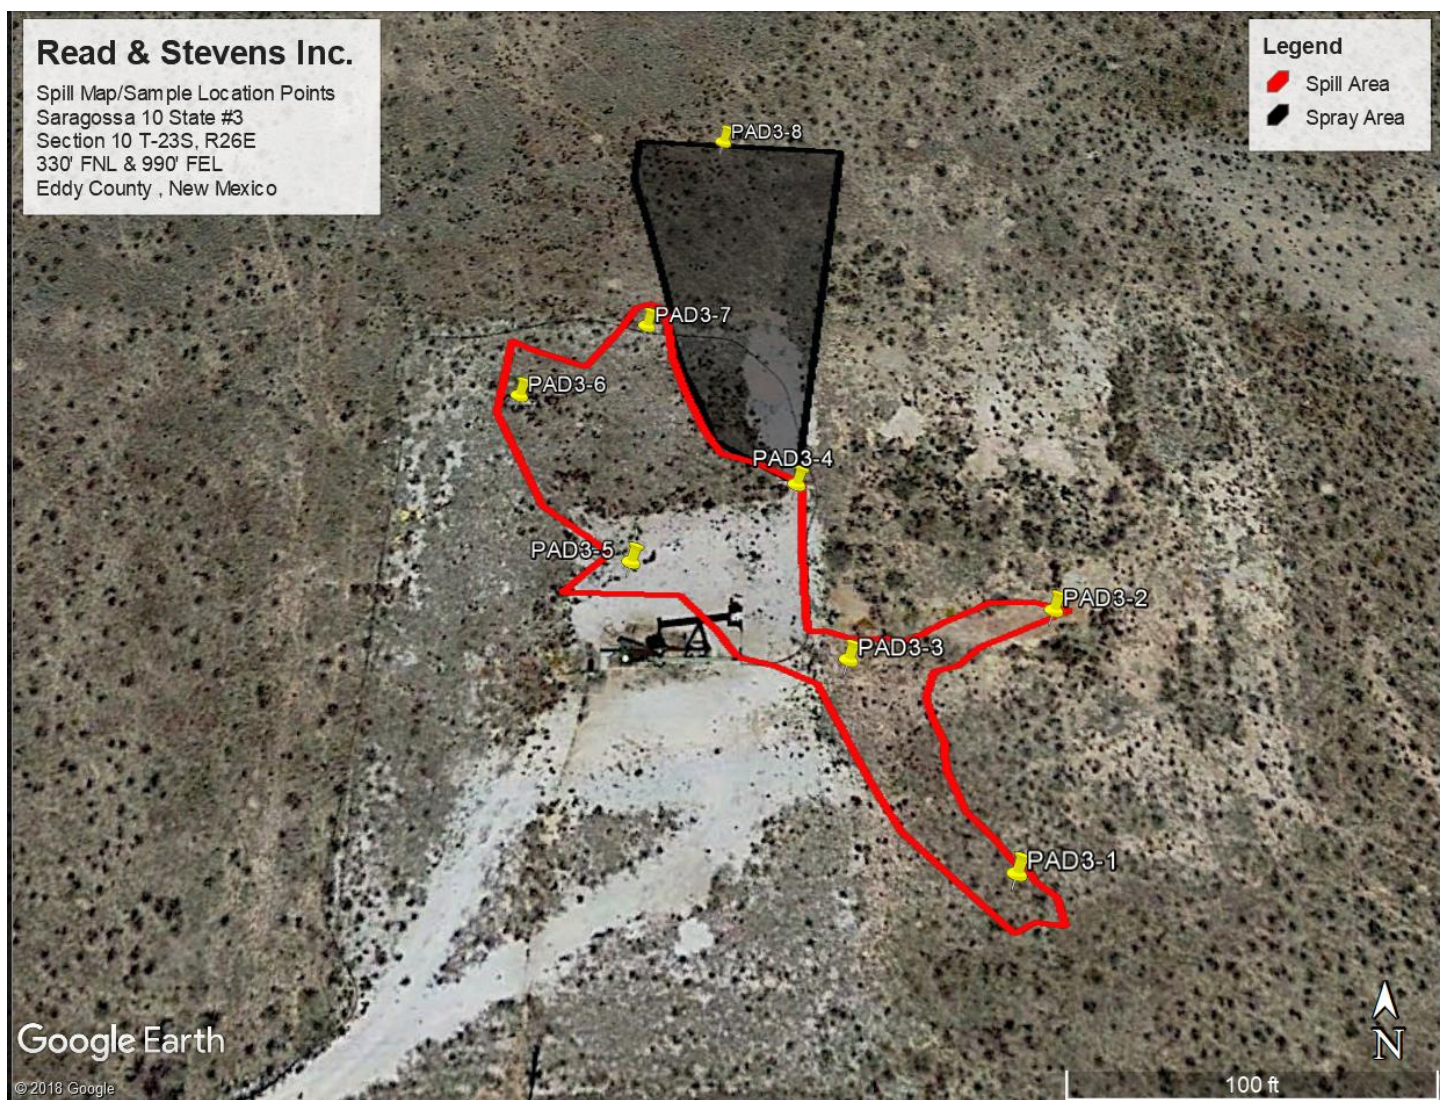
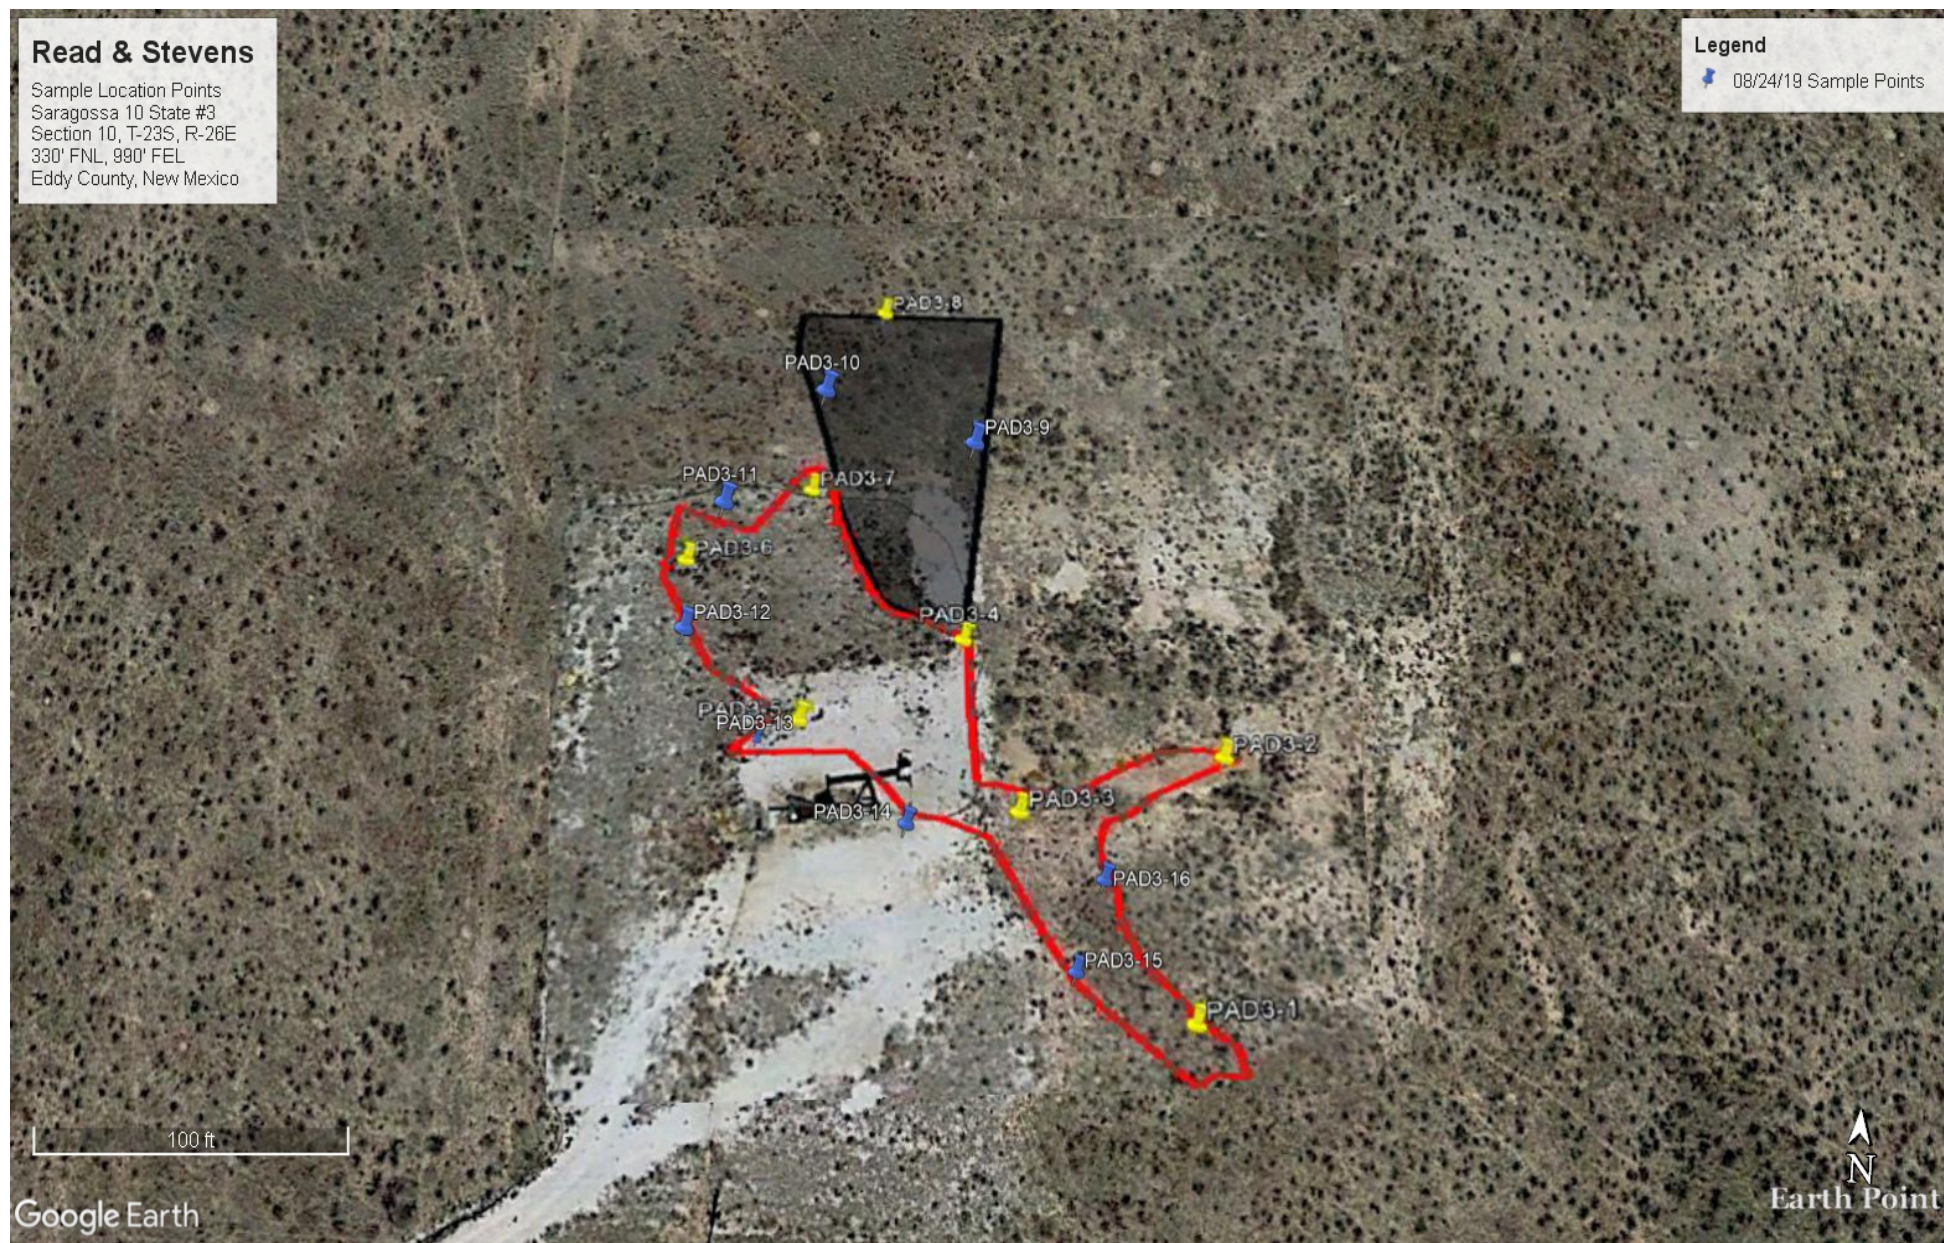
**Attachment 2**  
**Spill Map/Sample Location Points**

On November 16, 2018, RBS went to the location to delineate the site. According to the Spill Calculations (See Attachment 10) 100% of the release stayed on the well pad (Attachment 11 Spill Calculation Map). The release poses no threat to ground water as laboratory results concluded that no TPH/Chloride concentrations were found at 2' (bgs). Furthermore, soil samples collected and analyzed at 5' (bgs) show constituents level significantly lower than NMOCD permissible levels. A backhoe was used to dig a total of 8 trenches at the site (See Attachment #2). Samples were collected at surface, 2 feet (bgs), and 5 feet (bgs). The following table summarizes the laboratory analytical results from the soil samples collected during the site assessment: Table 4 below.
