## Release Notification

Site Name: Rodney Robinson Federal 101H Lease Road	Site Type: Oil Well Lease Road
Date Release Discovered: 01/24/2020	API# (if applicable) 30-025-46278

**Spill Closure Report:** Rodney Robinson 101H Lease Road  
Unit L, Section 6, Township 24 South, Range 32 East  
County: Lea  
API: 30-025-46278  
Tracking Number: NCE2003652970

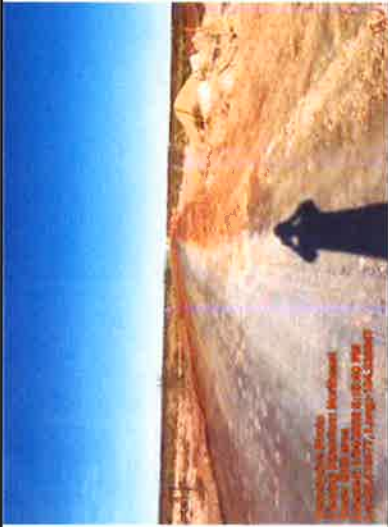
<p>Site Photo Viewing Direction: Northeast Date: 1/25/2020 1:50 PM Location: Spill area Photo by: [redacted]</p></div> <div>Spill area</div>	<div>Viewing Direction: Southwest</div> <div>

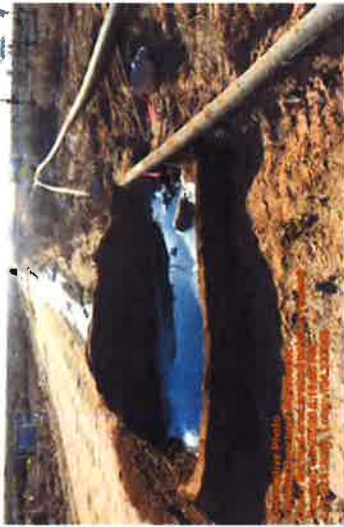
<p>Site Photo Viewing Direction: Southwest Date: 1/25/2020 1:50 PM Location: Spill area Photo by: [redacted]</p></div> <div>Bermed area around point of release</div>
<div>Viewing Direction: West</div> <div>

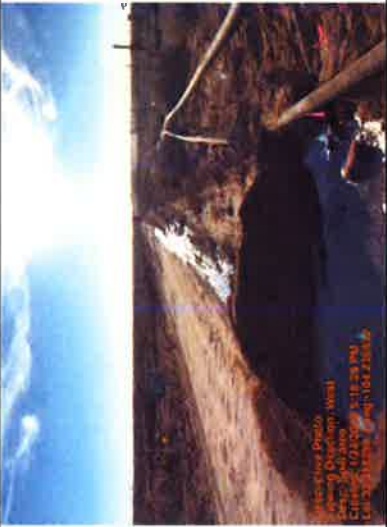
<p>Site Photo Viewing Direction: West Date: 1/25/2020 1:50 PM Location: Spill area Photo by: [redacted]</p></div> <div>Spill area</div>	<div>Viewing Direction: East</div> <div>

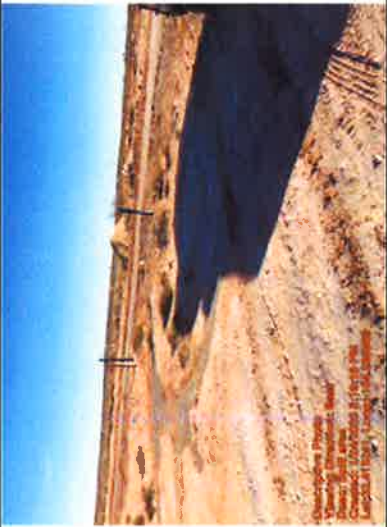
<p>Site Photo Viewing Direction: East Date: 1/25/2020 1:50 PM Location: Spill area Photo by: [redacted]</p></div> <div>Spill area</div>

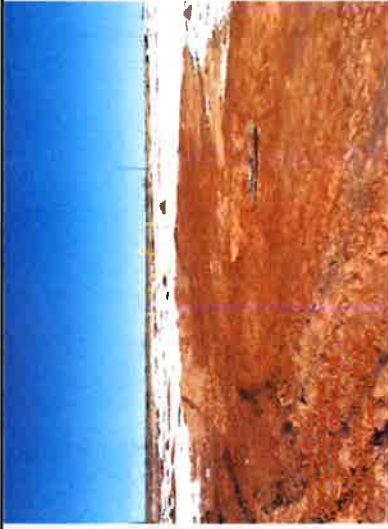
<p>Excavation area 1 6" BS20-01 L48'xW27'</p>

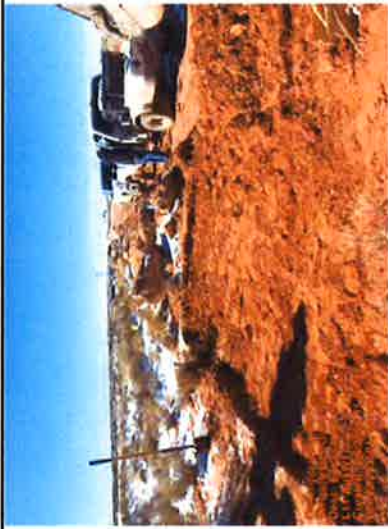
<p>Excavation area 2 @ 6" L11'xW17' BS20-02</p>

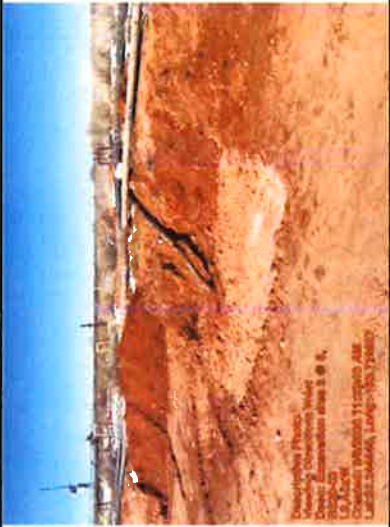
<p>Excavation area 3 @ 6" BS20-03 L9'xW9'</p>
Viewing Direction: South

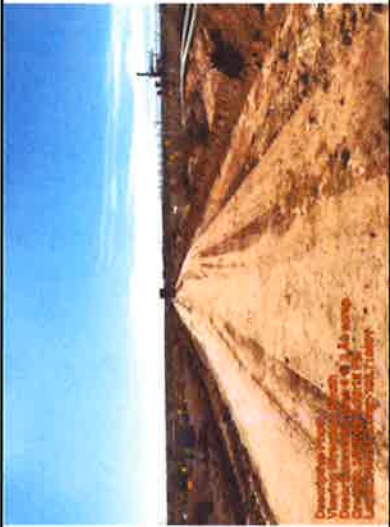
<p>Excavation area 4 @ 2" scrape</p>
