## **Soil Assessment and Remediation Work Plan**

Chaparral 14 Federal Com #001  
Eddy County, New Mexico  
API # 30-015-34038; 2RP-5607

**April 13, 2020**

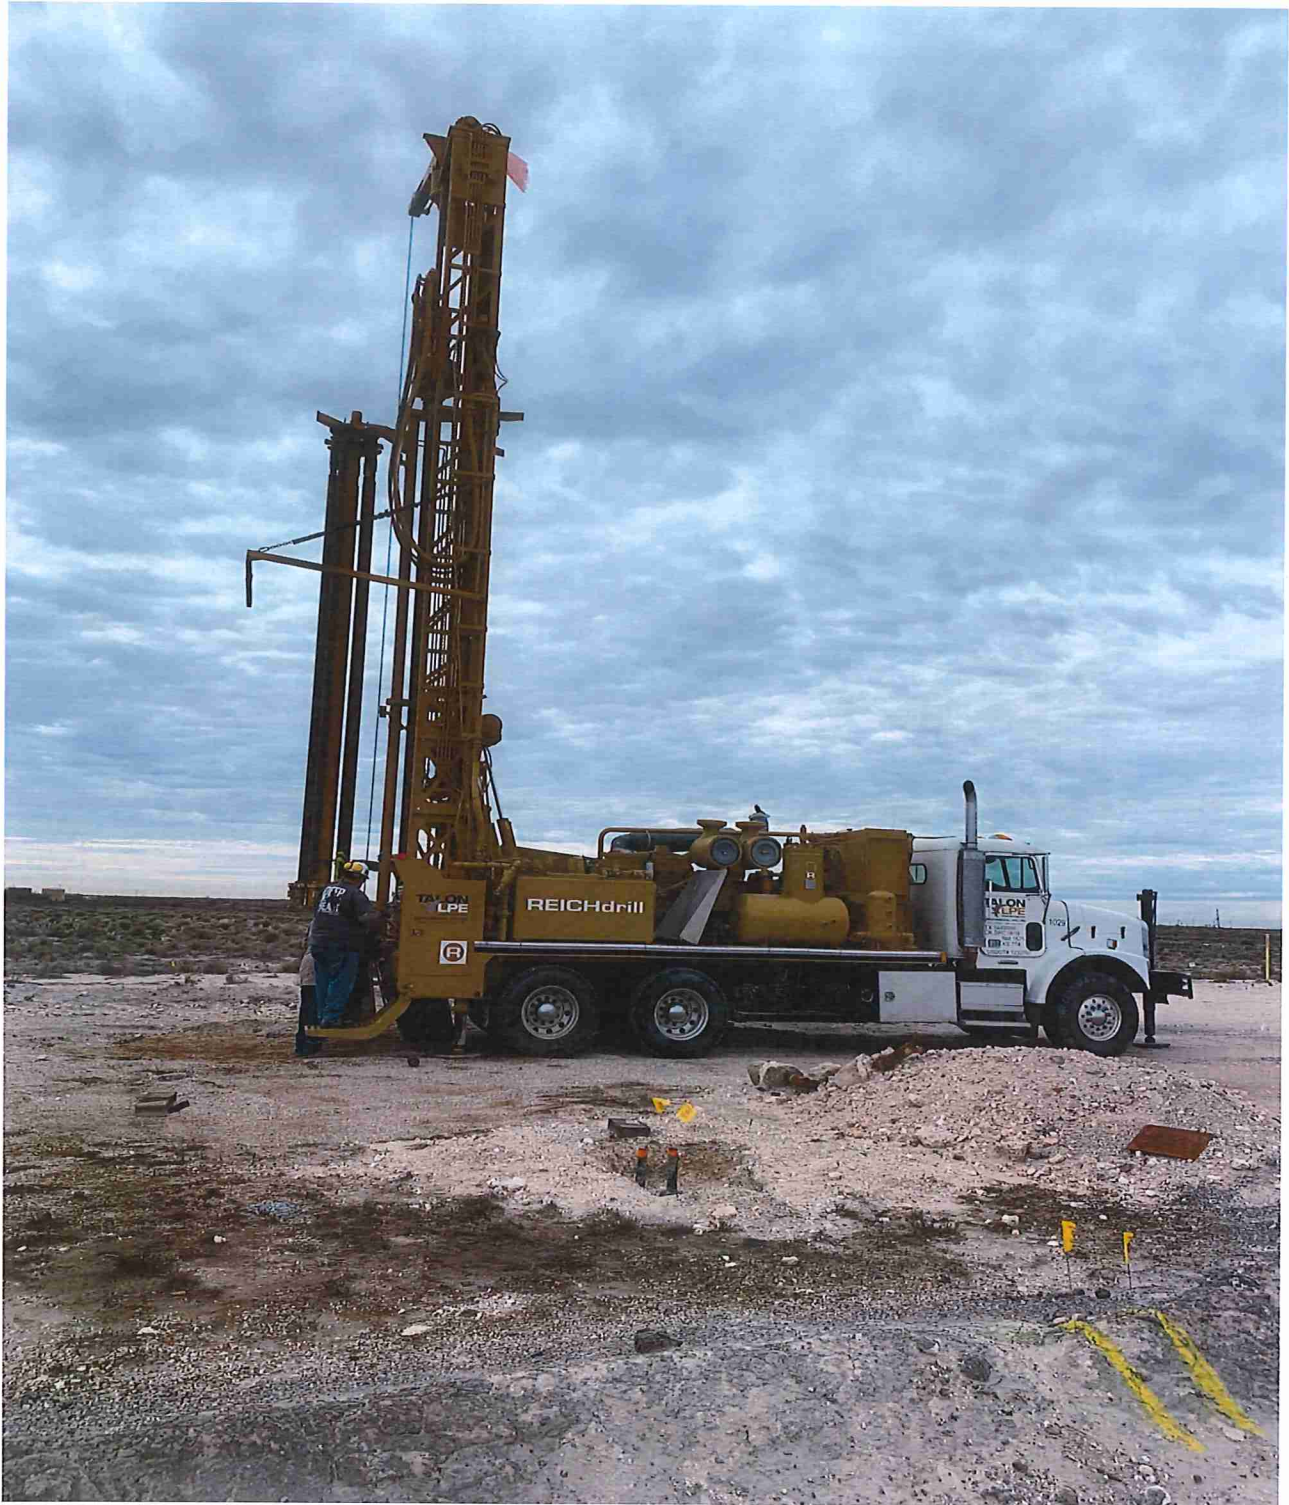
# Drilling Photograph

On December 4, 2019, Talon personnel mobilized an air rotary drilling rig to further vertically delineate sample location B-2 due to TPH and BTEX concentrations were found to be above NMOCD closure criteria. Results from our sampling events are presented on the following data table. A complete laboratory reports can be found in [Appendix V](#).
