Remediation and Closure Report

Hadar 10 Fed Com #4H
API # 30-015-42572
NRM2003156306
Talon Project #700794.308.01

Subject: **Remediation and Closure Report**
Hadar 10 Fed Com #4H
API # 30-015-42572
NRM2003156306

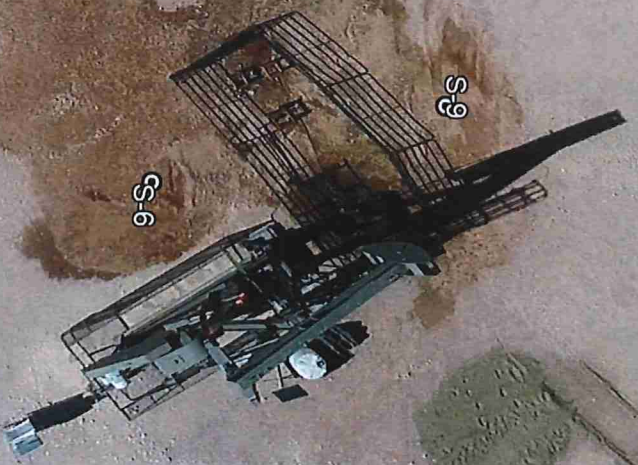
Site Map

S-4 ○

S-1 ○

S-5

S-8

S-9

S-6

S-7

S-3 ○

S-2

- The impacted areas in the vicinity of S-2, S-3, S-5, S-6, S-7, and S-8 were excavated to a depth of 1.5-feet BGS, laboratory analytical results from confirmation bottom and sidewall composite soil samples indicated that TPH concentrations were below NMOCD Closure Criteria 19.15.29.12 D NMAC.
- The spill areas in the vicinity of S-4 and S-9 were scraped, removing the staining.
- All removed soil was transported to Lea Land, LLC, an NMOCD approved soil waste disposal facility.
- The excavated area was backfilled with clean caliche, machine compacted and contoured to match the surrounding location.
- Final C-141 is attached in [Appendix IV](#)

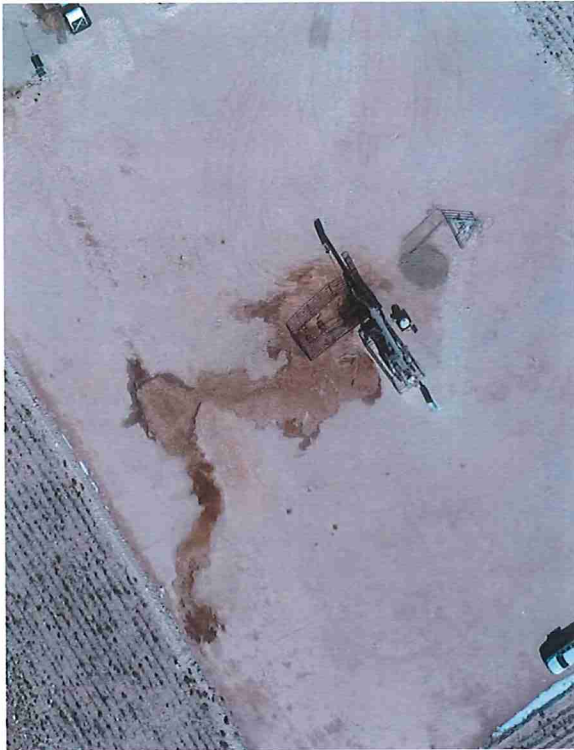
Aerial Photo of Incident

On November 16, 2019, a release occurred from the pumping unit packing failure releasing 20.3 barrels (bbls) of oil. The spill area remained on location. Vac trucks were dispatched to the site to recover the spilled fluids and were able to recover 14 bbls of oil. Site maps are presented in [Appendix I](#). The initial C-141 is attached in [Appendix III](#).

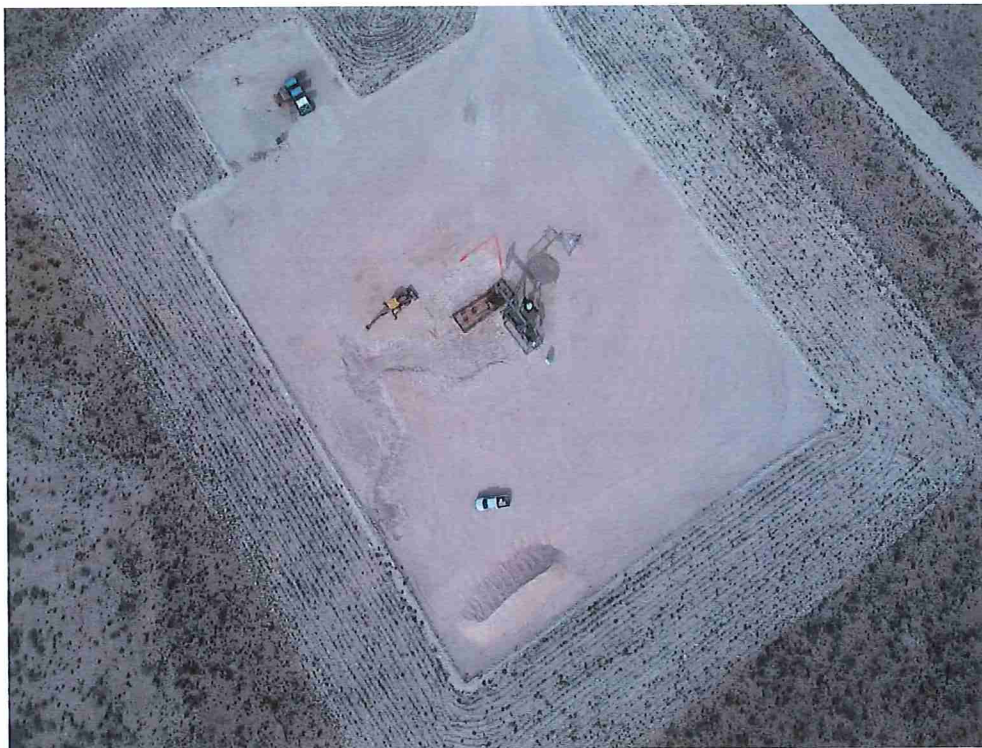
Excavation Photos

Talon mobilized personnel and equipment to the site to begin assessment and remediation activities. The impacted area was excavated utilizing a backhoe. Confirmation samples were collected from the bottom and sidewalls of the excavation to ensure that all environmental impacts had been addressed.
