Remediation and Closure Report

Sirius 17 Fed #6H
API # 30-015-41761
NRM2002843138
Talon Project #700794.302.01

Devon Energy Production Company
6488 Seven Rivers Hwy
Artesia, NM 88210

February 24, 2020

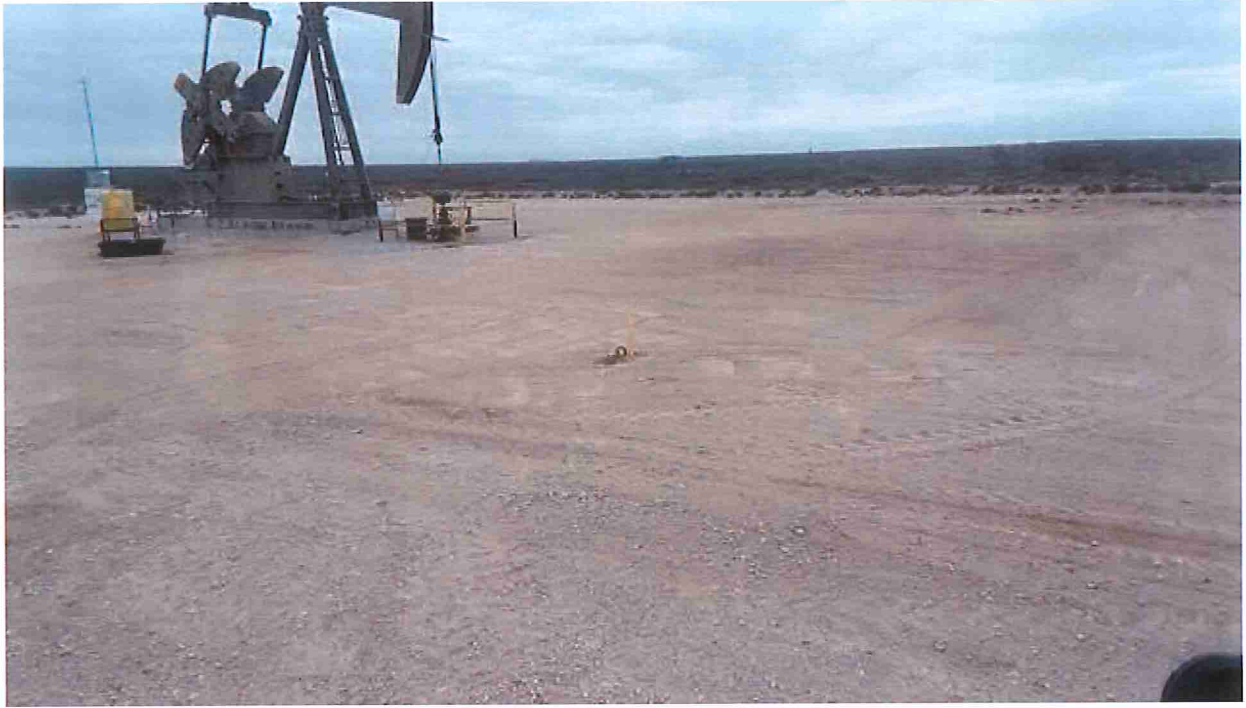
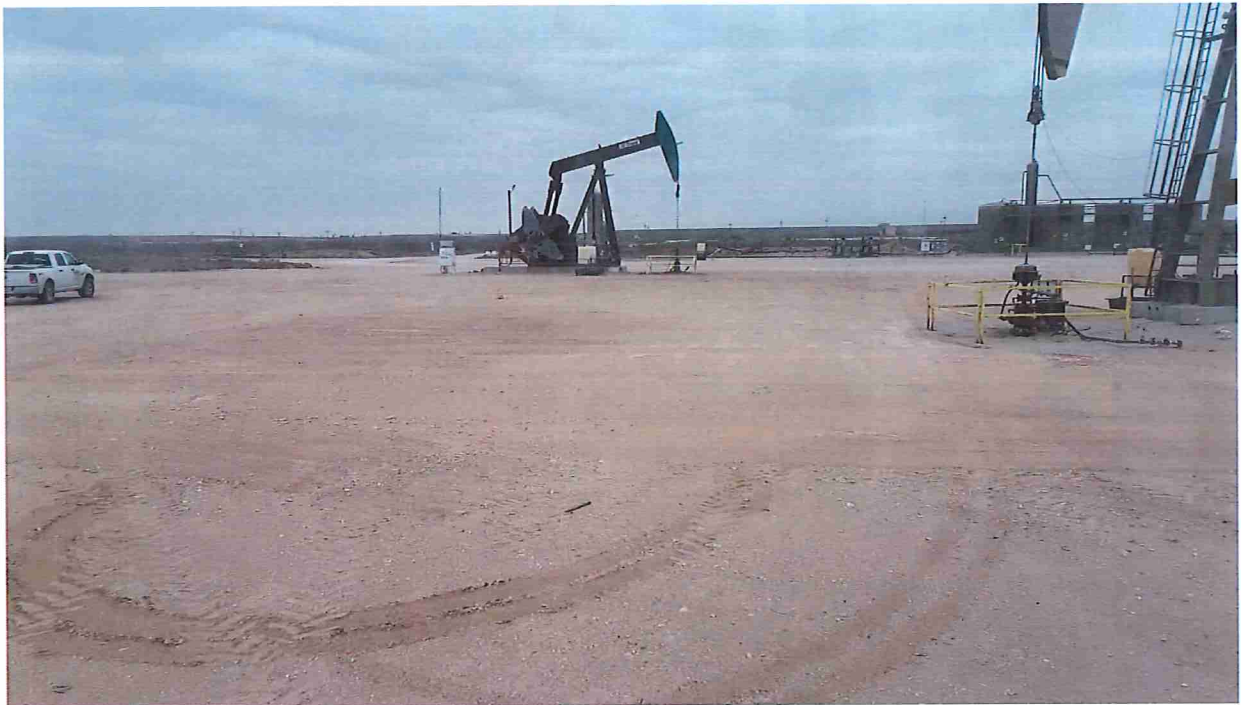
PHOTOGRAPHIC DOCUMENTATION

Project Completed

- The spill area on location was scraped up, removing the staining.
- All removed soil was transported to Lea Land, LLC, an NMOCD approved soil waste disposal facility.
- The excavated area was backfilled with clean caliche, machine compacted and contoured to match the surrounding location.
- Final C-141 is attached in [Appendix IV](#)
