Vertex Project #: 19E-00575-014

**Spill Closure Report:** SDE 31 Federal #001 (Section 31, Township 23 South, Range 32 East)  
API: 30-025-32676  
County: Lea  
Incident Report: 1RP-5530

**Prepared For:** **Devon Energy Corporation**  
6488 Seven Rivers Highway  
Artesia, New Mexico 88210

2019 Spill Assessment and Closure  
July 2019

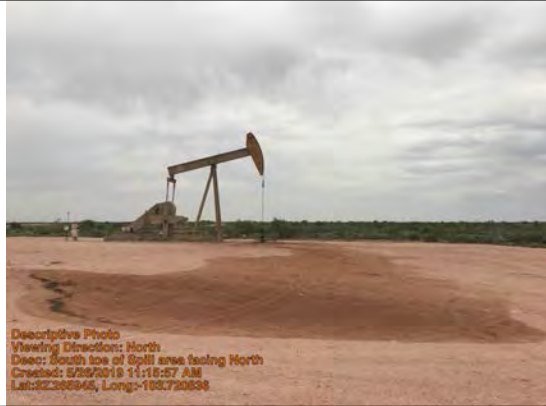
**Viewing Direction: North**

South toe of spill area facing North

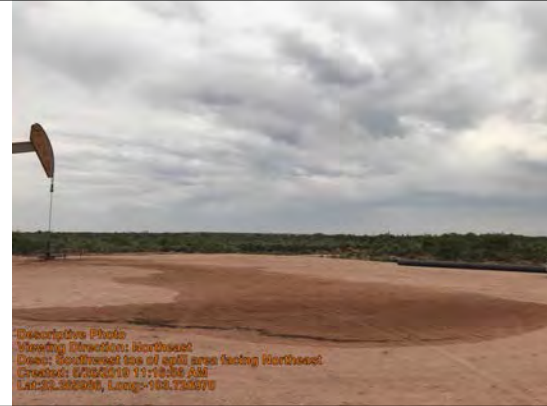
**Viewing Direction: Northeast**

Southwest toe of spill area facing Northeast

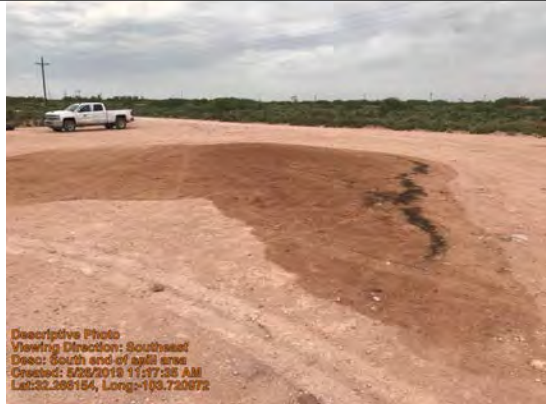
**Viewing Direction: Southeast**

South end of spill area

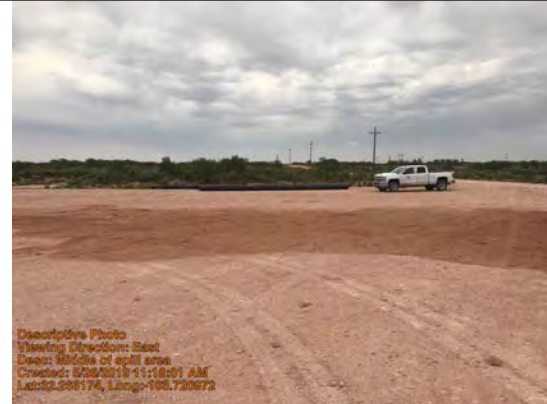
**Viewing Direction: East**

Middle of spill area

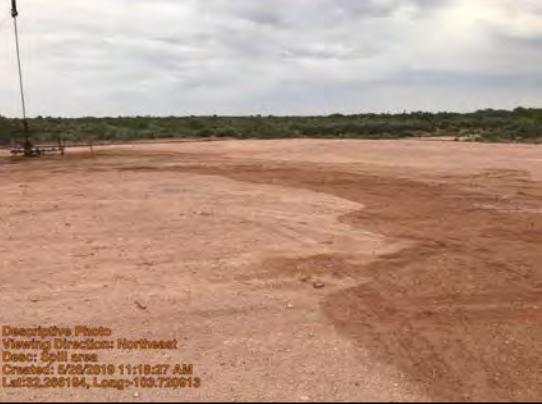
<p>Descriptive Photo Viewing Direction: Northeast Desc: Spill area Created: 5/22/2019 11:18:27 AM Lat:32.286184, Long:-103.720613</p> <p>Spill area</p>	<p><b>Viewing Direction: Northeast</b></p>

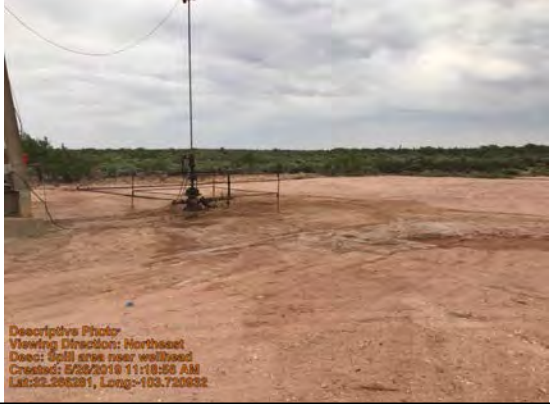
<p>Descriptive Photo Viewing Direction: Northeast Desc: Spill area near wellhead Created: 5/22/2019 11:18:58 AM Lat:32.286281, Long:-103.720632</p> <p>Spill area near wellhead</p>
<p><b>Viewing Direction: South</b></p>

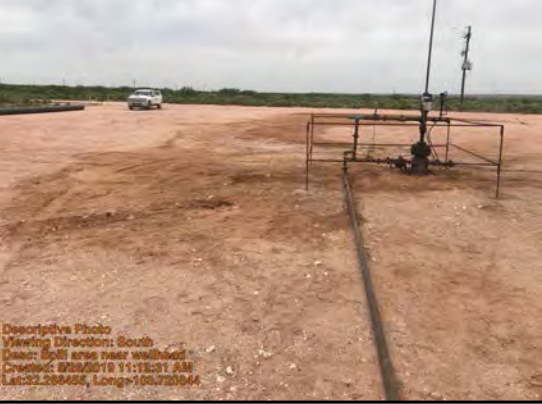
<p>Descriptive Photo Viewing Direction: South Desc: Spill area near wellhead Created: 5/22/2019 11:18:31 AM Lat:32.286455, Long:-103.720644</p> <p>Spill area near wellhead</p>	<p><b>Viewing Direction: North</b></p>

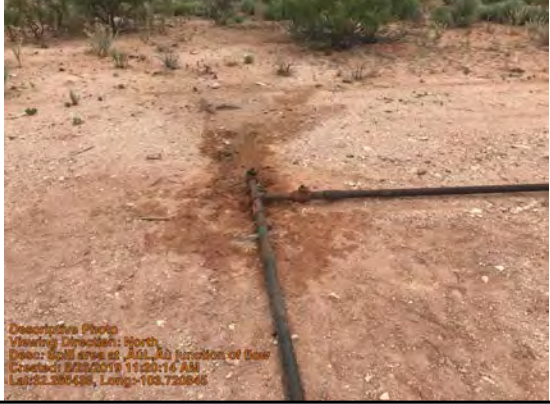
<p>Descriptive Photo Viewing Direction: North Desc: Spill area at "L" junction of flow line Created: 5/22/2019 11:20:14 AM Lat:32.286438, Long:-103.720645</p> <p>Spill area at "L" junction of flow line</p>

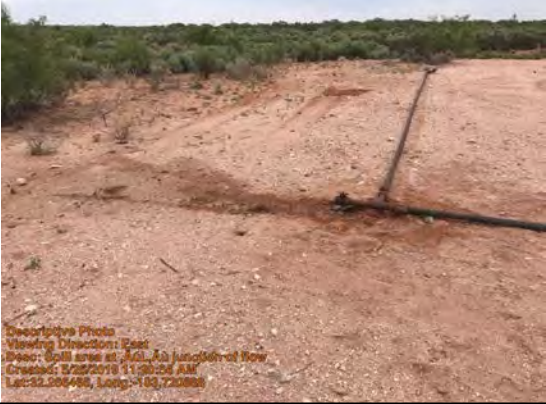
<p><b>Viewing Direction: East</b></p>

<p><small>Descriptive Photo Viewing Direction: East Desc: Spill area at "L" junction of flow Created: 5/25/2019 11:20:56 AM Lat:32.285486, Long:-103.720760</small></p>	<p><b>Viewing Direction: Southwest</b></p>

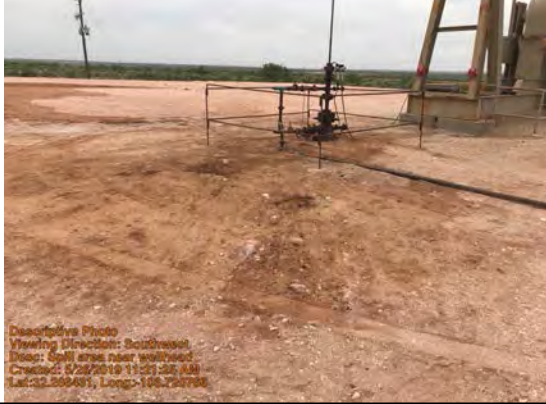
<p><small>Descriptive Photo Viewing Direction: Southwest Desc: Spill area near wellhead Created: 5/25/2019 11:21:32 AM Lat:32.285481, Long:-103.720760</small></p>
Spill area at "L" junction of flow line	Spill area near wellhead
<p><b>Viewing Direction: West</b></p>

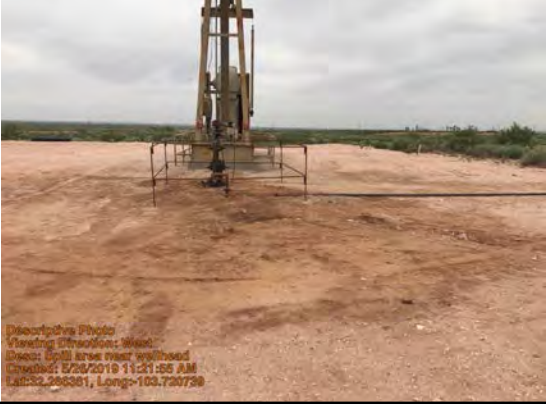
<p><small>Descriptive Photo Viewing Direction: West Desc: Spill area near wellhead Created: 5/25/2019 11:21:55 AM Lat:32.285301, Long:-103.720750</small></p>	<p><b>Viewing Direction: Southwest</b></p>

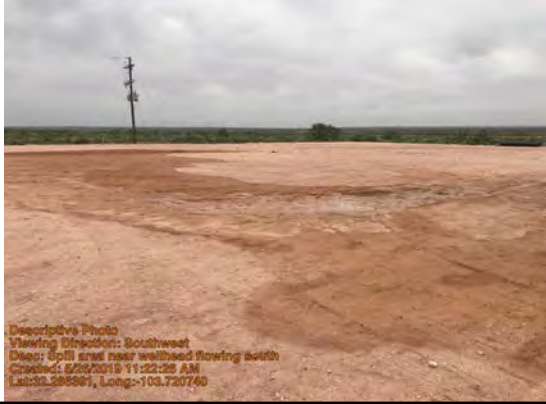
<p><small>Descriptive Photo Viewing Direction: Southwest Desc: Spill area near wellhead flowing south Created: 5/25/2019 11:22:35 AM Lat:32.285301, Long:-103.720760</small></p>

Spill area near wellhead	Spill area near wellhead flowing south

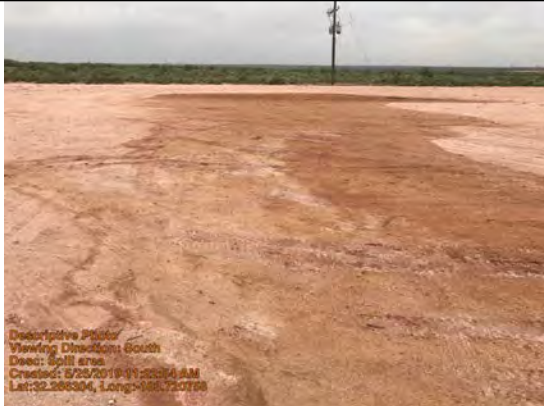
Viewing Direction: South

Spill area

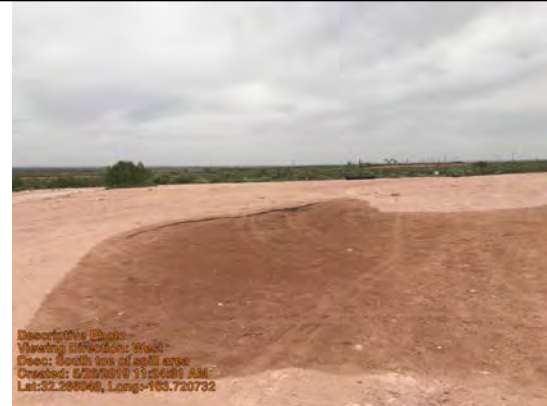
Viewing Direction: West

South toe of spill area

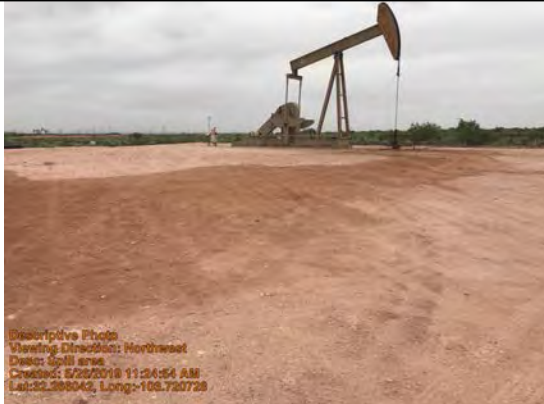
Viewing Direction: Northwest

Spill area

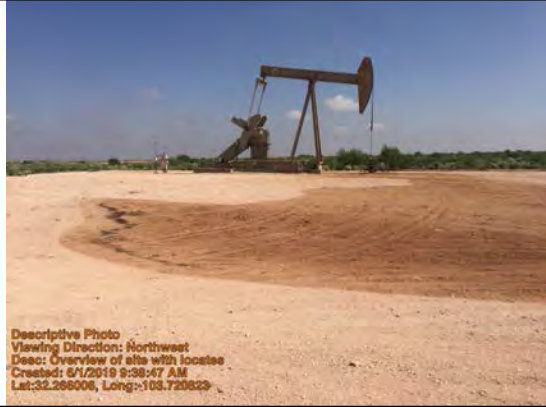
**Viewing Direction: Northwest**

Overview of site with locates

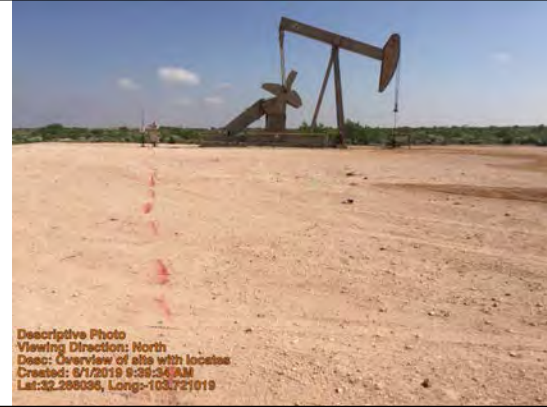
**Viewing Direction: North**

Overview of site with locates

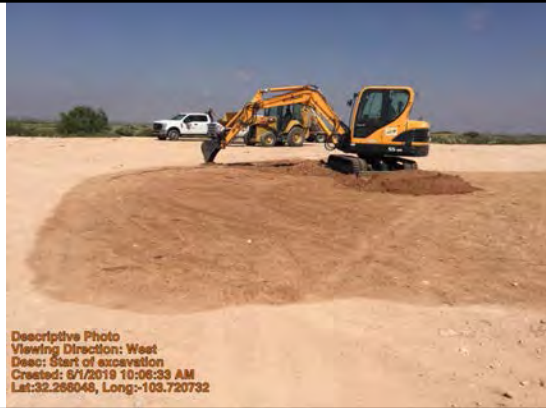
**Viewing Direction: West**

Start of excavation

Remediation efforts began on June 1, 2019 and was completed on June 1, 2019. Vertex personnel supervised the excavation of impacted soils. Field screening was completed on a total of 7 sample points and consisted of analysis using a Photo Ionization Detector (volatile hydrocarbons), a Dextil Petroflag using EPA SW-846 Method 9074 (extractable hydrocarbons) and Quantabs (chlorides). Field screening results were used to identify areas requiring further remediation from those areas showing concentrations below determined closure criteria levels. Soils were removed to a depth of 0.5 feet bgs. Impacted soil was transported by a licensed waste hauler and disposed at an approved waste management facility. Waste Manifest is presented in Attachment 5. Field screening results are presented in Attachment 6, as well as in the DFRs in Attachment 3.

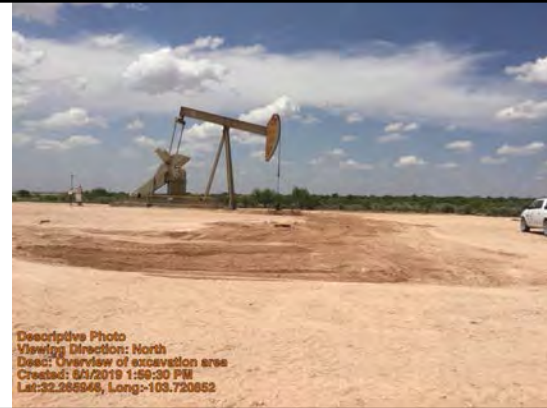
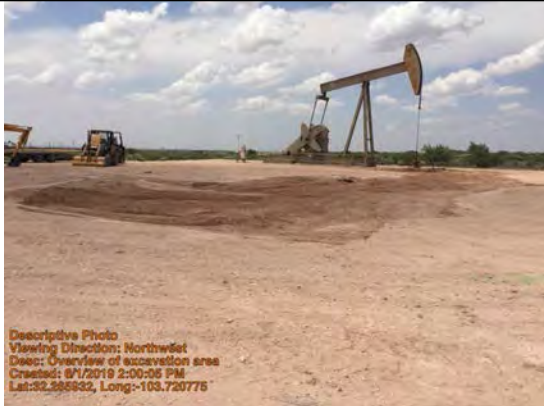
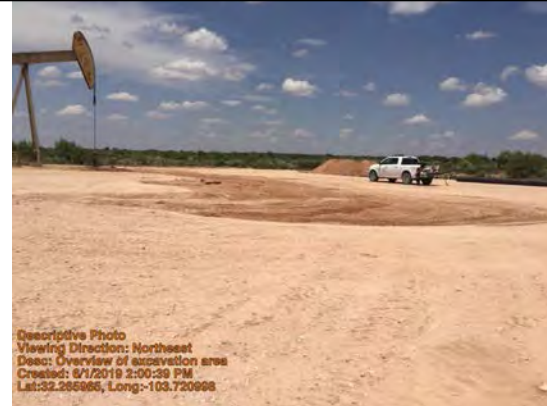
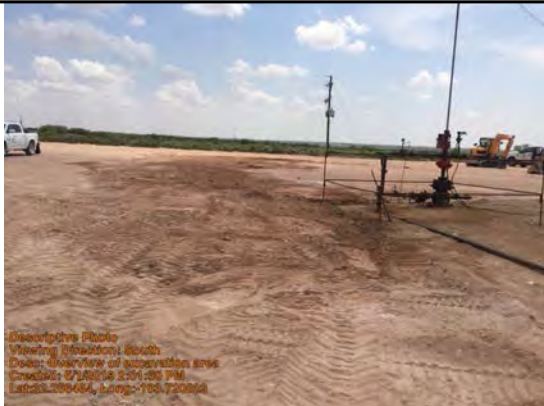
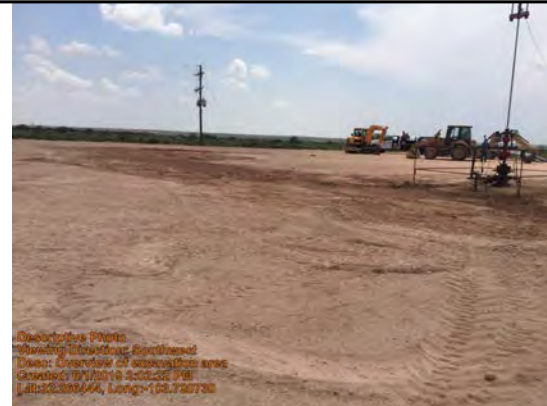
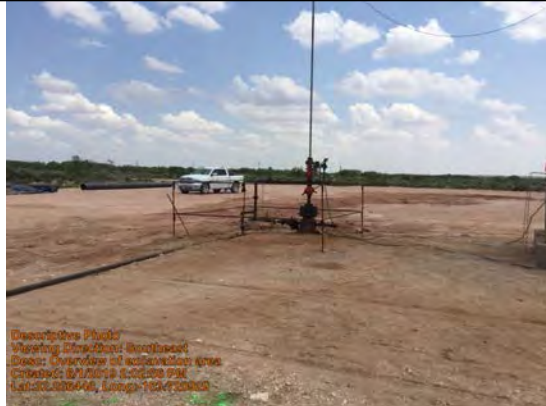
Overview of excavation area

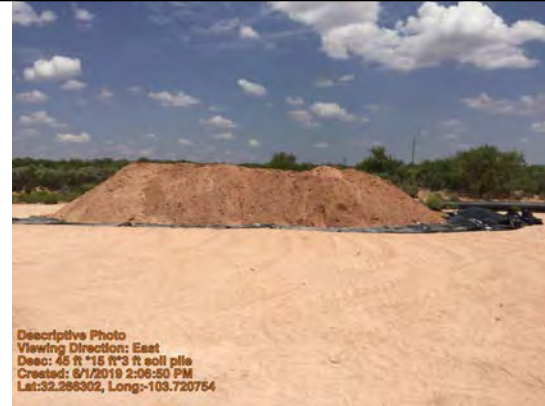
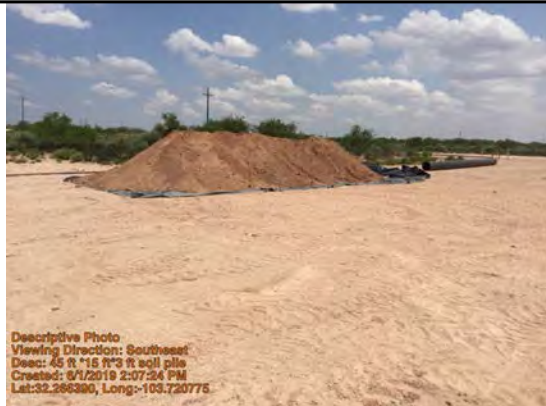
45 ft \* 15 ft \* 3 ft soil pile

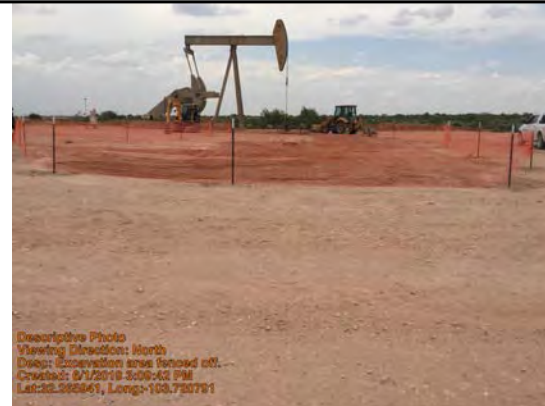
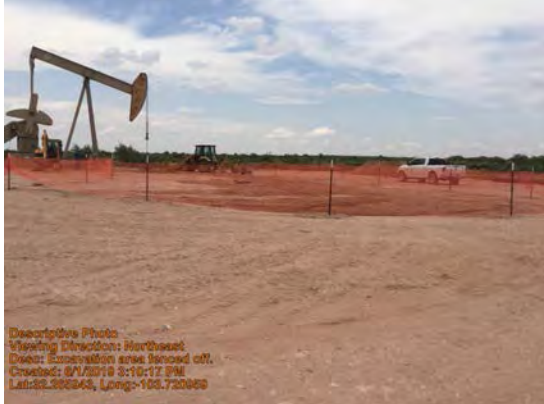
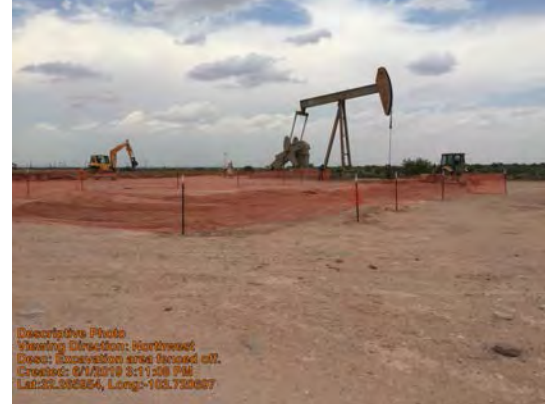
Excavation area fenced off.

Descriptive Photo  
Viewing Direction: Northeast  
Event: Excavation area fenced off.  
Created: 6/1/2019 3:10:17 PM  
Lat:28.502543, Long:-103.720065

Descriptive Photo  
Viewing Direction: Northwest  
Event: Excavation area fenced off.  
Created: 6/1/2019 3:11:00 PM  
Lat:28.502544, Long:-103.720067

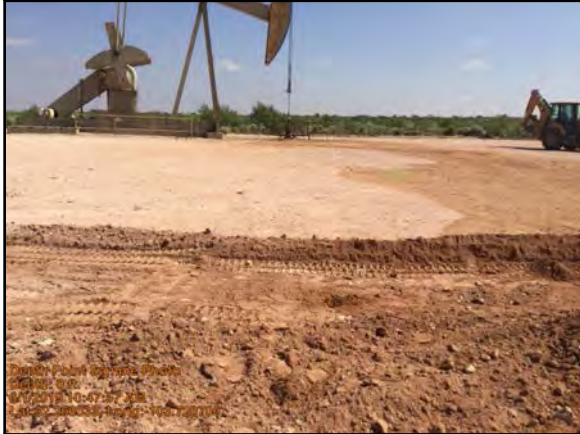
Sample Point ID: SS19-01

Depth: 0.5ft.

Notification that confirmatory samples were being collected was provided to the NMOCD on June 1, 2019 and is included in Attachment 7. Confirmatory composite samples were collected from the base of the excavation in 200 square foot increments. A total of seven (7) samples were collected for laboratory analysis following NMOCD soil sampling procedures. Samples were submitted to Hall Environmental Analysis Laboratory under chain-of-custody protocols and analyzed for BTEX (EPA Method 8021B), Total Petroleum Hydrocarbons (GRO, DRO, MRO – EPA Method 8015M/D) and Total Chlorides (EPA Method 300.0). Laboratory results are presented in Table 3, Attachment 6 and the laboratory data report can be found in Attachment 8. All confirmatory samples collected and analyzed were below closure criteria for the site.

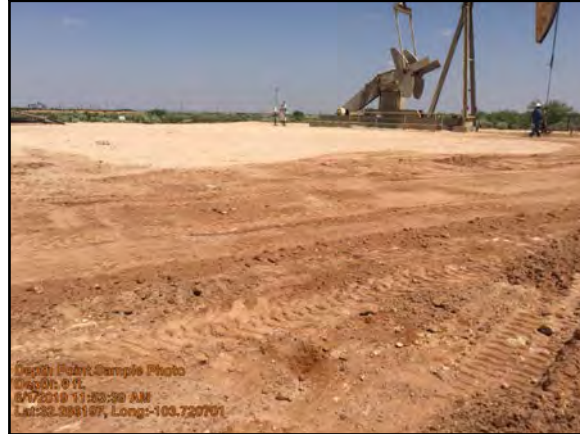
Sample Point ID: SS19-02

Depth: 0.5ft.

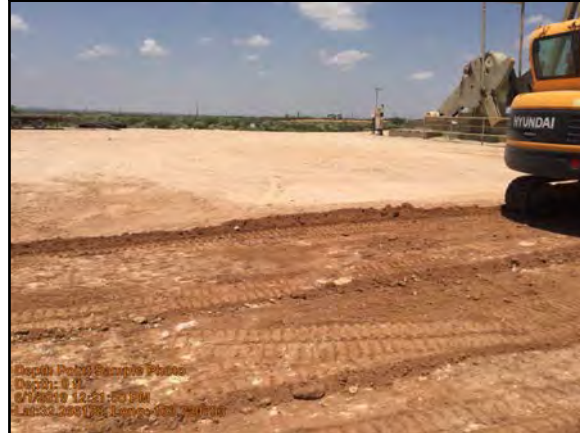
Sample Point ID: SS19-04

Depth: 0.5ft.

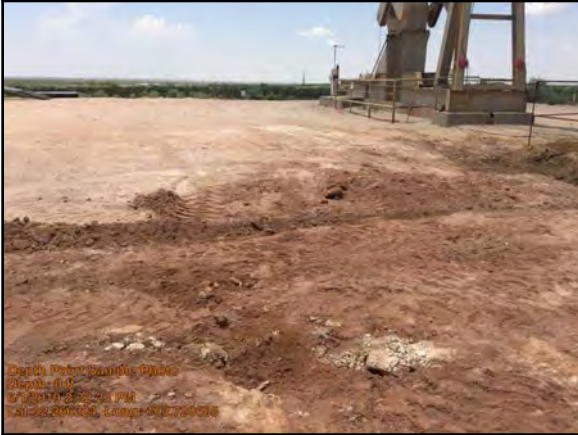
**Sample Point ID: SS19-05**

**Depth: 0.5ft.**

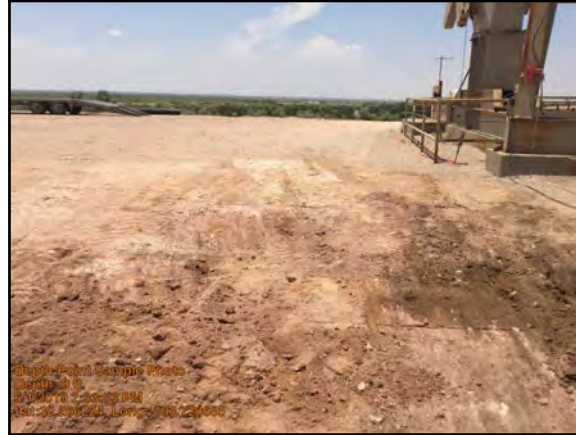
**Sample Point ID: SS19-06**

**Depth: 0.5ft.**

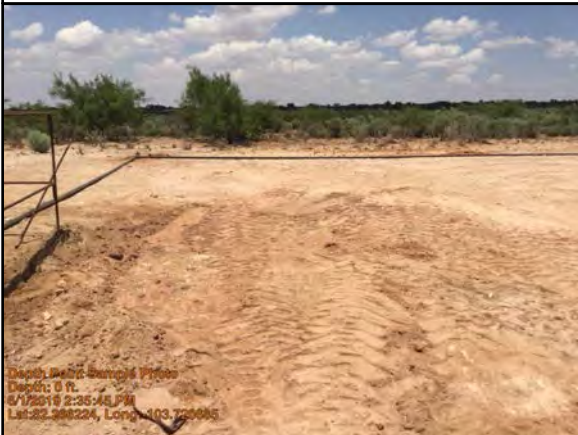
**Sample Point ID: SS19-07**

**Depth: 0.5ft.**

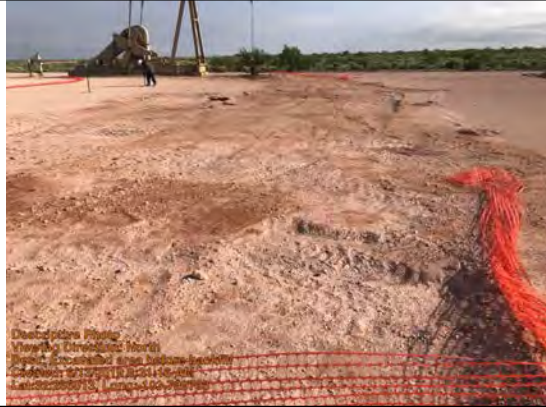
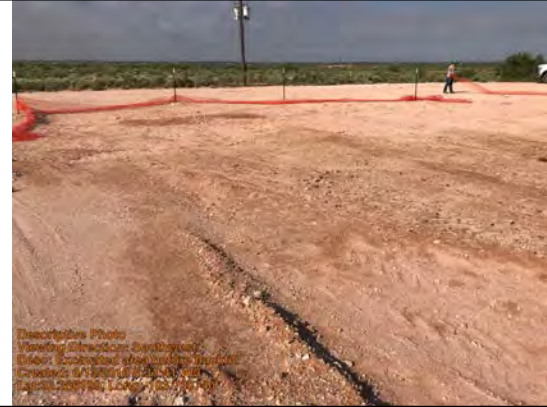
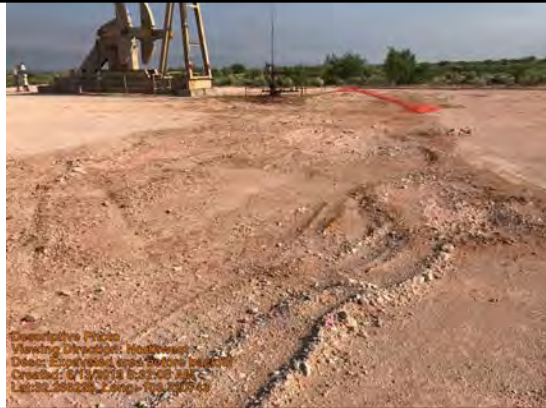
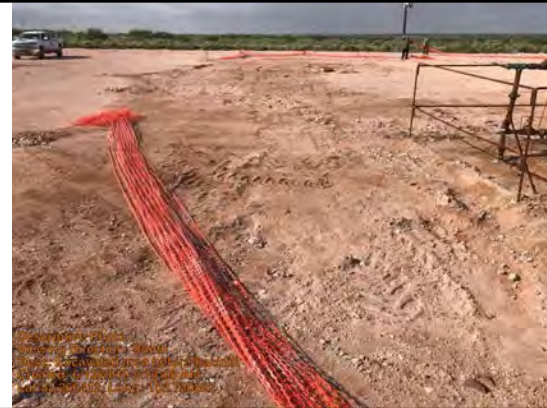
Excavated area before backfill

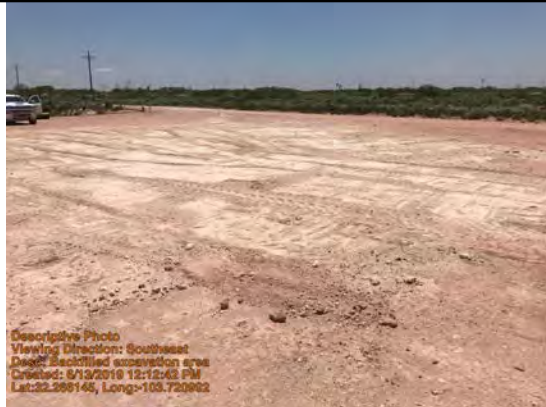
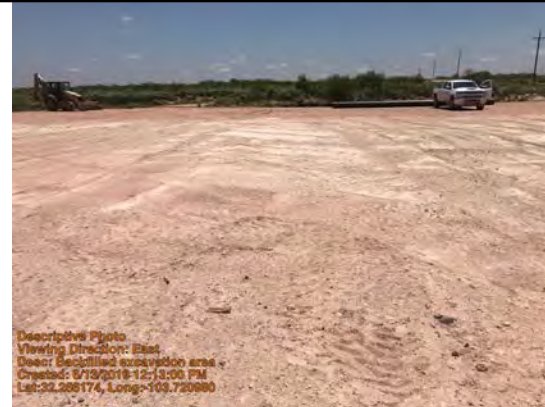
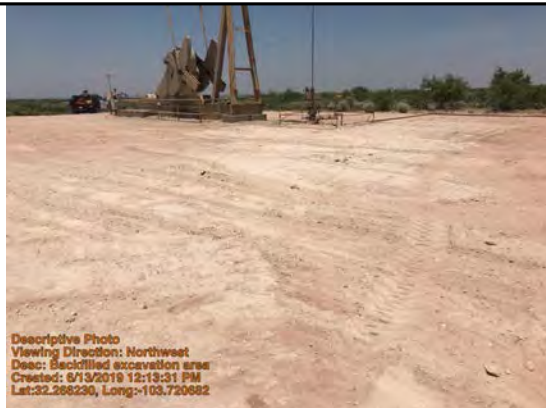
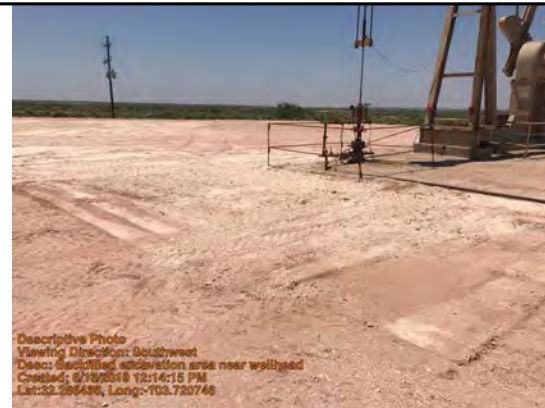
Backfilled excavation area

Backfilled excavation area near wellhead

The spill area was fully delineated, remediated and backfilled with local soils by June 1, 2019 (Attachment 7). Confirmatory samples were analyzed by the laboratory and found to be below allowable concentrations as per the New Mexico Administrative Code (NMAC) Closure Criteria for Soils Impacted by a Release locations "greater than 100 feet to groundwater". Based on these findings, Devon Energy Corporation requests that this spill be closed.
