Remediation and Closure Report

Allthorn Transfer Line
API # 30-015-43951, 2RP-4865
Talon Project No. 701307.111.01

Lime Rock Resources II-A, L.P.
1111 Bagby St Suite 4600
Houston, TX 77002

February 15, 2019

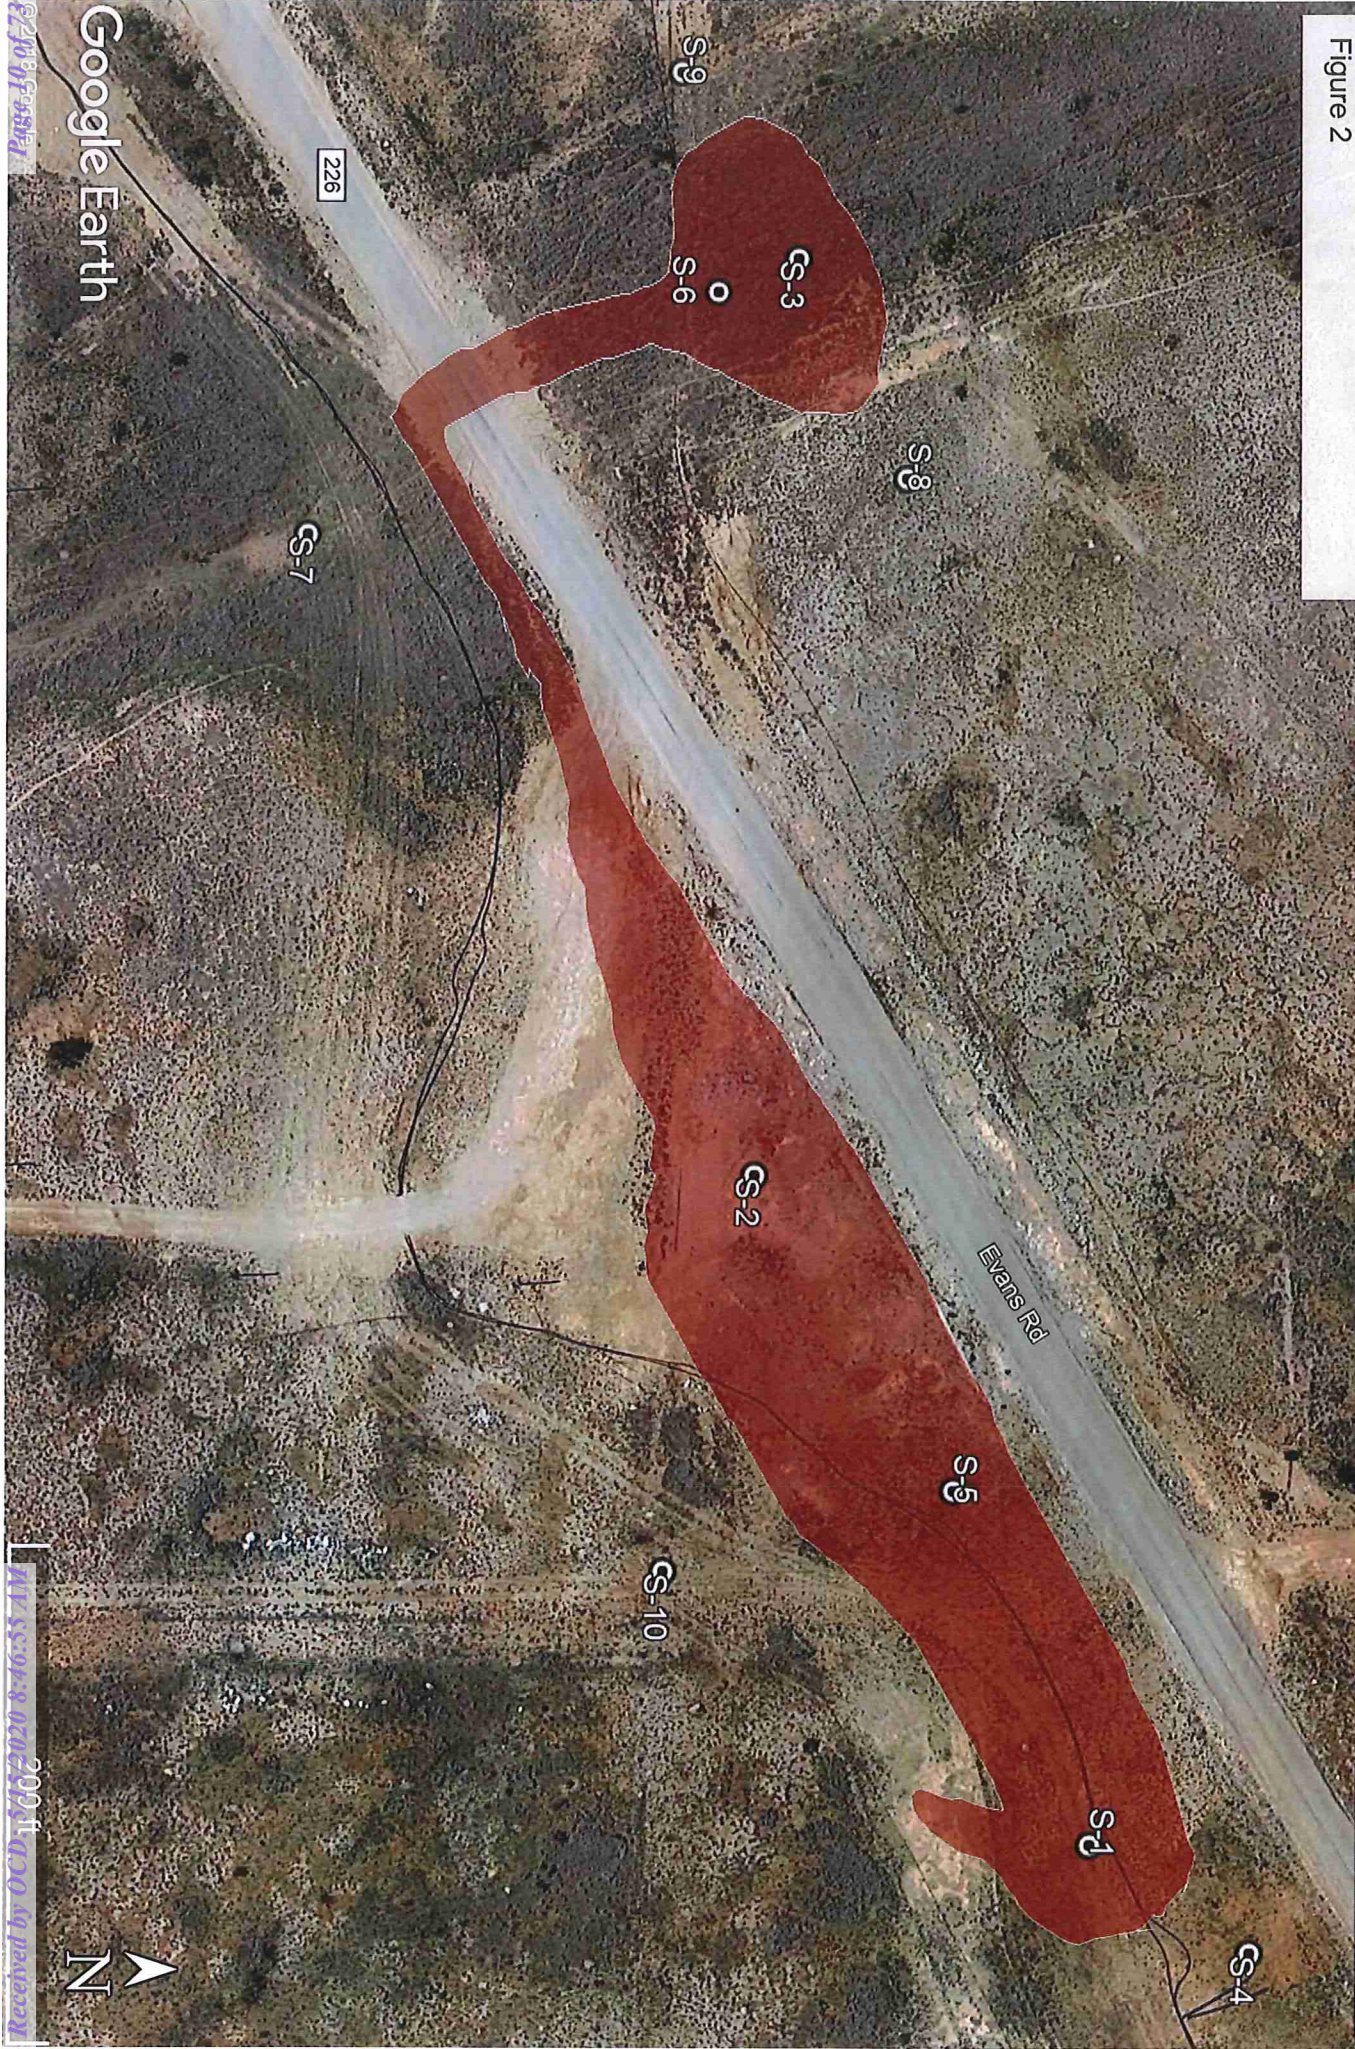
Lime Rock Resources
Eddy County, NM
AP# 30-015-43951
Figure 2

On June 28, 2018, vandals stole the transfer line connections resulting in a release of approximately 25 bbls of fresh and produced water that was trapped in the line. The 12-inch transfer line from the All Thorn Facility to the Hawk 8K Federal #51 had previously been flushed with fresh water and was idle at the time of the release. The line was subsequently capped to stop the leak. A backhoe and a dump truck with clean fill were dispatched to berm the spill at Evans Road. The backhoe was also utilized to scrape up the impacted soil from accessible areas in the flow path. A vac truck was dispatched and was able to recover 8 bbls of standing water. A site plan is presented in [Appendix I](#) which illustrates the impacted area.

Spill Path

Soil Sample

- The impacted area in the vicinity of S-1 was excavated to a depth of 4.0 feet deep with field titrations used to guide the excavation. See aerial photographs of the excavation in [Appendix III](#).

- The impacted soil in the vicinity of S-2 was excavated to a depth of 1.5 feet with field titrations used to guide the excavation.
- The impacted area in the vicinity of S-3 and S-6 was excavated to a depth of 4.0 feet deep with a 20 mil liner installed at the bottom of the excavation.

- The flow path along Evans Road was excavated to a depth of 1.5 feet, as close as practicable to Evans Road.
- All of the excavated material was transported to Lea Land, LLC, a NMOCD approved solid waste disposal facility.

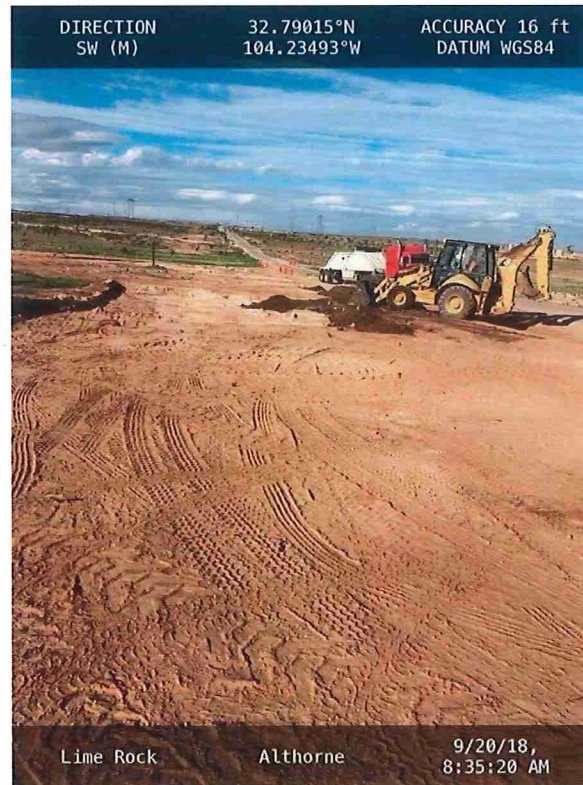
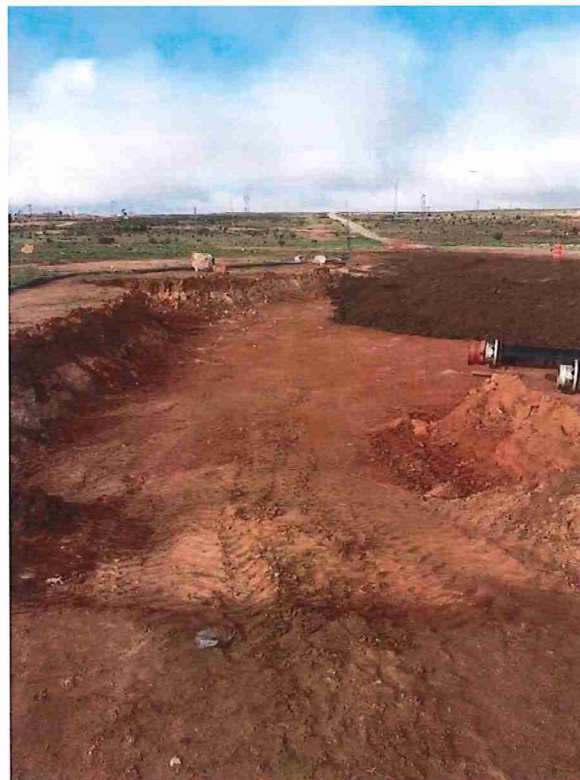
Backfill

- The excavated areas were backfilled with locally obtained topsoil, machine compacted and contoured to match the surrounding terrain.
- The work area was then seeded with BLM #4 seed mix which correlates with the published soil survey information ([Appendix II](#)).
