## **Soil Assessment, Remediation and Closure Report**

Logan Transfer Line  
API # 30-015-32179  
Talon Project No. 701307.110.01

Subject:       **Soil Assessment and Remediation Work Plan**  
                    Logan Transfer Line  
                    API # 30-015-32179

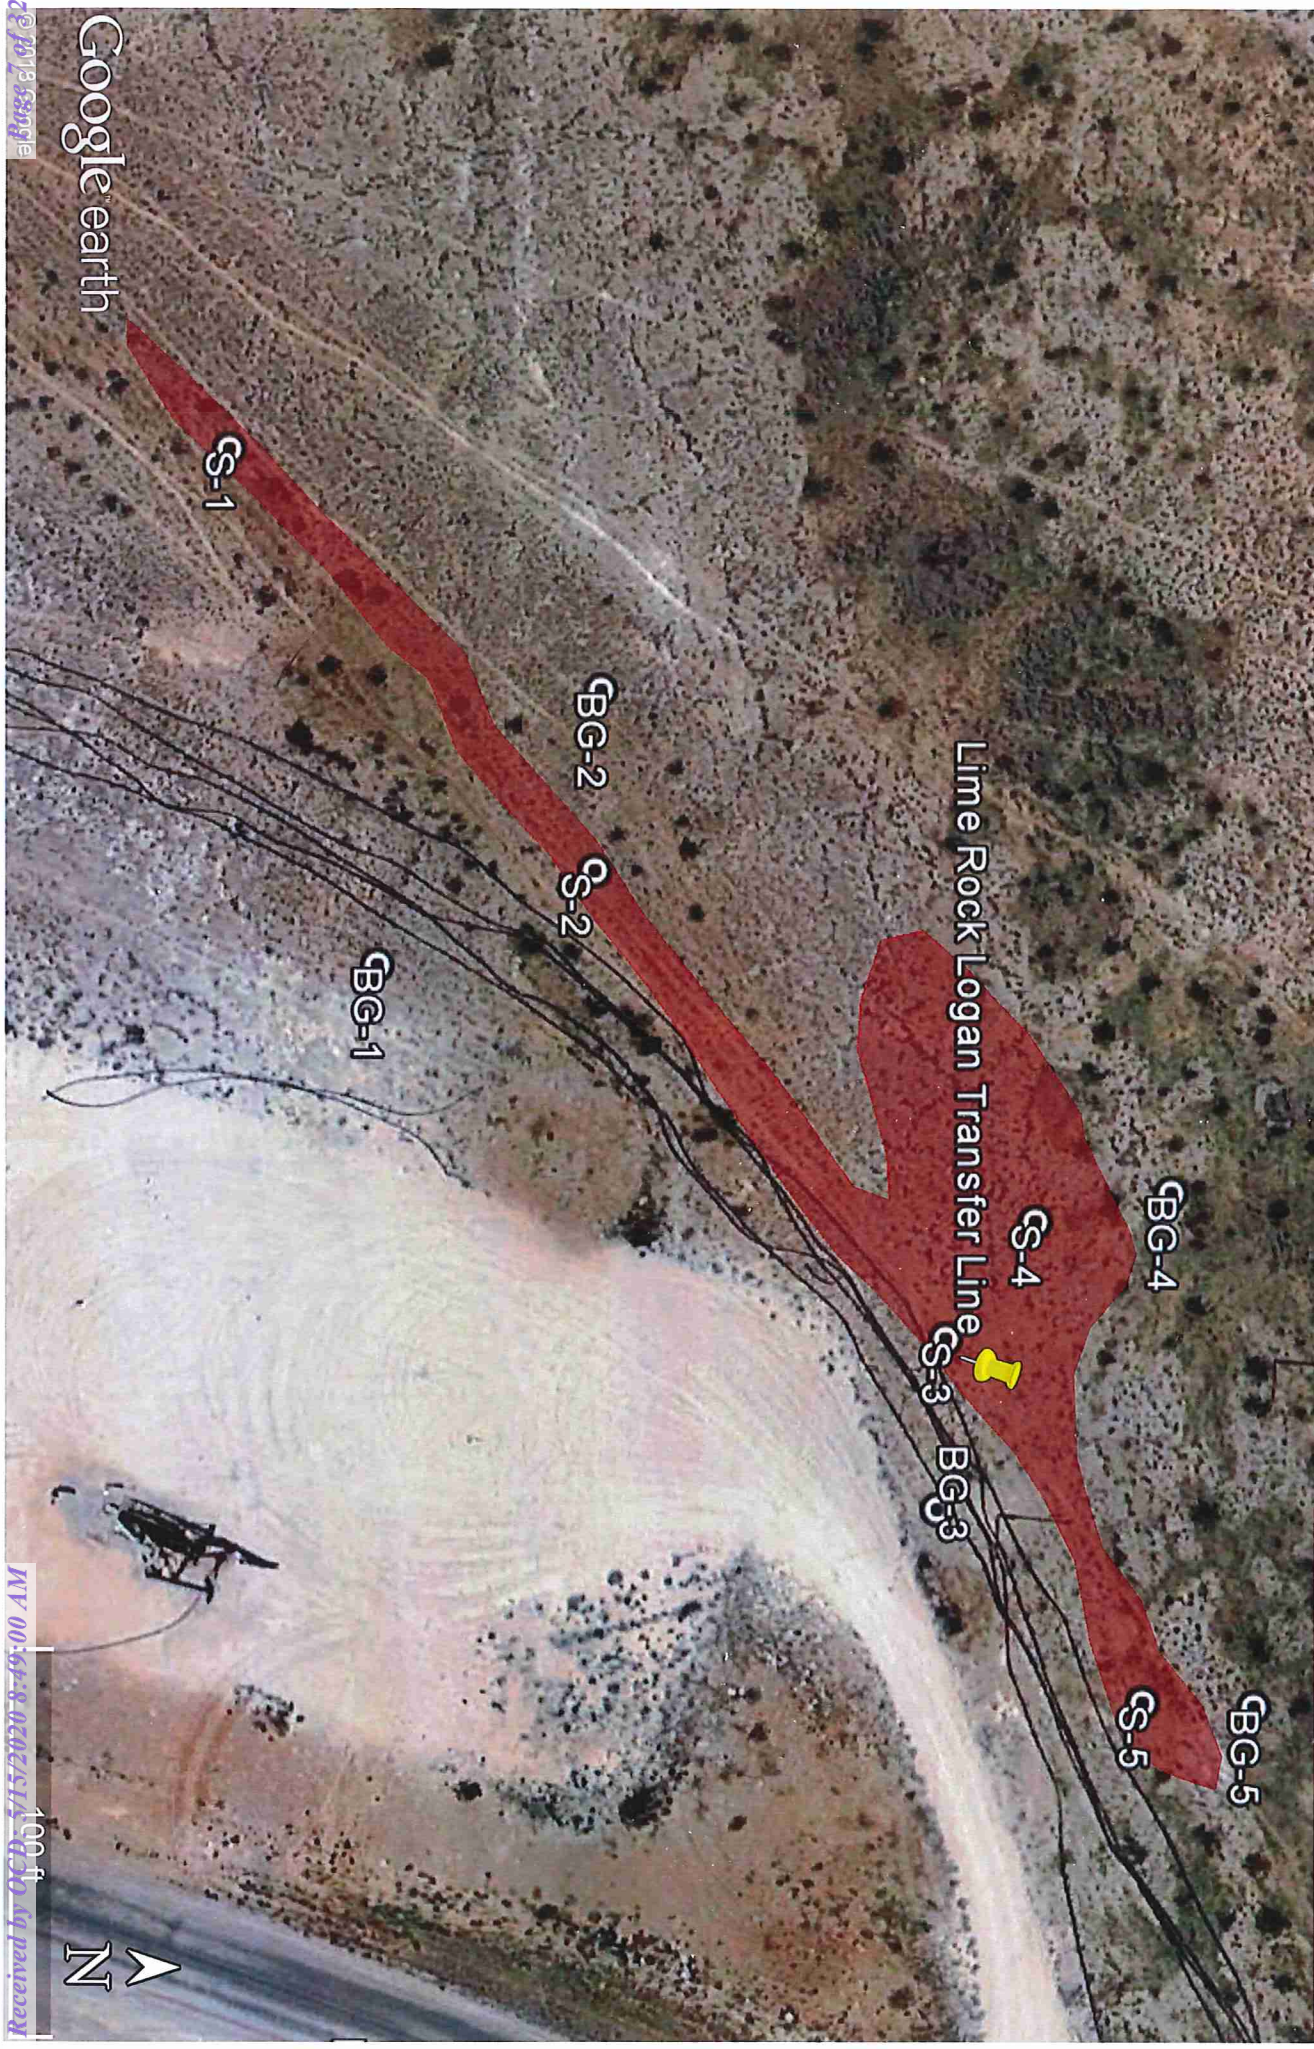
### SITE PLAN

Logan Transfer line

- Impacted area
- Lime Rock Logan Transfer Line
- Sample Locations

The Logan Transfer Line is located approximately 10 miles E of Artesia, New Mexico. The legal location for this release is Unit Letter G, Section 2, Township 18 South and Range 27 East in Eddy County, New Mexico. More specifically the latitude and longitude for the release are 32.7824554 North and -104.2548904 West. A site plan is presented in [Appendix I](#).

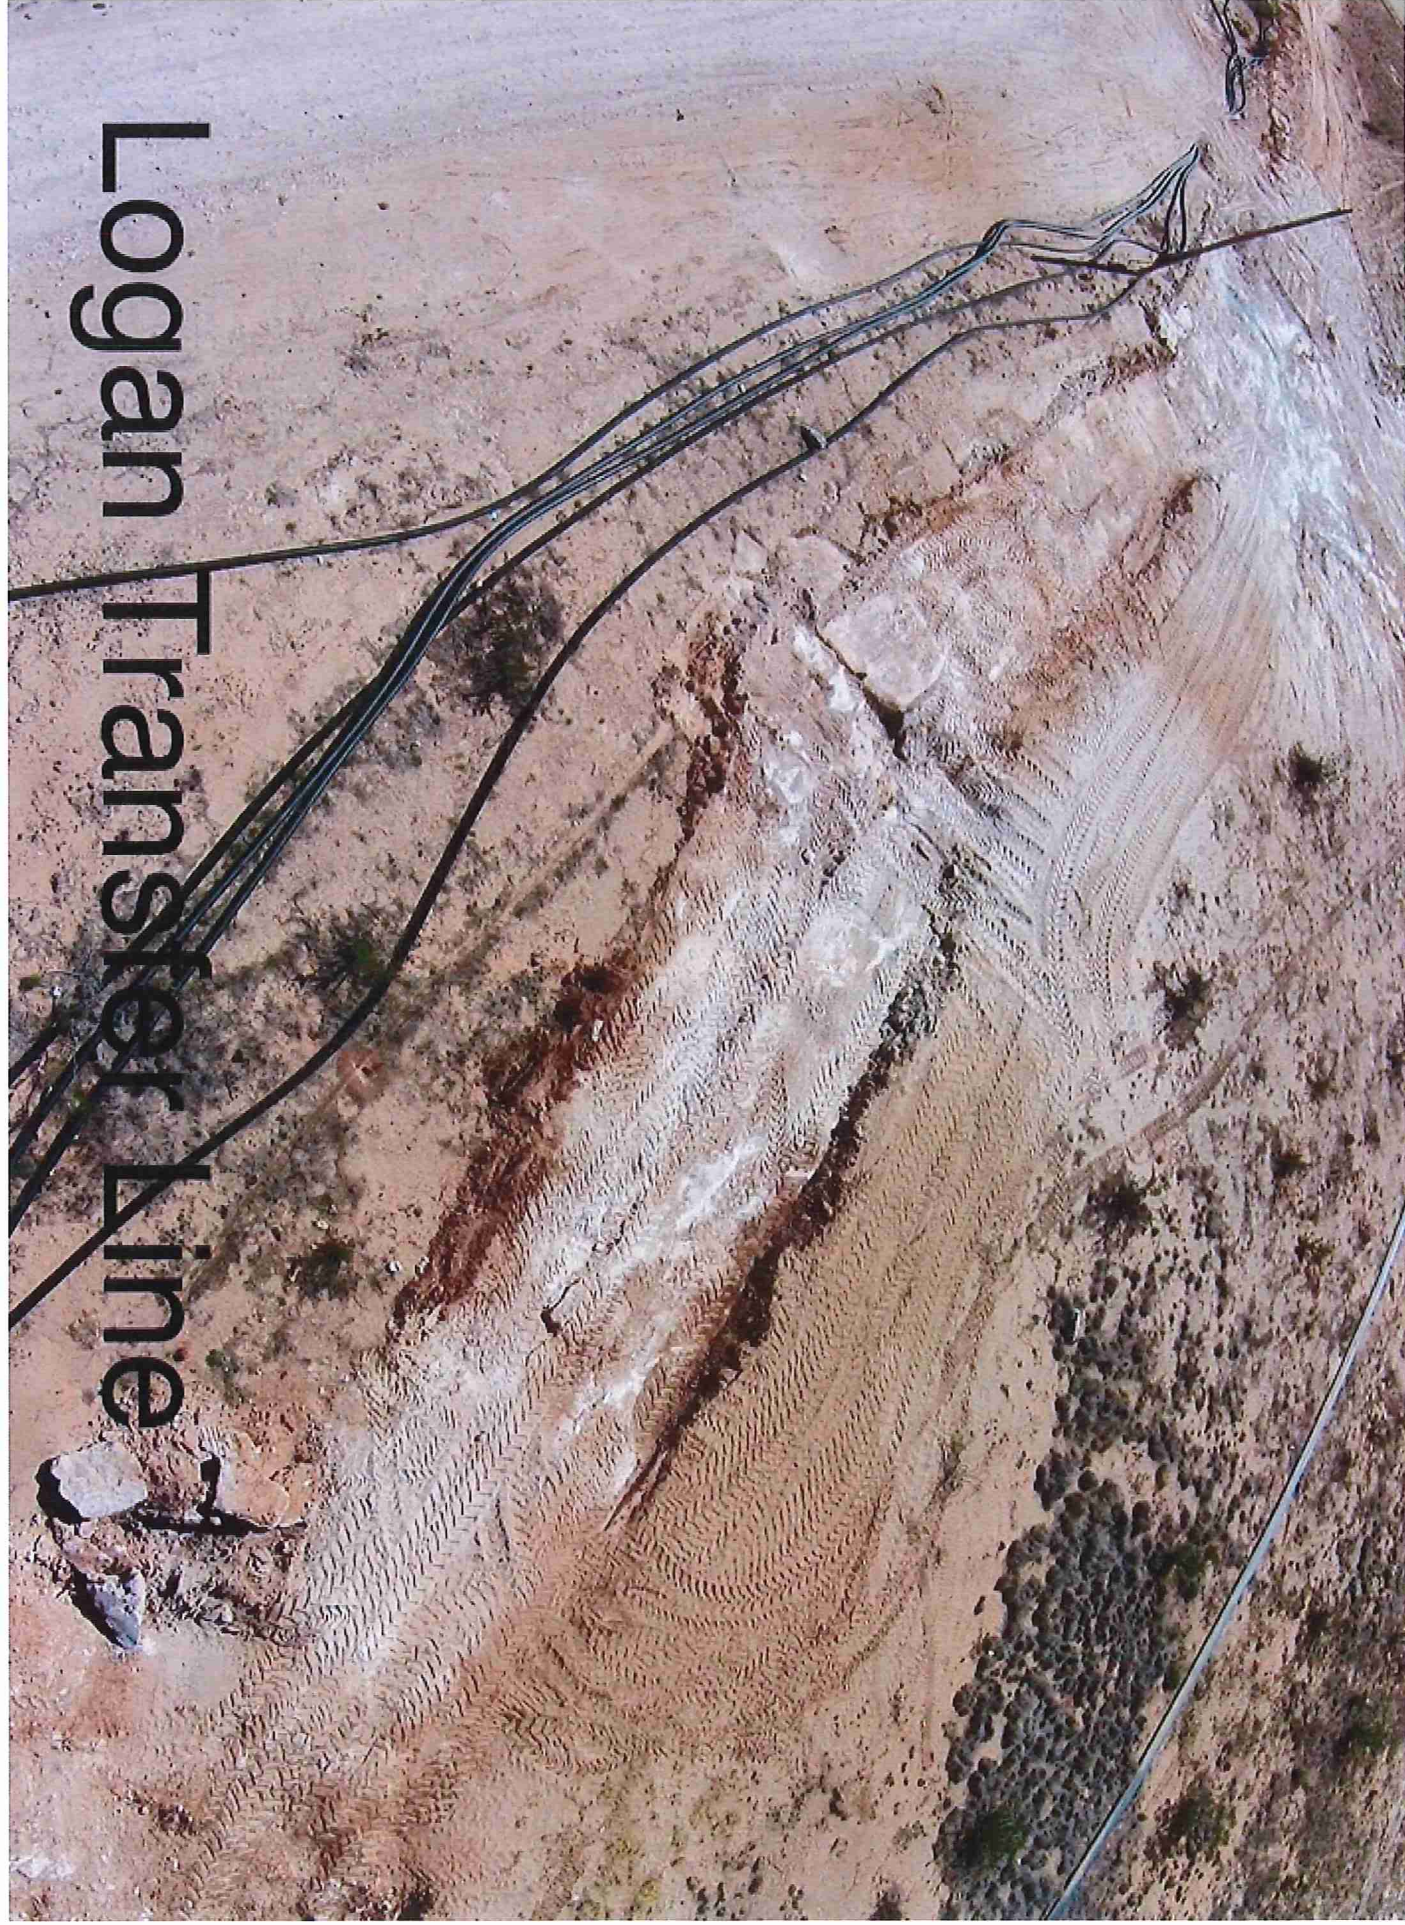
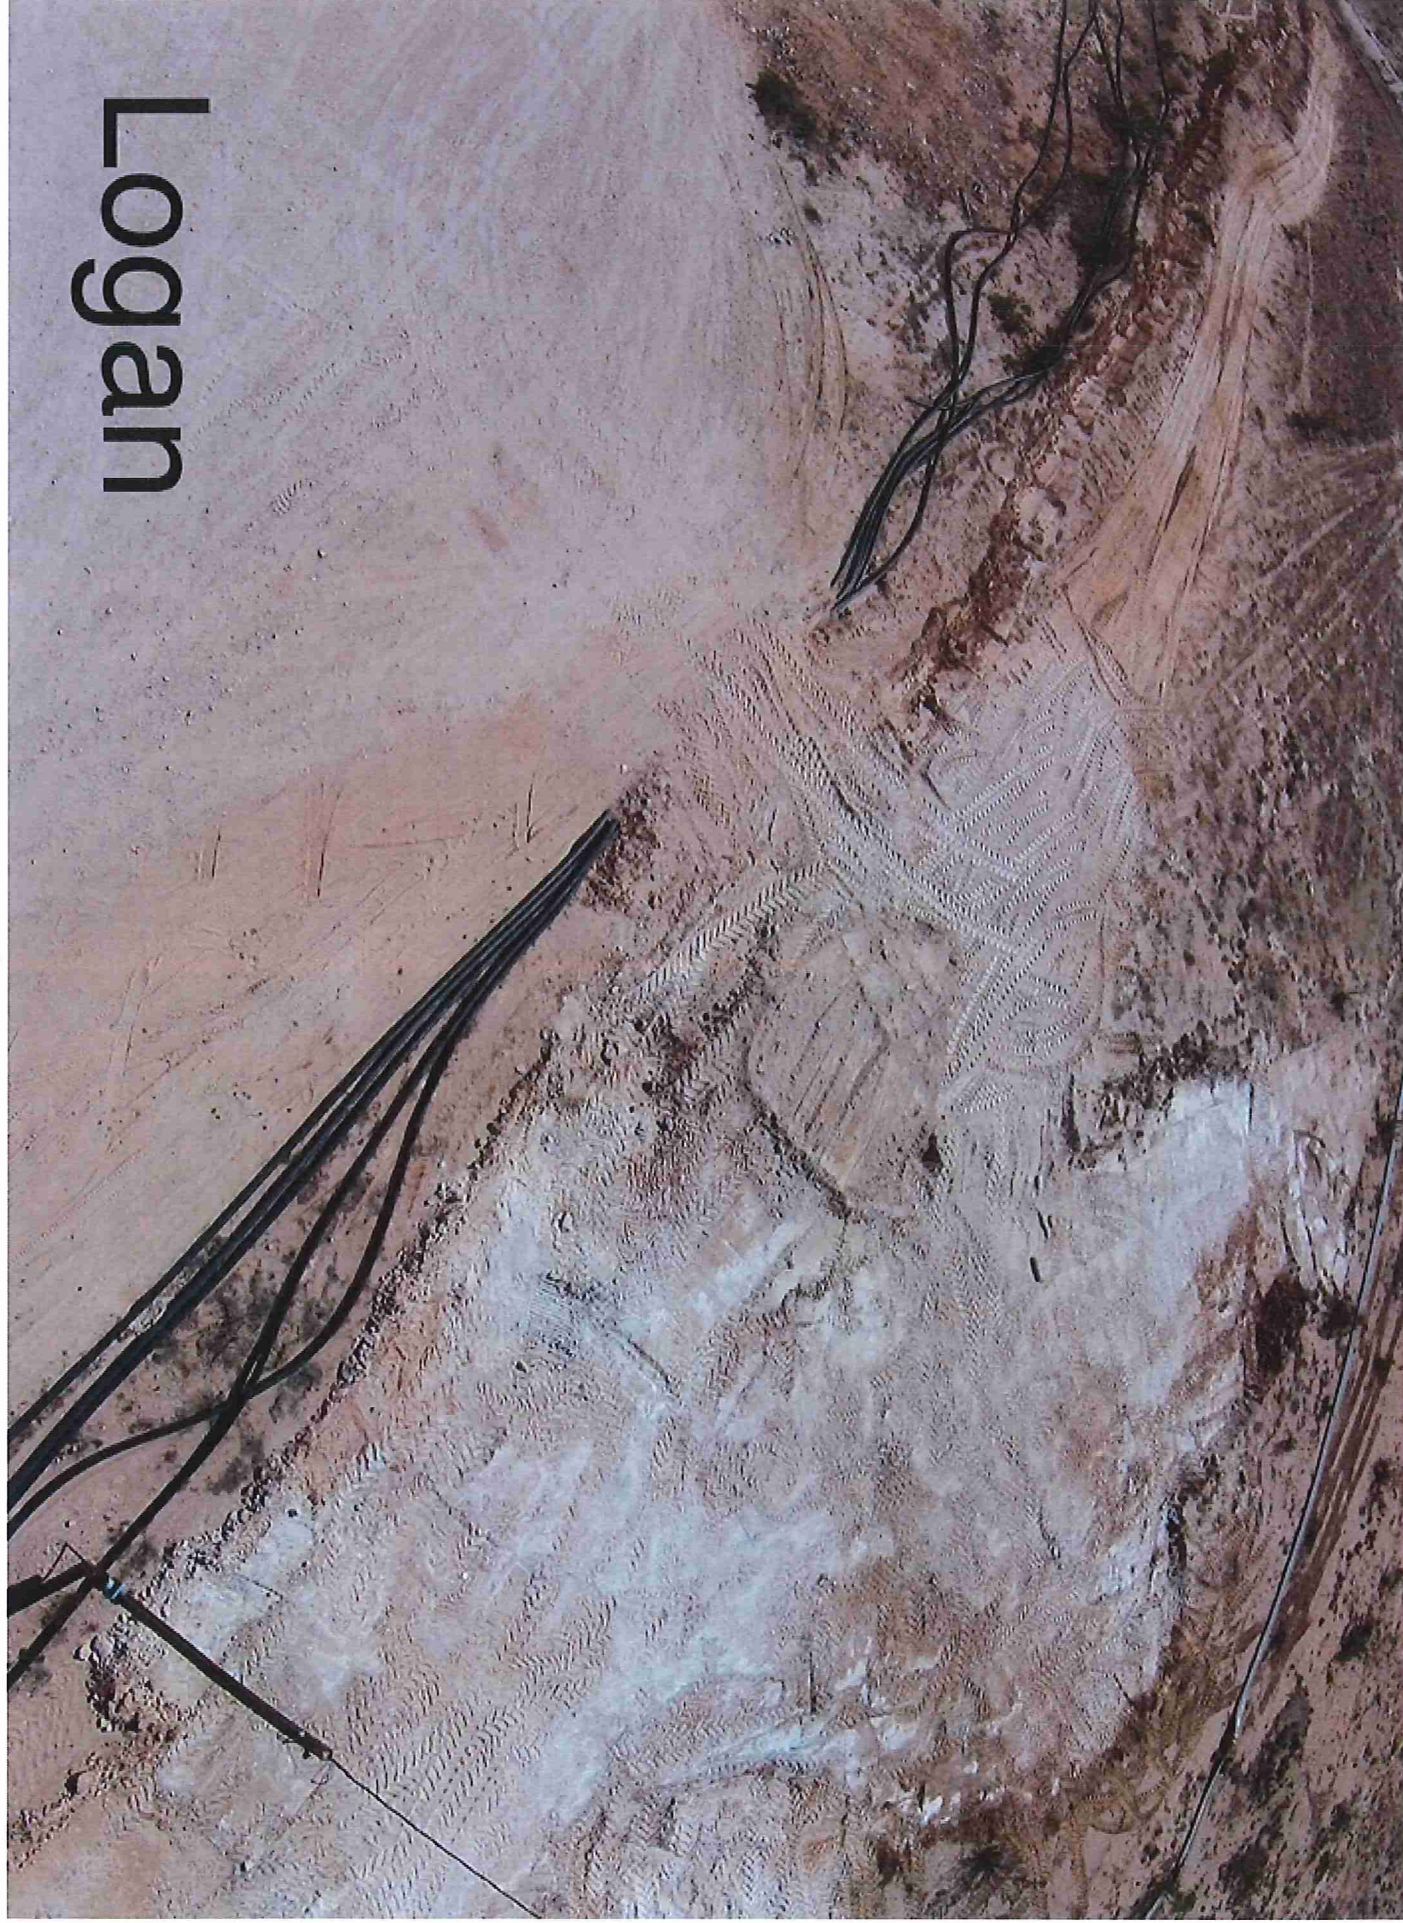
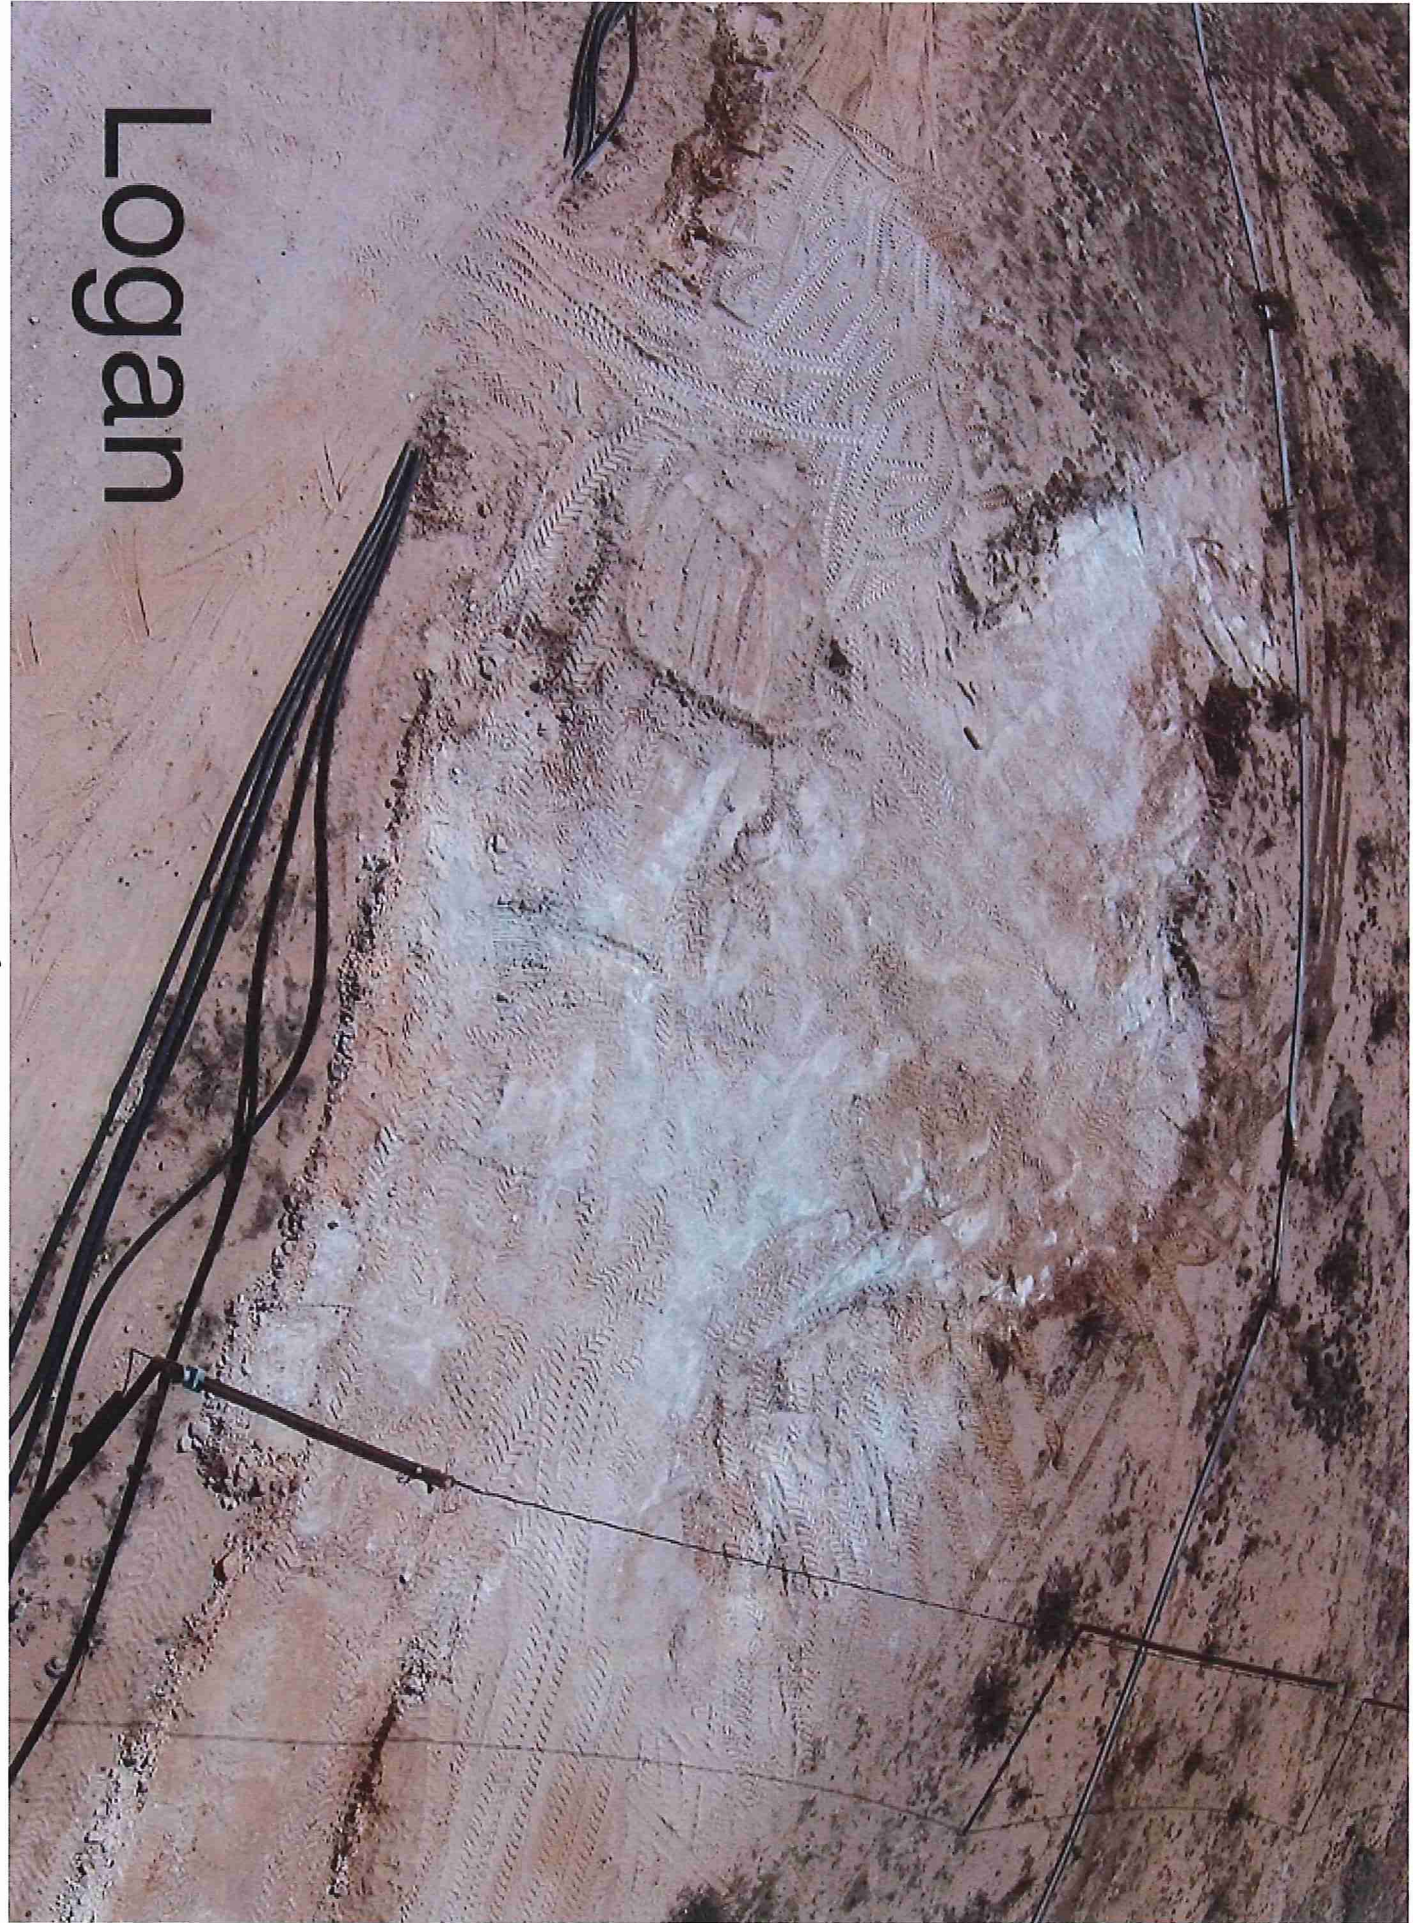
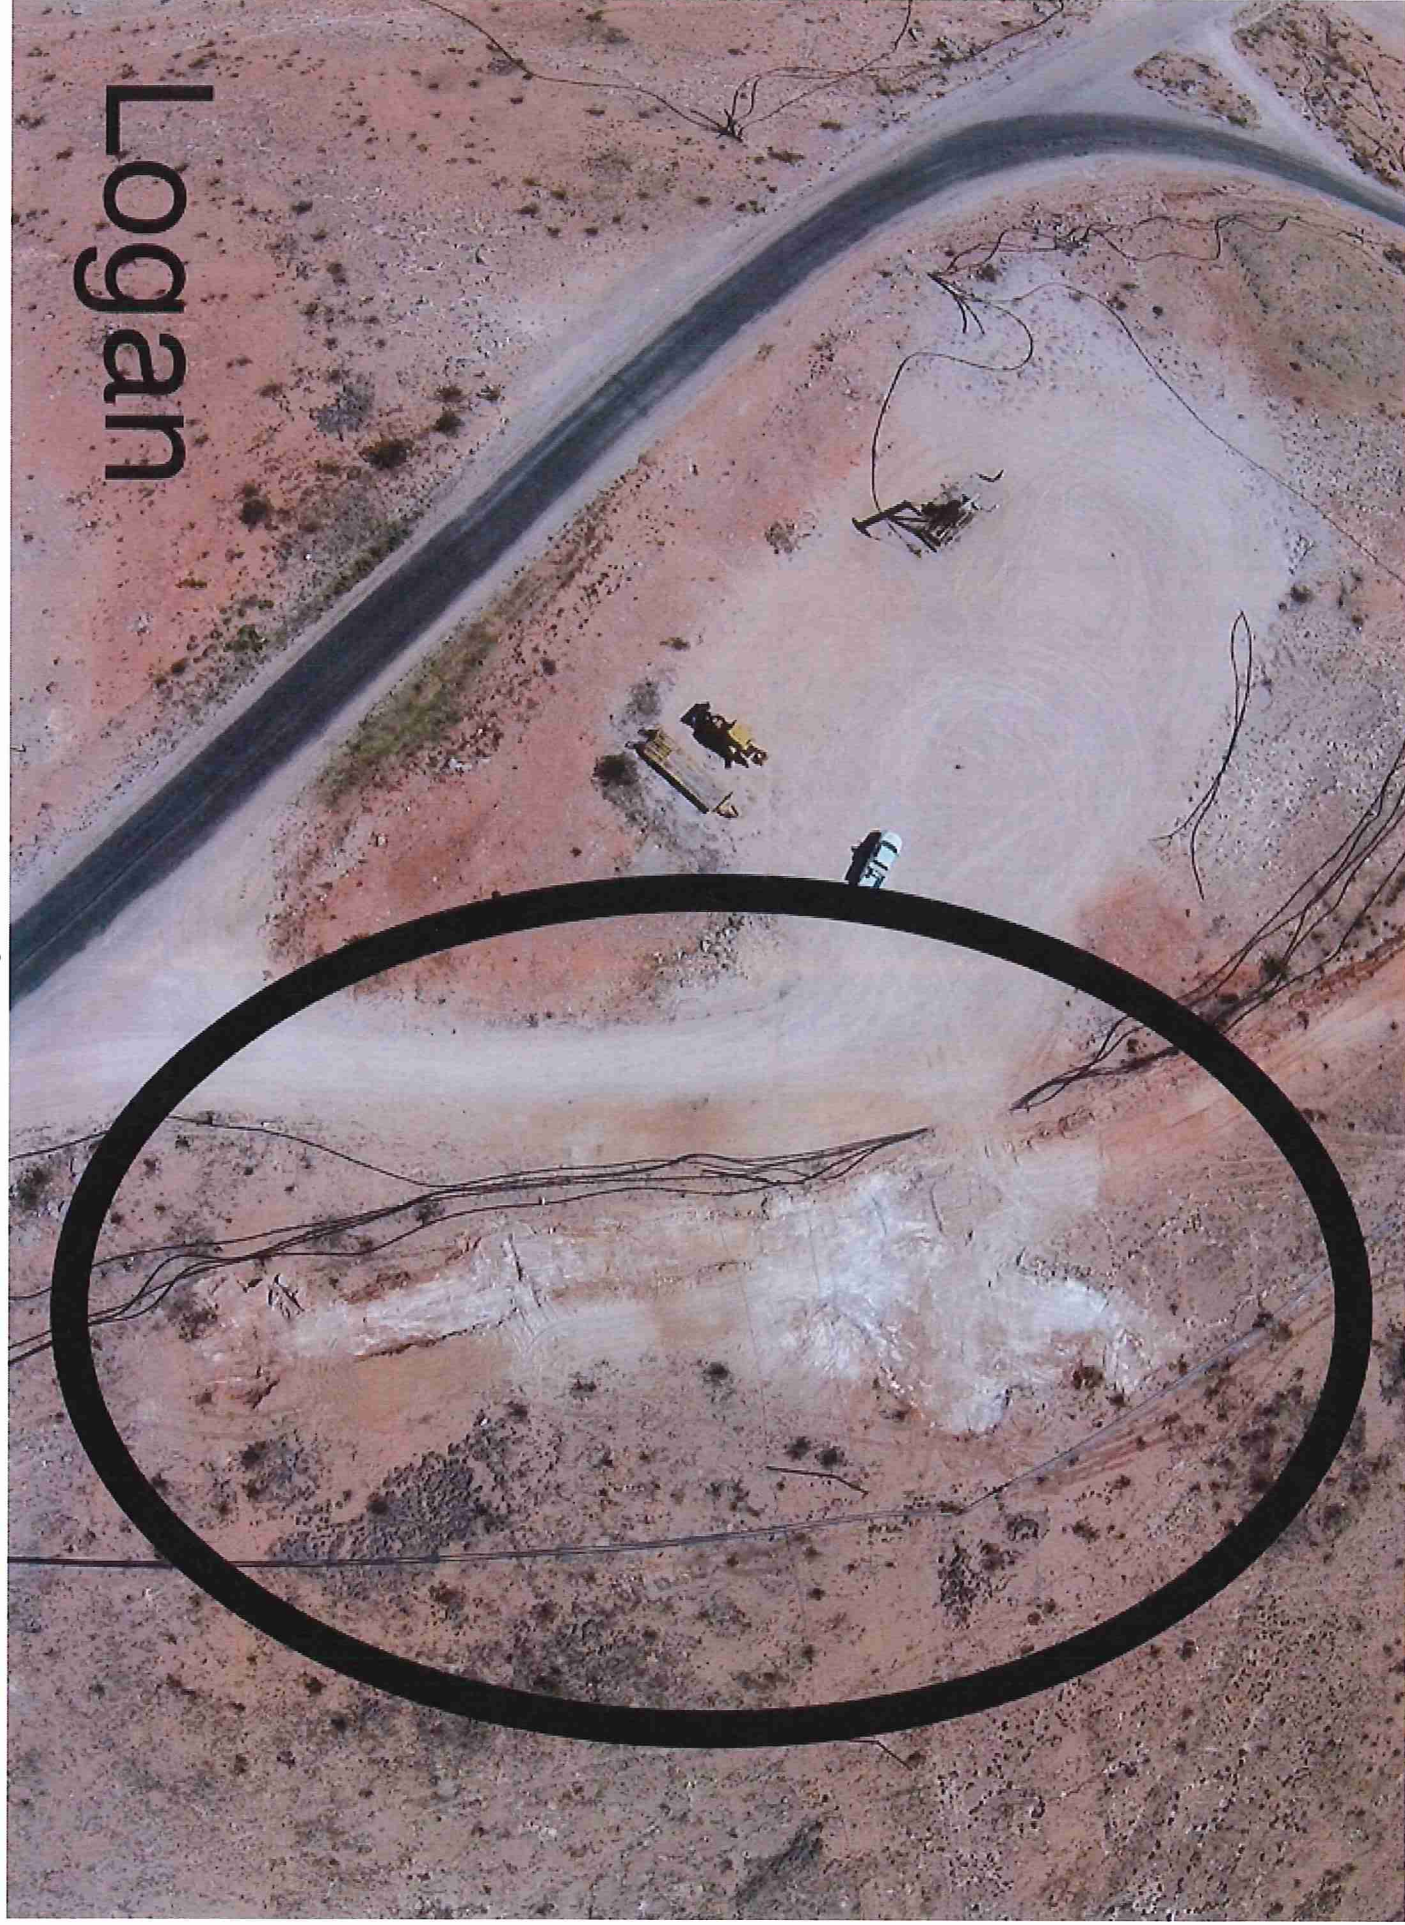
### Aerial Pictures of Excavation

# Logan Transfer Line

On June 20, 2018, Talon personnel mobilized to the site to carry out additional soil sampling. Soil samples were collected utilizing a hand auger to depths at which refusal (rock) was encountered. Refusal was encountered at depths of 1.0 foot BGS at all sample locations. Based on the laboratory results, further delineation was completed vertically and horizontally utilizing a backhoe. Aerial pictures of the excavated site are provided in [Appendix III](#).

- The impacted soil from the area of S-1 to S-5 was initially excavated to a depth of 1.0 foot BGS.
- Once the initial lab data was analyzed, further delineation was needed vertically and horizontally.
- The impacted areas at S-3 and S-4 were subsequently excavated to a depth of 1.5 feet BGS.
- Horizontal sidewall excavation continued until all sample analysis was below NMOCD RRAL's.
- All of the excavated material was hauled to Lea Land LLC, a NMOCD approved disposal facility.
- The excavated areas were backfilled with new sand, contoured to match the surrounding terrain and will be seeded with BLM seed mixture #4.
