Release Notification

RE: Closure Request Remuda 500 CTB Incident Number NRM2011537308 Eddy County, New Mexico

LT Environmental, Inc. (LTE), on behalf of XTO Energy, Inc. (XTO), presents the following Closure Request detailing site assessment and soil sampling activities at the Remuda 500 CTB (Central Tank Battery; Site) in Unit O, Section 25, Township 23 South, Range 29 East, in Eddy County, New Mexico (Figure 1). The purpose of the site assessment and soil sampling activities was to assess the presence or absence of impacts to soil following a condensate release at the Site. Based on field observations, field screening, and laboratory analytical results from soil sampling activities, XTO is submitting this Closure Request and requesting no further action (NFA) for Incident Number NRM2011537308.

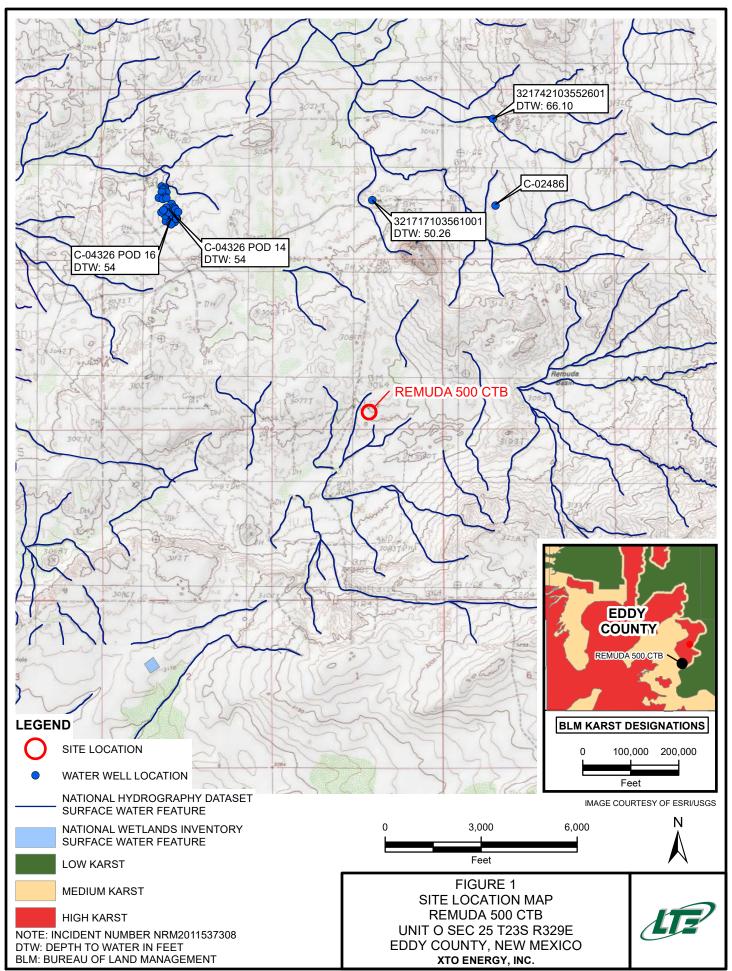
Mexico Office of the State Engineer (NMOSE) well C-04326, located 1.6 miles northwest of the Site, was most recently measured in May 2019 and has a reported depth to water of 54 feet bgs. All wells used for depth to groundwater determination are depicted on Figure 1.

The closest continuously flowing water or significant watercourse to the Site is an unnamed dry wash, located approximately 45 feet west of the Site. The Site is greater than 200 feet from a lakebed, sinkhole, or playa lake and greater than 300 feet from an occupied residence, school, hospital, institution, church, or wetland. The Site is greater than 1,000 feet to a freshwater well or spring and is not within a 100-year floodplain or overlying a subsurface mine. The Site is not underlain by unstable geology (medium potential karst designation area). Site receptors are identified on Figure 1.

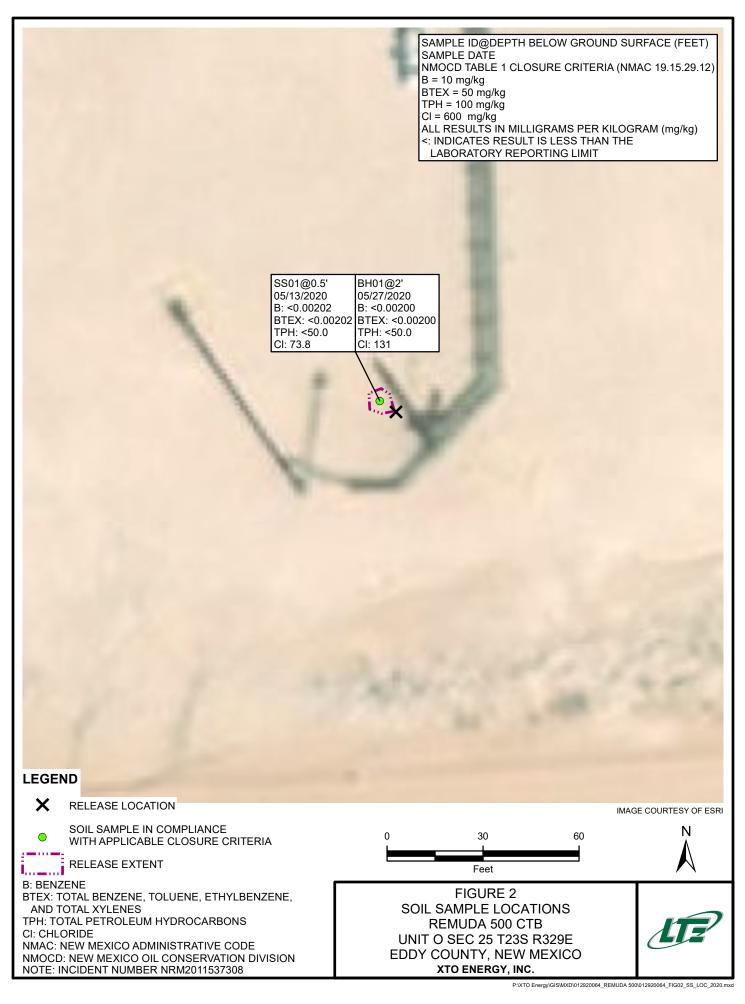
On May 27, 2020, LTE personnel returned to the Site to oversee additional soil assessment activities. One borehole (BH01) was advanced using a stainless-steel hand auger, to a depth of 2 feet bgs within the release extent. Borehole BH01 was advanced at the location of preliminary soil sample SS01. Soil from the borehole was field screened for volatile aromatic hydrocarbons and chloride utilizing a PID and Hach[©] chloride QuanTab[©] test strips, respectively. Field screening results and observations for the borehole were logged on a lithologic/soil sampling log, which is included in Attachment 2. The borehole and soil sample locations are presented on Figure 2.

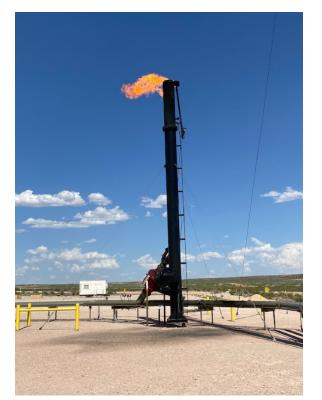
Photograph 1: East facing view of the release area.

On May 13, 2020, LTE personnel inspected the Site to evaluate the release extent based on information provided in the Form C-141 and visual observations. Indications of the release and fire were observed directly beneath the flare stack; the stained area measured approximately 45 square feet. The release extent was mapped utilizing a handheld Global Positing System (GPS) and is depicted on Figure 2. LTE personnel collected one preliminary soil sample (SS01) within the release extent from a depth of 0.5 feet bgs. Photographic documentation was conducted at the Site and a photographic log is included in Attachment 1.

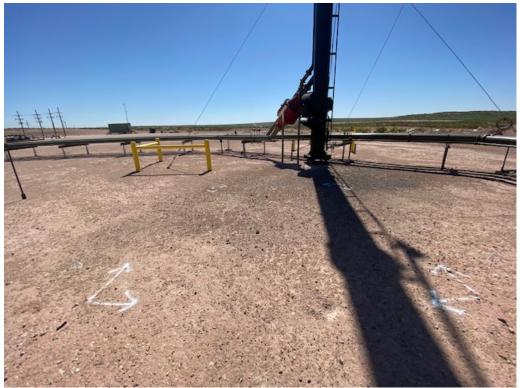
Photograph 2: East facing view of the release area.
