Vertex Project #: 20E-00239-010

**Spill Closure Report:** Nina Cortell Federal Com #124H  
Unit M, Section 3, Township 22 South, Range 32 East  
County: Lea  
API: 30-025-44550  
Tracking Number: NRM2012169218

**2020 Spill Assessment and Closure**  
July 2020

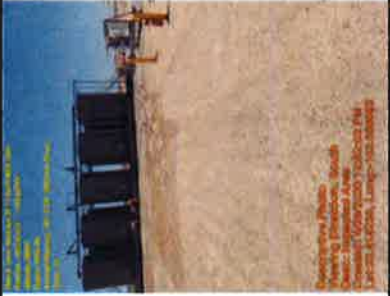
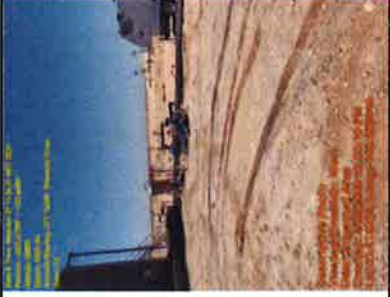
| <div>Viewing Direction: South</div> <div><div>Descriptive Photo<br/>Viewing Direction: South<br/>Camera: Nikon D5300 18-55mm f/3.5-5.6 VR<br/>Date: 5/5/2020 2:19 PM<br/>Location: Kilauea, Long Beach, CA</div></div> <div>Impacted Area</div> | <div>Viewing Direction: West</div> <div><div>Descriptive Photo<br/>Viewing Direction: West<br/>Camera: Nikon D5300 18-55mm f/3.5-5.6 VR<br/>Date: 5/5/2020 2:19 PM<br/>Location: Kilauea, Long Beach, CA</div></div> <div>Impacted Area</div> |

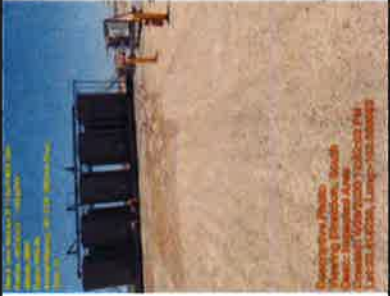
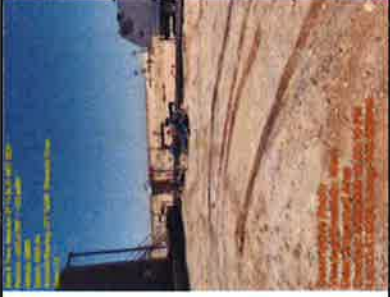
| <div>Viewing Direction: East</div> <div><div>Descriptive Photo<br/>Viewing Direction: East<br/>Camera: Nikon D5300 18-55mm f/3.5-5.6 VR<br/>Date: 5/5/2020 2:19 PM<br/>Location: Kilauea, Long Beach, CA</div></div> <div>Impacted Area</div> | <div>Viewing Direction: East</div> <div><div>Descriptive Photo<br/>Viewing Direction: East<br/>Camera: Nikon D5300 18-55mm f/3.5-5.6 VR<br/>Date: 5/5/2020 2:19 PM<br/>Location: Kilauea, Long Beach, CA</div></div> <div>Impacted Area</div> |

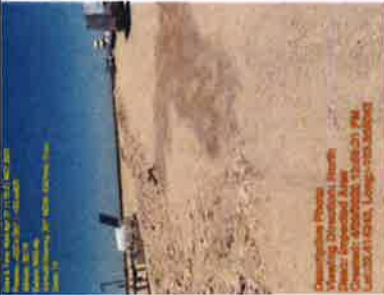
| Viewing Direction: North |
|---|
| <p>Photograph taken on 5/5/2020 at 1:14 PM. The image shows a desert landscape with a body of water in the distance. The water is a deep blue, and the sky is clear. The foreground is a sandy, light-colored desert floor. There are some small, dark objects on the ground, possibly rocks or debris. The overall scene is arid and open.</p> |
| Impacted Area |

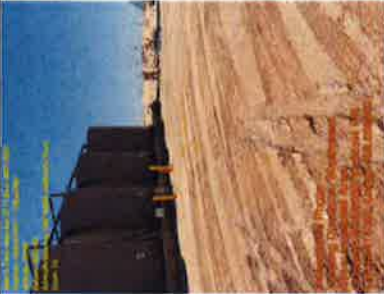
| Viewing Direction: Southwest |
|---|
| <p>Photograph taken on 5/5/2020 at 1:14 PM. The image shows a desert landscape with a body of water in the distance. The water is a deep blue, and the sky is clear. The foreground is a sandy, light-colored desert floor. There are some small, dark objects on the ground, possibly rocks or debris. The overall scene is arid and open.</p> |
| Impacted Area |

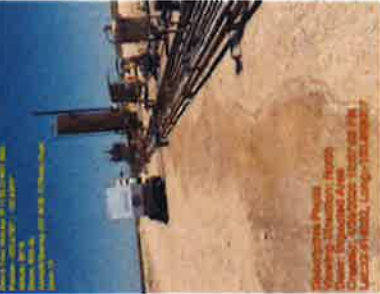
| Viewing Direction: North |
|---|
| <p>Photograph taken on 5/5/2020 at 1:14 PM. The image shows a desert landscape with a body of water in the distance. The water is a deep blue, and the sky is clear. The foreground is a sandy, light-colored desert floor. There are some small, dark objects on the ground, possibly rocks or debris. The overall scene is arid and open.</p> |
| Impacted Area |

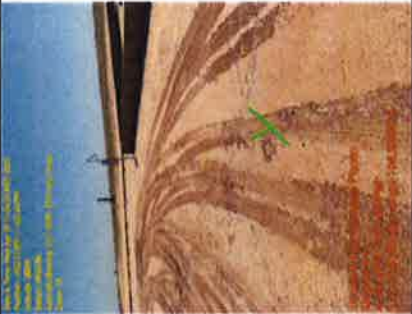
| Sample Point ID: SS20-06 |

| Depth: 0 ft. |

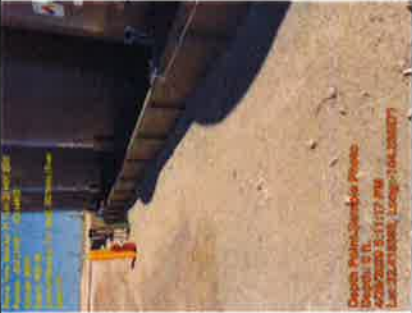
| Sample Point ID: SS20-05 |

| Depth: 0 ft. |

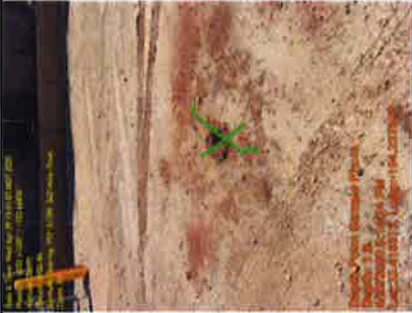
| Sample Point ID: BH20-01 |

| Depth: 1 ft. |

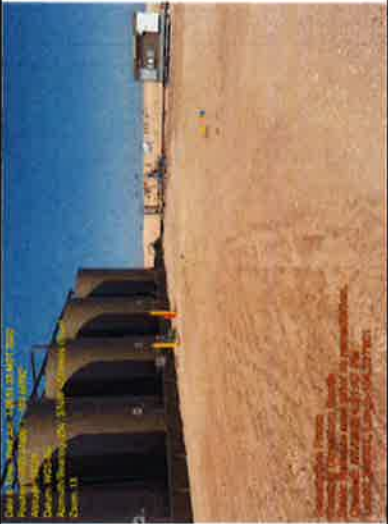
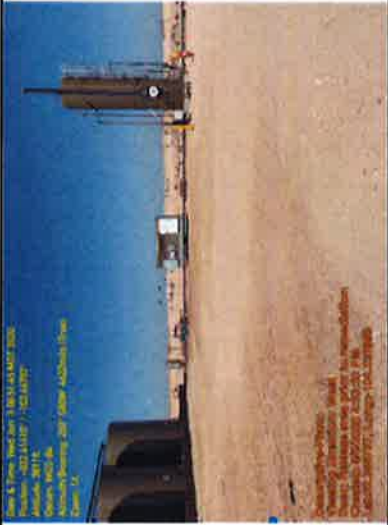
| <div>Viewing Direction: South</div> <div><p>Viewing Direction: South<br/>Release area prior to remediation.<br/>Area prior to remediation</p></div> | <div>Viewing Direction: West</div> <div><p>Viewing Direction: West<br/>Release area prior to remediation<br/>Area prior to remediation</p></div> |

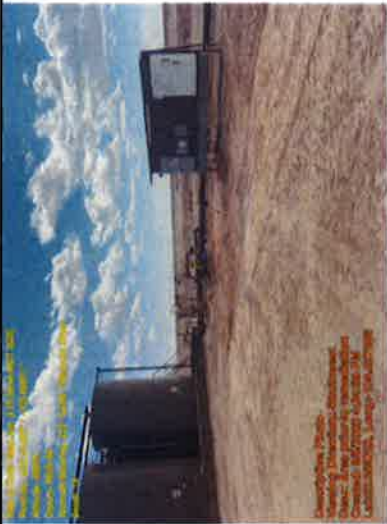
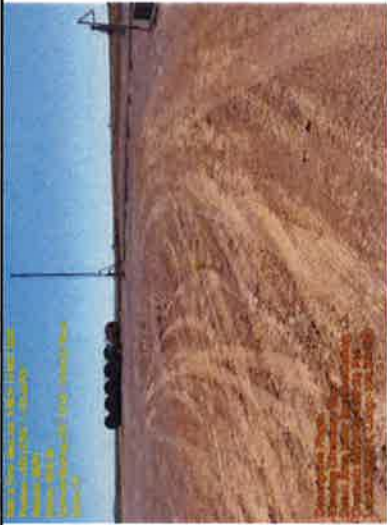
| <div>Viewing Direction: Southwest</div> <div><p>Viewing Direction: Southwest<br/>Release area prior to remediation<br/>Area prior to remediation</p></div> | <div>Viewing Direction: East</div> <div><p>Viewing Direction: East<br/>Release area prior to remediation<br/>Area prior to remediation</p></div> |

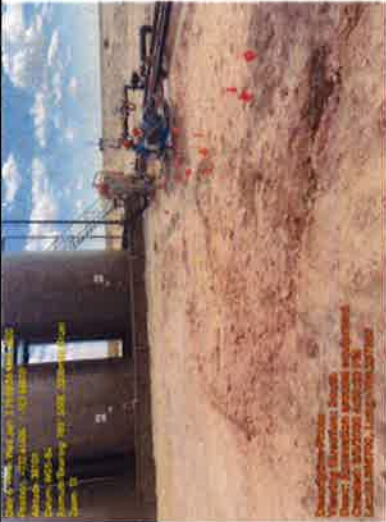
| <p>Excavation around equipment</p> |

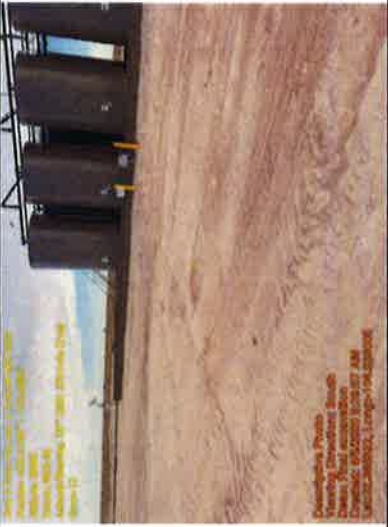
| <div>Viewing Direction: South</div> <div><div>Descriptive Photo<br/>Viewing Direction: South<br/>Camera: Panasonic Lumix<br/>Date: 6/5/2020 10:30 AM<br/>Latitude: 36.85000, Longitude: -114.07911</div></div> <div>Final excavation</div> | <div>Viewing Direction: South</div> <div><div>Descriptive Photo<br/>Viewing Direction: South<br/>Camera: Panasonic Lumix<br/>Date: 6/5/2020 10:30 AM<br/>Latitude: 36.85000, Longitude: -114.07911</div></div> <div>Final excavation</div> |

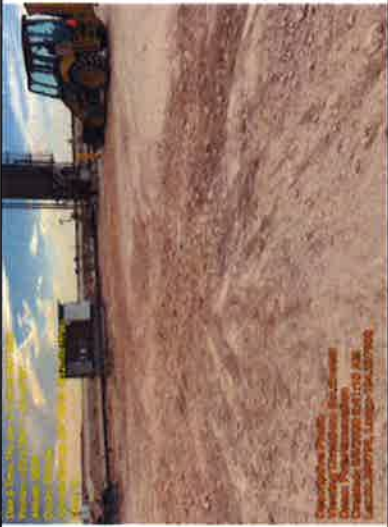
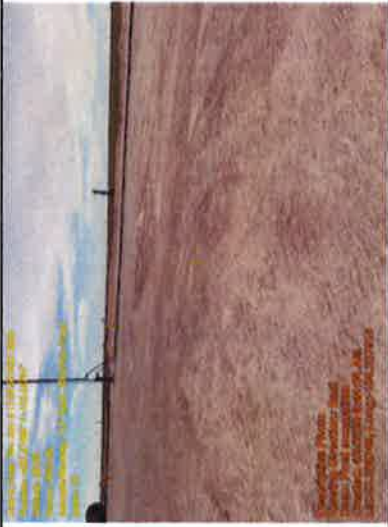
| <div>Viewing Direction: Southwest</div> <div><div>Descriptive Photo<br/>Viewing Direction: Southwest<br/>Camera: Panasonic Lumix<br/>Date: 6/5/2020 10:30 AM<br/>Latitude: 36.85000, Longitude: -114.07911</div></div> <div>Final excavation</div> | <div>Viewing Direction: East</div> <div><div>Descriptive Photo<br/>Viewing Direction: East<br/>Camera: Panasonic Lumix<br/>Date: 6/5/2020 10:30 AM<br/>Latitude: 36.85000, Longitude: -114.07911</div></div> <div>Final excavation</div> |

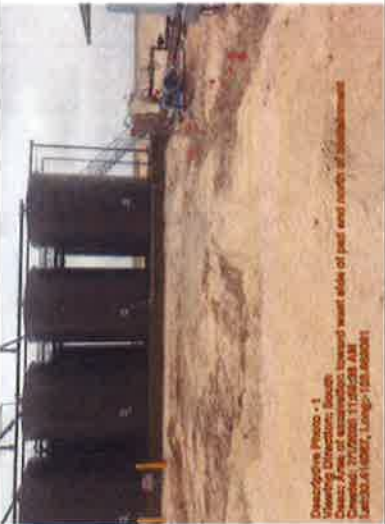
| Viewing Direction: South |
|---|
| <p>Excavation Photo - 1<br/>Viewing Direction: South<br/>Crack Area of excavation toward west side of pad and north of containment<br/>Created: 7/27/2020 11:06:28 AM<br/>Location: (605), Longo (125-10000)</p> |
| Area of excavation toward west side of pad and north of containment |

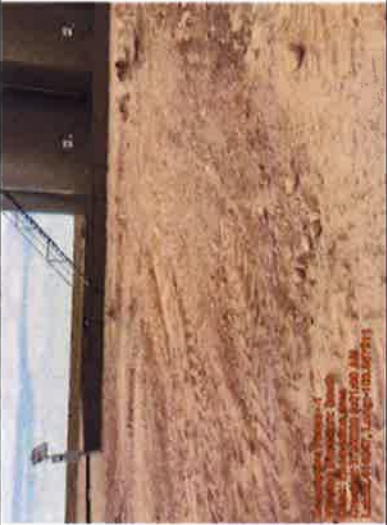
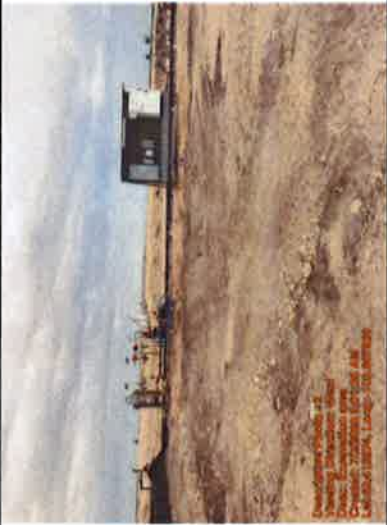
| <div>Viewing Direction: South</div> <div><div>Excavation area</div></div> | <div>Viewing Direction: West</div> <div><div>Excavation area</div></div> |

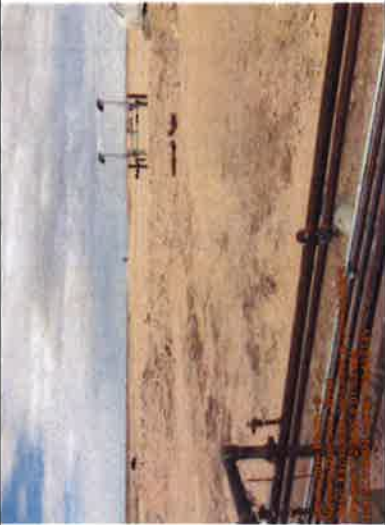
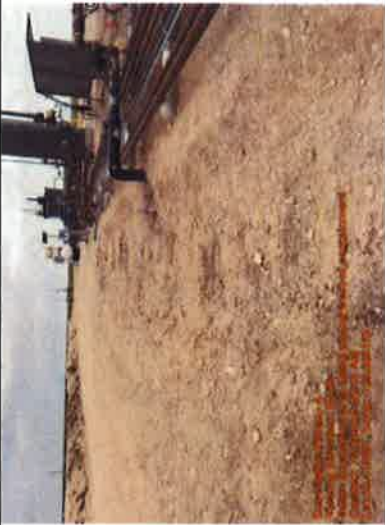
| <div>Viewing Direction: West</div> <div><div>Excavation area west of containment</div></div> | <div>Viewing Direction: North</div> <div><div>Excavation area along piping west of containment</div></div> |

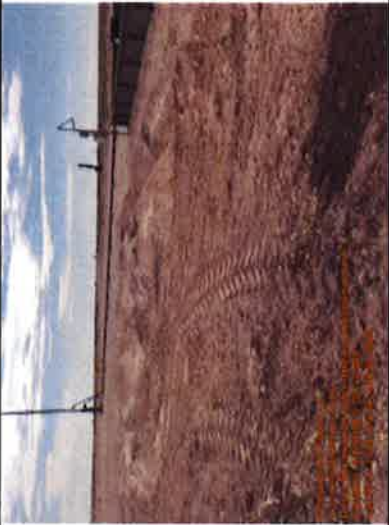
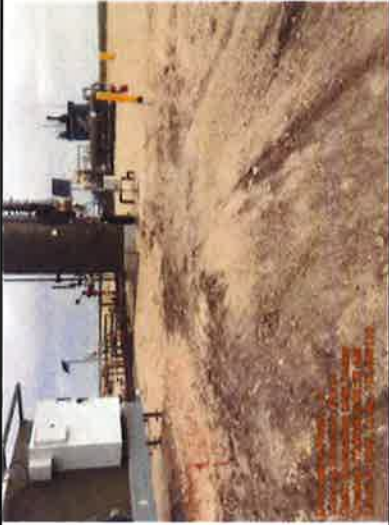
| <p>Excavation towards east of containment</p> | <p>Excavation near heater</p> |

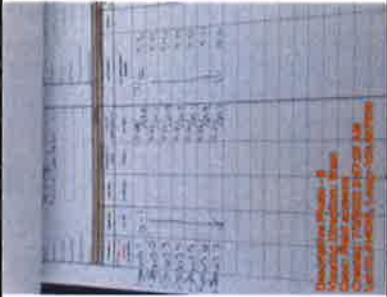
| <p>Field screens</p> | <p>Field screens</p> |
