Re: RDX Federal Com 17 #044H Release Closure Request (NRM2019550825)

This report summarizes the secondary containment inspection activities at the RDX Federal Com 17 #044H well pad (Site). The topographic map of the Site is provided as Figure 01. On June 29, 2020, a produced water line inside secondary lined containment developed a pinhole leak releasing 20 barrels (bbls) of produced water into the containment. No fluids were observed outside the containment and all fluids were recovered using a water truck.

Well Location: RDX Federal Com 17 #044H

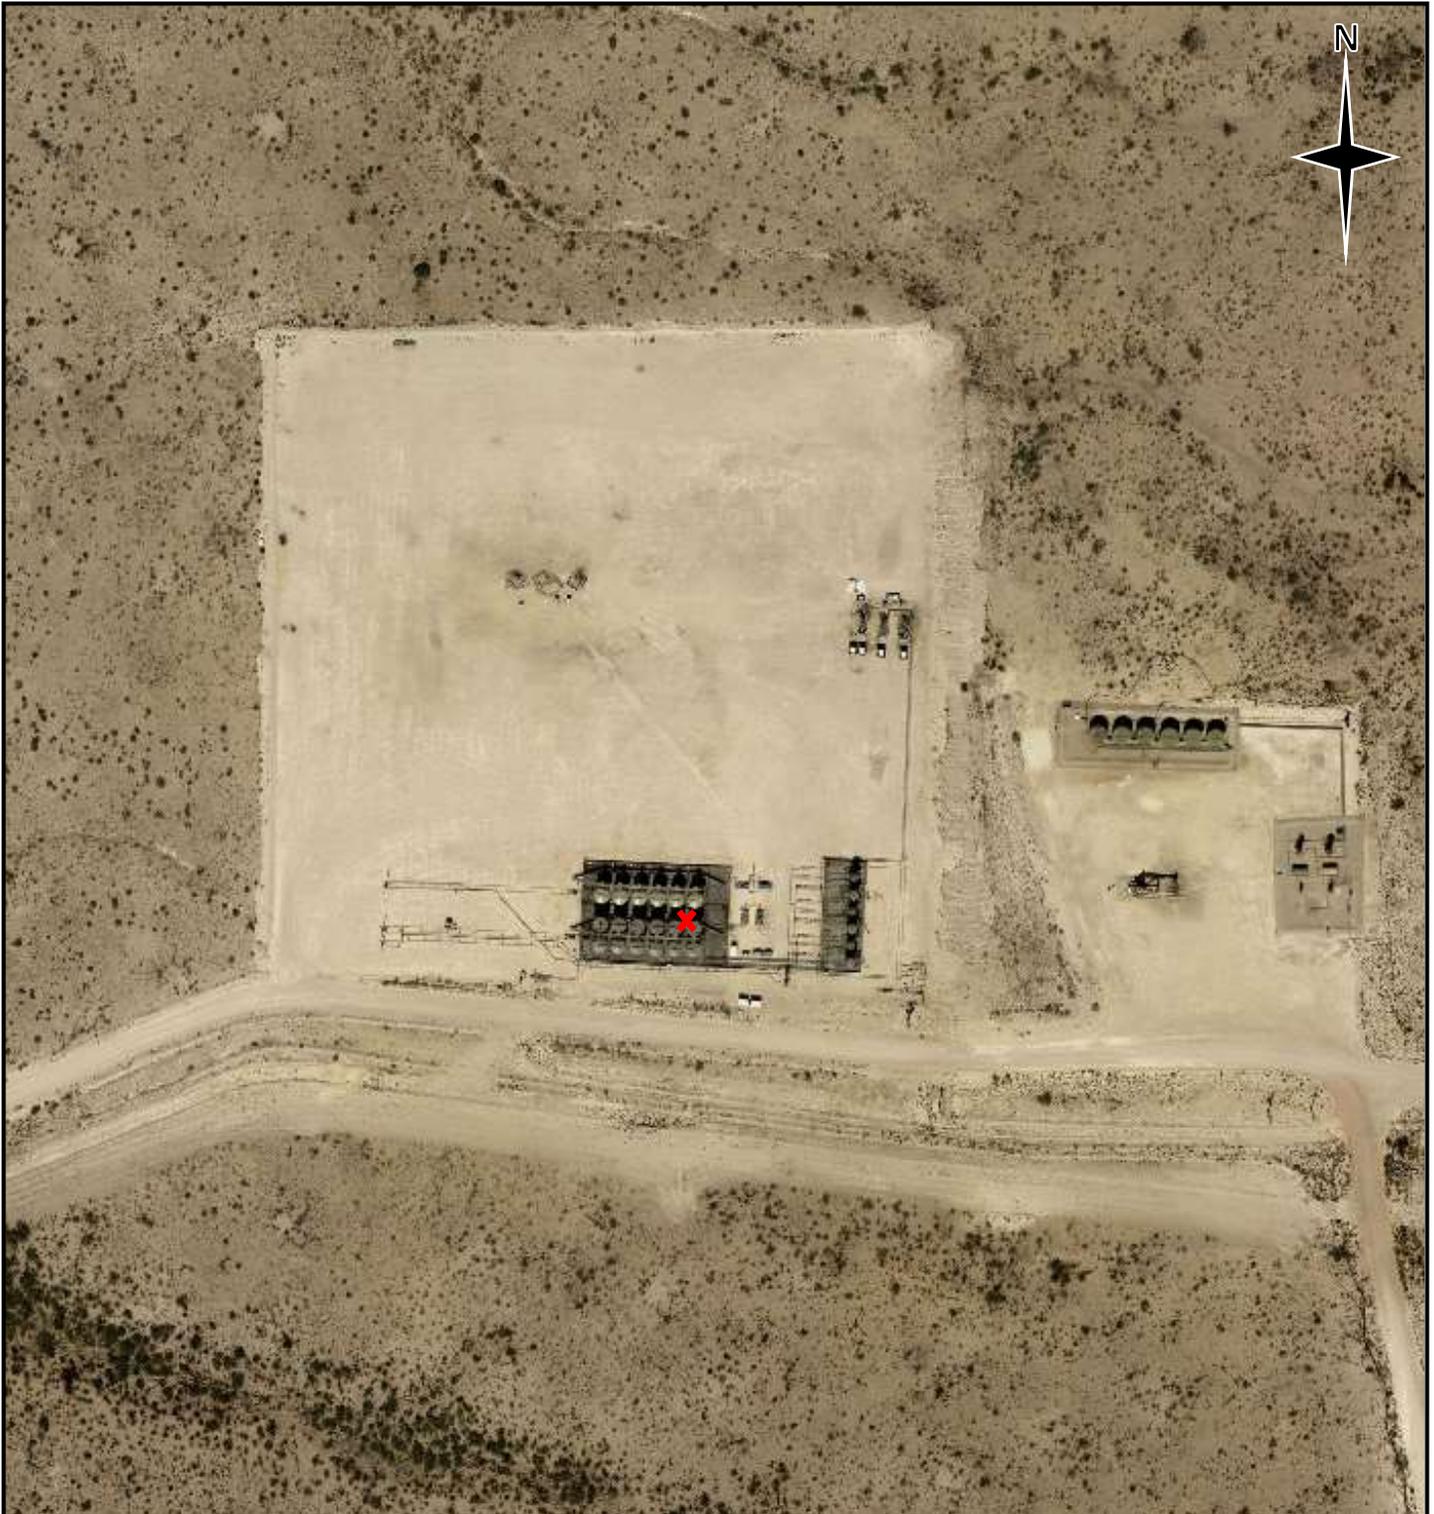
Figure 02

The secondary liner containment was washed on July 14, 2020. The area of interest is located on Figure 02. Notification of liner inspection was scheduled with the NMOCD on July 17, 2020 for July 21, 2020. The liner inspection was completed July 15, 2020. Photographs of the secondary containment inspection are provided in Attachment 01.

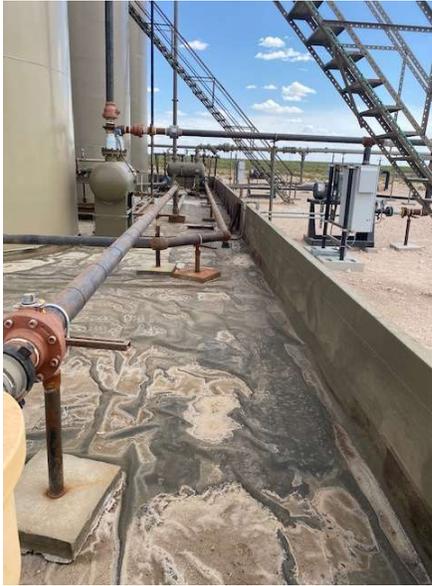
Picture 1- South face, west side of TB

The liner inspection to address the release impacts from NRM2019550825 demonstrates compliance with the Table 1 Closure Criteria set forth by the NMOCD. The secondary containment was determined to be intact and functioning properly to contain releases. Actions to mitigate initial impacts of this site have proven a successful remediation. WPX requests no further action for this incident. The updated C-141 is attached to the beginning of this report.
