Remediation and Closure Report

Kite 5 I Federal #005
Eddy County, New Mexico
API# 30-015-43873, NRM 2019636591

Subject: **Remediation and Closure Report**
Kite 5 I Federal #005
NRM 2019636591
API# 30-015-43873
Eddy County, NM

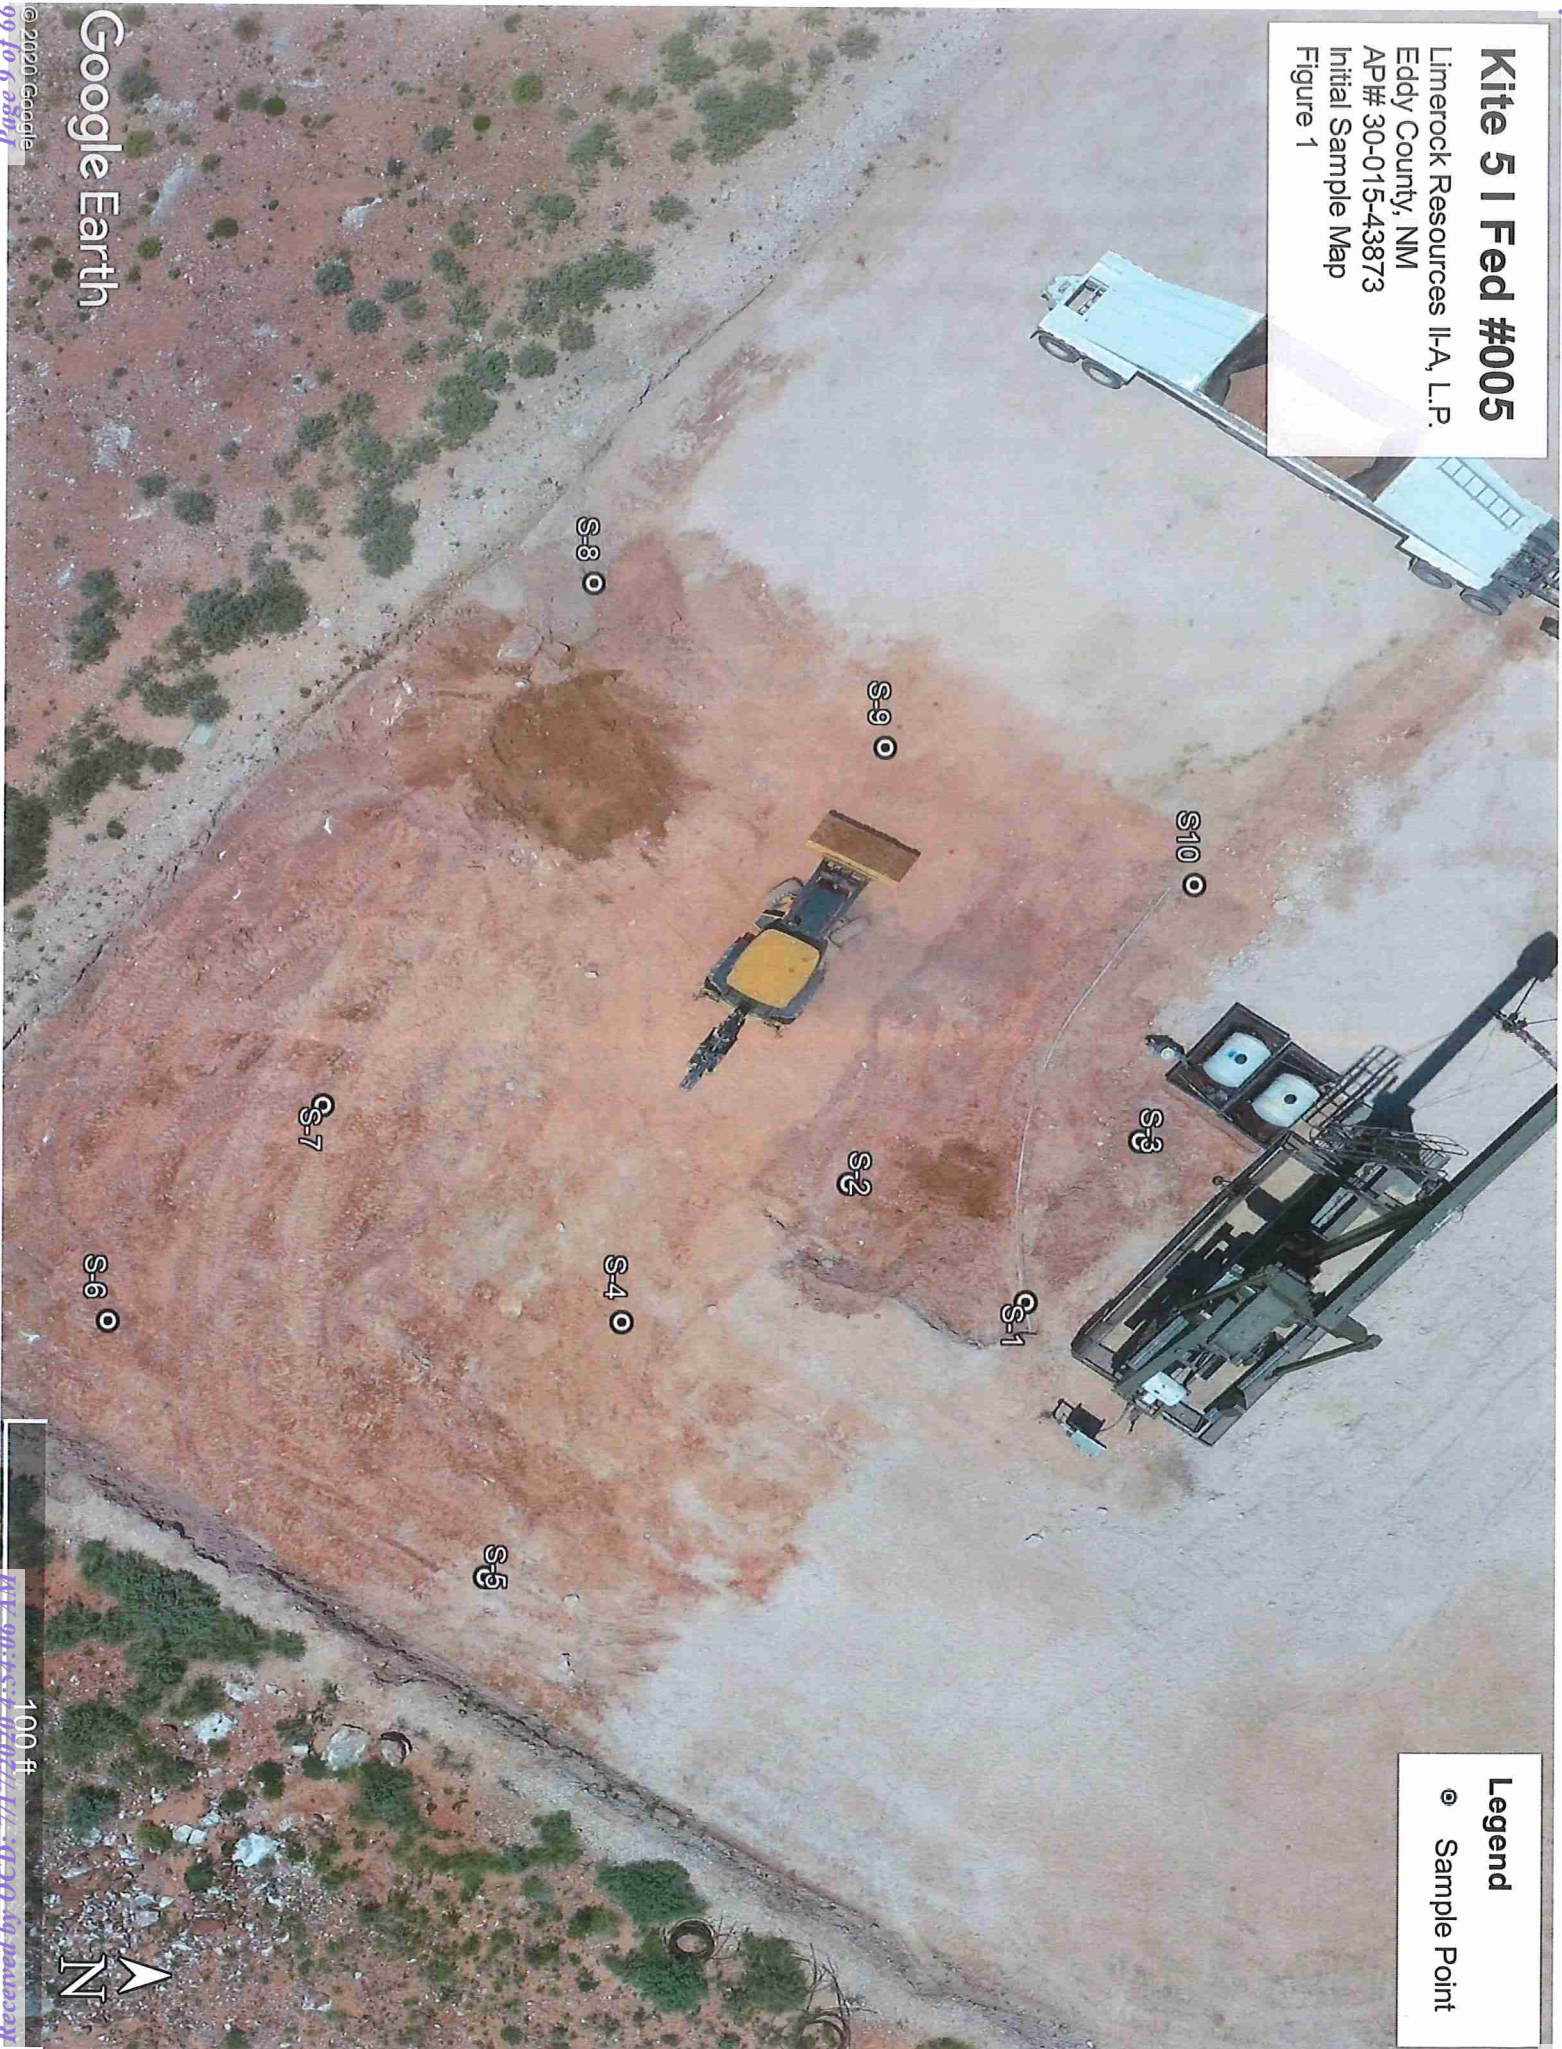
Limerock Resources II-A, L.P.
Eddy County, NM
AP# 30-015-43873
Initial Sample Map
Figure 1

On June 26, 2020, Talon mobilized personnel to begin site assessment and sampling activities of the impacted area. Grab soil samples were obtained utilizing a hand auger. Analytical results from our initial sampling event are presented on the following data table. Initial site assessment sampling locations are illustrated on the site map (Figure 1, [Appendix I](#)), and photographs of impacted area are attached in [Appendix IV](#). Complete laboratory reports can be found in [Appendix V](#).

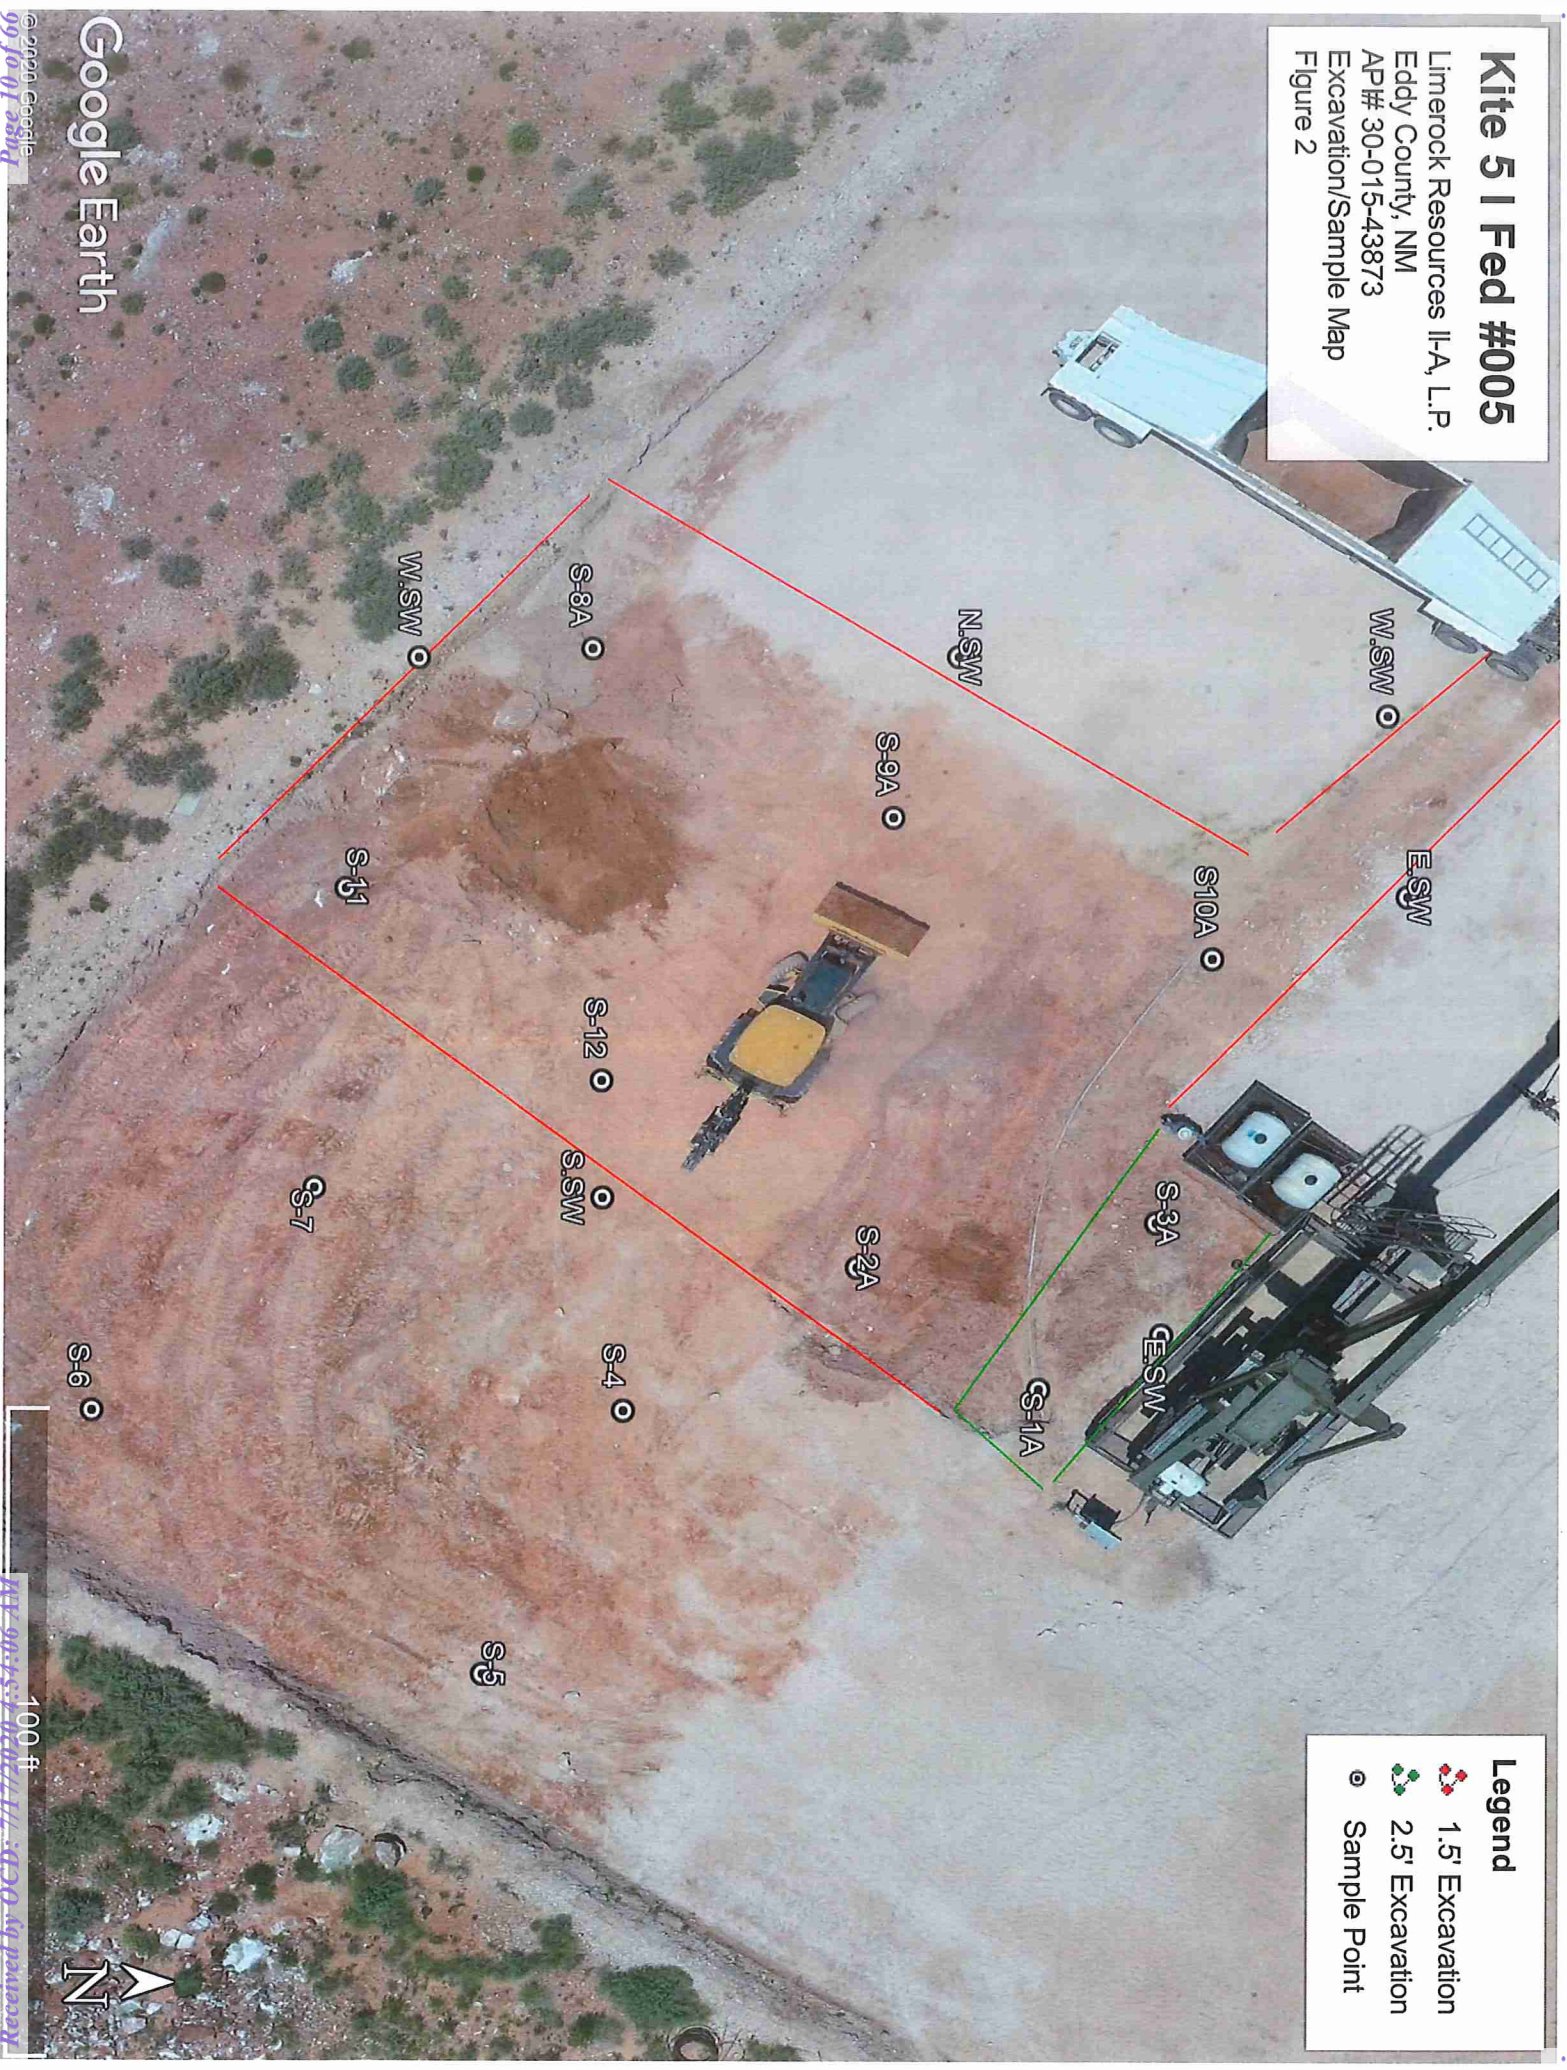
Limerock Resources II-A, L.P.
Eddy County, NM
AP# 30-015-43873
Excavation/Sample Map
Figure 2

- Immediately following the release, the impacted area southeast of the pump jack was scraped to remove the saturated material.
- Based on our soil sampling results, the impacted areas in the vicinity of sample points S-1 and S-3 were excavated to a total depth of 2.5-feet BGS.

- The impacted areas near sample points S-2, S-8, S-9, S-10, S-11, and S-12 were excavated to 1.5-feet BGS. Excavation areas and depths are shown on Figure 2 in [Appendix I](#).

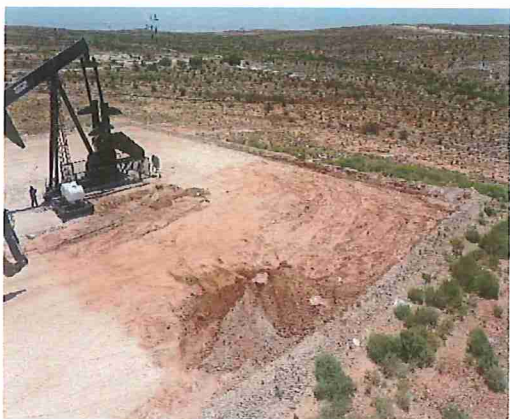
Aerial of Initial Scrape

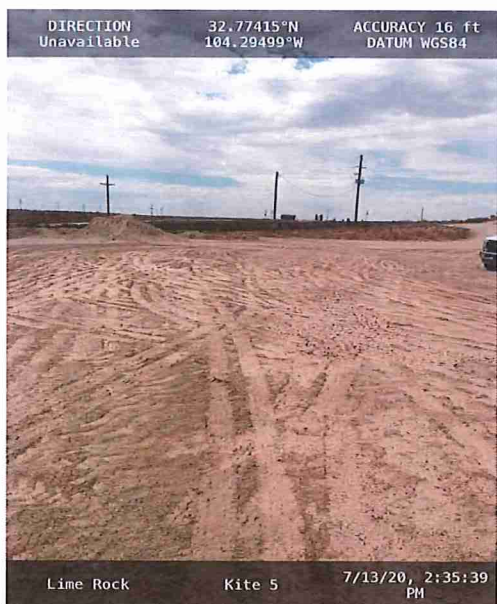
Back to grade

- All the excavated material (649.6 tons) was transported to Lea Land, LLC, a NMOCD approved solid waste disposal facility.
- The excavated areas on the well pad were backfilled with new caliche, machine compacted and contoured to match the surrounding location.

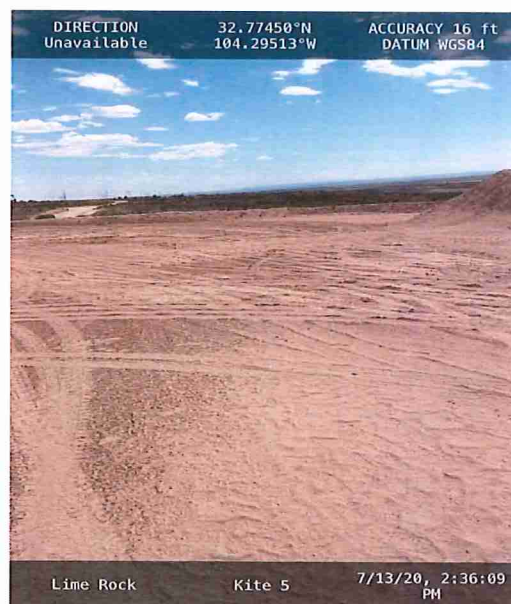
Back to grade
