SUBJECT: Remediation Closure Report for the Ragin Cajun 12 Federal 1H (NRM2017055850), Lea County, New Mexico

Site Map
 Ragin Cajun 12 Federal 1H- Devon Energy
 32.0505981, -103.4205627, Lea County, New Mexico

Site and Sample Location Map
 Raging Cajun 12 Federal 1H - Devon Energy
 32.0505981, -103.4205627 Lea County, New Mexico

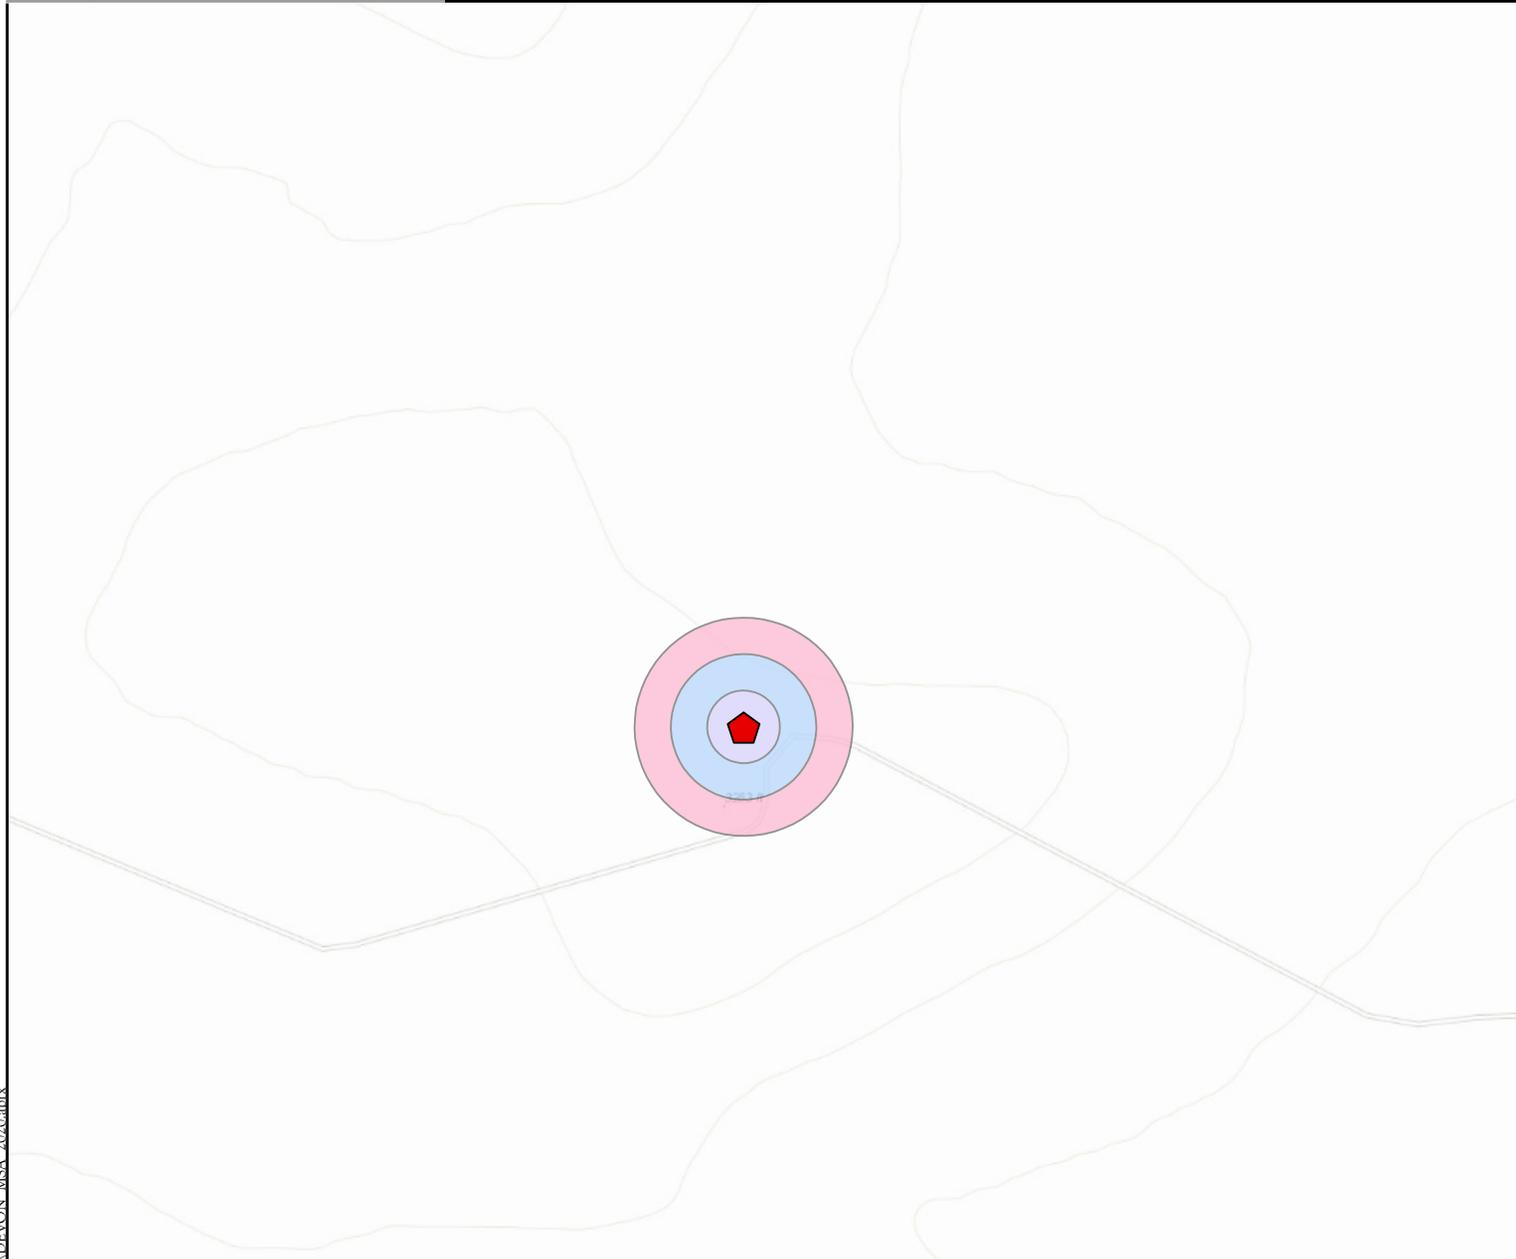
Figure 2

Surface Water Protection Map
 Ragin Cajun 12 Federal 1H- Devon Energy
 32.0505981, -103.4205627 Lea County, New Mexico

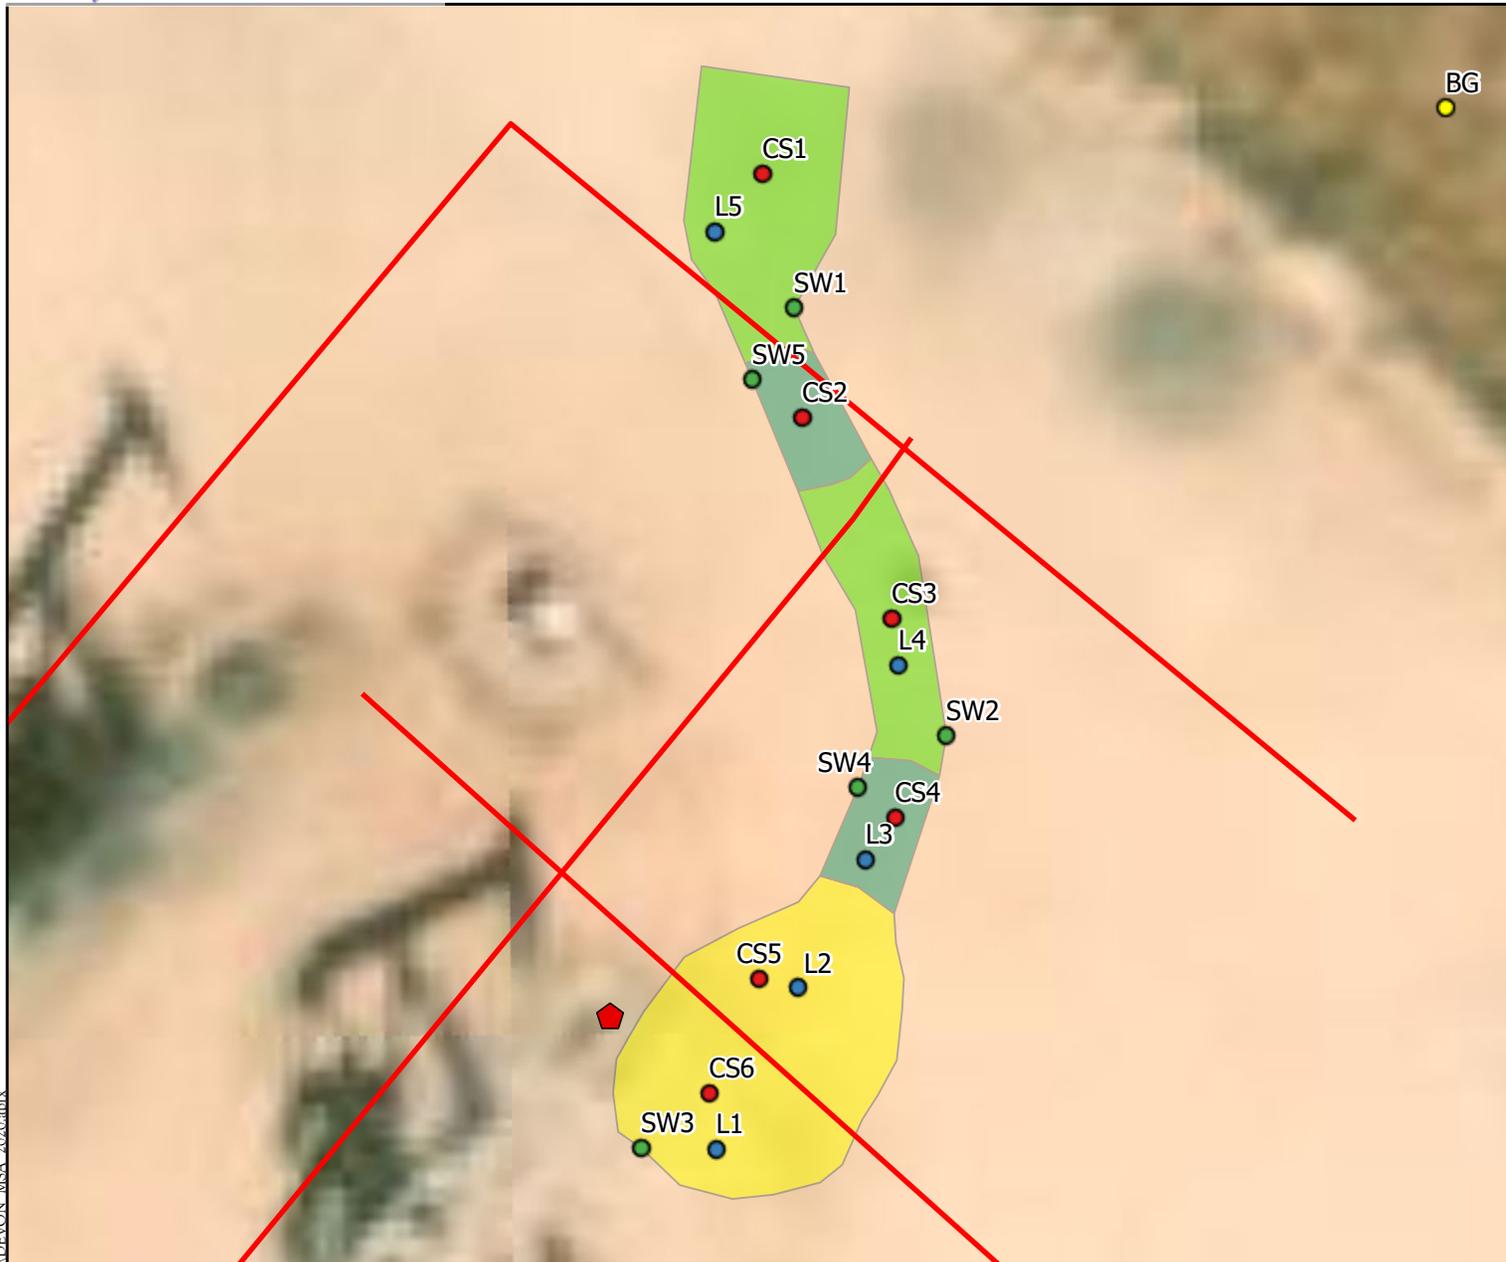
On July 31, and August 14, 2020 SMA conducted confirmation sampling of the walls and base of the excavation, which measured approximately 20 feet by 30 feet along the pooling area and 80 feet by 8 feet along the elongated portion of the contaminated area. The area around sample location L1 and L2 was excavated to a depth of 0.5 feet, the areas around L4 and L5 were excavated to a depth of one (1) foot, and the areas around L3 and in between L4 and L5 were excavated to a depth of 1.5 feet bgs.

Confirmation samples were comprised of five-point composites of the base (CS1-CS6) and walls (SW1-SW5).

Figure 3 shows the extent of the excavation and sample locations. All laboratory results are summarized in Table 3. Laboratory reports are included in Appendix D.

Contaminated soils were removed and replaced with clean backfill material to return the surface to previous contours. The contaminated soil was transported and disposed of at Northern Delaware Basin Landfill near Jal, NM, an NMOCD permitted disposal facility.
