1RP-5350 Characterization Report and Remediation Plan

AO 6 #501H Tank Release

**Prepared for
Advance Energy Partners Hat Mesa LLC
Houston, Texas**

**Prepared by
R.T. Hicks Consultants, Ltd.
Albuquerque, New Mexico**

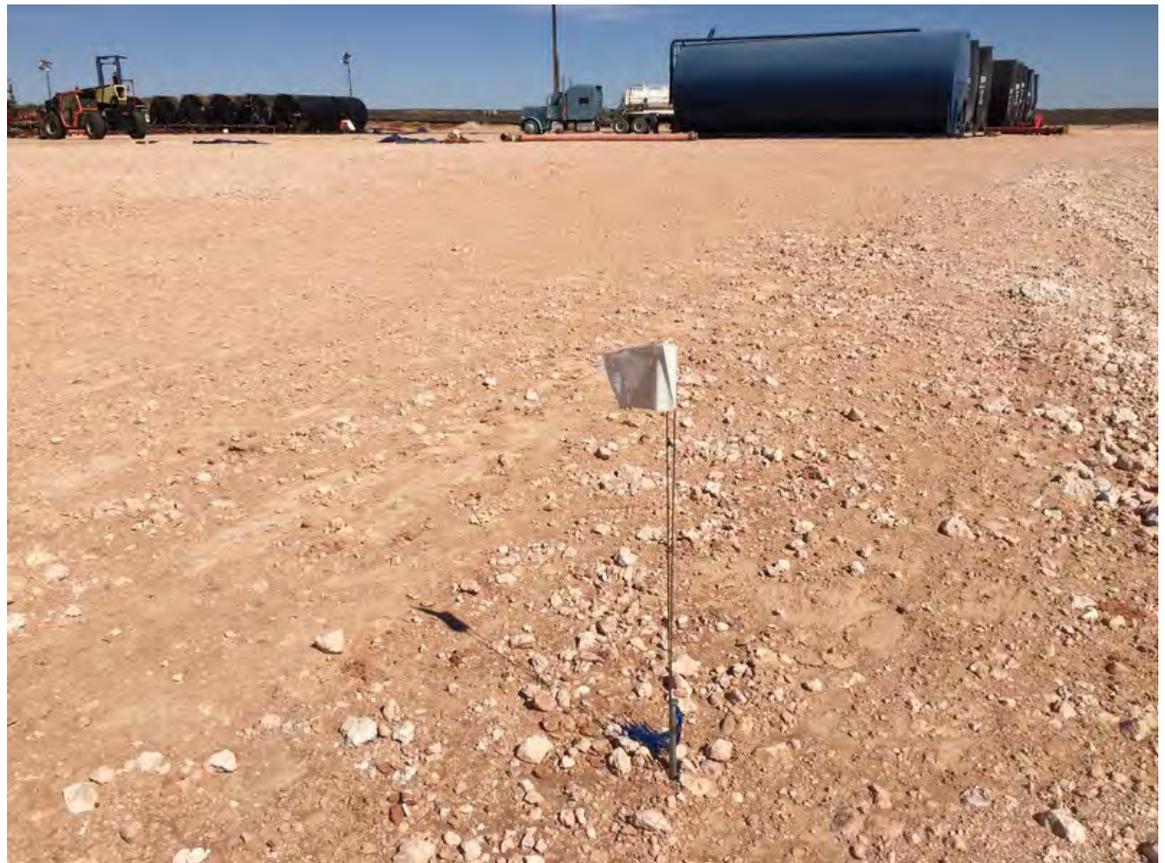
Staked point for Trench-01. Photo viewing east-northeast. Release point is located photo upper-right.

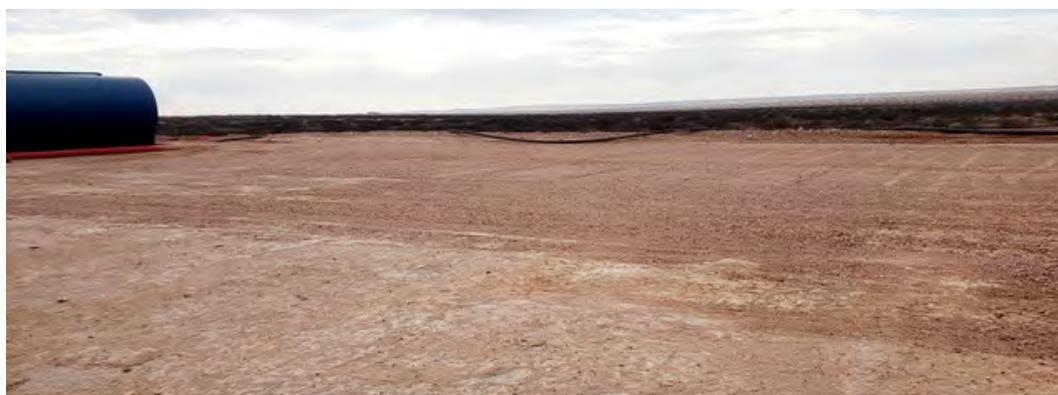
Following the removal of free-standing liquid, the upper 10 to 12 inches of the production pad within the release extent was removed and replaced with clean caliche. The graded area as shown in Figure 1, below, shows the eastern portion of the release extent that was removed and replaced with clean caliche.

Figure 1: Graded area shows the eastern half of the release extent that was removed and replaced with clean caliche. Frac tanks are visible photo left. Photo is viewing south-southeast. GPS: 32.4158530 N, -103.6036710 W. Date/Time: 2019-02-08 09:28:16

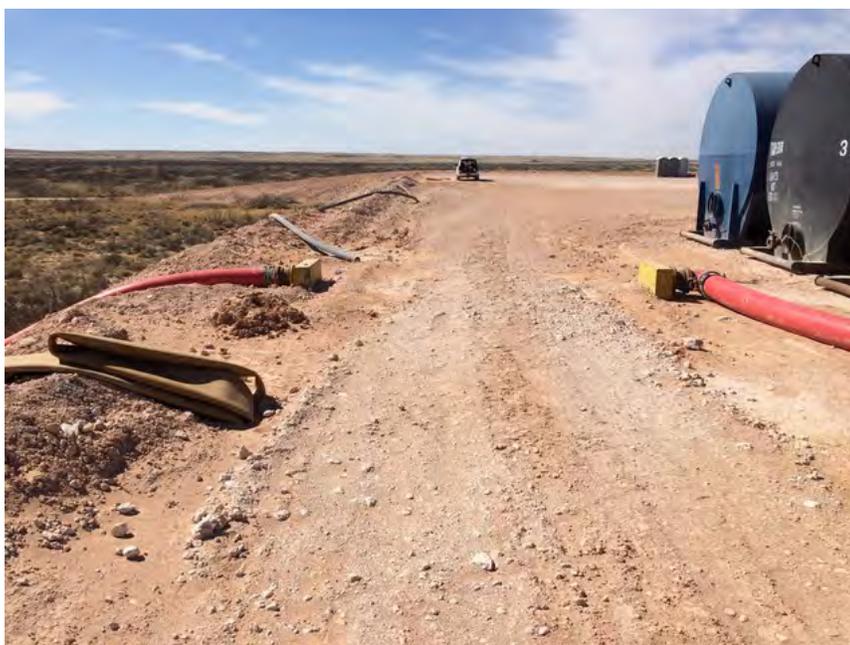
Figure 2: Photo viewing west near the source (frac tank). Vehicle in photo center background is the western extent of the release. The graded surface is where the removal of impacted surface soils and replacement with clean caliche occurred during initial response. GPS: 32.4151778 N, -103.6033083 W. Date/Time: 2019-02-24 13:19:36

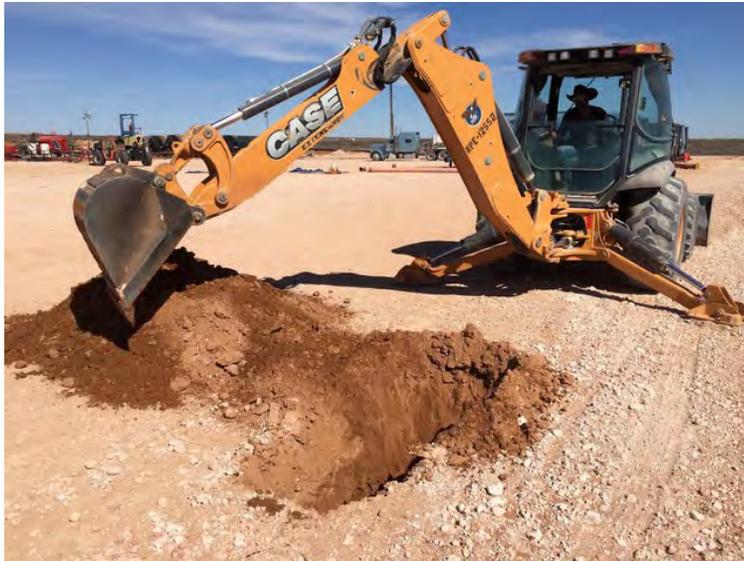
Trench 1 the soil was moist. Trench 2 the soil was dry.

Figure 3: Trench-01 sampling viewing east-northeast.
GPS: 32.4151611 N, -103.6039111 W. Date/Time: 2019-02-24 13:25:09

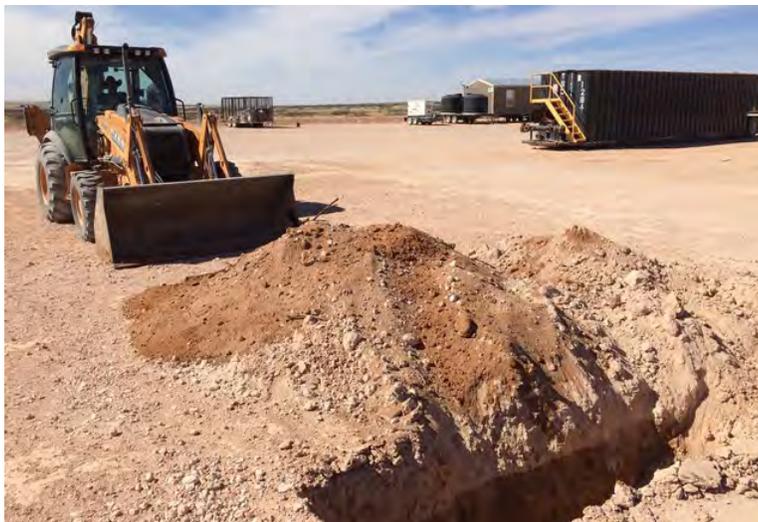
Figure 4: Trench -02 sampling viewing west-northwest.
GPS: 32.4152972 N, -103.6037056 W. Date/Time: 2019-02-24 13:40:33

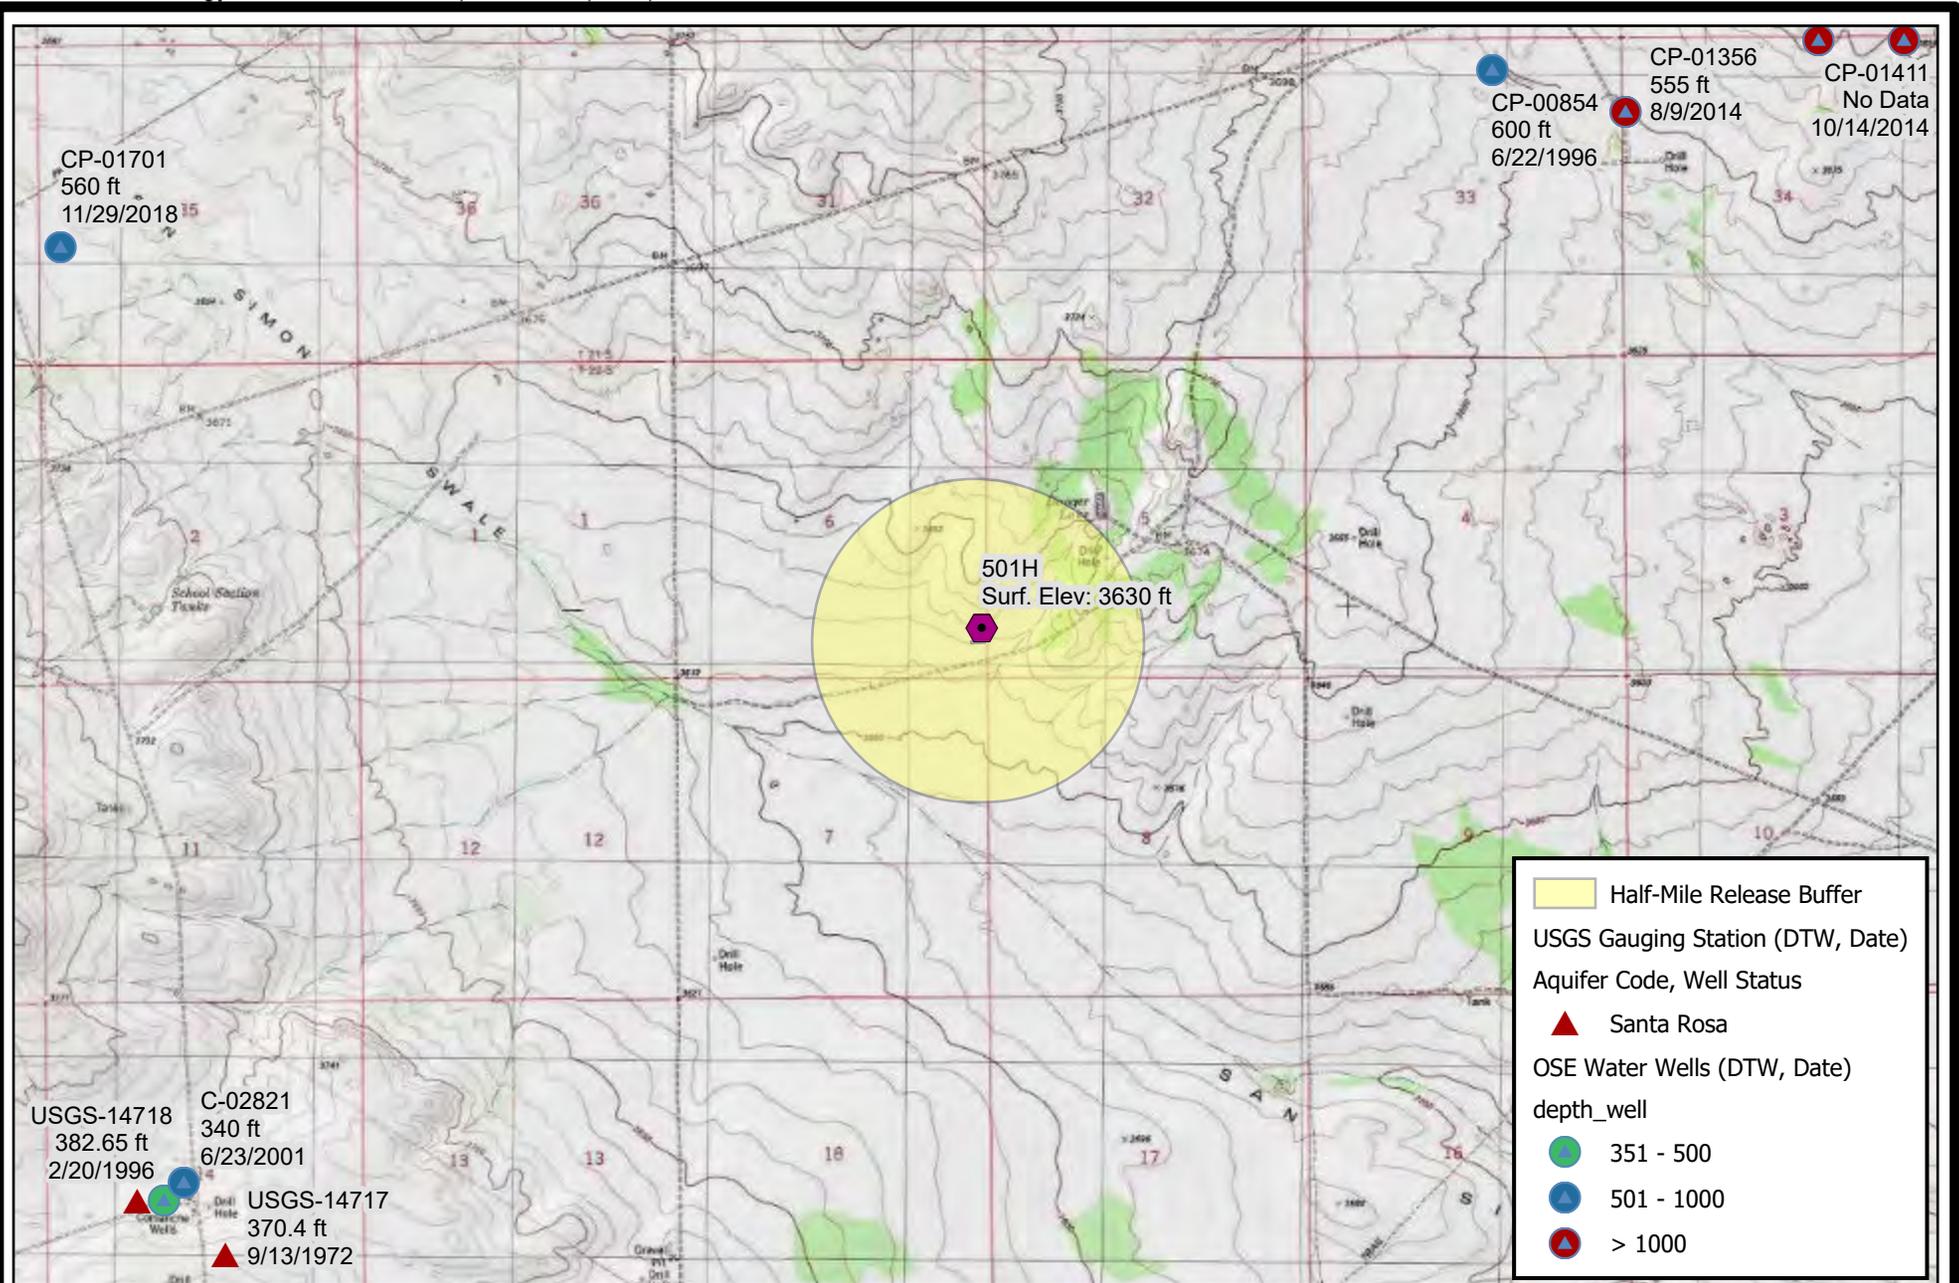
Plate 02
March 2019

Most recent depth to water data was queried from the USGS and New Mexico Office of the State Engineer (OSE) online databases (Plate 2). Spatial analysis shows:

- The nearest water well is located 2.38-miles northeast of the release (OSE CP-00854) with a depth to water of 600-feet.
- The next two nearest water wells are located
 - 2.59-miles northeast (OSE CP-01356) with a depth to water of 555-feet.
 - 3.05-miles southwest (OSE CP-02821) with a depth to water of 340-feet.

Depth to Water
Advance Energy Partners Hat Mesa, LLC
AO 6 #501H Frac Tank Release

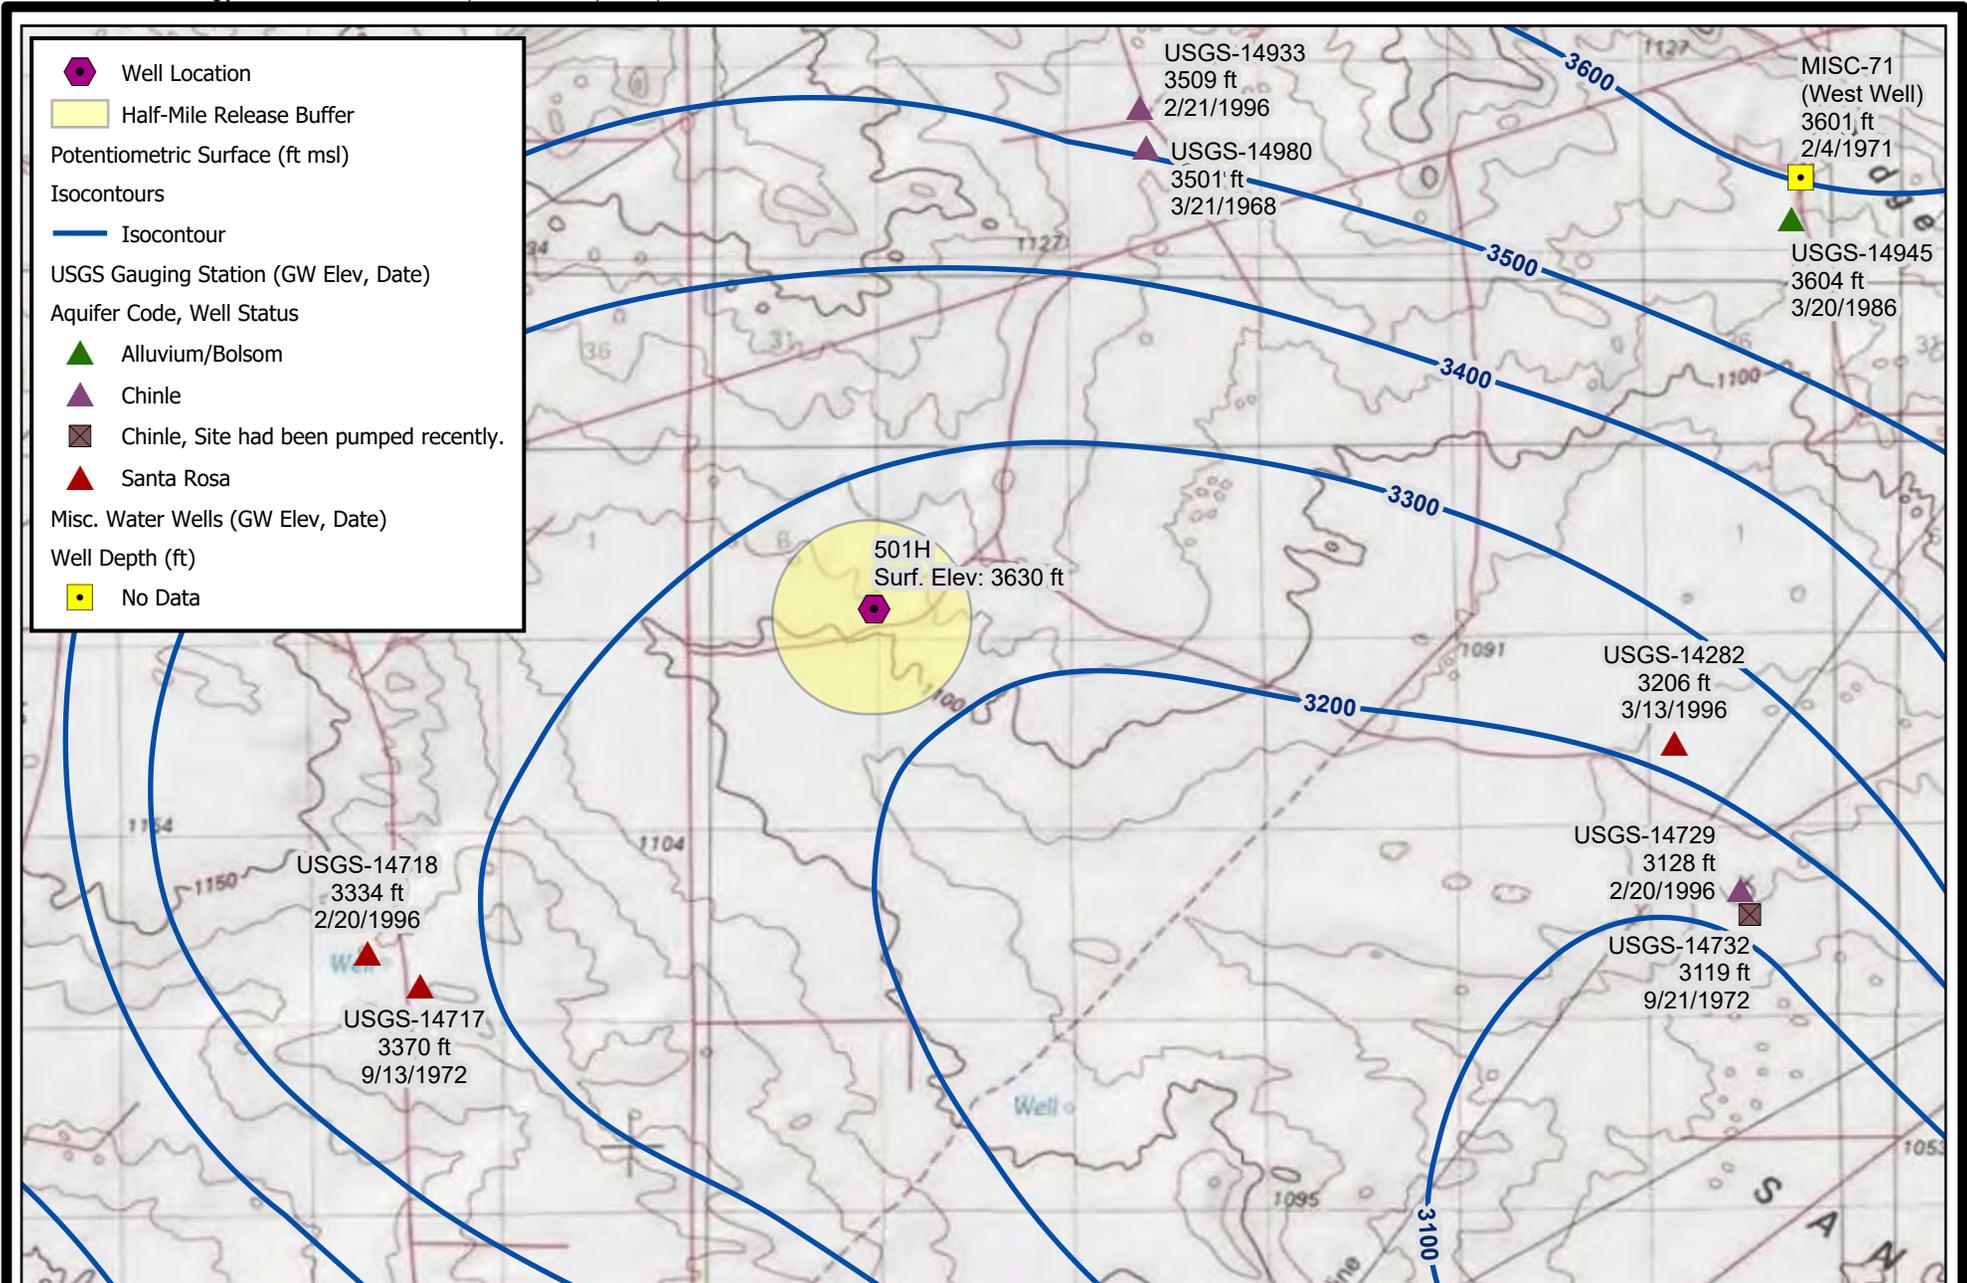
Plate 03
 March 2019

Ground water flow is to the southeast as demonstrated on the potentiometric map (Plate 3). We relied on the USGS water wells to generate the potentiometric surface. Regionally, USGS water wells show that ground water is within the Santa Rosa and Chinle Formation.

The potentiometric surface indicates that the depth to water, which is under artesian flow, is approximately 380 feet below ground surface, where
 $380 \text{ feet} = 3630 \text{ ft surface elevation} - 3250 \text{ ft potentiometric surface}$.

Potentiometric Surface with Groundwater Elevation
 Advance Energy Partners Hat Mesa, LLC
 AO 6 #501H Frac Tank Release

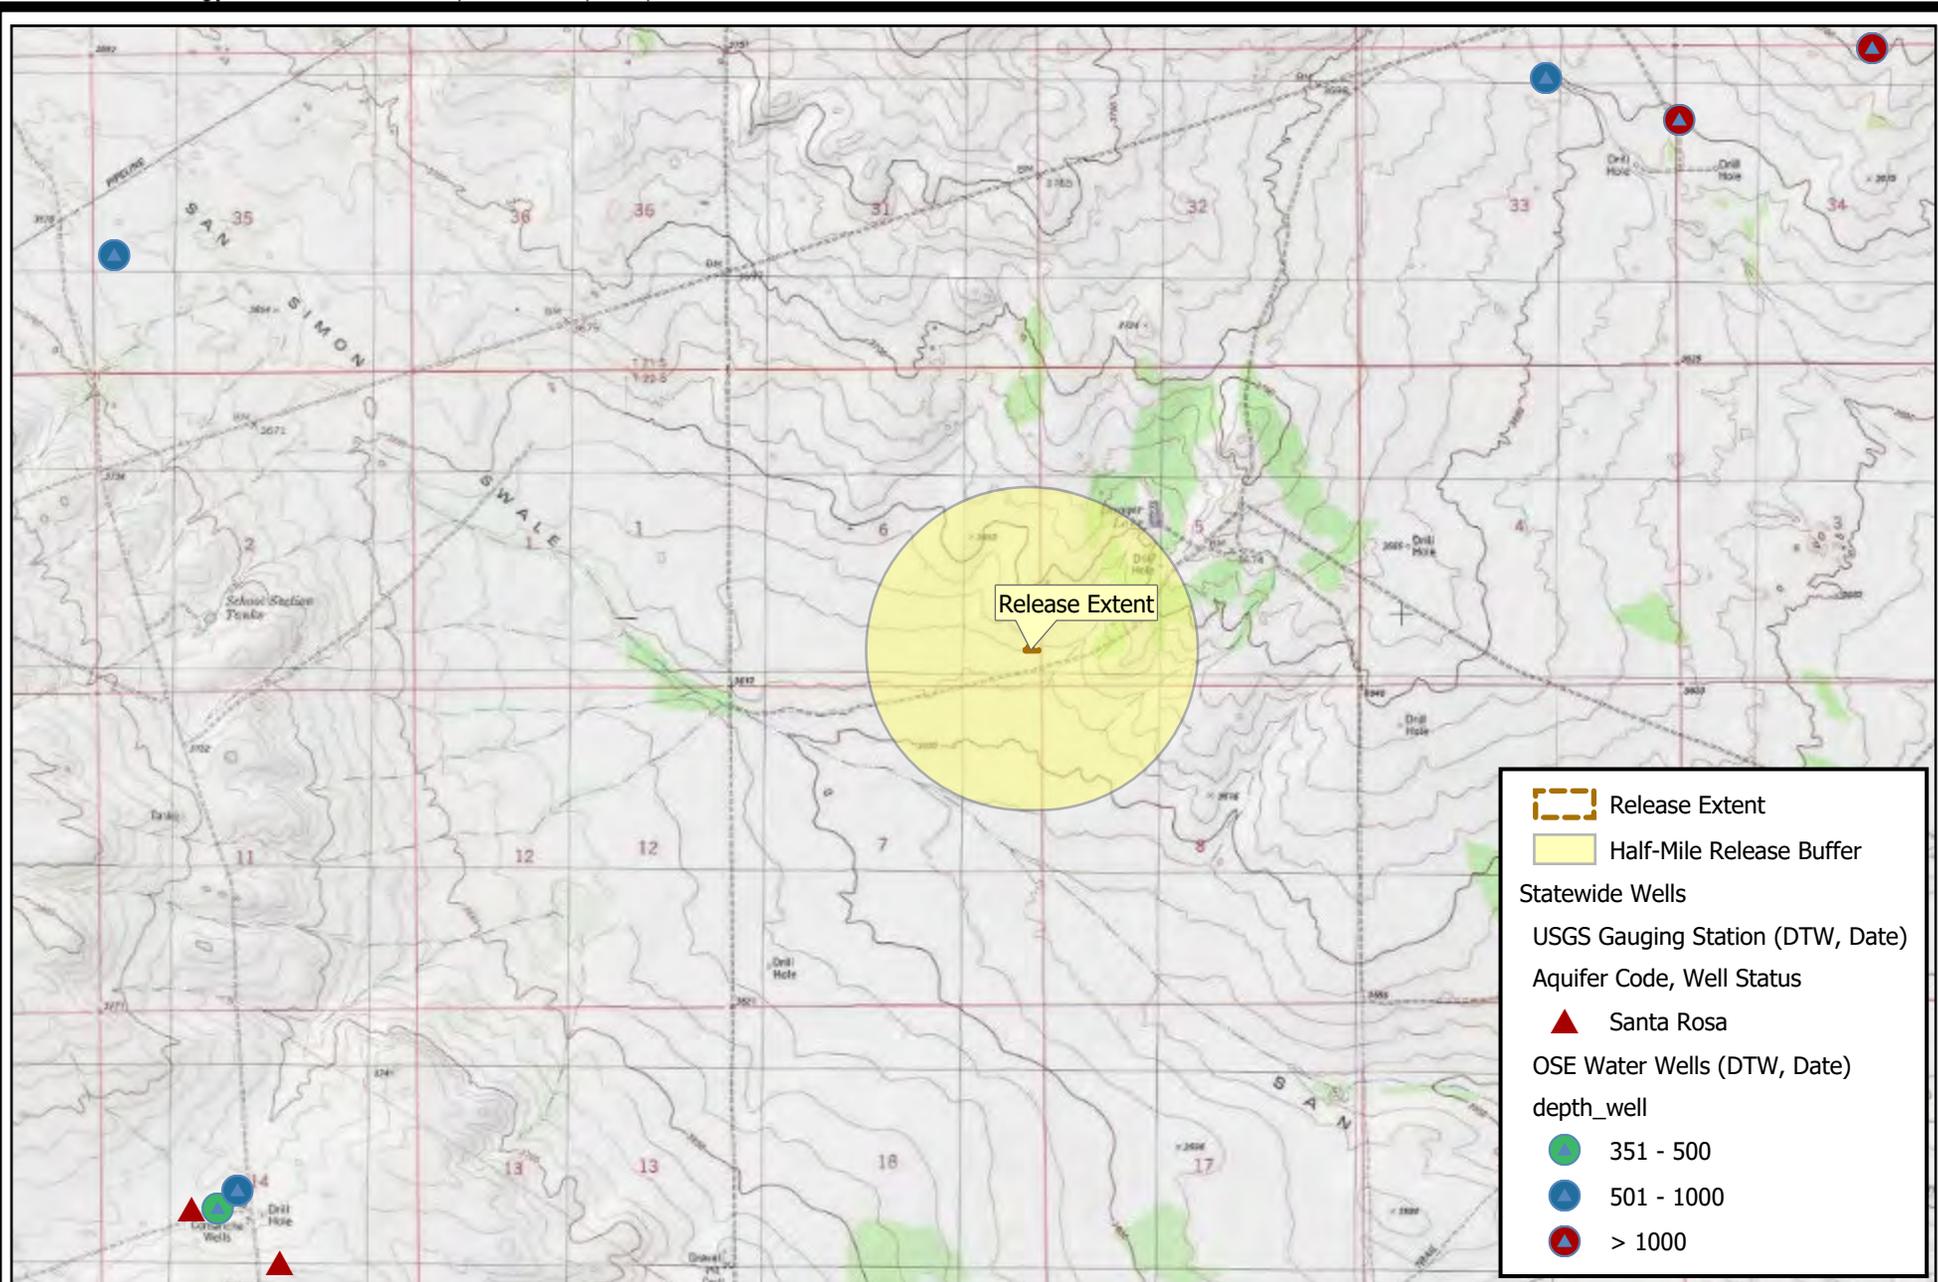
Plate 04
March 2019

Plate 4 shows that the release extent is not:

- Within incorporated municipal boundaries or within a defined municipal fresh water well field.
- Within ½-mile private and domestic water sources (wells and springs).
- Within 500 horizontal feet of a spring or a private domestic fresh water well used by less than five households for domestic or stock watering purposes
- Within 1000 feet of any other fresh water well or spring

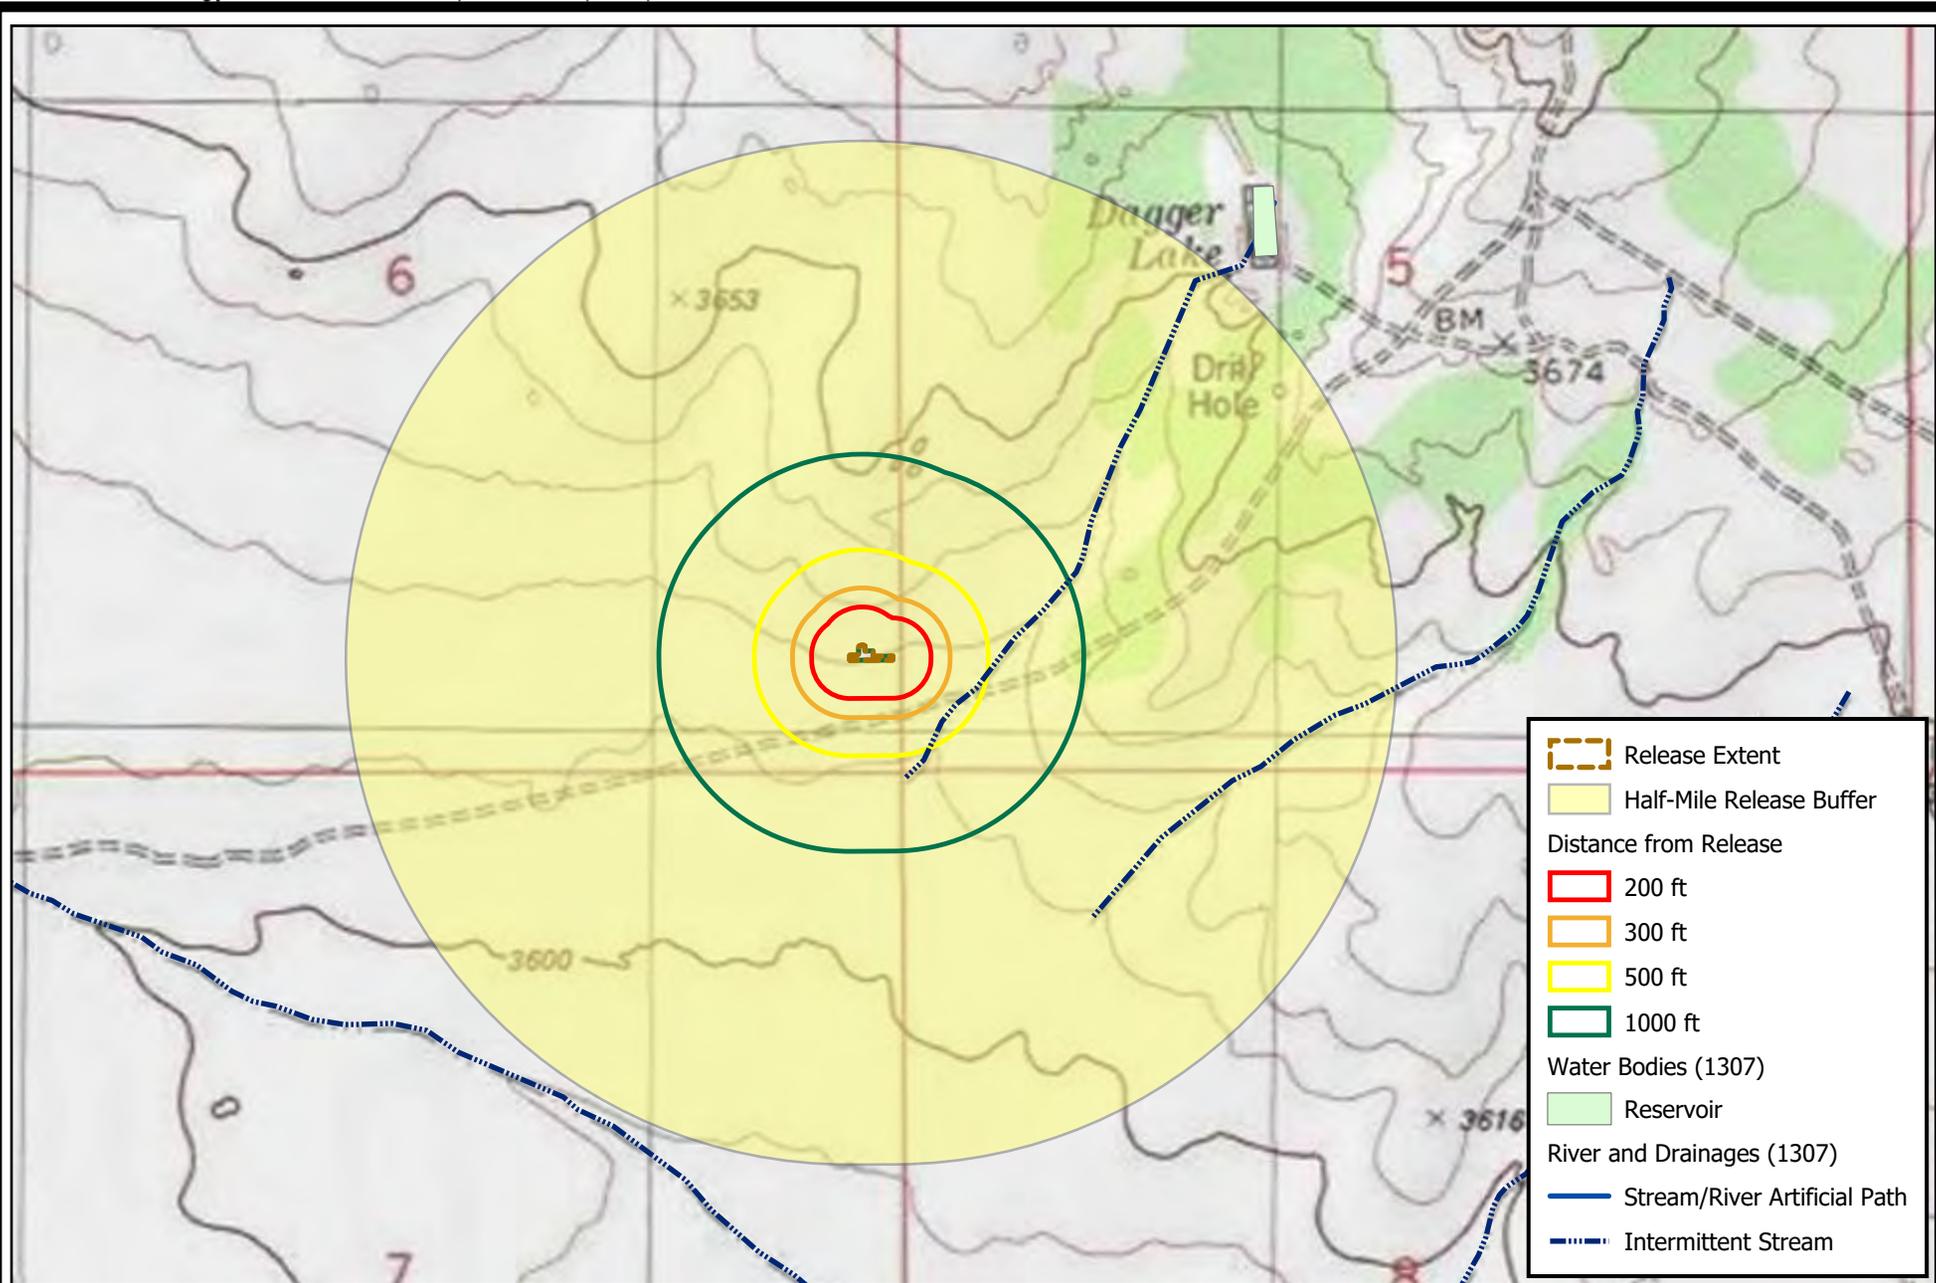
Plate 05
March 2019

Plate 5 shows that the release extent is not:

- Within ½ mile of any significant water course.
- Within 300 feet of a continuously flowing watercourse or any other significant watercourse.
- Within 200 feet of any lakebed, sinkhole, or playa lake (measured from the ordinary high-water mark).

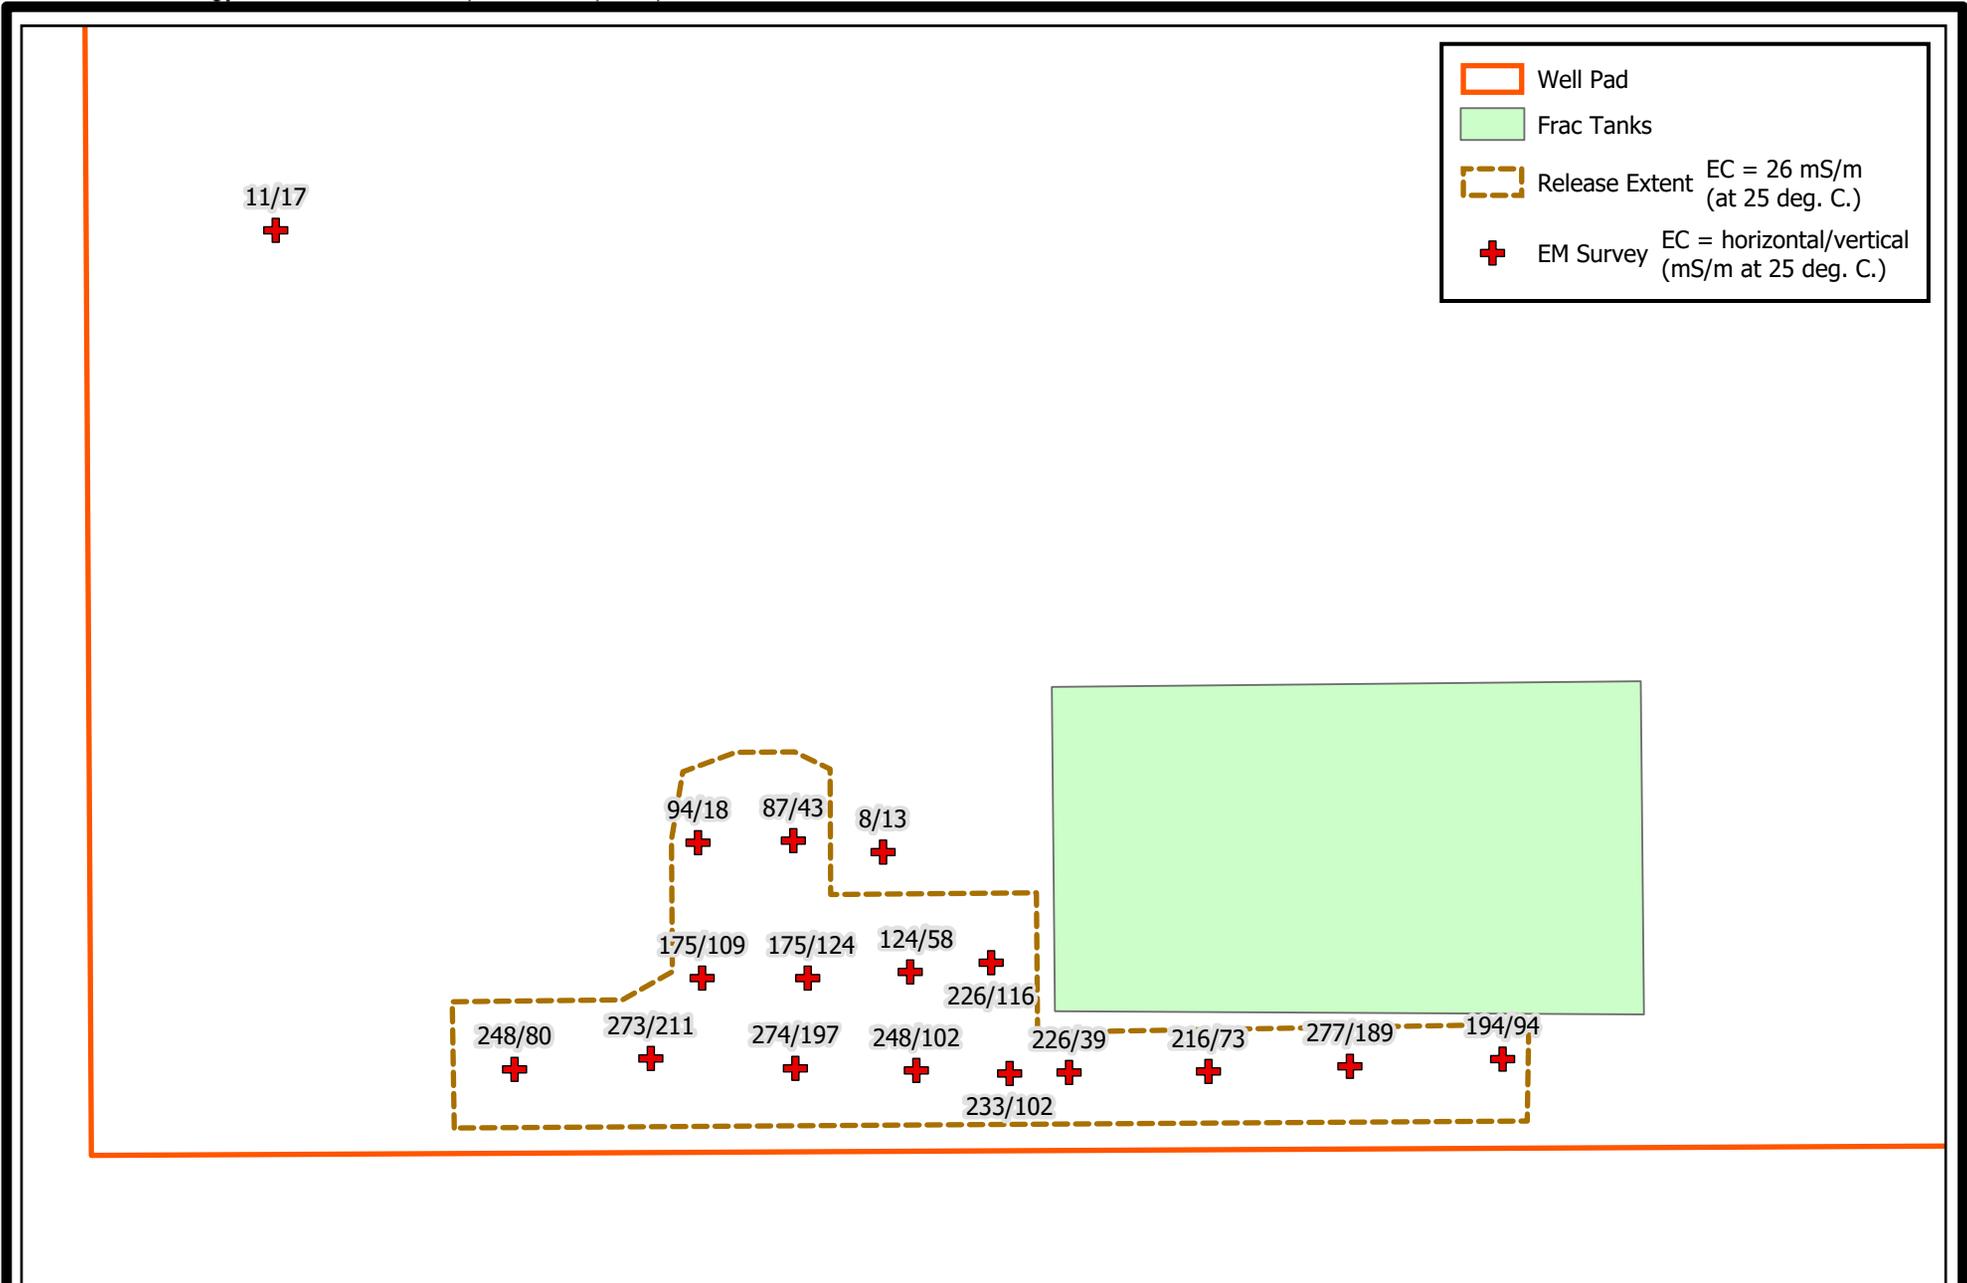
Plate 11
 March 2019

Plate 11 shows the results of the EM Survey. The EM Survey 26 mS/m delineation extent aligned with the observed surface grading from the removal of impacted material during the initial response.

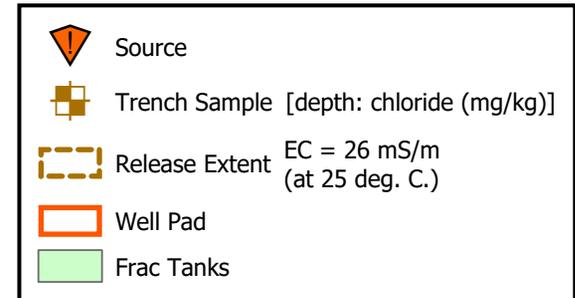
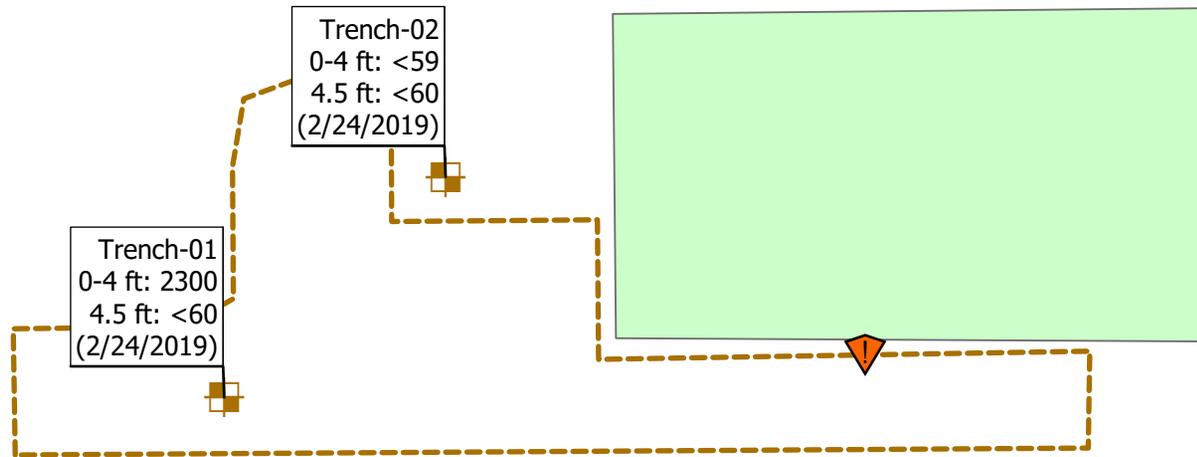
Chloride Sampling Results
 Advance Energy Partners Hat Mesa, LLC
 AO 6 #501H Frac Tank Release

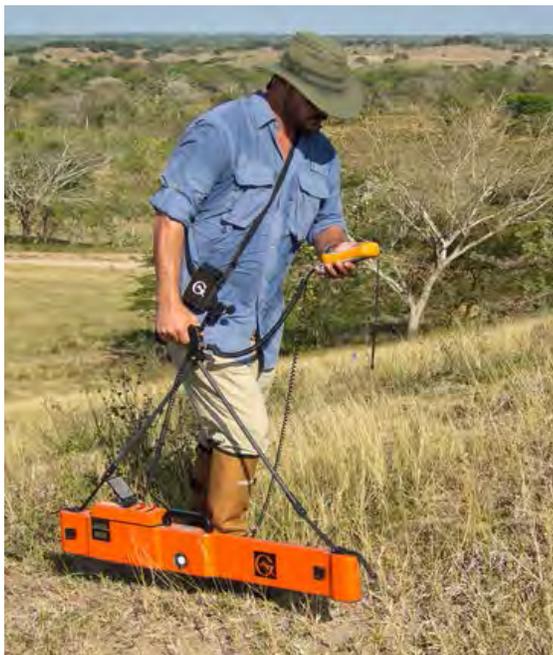
Exhibit 1: Measuring EC with the EM38 in the vertical position.

The EM38 detects EC from the surface to a depth of approximately 4-feet. EC measurements can be obtained in the vertical or horizontal positions. In the vertical position, EC readings are weighted toward the lower depths of 3 to 4 feet. In the horizontal position, EC readings are weighted toward the upper 0 to 2 feet. If a higher EC reading is obtained in the horizontal position than the vertical position, produced water has likely impacted the upper surface more than at lower depths. If a higher EC reading is obtained in the vertical position than the horizontal position, produced water has likely impacted lower soils than the upper surface soils.
