HRL
COMPLIANCE
SOLUTIONS

Subject: Site Characterization and Closure Report
Cotton Draw Unit 171H
2RP-2907
Eddy County, New Mexico

HRL Compliance Solutions, Inc. (HRL) is pleased to present this site characterization and closure report for the March 15, 2015 release at the Cotton Draw Unit 171H (Site). The release is at latitude 32.1526200 and longitude -103.7320907 in Eddy County, New Mexico (Figure 1). Photographs of the Site can be found in Attachment A.

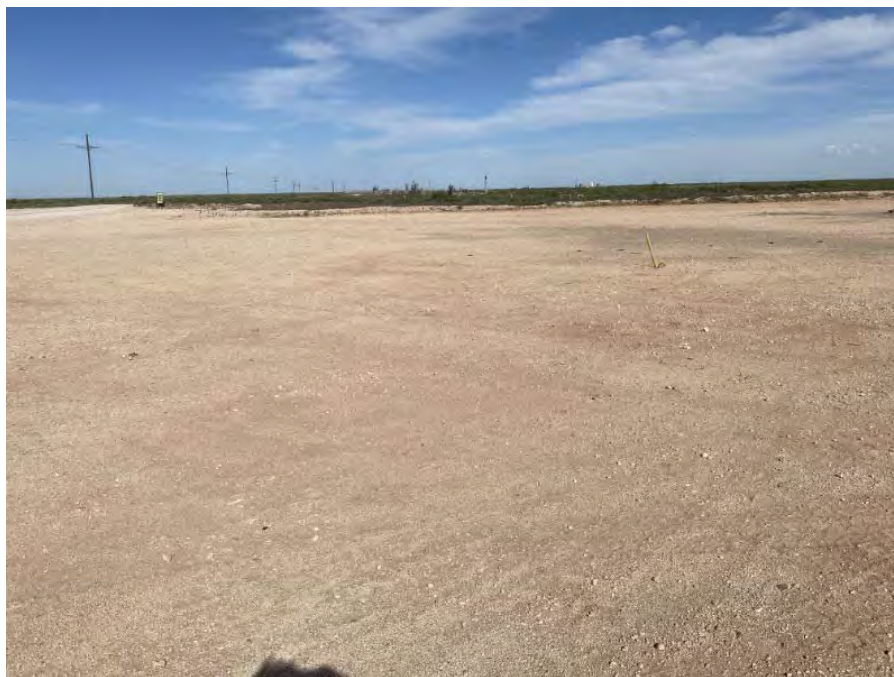
View of the
Site

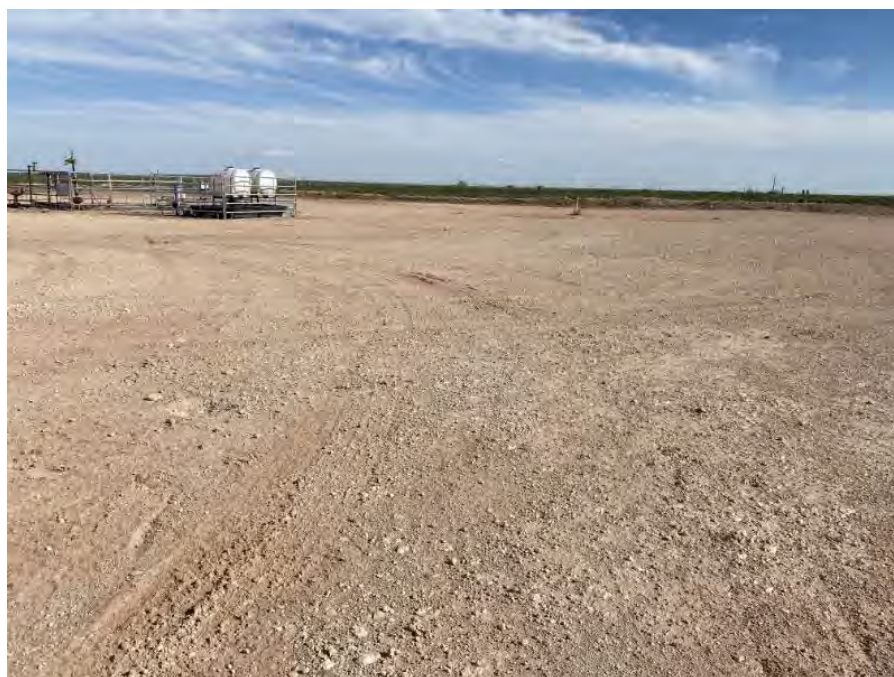
View of the
Site
