Incident ID	NRM2012229165
District RP	
Facility ID	
Application ID

**RE: Closure Request
Corral Canyon 212H Gas Lift
Incident Number NRM2012229165
Eddy County, New Mexico**

LT Environmental, Inc. (LTE), on behalf of XTO Energy, Inc. (XTO), presents the following Closure Request detailing site assessment, soil sampling, and remediation activities at the Corral Canyon 212H Gas Lift (Site) in Unit B, Section 16, Township 25 South, Range 29 East, in Eddy County, New Mexico (Figure 1). The purpose of the site assessment, remediation and soil sampling activities was to confirm the presence or absence of impact to soil by a release of produced water at the Site. Based on field observations, field screening, and laboratory analytical results from soil sampling activities, XTO is submitting this Closure Request and requesting no further action (NFA) for Incident Number NRM2012229165.

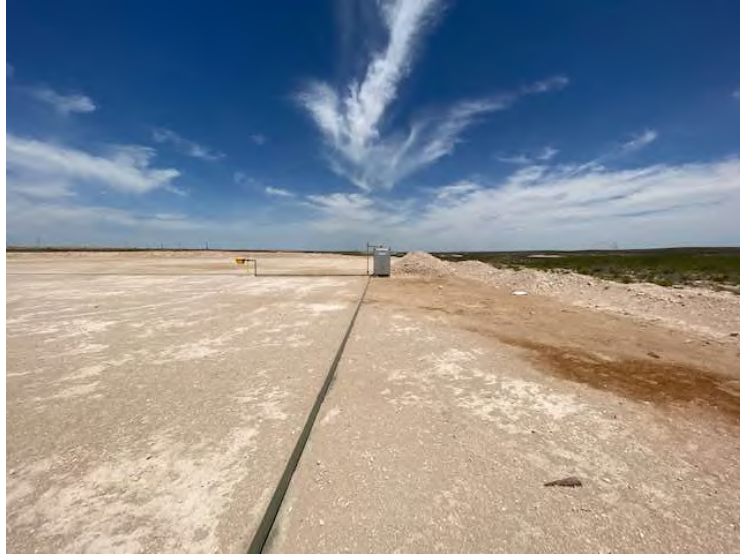
Photograph 1: Southeastern view of stained area.

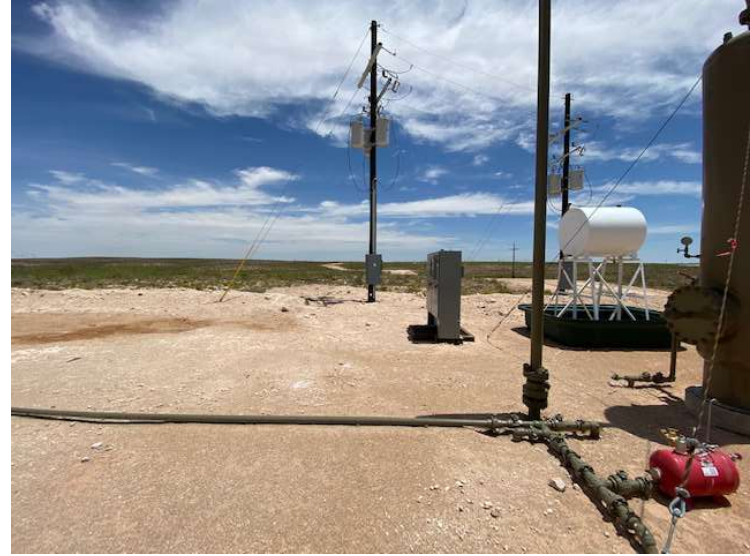
Photograph 2: Northeastern view of stained area.

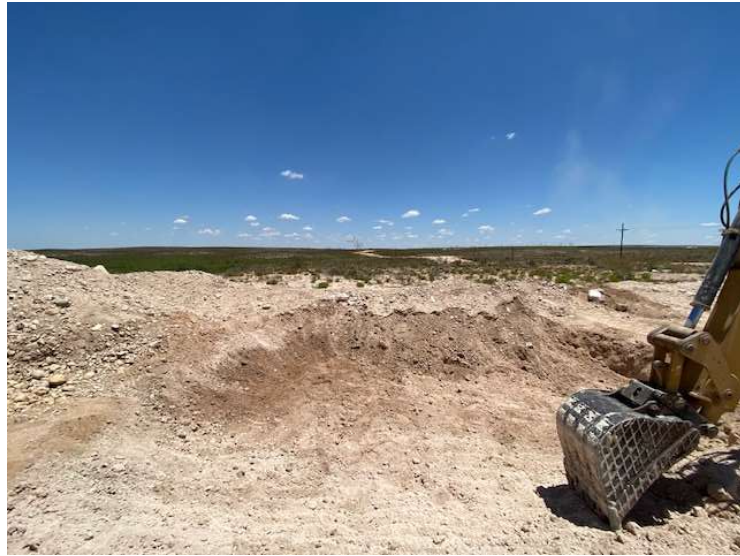
Photograph 3: Eastern view of excavated area.

The excavation extent totaled approximately 306 square feet. A total of approximately 22 cubic yards of impacted soil were removed during the excavation activities. The impacted soil was transported and properly disposed of at the R360 Facility located in Hobbs, New Mexico. After completion of confirmation sampling, the excavation was secured with fencing.

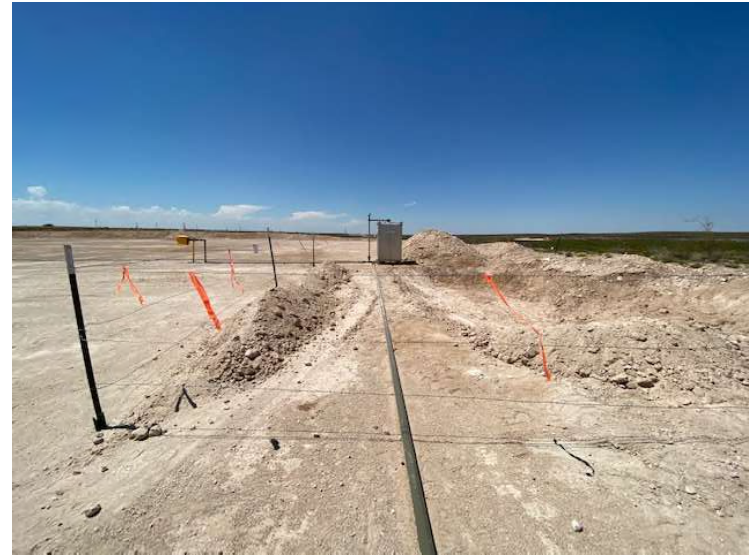
Photograph 4: Southeastern view of excavation.
