# Closure Report

2RP-5575

Site Description					
Site Name:	Mesquite Moutray SWD	Incident ID: NAB1922432657			
Company:	Oxy, Permian				
Legal Description:	U/L B, Section 28, T24S, R29E				
County:	Eddy County, NM				
GPS Coordinates:	N 32.19539 W -103.98547

Release Data				
Date of Release:	6/26/2019			
Type of Release:	Produced water			
Source of Release:	Compromised 3 inch PW line on manifold going to SWD facility			
Volume of Release:	35 bbls			
Volume Recovered:	1 bbls

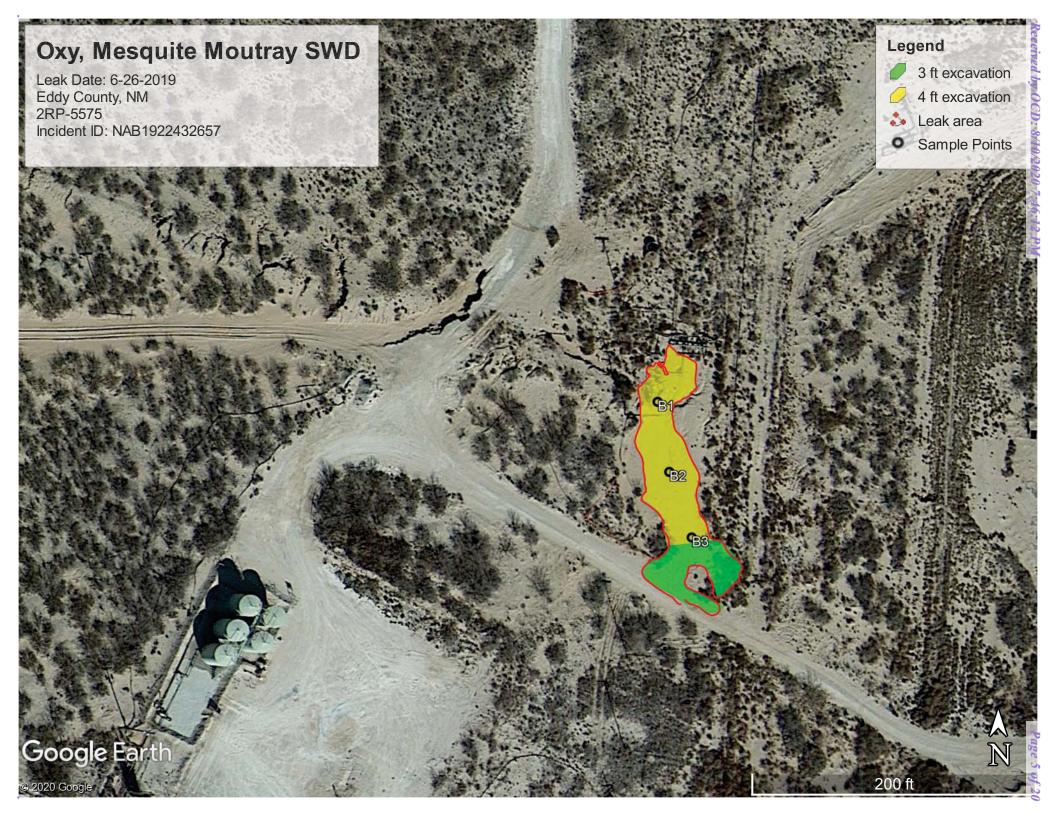
## Oxy, Mesquite Moutray SWD

Sample points

SP1, N 32.19554 W-103.98550

SP2, N 32.19541 W-103.98548

SP3, N 32.19528 W-103.98543

Remediation Specifications					
Remediation Parameters:	SP5, SP6 &	SP1 and SP2 to a depth of 3 feet. Excavated leak area SP3, SP4, SP7 to a depth of 4 feet. Bottom confirmation samples were very 75 feet. The entire site has been backfilled with clean soil.			
Remediation Activities:	7/9/20 throu	gh 7-24-20			
Plan Sent to OCD:	August '19				
OCD Approval of Plan:	8/12/2019	Email to Wade Dittrich from NM OCD			
Plan Sent to BLM:	N/A				
BLM Approval of Plan:	N/A
