**EOG Resources, Inc.**

***Characterization &  
Remediation Plan***

**Lacama 20 State Com #602H**

**June 3, 2020**

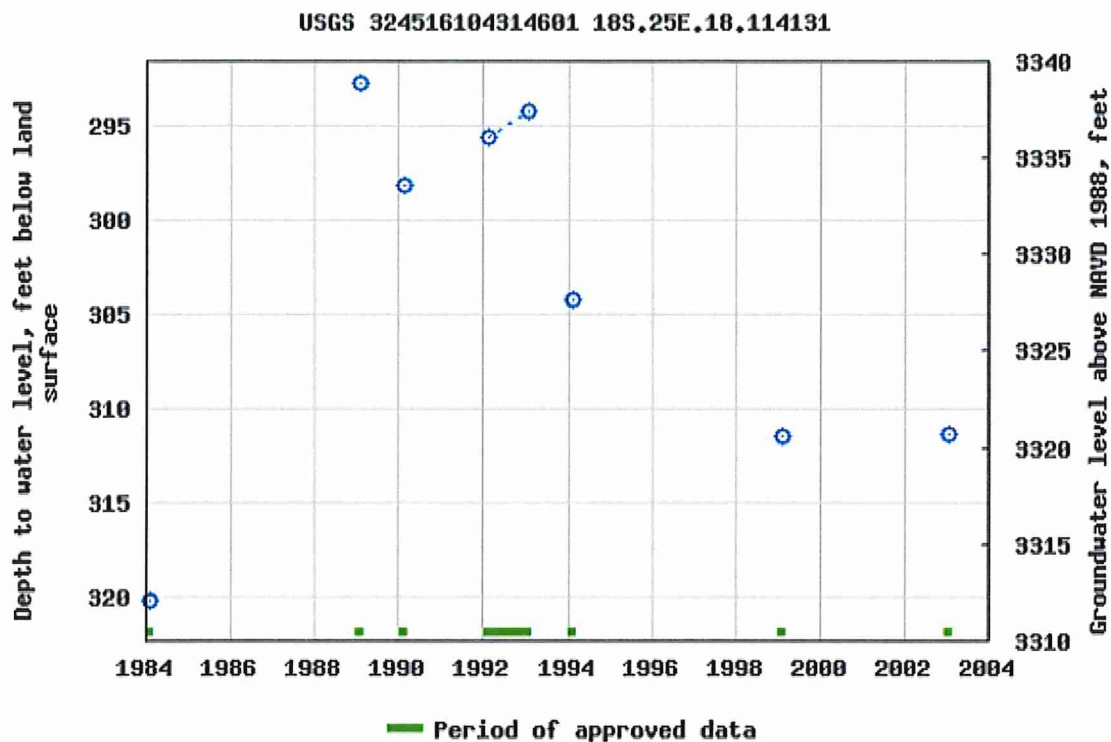
## USGS 324516104314601 18S.25E.18.114131

The depth of the well is 305.0 feet below land surface.

This well is completed in the San Andres Limestone (313SADR) local aquifer.

Breaks in the plot represent a gap of at least one year between field measurements.

Based on information regarding this location (Section 19, T18S-R25E), the United States Geological Survey (USGS) National Water Information System, indicates the depth to groundwater as follows: USGS #324516104314601 (Depth to Water: 312'; Field Groundwater-Level Measurements: 1/24/2003; Distance from Location: 1.34 miles), USGS #324406104330701 (Depth to water: 385'; Field Groundwater-Level Measurements: 2/2/1999; Distance from Location: 1.94 miles), USGS #324430104284801 (Depth to Water: 135', Field groundwater-level measurements: 1/28/2013, Distance from Location: 2.3 miles). USGS # 324251104304901 (Depth to Water: 300', Field groundwater-level measurements: 2/7/1984, Distance from Location: 1.53 miles). See Appendix 2.

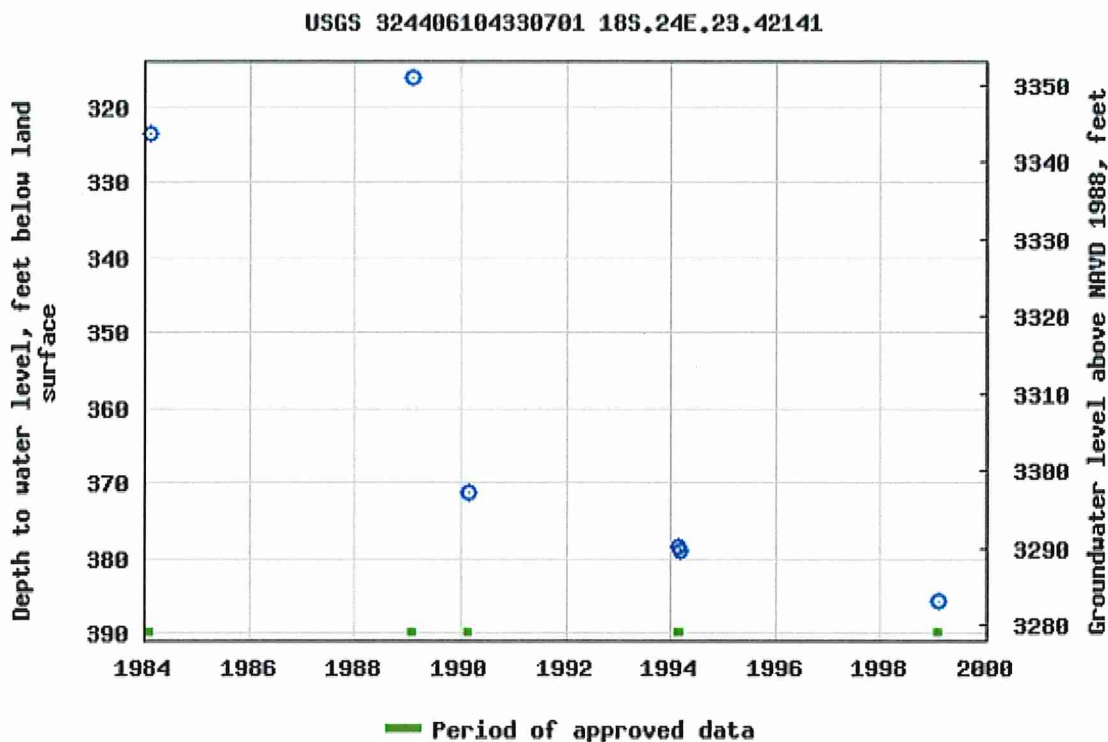
## USGS 324406104330701 18S.24E.23.42141

The depth of the well is 475 feet below land surface.

This well is completed in the San Andres Limestone (313SADR) local aquifer.

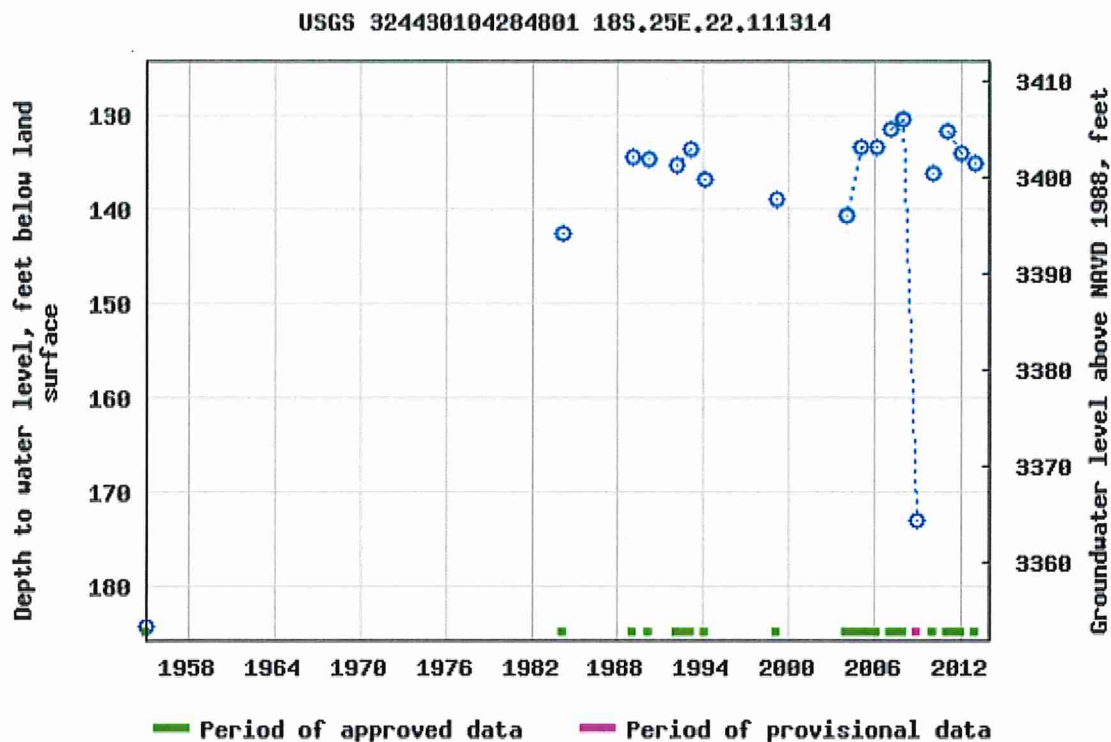
## USGS 324430104284801 18S.25E.22.111314

The depth of the well is 320.0 feet below land surface.

This well is completed in the San Andres Limestone (313SADR) local aquifer.

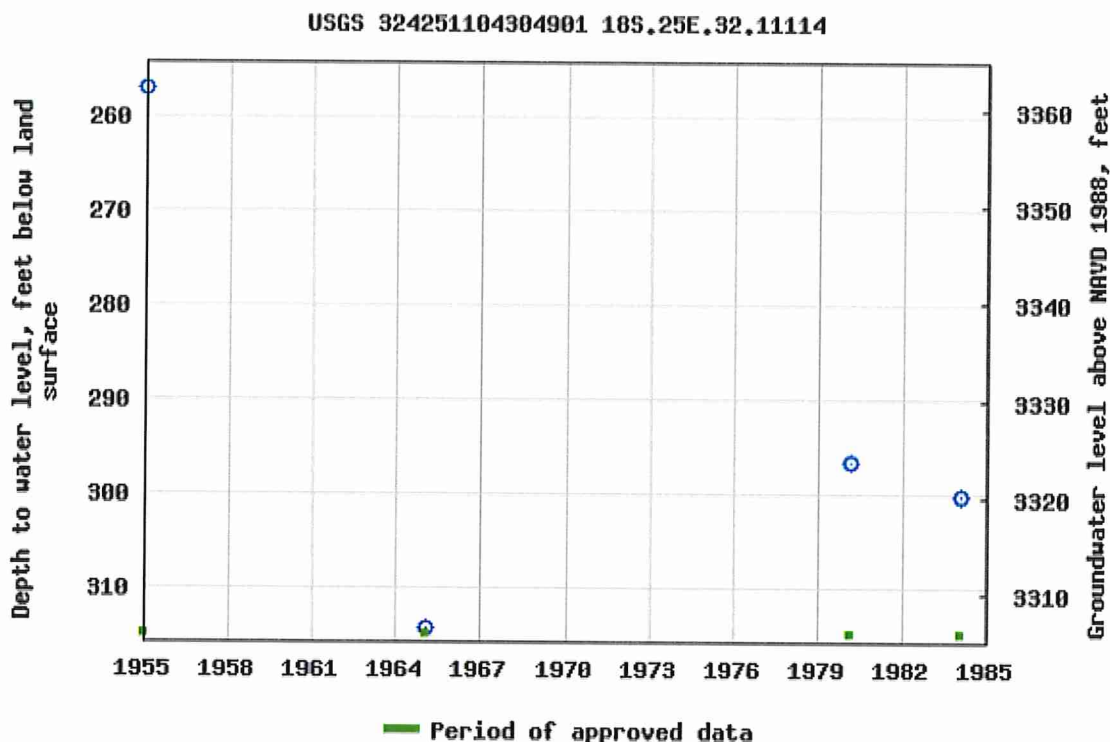
## USGS 324251104304901 18S.25E.32.11114

Land-surface elevation 3,620 feet above NAVD88
