September 14, 2020

Vertex Project #: 20E-01585-003

Spill Closure Report: C 17 State #001H
Unit A, Section 17, Township 23 South, Range 27 East
County: Eddy
API: 30-015-44534
Tracking Number: nRM2017052769

Liner Inspection

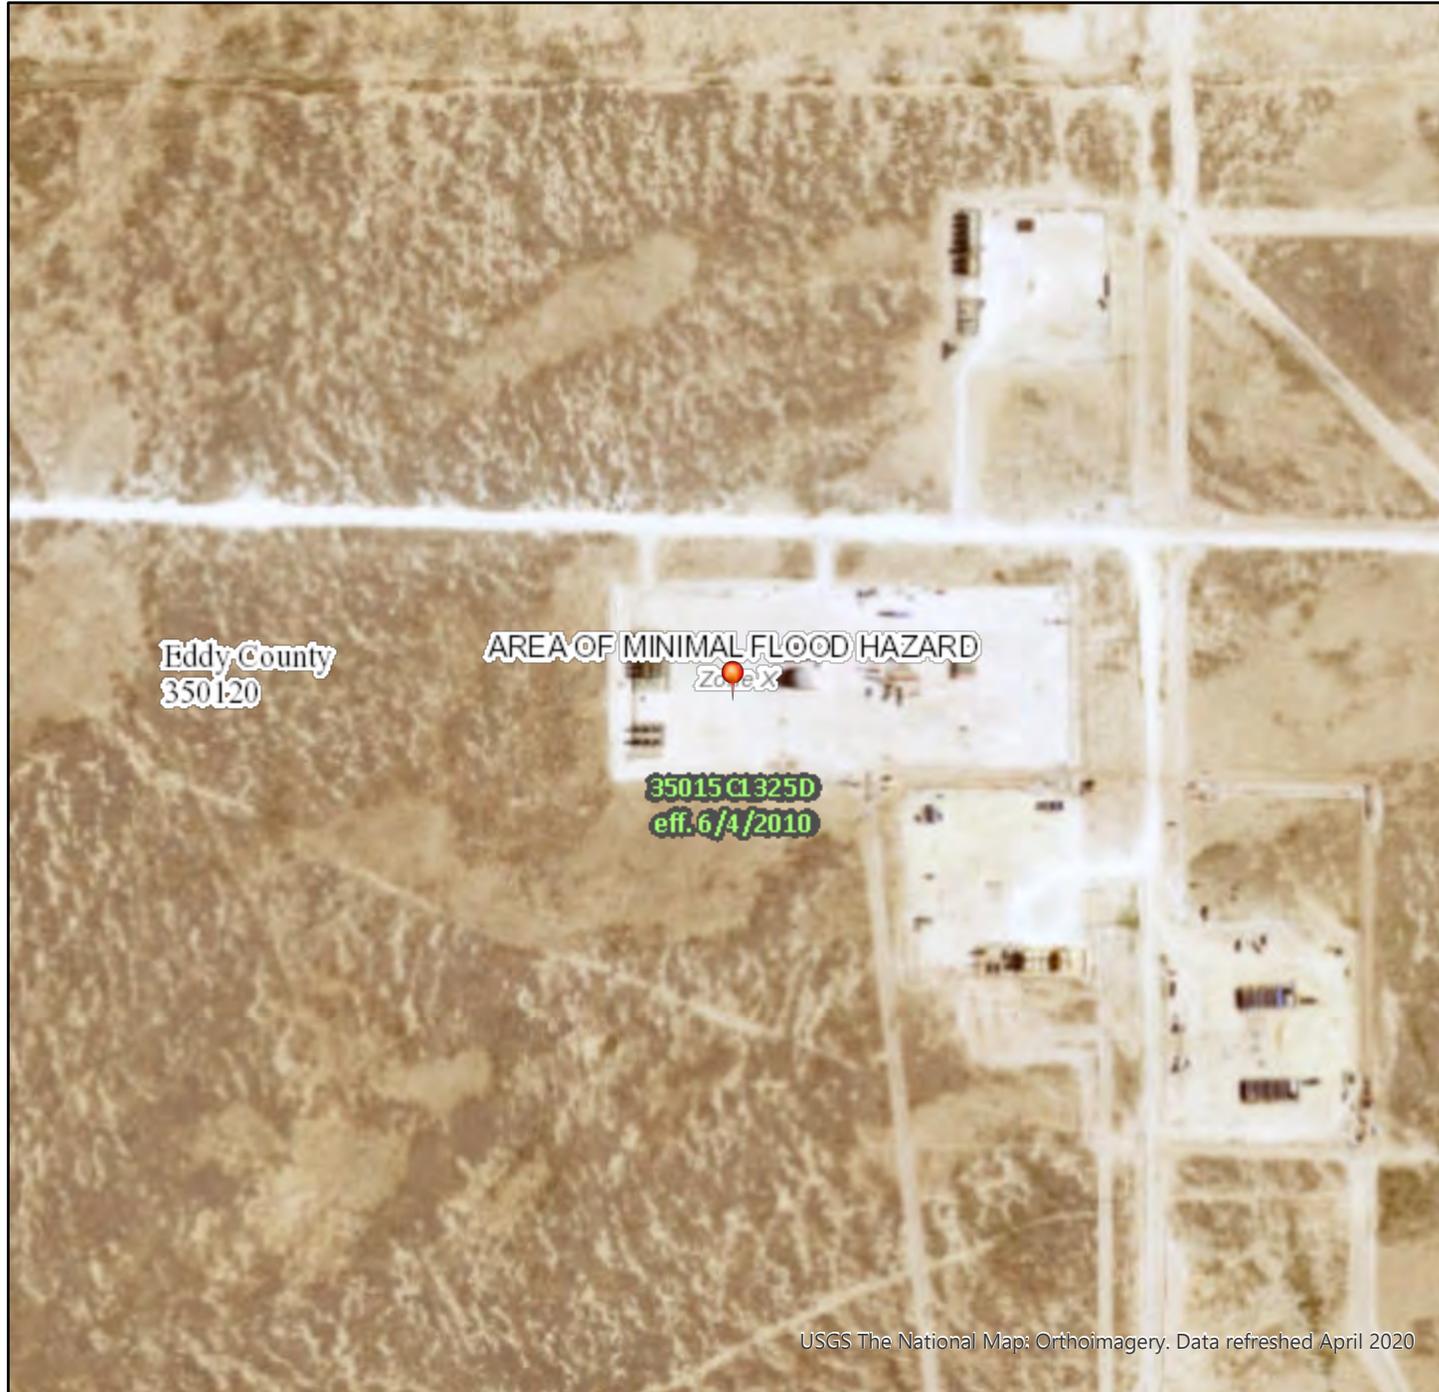
National Flood Hazard Layer FIRMette

The flood hazard information is derived directly from the authoritative NFHL web services provided by FEMA. This map was exported on 9/11/2020 at 2:51 PM and does not reflect changes or amendments subsequent to this date and time. The NFHL and effective information may change or become superseded by new data over time.

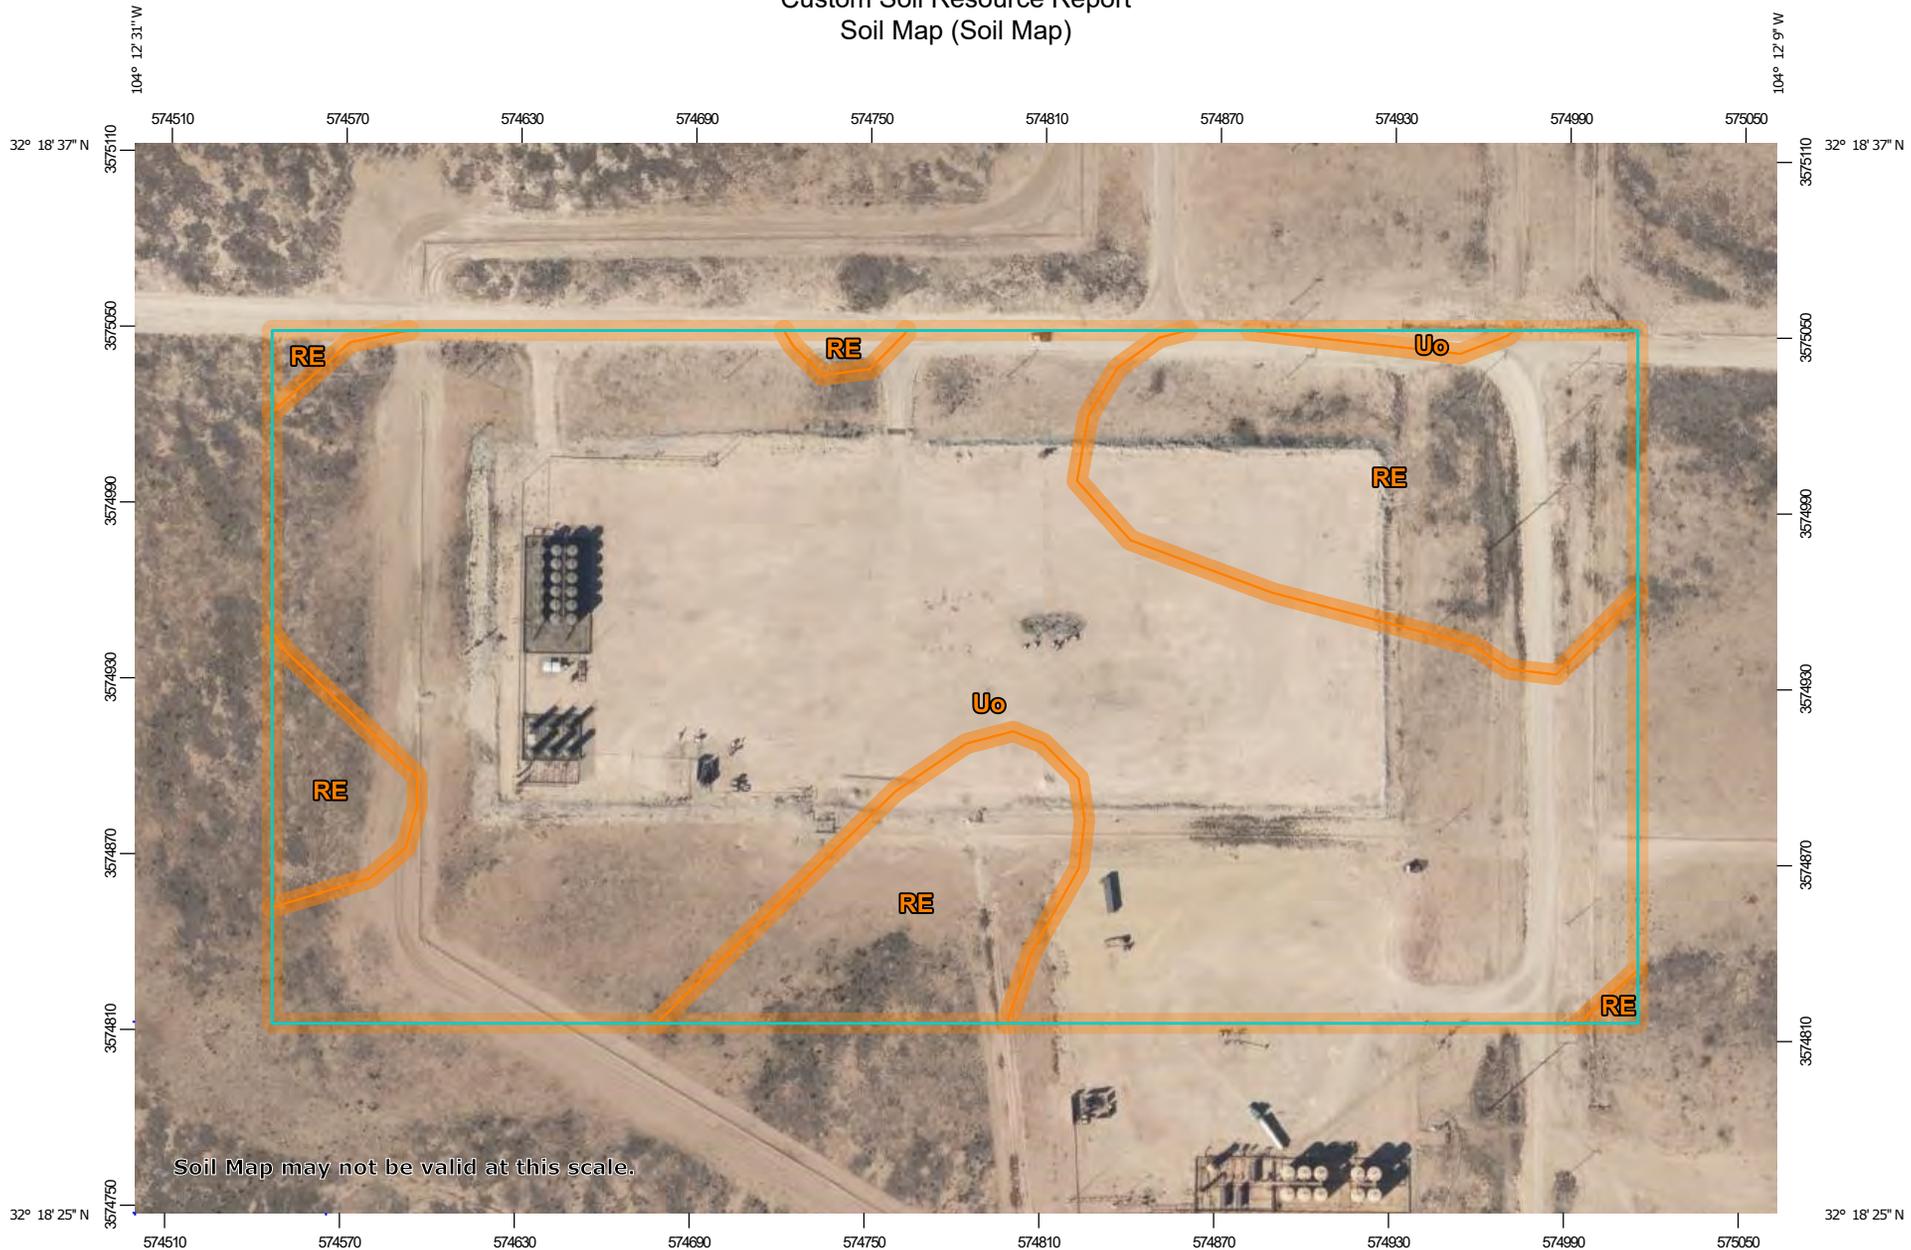
Custom Soil Resource Report Soil Map (Soil Map)

The soil map section includes the soil map for the defined area of interest, a list of soil map units on the map and extent of each map unit, and cartographic symbols displayed on the map. Also presented are various metadata about data used to produce the map, and a description of each soil map unit.

Map Scale: 1:2,580 if printed on A landscape (11" x 8.5") sheet.

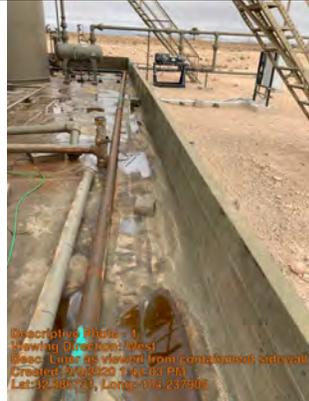
Descriptive Photo - 9
Viewing Direction: West
Desc: Liner as viewed from containment sidewalk
Created: 9/9/2020 1:42:00 PM
Lat: 32.384728, Long: -104.327818

Liner, viewing containment sidewall

1 No further remedial actions recommended at this time. The liner was found to contain no tears, cracks or holes. No visible signs of liquids escaping around the perimeter of containment present.

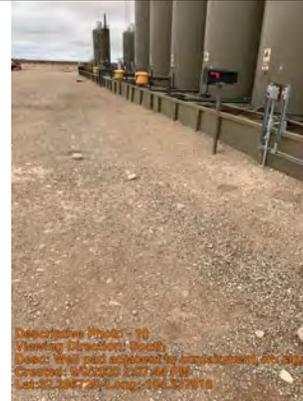
Descriptive Photo - 10
Viewing Direction: South
Desc: Well pad adjacent to containment, no signs
Created: 9/9/2020 2:07:44 PM
Lat: 32.384728, Long: -104.327818

Well pad adjacent to containment, no signs of escaped liquids

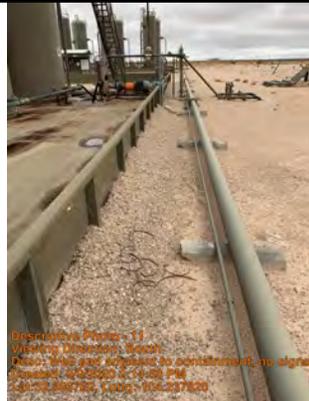
Descriptive Photo - 11
Viewing Direction: South
Desc: Well pad adjacent to containment, no signs
Created: 9/9/2020 2:14:08 PM
Lat: 32.384728, Long: -104.327818

Well pad adjacent to containment, no signs of escaped liquids

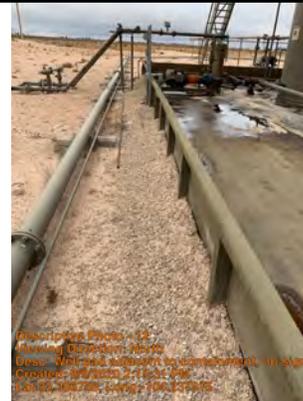
Descriptive Photo - 12
Viewing Direction: North
Desc: Well pad adjacent to containment, no signs
Created: 9/9/2020 2:15:01 PM
Lat: 32.384728, Long: -104.327818

Well pad adjacent to containment, no signs of escaped liquids

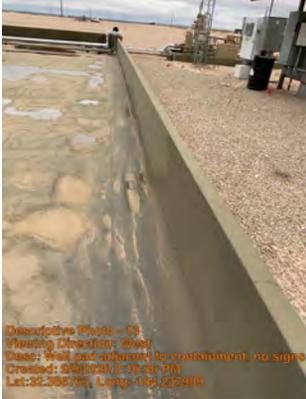
Descriptive Photo - 19
Viewing Direction: West
Desc: Well pad adjacent to containment, no signs of escaped liquids
Created: 9/9/2020 1:25:33 PM
Lat:32.386725, Long:-104.317898

Well pad adjacent to containment, no signs of escaped liquids

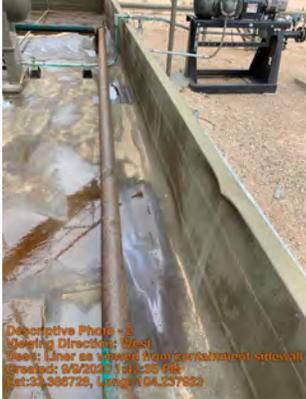
Descriptive Photo - 3
Viewing Direction: West
Desc: Liner as viewed from containment sidewall
Created: 9/9/2020 1:32:35 PM
Lat:32.386728, Long:-104.317893

Liner, viewing containment sidewall

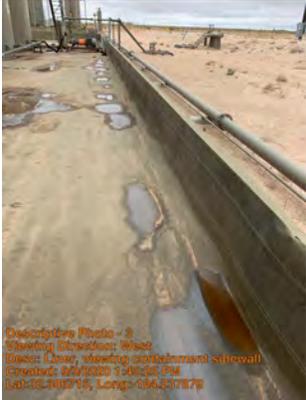
Viewing Direction: South

Descriptive Photo - 3
Viewing Direction: West
Desc: Liner, viewing containment sidewall
Created: 9/9/2020 1:36:52 PM
Lat:32.386716, Long:-104.317879

Liner, viewing containment sidewall

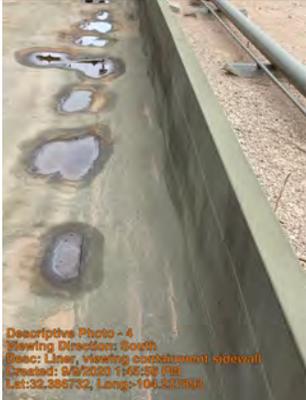
Descriptive Photo - 4
Viewing Direction: South
Desc: Liner, viewing containment sidewall
Created: 9/9/2020 1:45:52 PM
Lat:32.386732, Long:-104.317890

Liner, viewing containment sidewall

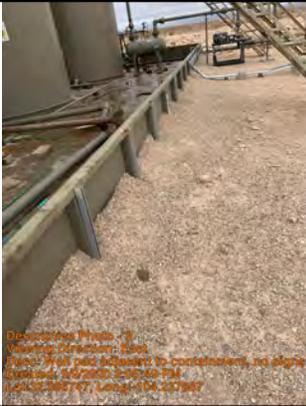
A photograph showing a gravel well pad next to a concrete containment wall. In the background, there are industrial structures and a clear sky. The photo is taken from an elevated position looking east. <p>Disposing Photo - 1 Viewing Direction: East Photo: Well pad adjacent to containment, no signs Observed: 9/22/2020 2:05:40 PM Lat: 33.265747, Long: -104.227987</p>	
Well pad adjacent to containment, no signs of escaped liquids
