**RE: LINER INSPECTION REPORT  
SALADO DRAW 6 FEDERAL #1H (NRM2018253989)**

Souder, Miller & Associates (SMA) is pleased to submit this letter report on behalf of Devon Energy Production Company (Devon Energy) summarizing the liner inspection that occurred due to the Salado Draw 6 Federal #1H Tank Battery release. The site is located in Unit Letter M Section 6, Township 26S, Range 34E (N32.065401/W-103.514801) Lea County, New Mexico, on Federal land.

Devon Energy Production Company  
Salado Draw 6 Federal #1H (NRM2018253989)

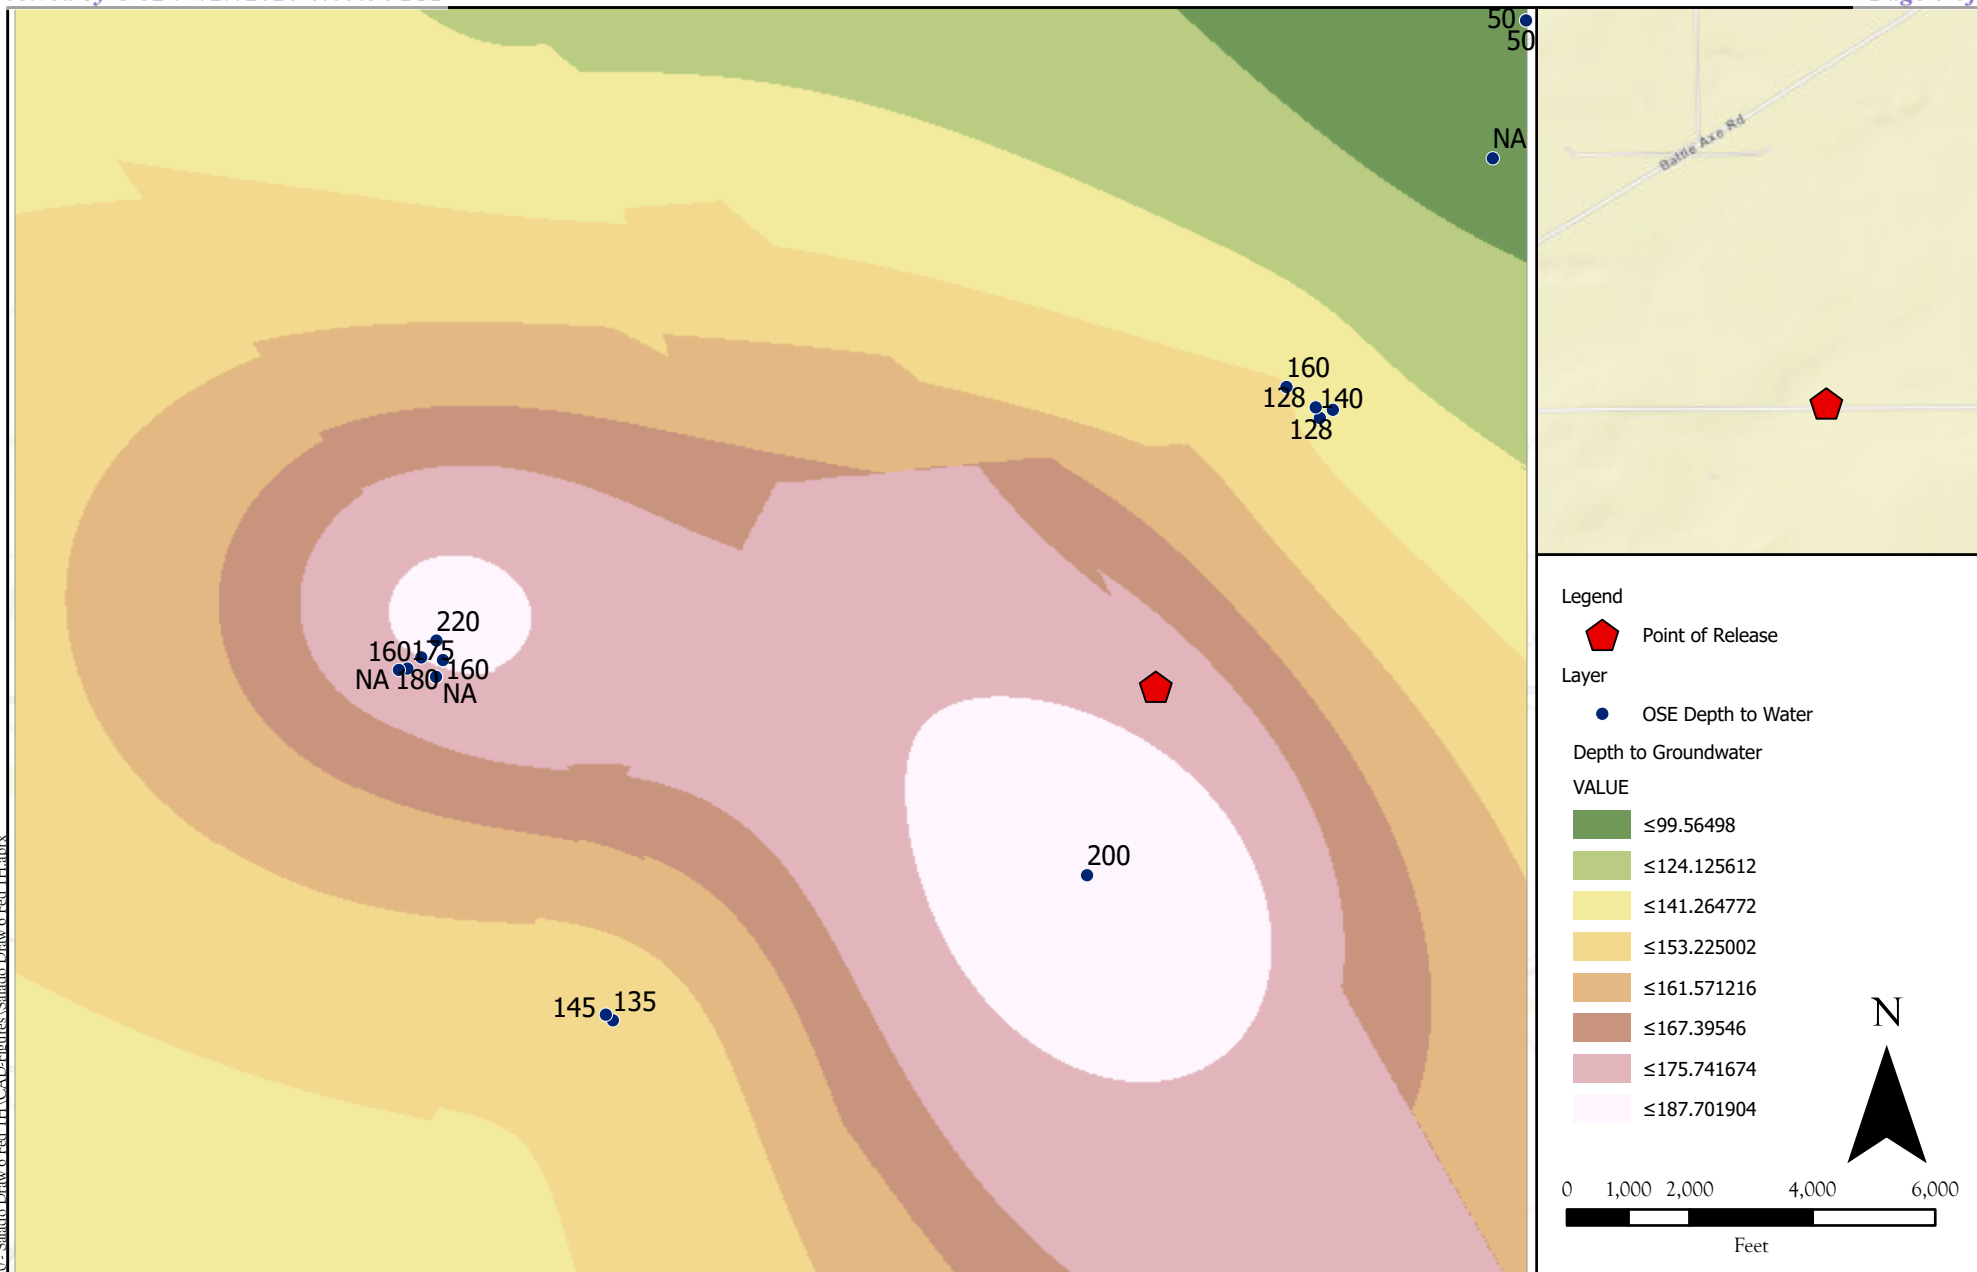
Figure 1A

Salado Draw 6 Fed #001H- Devon Energy Production Company  
 UL: M S: 06 T: 26S R: 34E, Lea County, New Mexico

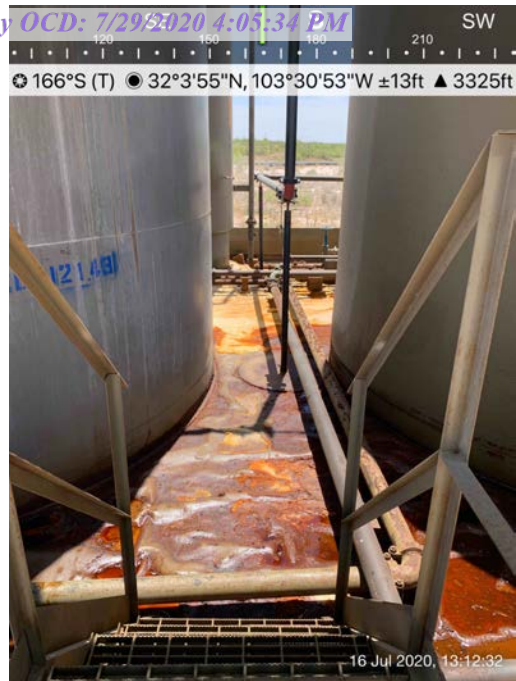
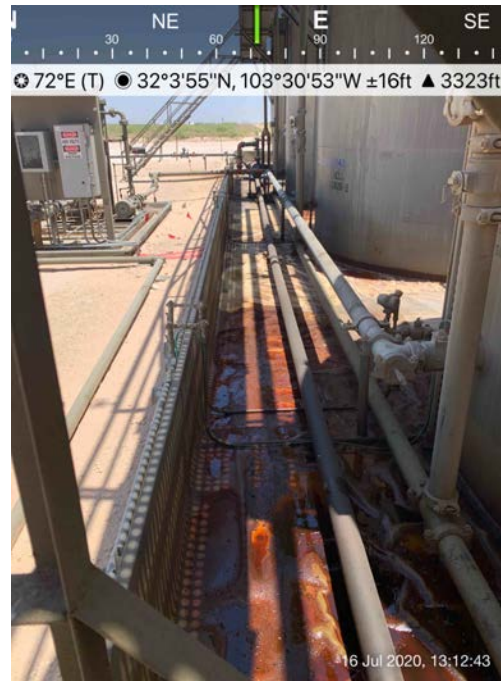
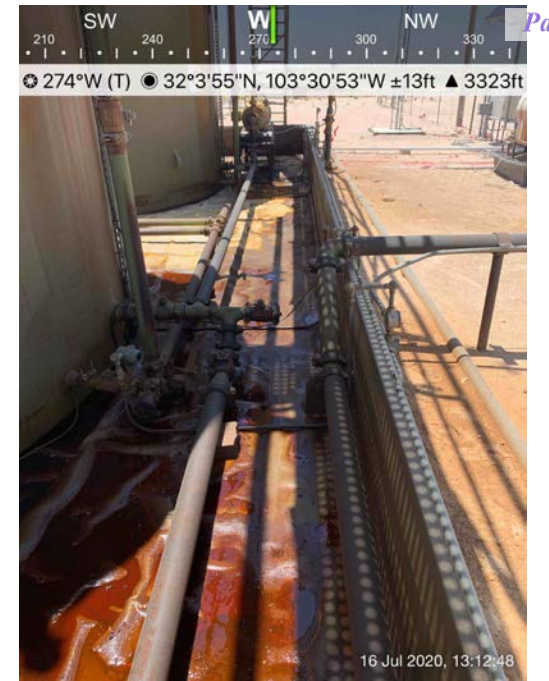
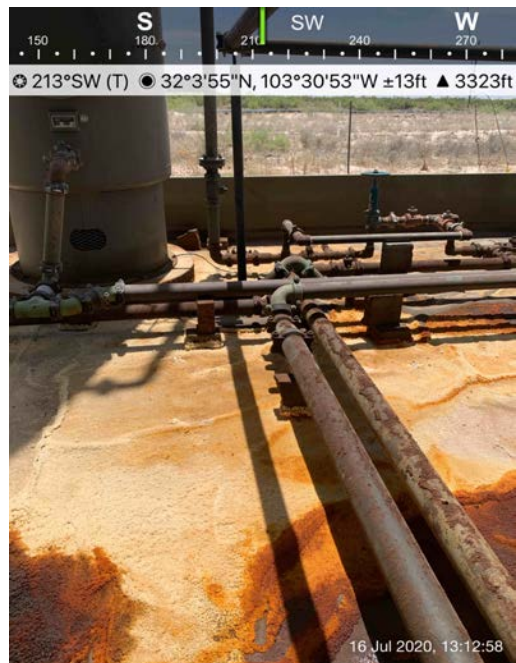
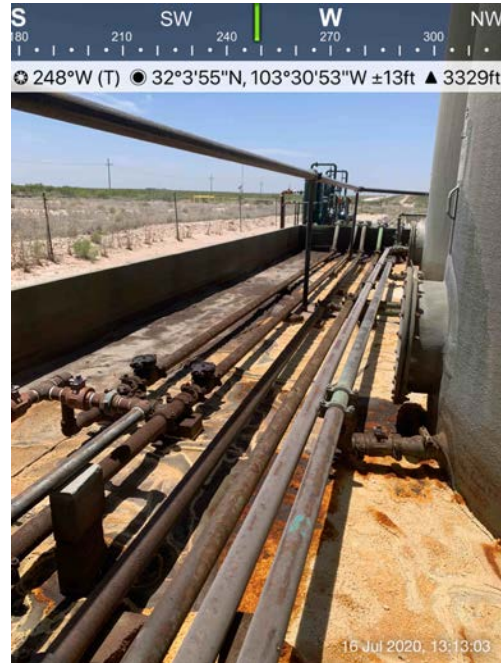
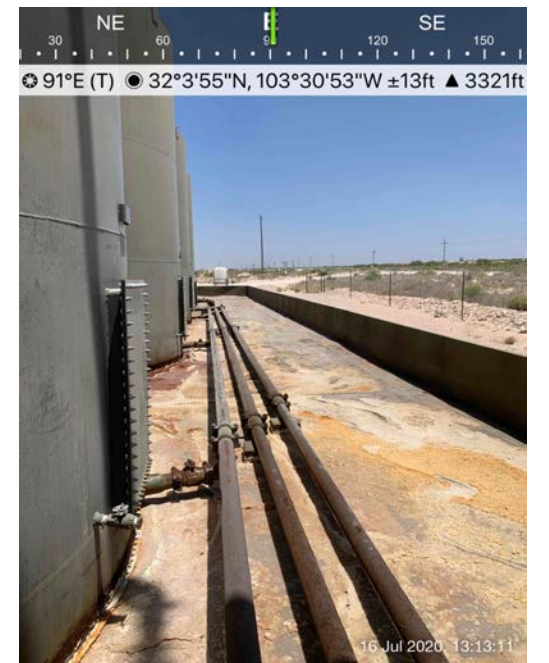
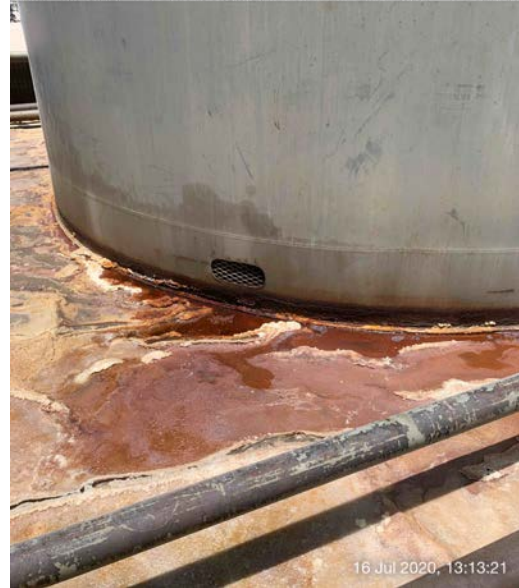
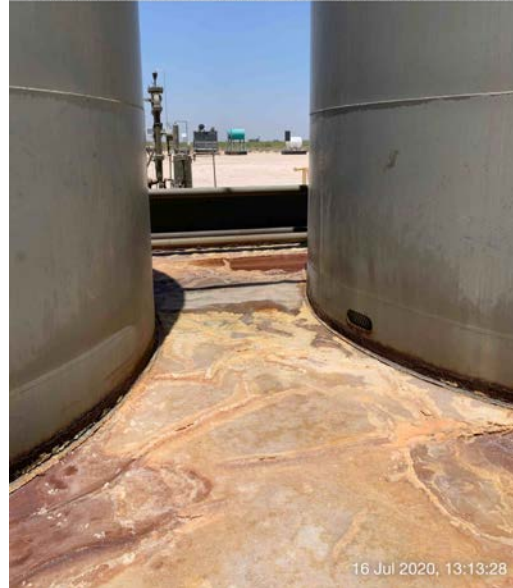
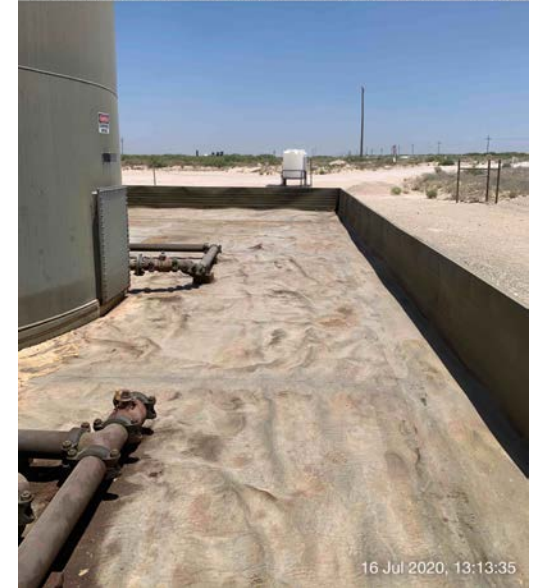
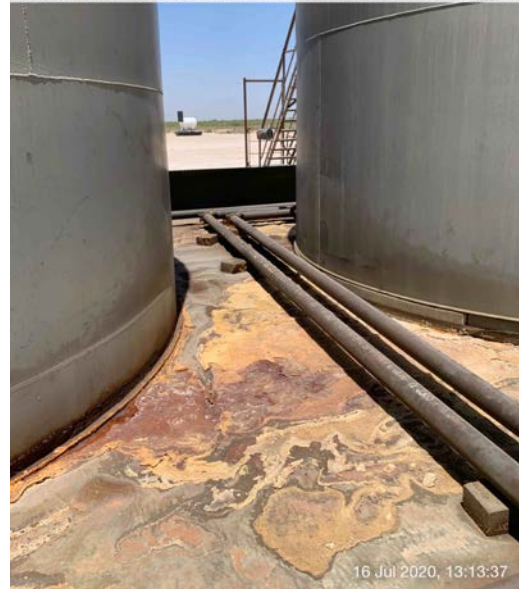
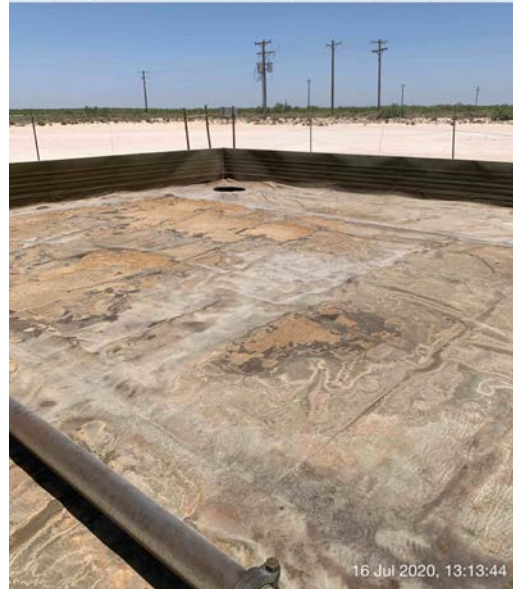
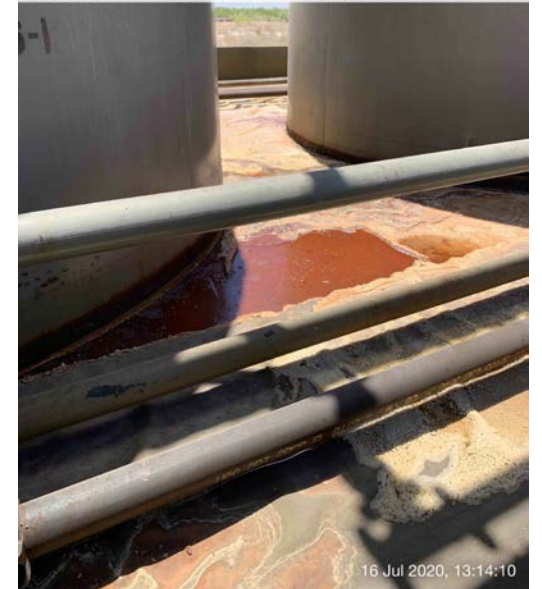
**Appendix A**  
**PHOTO LOG & FIELD NOTES**

At the request of Devon Energy, SMA conducted a liner integrity inspection per the requirements of 19.15.29.11.A(5)(a) NMAC. NMOCD was notified on July 14, 2020 that the liner inspection was to occur. After a thorough visual inspection of the liner within the tank battery containment, the liner appeared to be intact and had the ability to contain the leak in question. The tank from which the release occurred was identified, and SMA verified that the release did not occur outside of the lined containment. A photo log and field notes of the inspection is included in Appendix A.

SMA recommends no further action for this release.
