Release Notification

Site Name James Ranch Unit DI #2	Site Type Production Drill Island
Date Release Discovered 1/16/2019	API# (if applicable) 30-015-43370 (JRU DI2 #192H)

**RE: Closure Request
James Ranch Unit DI #2
Incident Number NAB1902551172
Remediation Permit Number 2RP-5205
Eddy County, New Mexico**

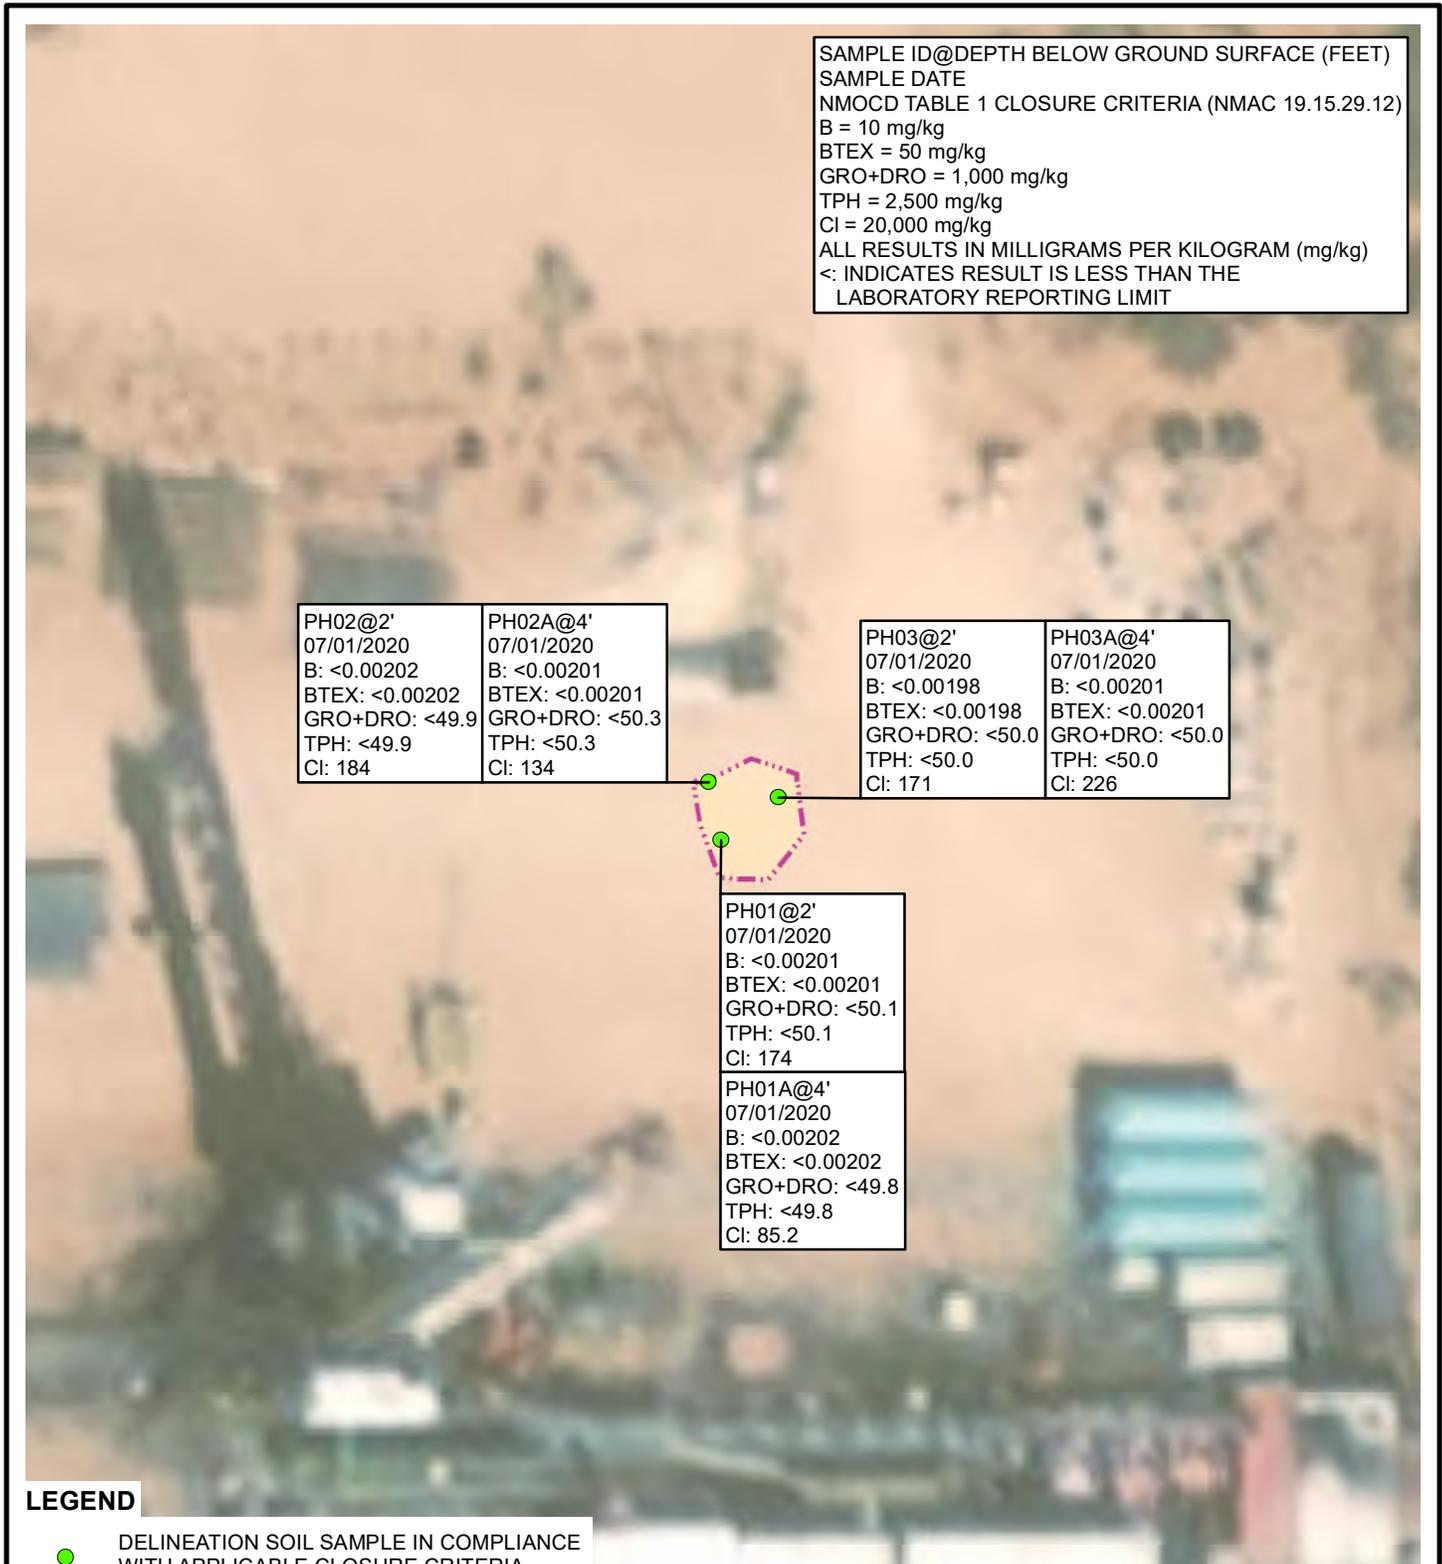
FIGURE 3
DELINEATION SOIL SAMPLE LOCATIONS
JAMES RANCH UNIT DI #2
UNIT F SEC 25 T22S R30E
EDDY COUNTY, NEW MEXICO
XTO ENERGY, INC.

Three potholes (PH01/PH01A through PH03/PH03A) were advanced to a depth of four feet bgs via track mounted backhoe at the SS01 through SS03 preliminary soil sample locations. Two discrete delineation soil samples were collected from each pothole at depths of 2 feet and 4 feet bgs. Soil from the potholes was field screened for volatile aromatic hydrocarbons and chloride utilizing a PID and Hach® chloride QuanTab® test strips, respectively. Field screening results and observations for each pothole were logged on lithologic/soil sampling logs, which are included in Attachment 3. The locations of delineation potholes (PH01/PH01A through PH03/PH03A) are presented on Figure 3.

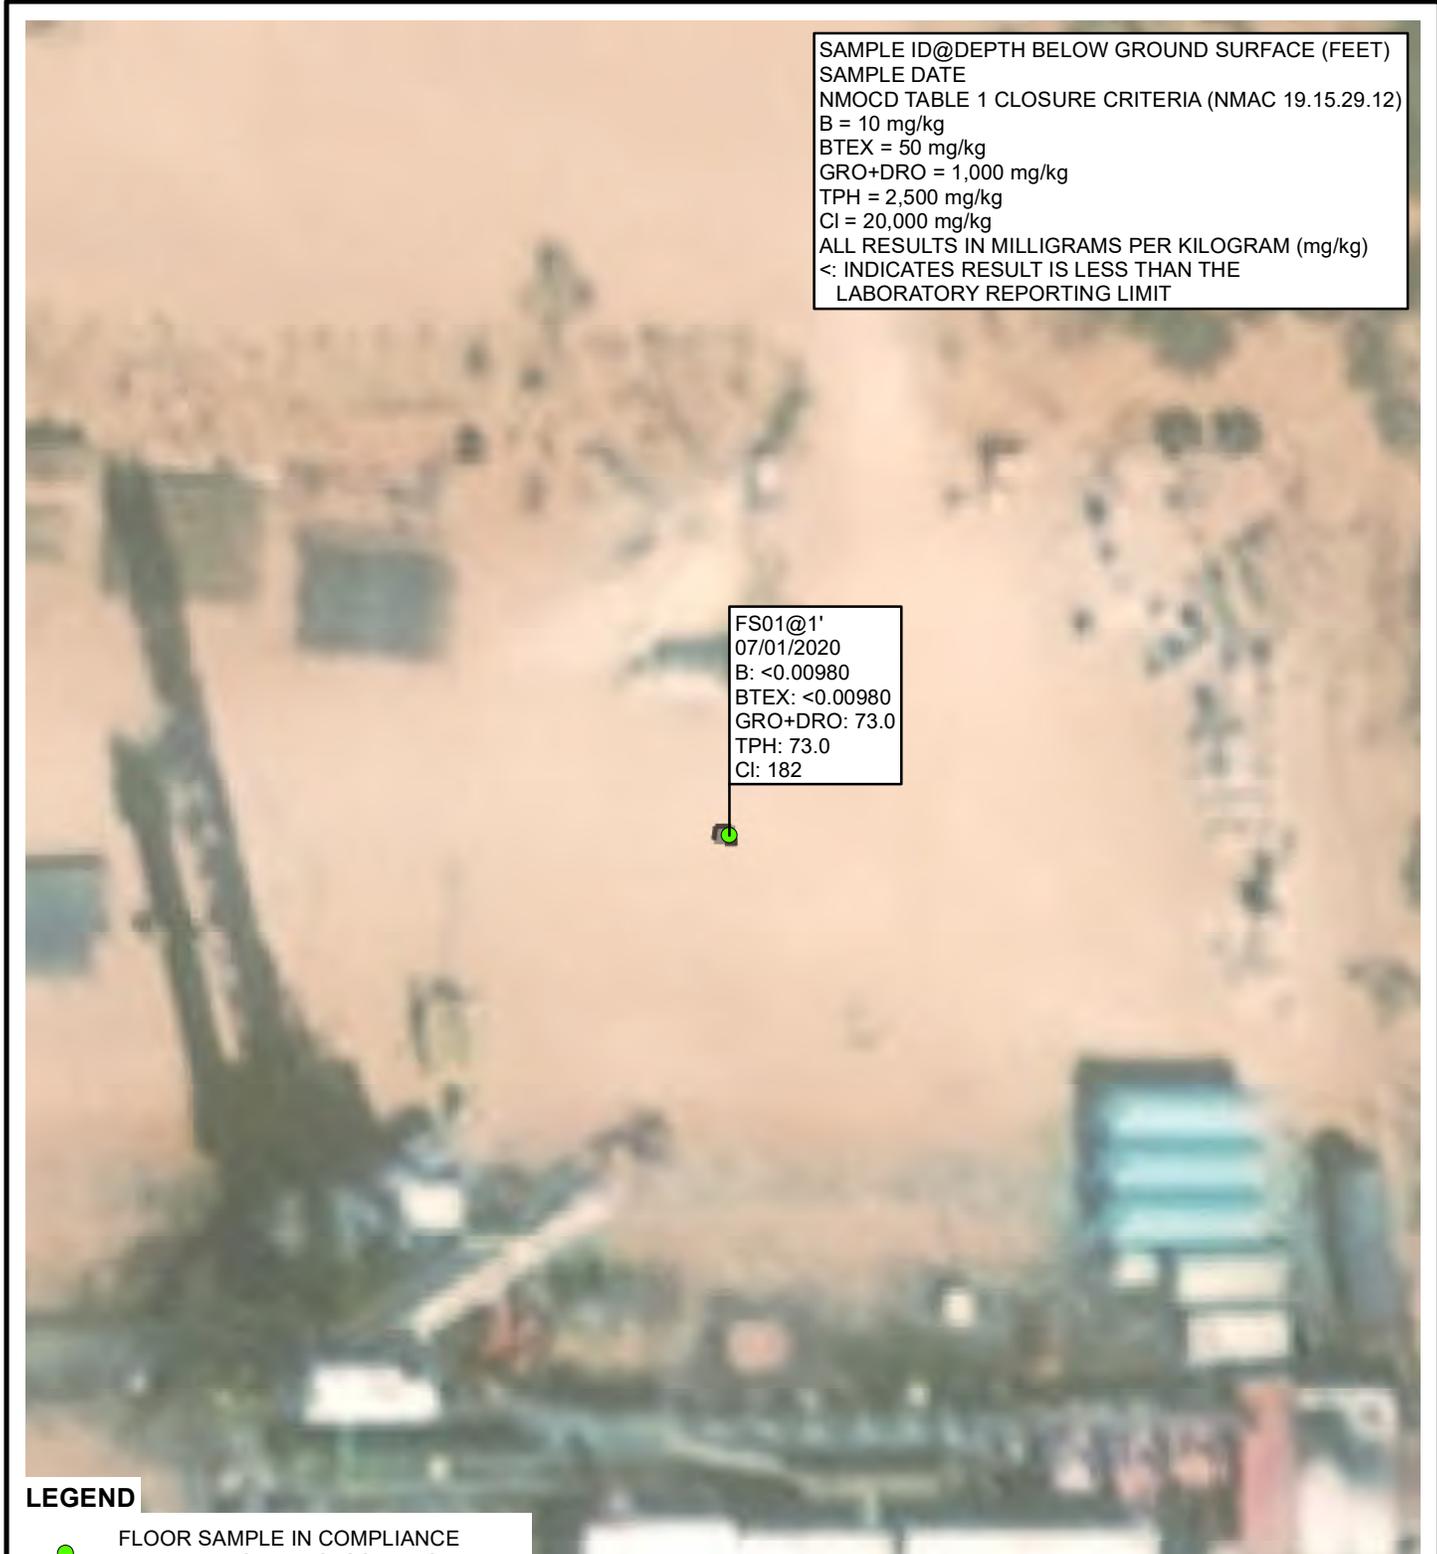
The excavation measured approximately 16 square feet in area and was completed to a depth of 1 foot bgs. As such, one composite floor soil sample (FS01) was collected from the floor and sidewalls of the excavation. The location of the final excavation extent and confirmation soil sample are presented on Figure 4. The delineation and excavation soil samples were collected, handled, and analyzed as described above at Xenco in Carlsbad, New Mexico.

FS01@1'
 07/01/2020
 B: <0.00980
 BTEX: <0.00980
 GRO+DRO: 73.0
 TPH: 73.0
 Cl: 182

Approximately 1 cubic yard of impacted soil was removed during the excavation activities. The impacted soil was transported and properly disposed of at the R360 Facility located in Hobbs, New Mexico. After completion of confirmation sampling, the excavation was secured with fencing.

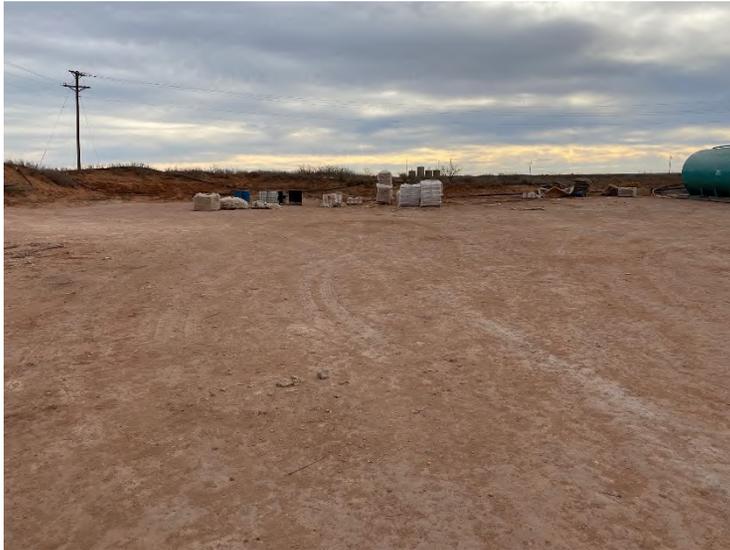
Photograph 1: View of Site facing east.

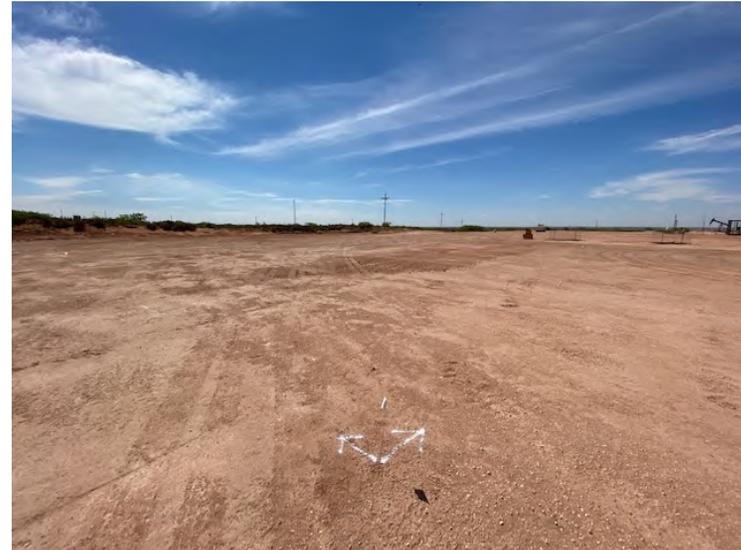
Photograph 2: View of Site facing southeast.

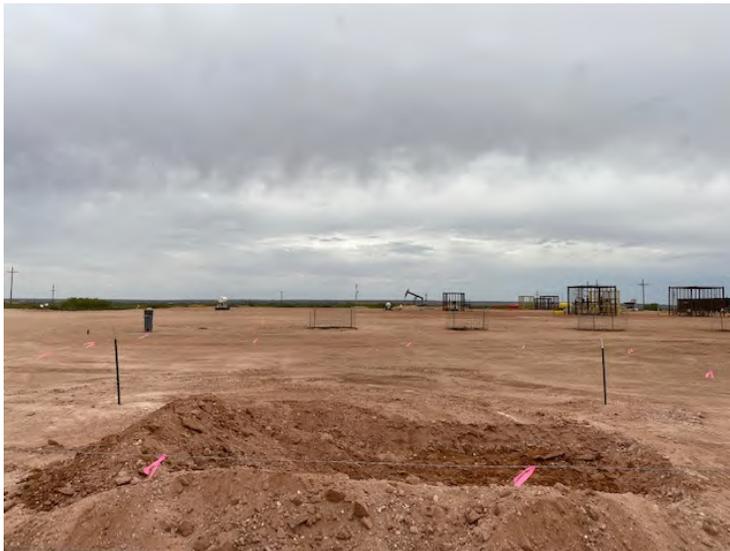
Photograph 3: View of final excavation facing south.

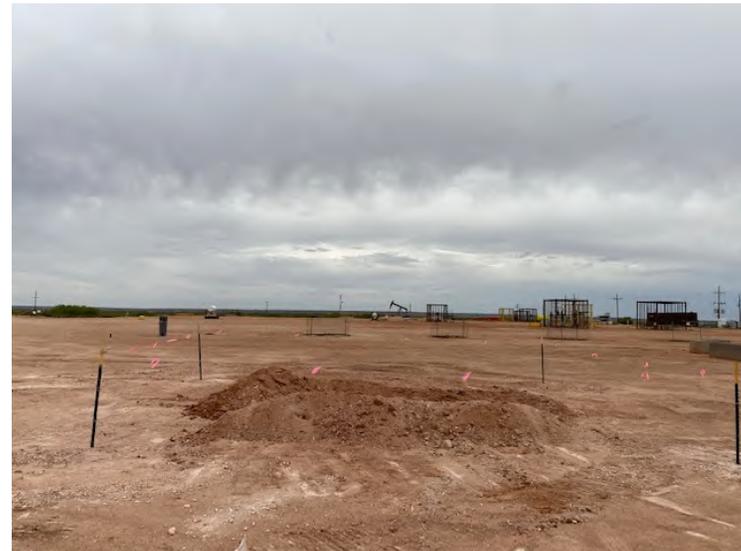
Photograph 4: View of final excavation facing south.
