## Release Notification

| Site Name JRU DI-1A CTB | Site Type Tank Battery |

Cause of Release A flange on the water transfer line leaked produced water onto the pad. A third-party contractor will be retained for remediation activities.

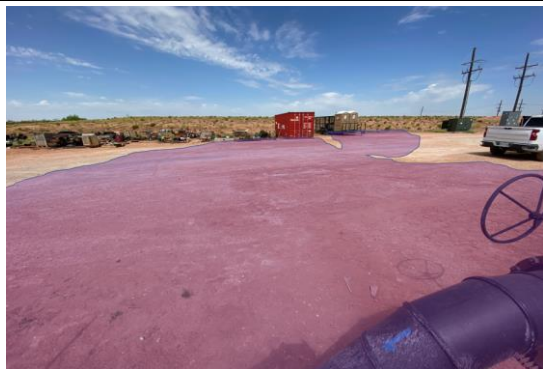
Northwest view of the subject release (outlined).

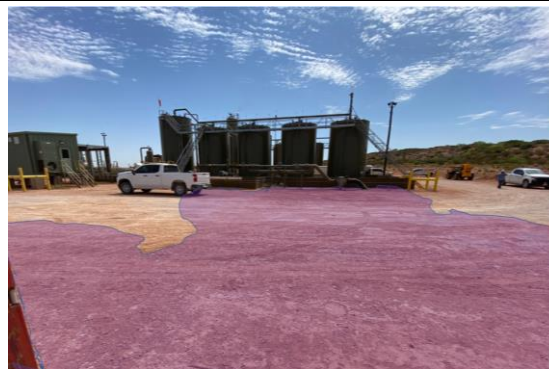
East view of the subject release (outlined).

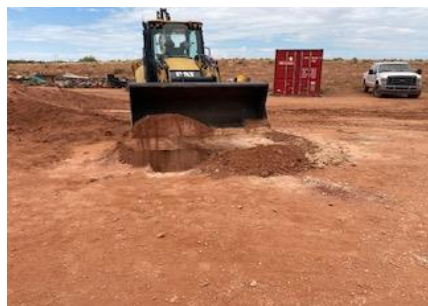
West view of the Site during delineation activities.

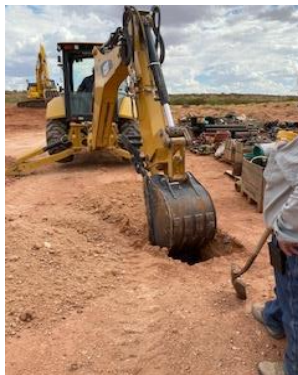
South view of the Site during delineation activities.

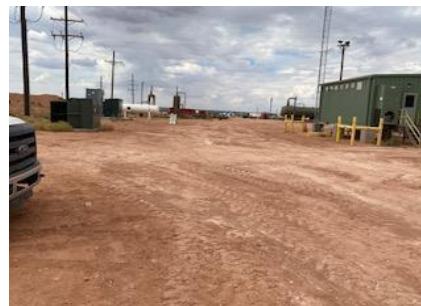
North view of the Site following delineation activities.

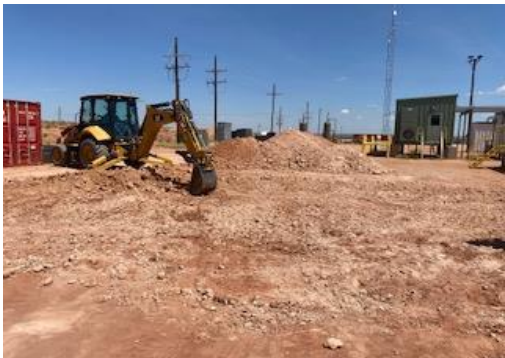
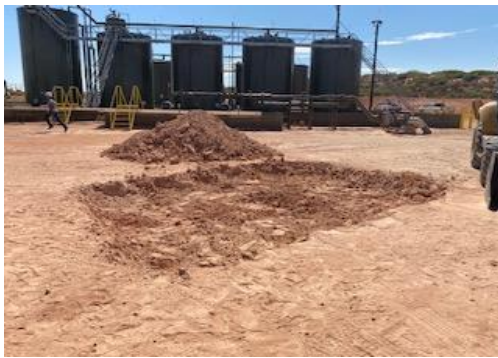
| EXCAVATION PHOTOGRAPHS | |
|---|---|
| Northwest view of the Site during excavation activities. | East view of the Site during excavation activities. |

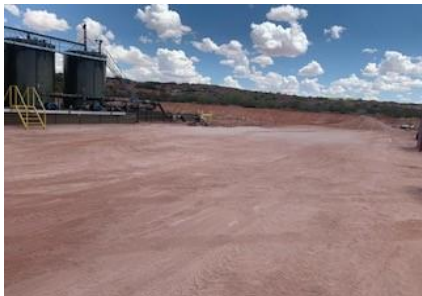
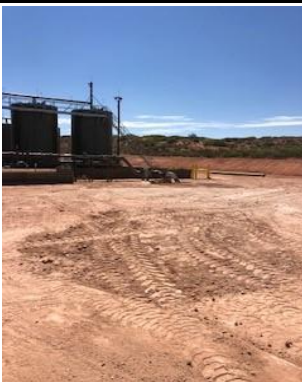
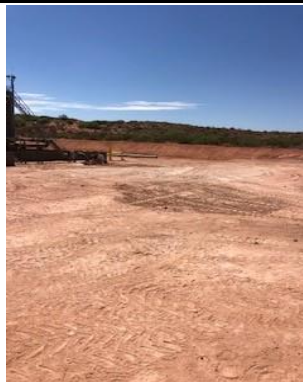
| BACKFILL PHOTOGRAPHS | | |
|---|---|---|
| Southeast view of the Site following backfilling activities. | Southeast view of the Site following backfilling activities. | Southeast view of the Site following backfilling activities. |
