PROPOSED SITE ASSESSMENT PLAN

**MCCULLAR PROPERTY
SECTION 16, TOWNSHIP 16S, RANGE 26E
EDDY COUNTY, NEW MEXICO
32.920457, -104.394299
RANGER REFERENCE NO. 5375**

**EOG RESOURCES, INC.
ARTESIA DIVISION
105 S 4TH STREET
ARTESIA, NEW MEXICO 88210**

**RANGER ENVIRONMENTAL SERVICES, INC.
P.O. BOX 201179
AUSTIN, TEXAS 78720**

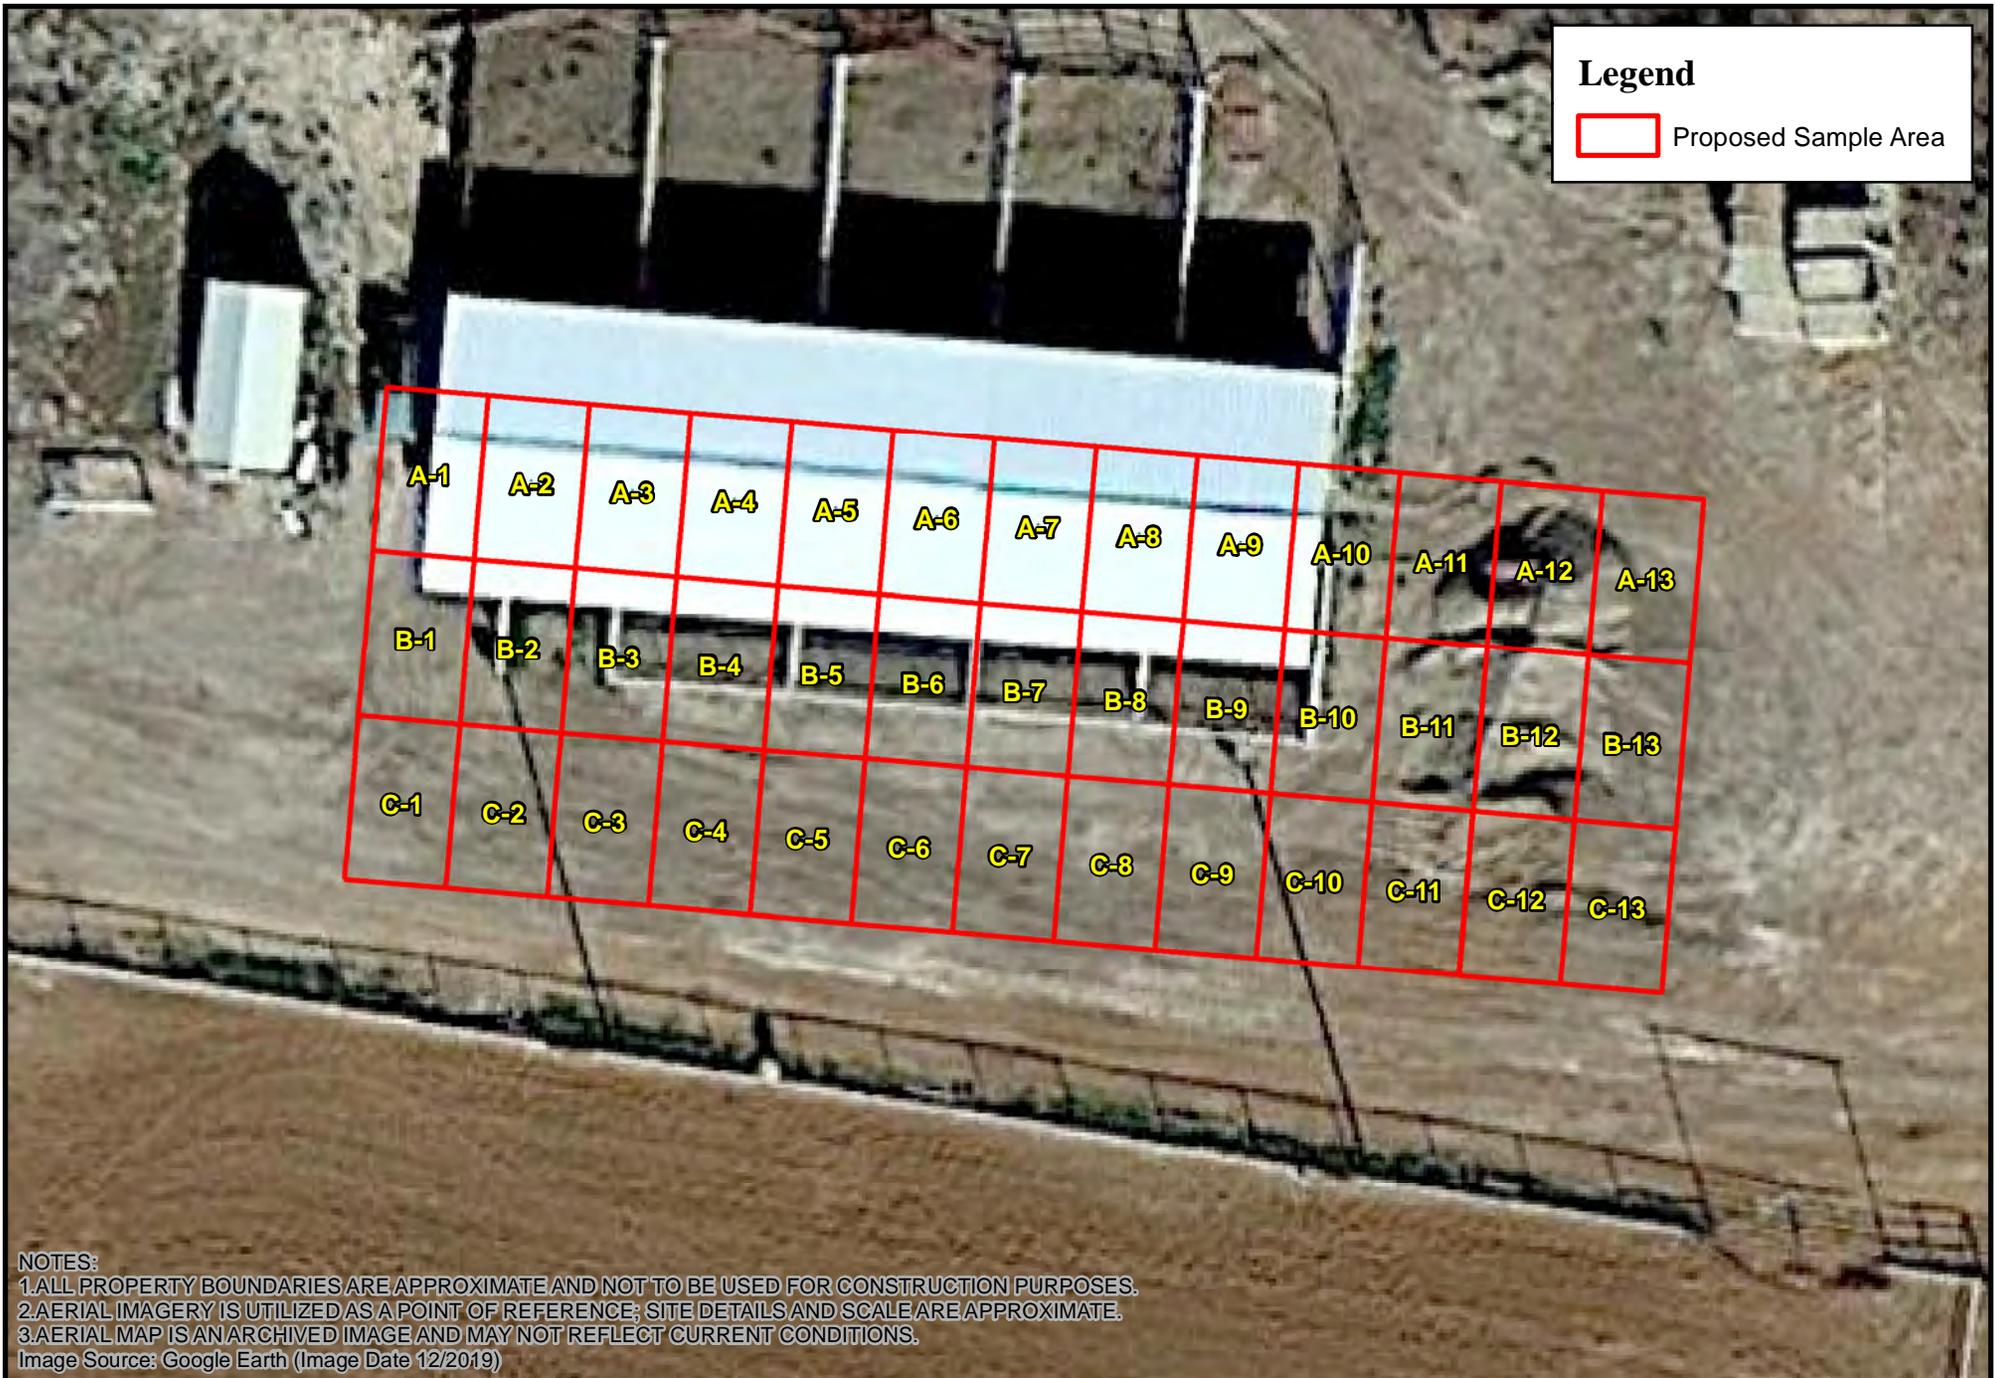
Figure 3 - Proposed Assessment Map
 Inex #3
 EOG Resources, Inc.

Proposed Sample Area

In order to assess the subject areas and immediately surrounding areas a proposed total of 39 approximately 200 square foot areas will be assessed. Within each approximate 200 foot square area, a total of five composite soil samples will be collected for laboratory analysis. The composite soil samples will be collected at the ground surface and at one foot depth intervals to a maximum depth of approximately four feet bgl. The samples will be comprised of five equal parts of soil from five separate locations within each sample area and at each target sample depth interval (ground surface and at one foot, two feet, three feet, and four feet bgl).

A Proposed Assessment Map depicting the proposed approximate 200 square foot sample areas is attached.
