Pit or Below-Grade Tank Registration or Closure

Closure Report

Potomac A9 Fee #1H
API # 30-015-35369
Eddy County, NM

Re: Drilling Pit Closure of EOG Resources – Potomac A9 Fee #1H
UL 'A' Sec. 9 T16S R25E Eddy County, NM
API # 30-015-35369

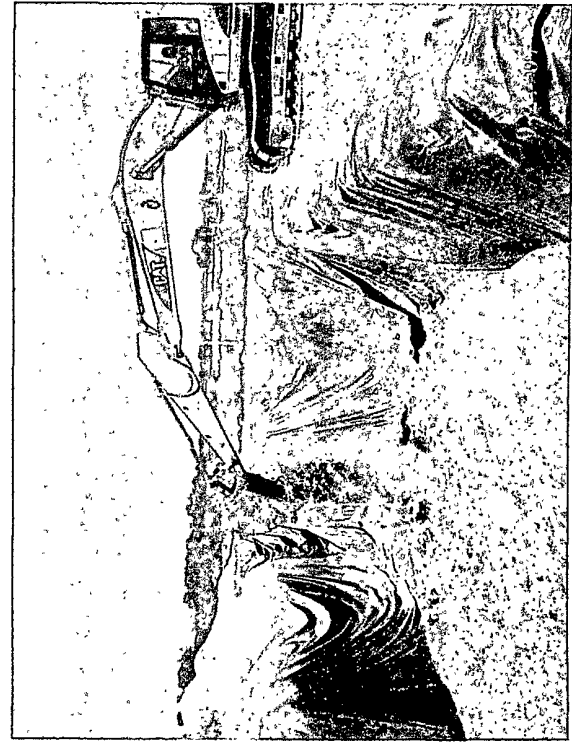
Placing mud in burial pit after stiffened with dry soil.

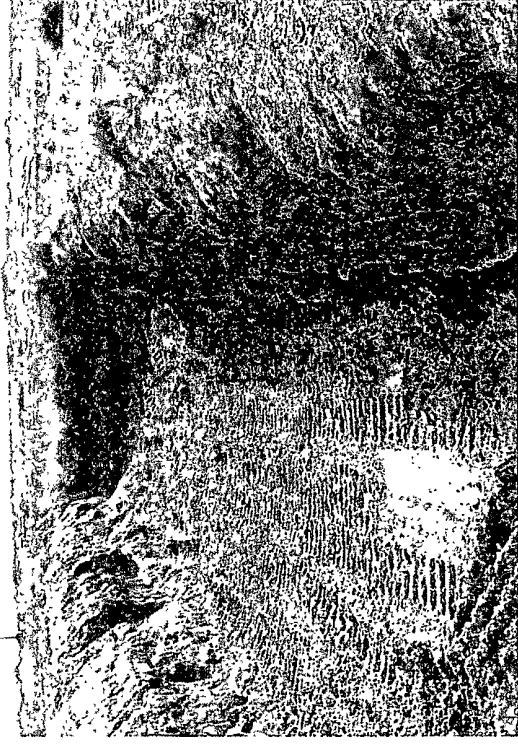
Drilling pit after removal of mud and drilling liner.
