Pit or Below-Grade Tank Registration or Closure

Re: Drilling Pit Closure of EOG Resources – Tiber A 5 Fee #1H
UL 'D' Sec. 5 T16S R25E Eddy County
API # 30-015-35467

Closure Report

Tiber A 5 Fee #1H
API # 30-015-35467
Eddy County, NM

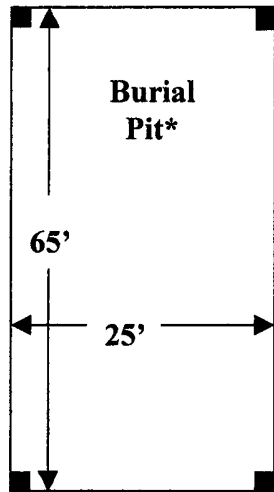
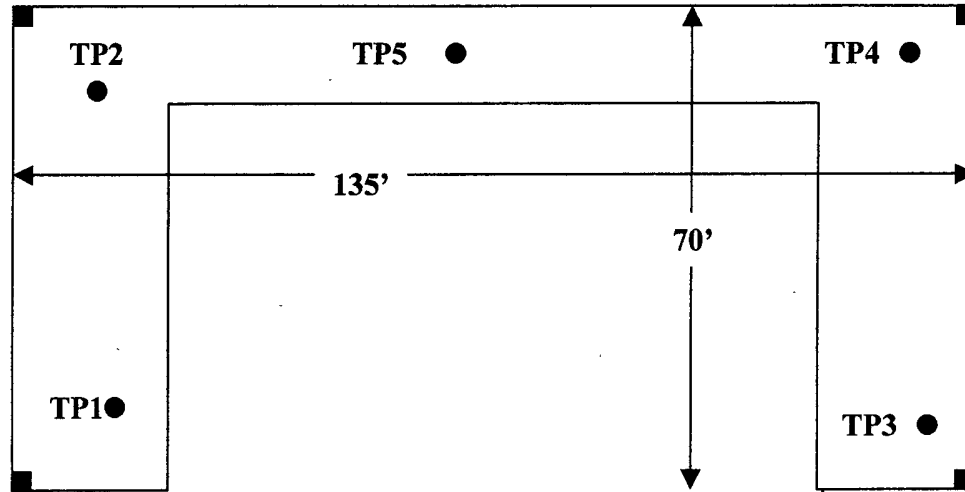
Plat Map

* Burial pit was built using
North leg of drilling pit
after testing showed no
contamination.

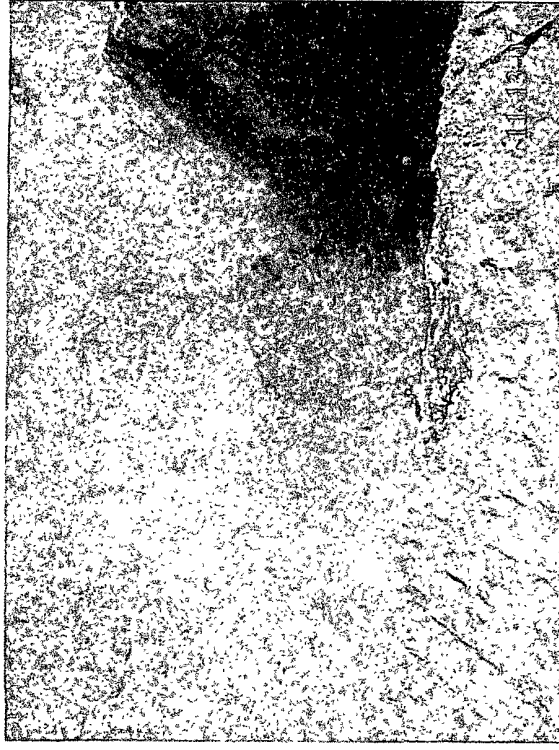
Burial pit before liner is installed.

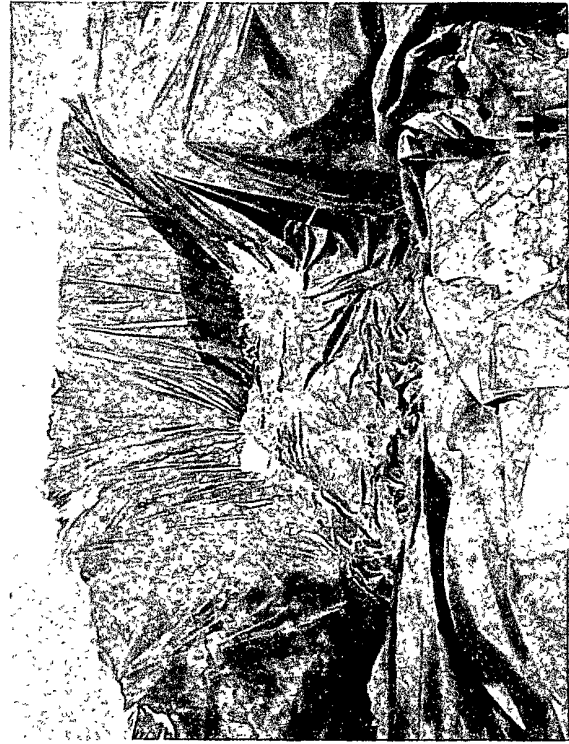
Burial pit lined with a 12 mil impervious liner.

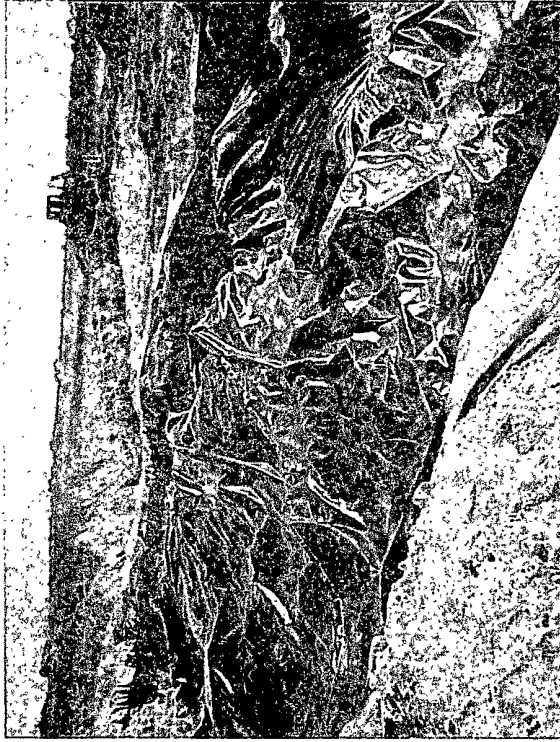
Burial pit capped with a 20 mil impervious liner.

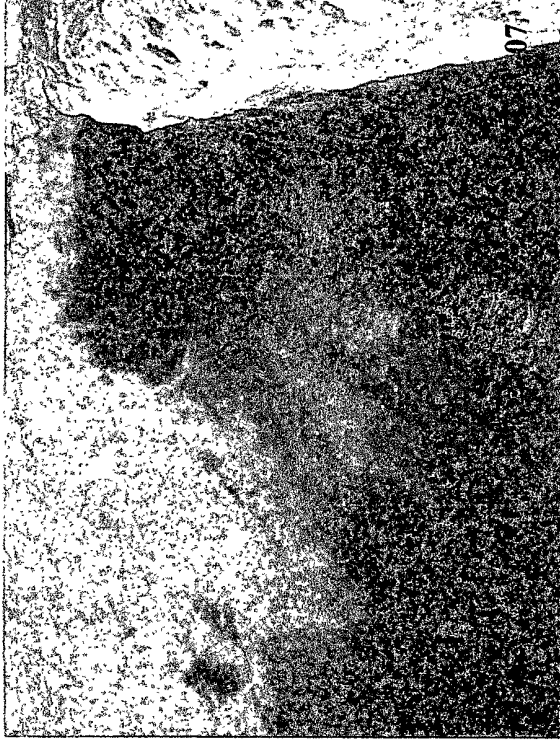
Drilling pit after all mud is removed.

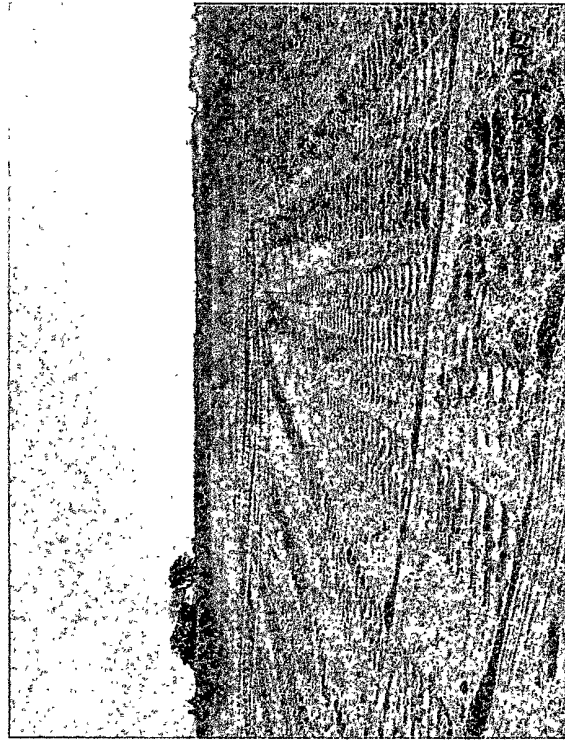
Site after backfill of clean soil and contouring.

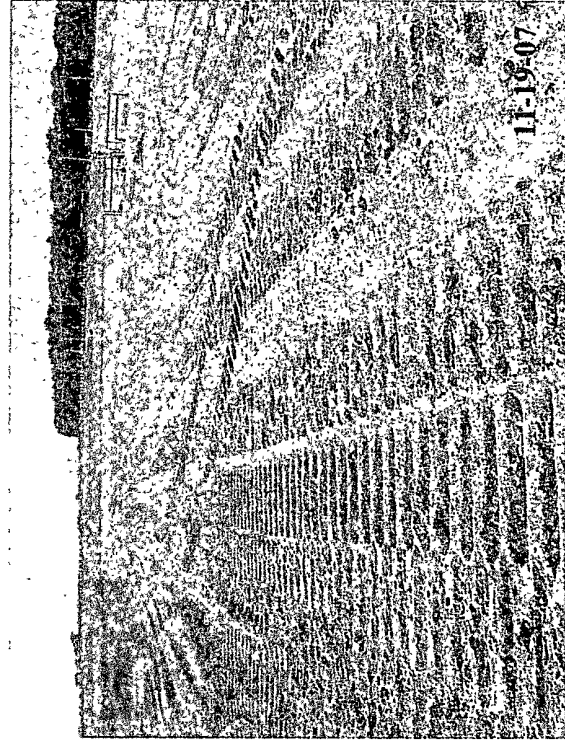
Site after backfill of clean soil and contouring.
