Pit or Below-Grade Tank Registration or Closure

Closure Report

Seine A 6 Fee #1H
API # 30-015-35106
Eddy County, NM

Re: Drilling Pit Closure of EOG Resources – Seine A 6 Fee #1H
UL 'A' Sec. 6 T16S R25E Eddy County, NM
API # 30-015-35106

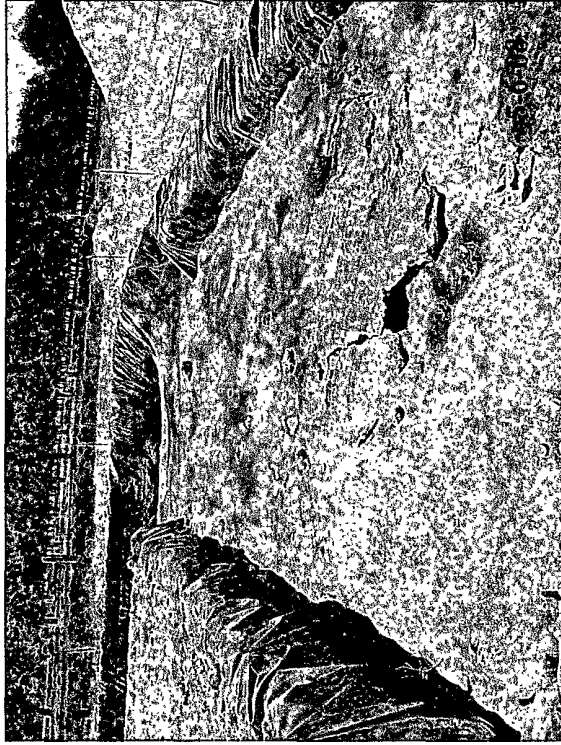
Drilling pit before closure.

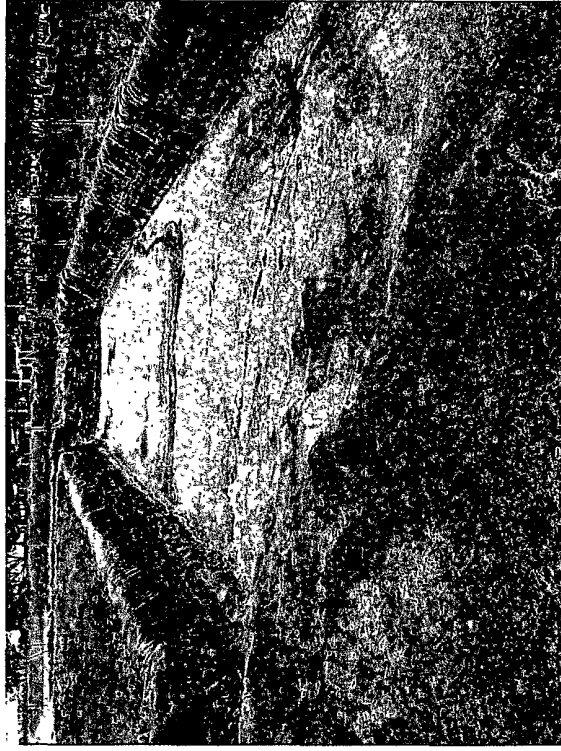
Drilling pit before closure.

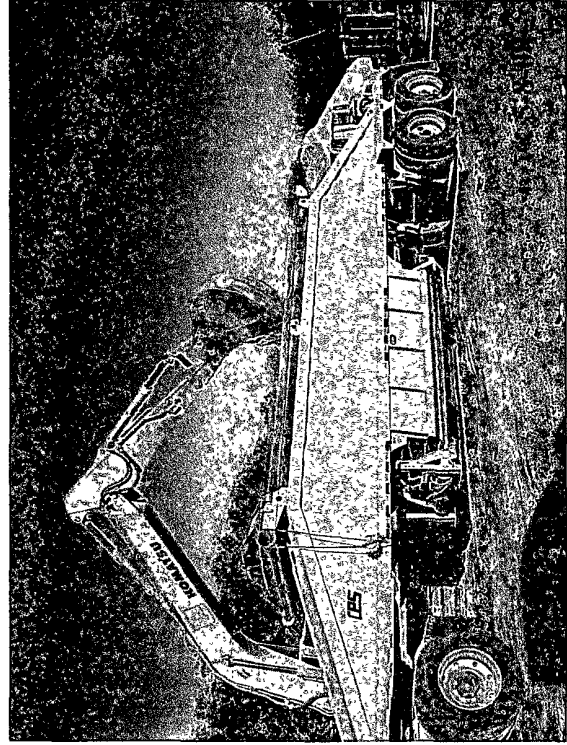
Drilling mud being loaded to be hauled to CRI Disposal.

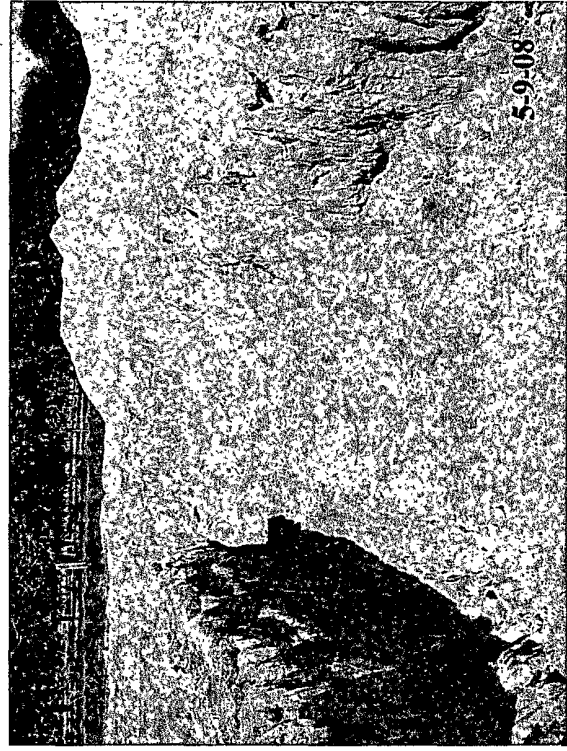
TP3 and TP4 after sampling per NMOCD Guidelines.

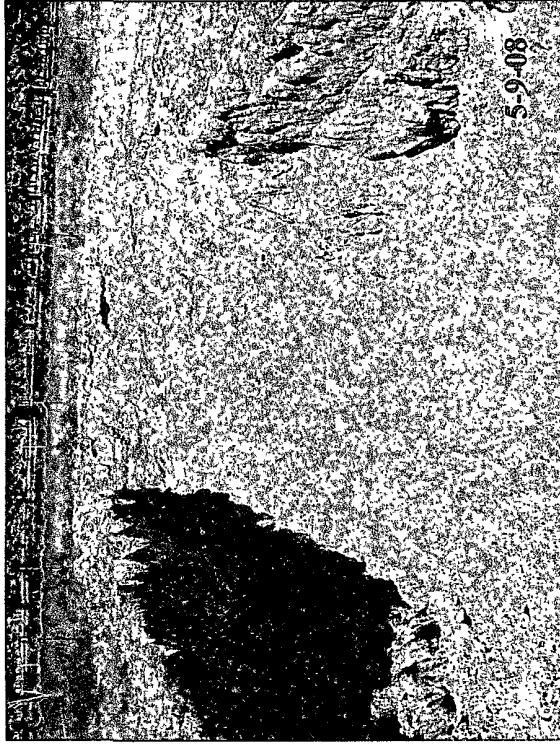
TP1 and TP2 after sampling per NMOCD Guidelines.

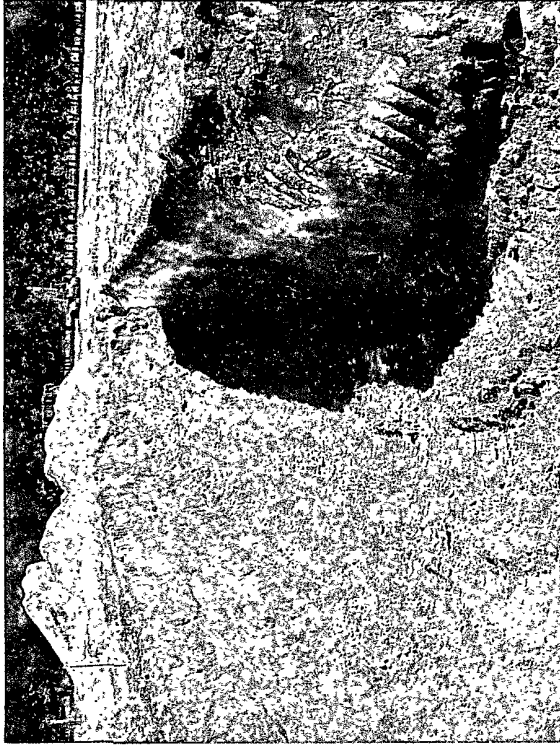
TP5 after sampling per NMOCD Guidelines.

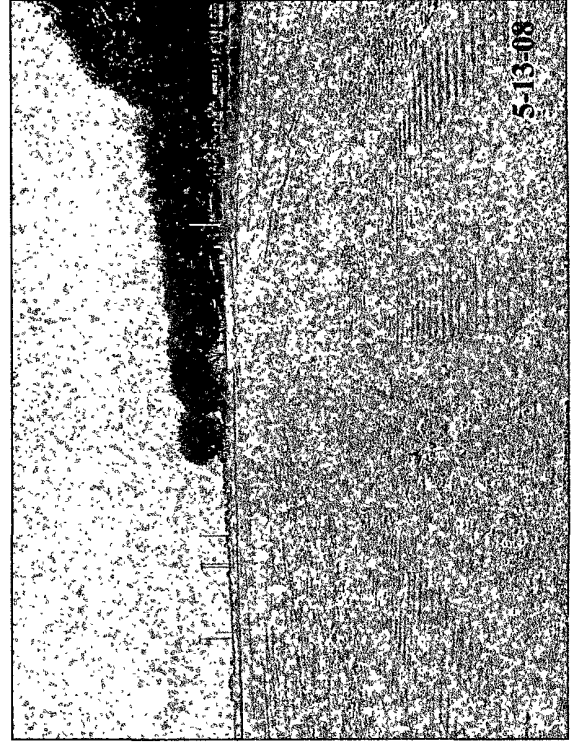
Drilling pit after backfill and contouring to area.

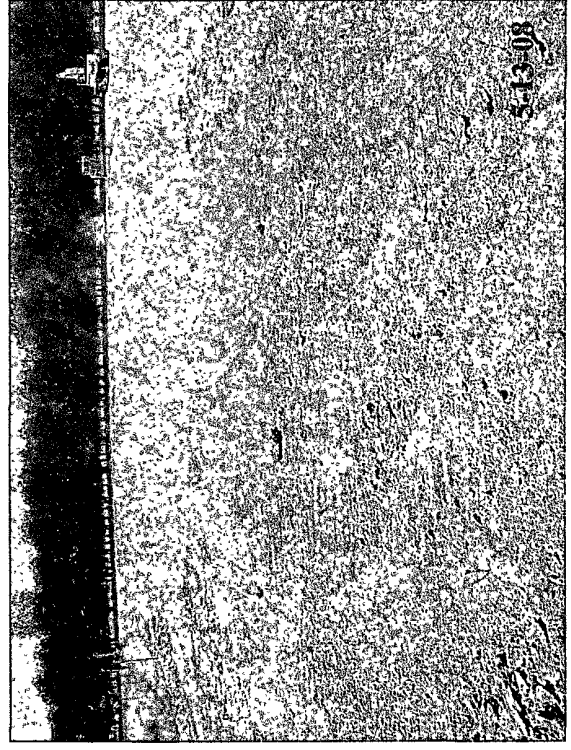
Drilling pit after backfill and contouring to area.
