Pit or Below-Grade Tank Registration or Closure

Closure Report

Cypress 34 Federal #4H
API # 30-015-35742
Eddy County, NM

Re: Drilling Pit Closure of Oxy USA – Cypress 34 Federal #4H
UL'D' Sec. 34 T23S R29E Eddy County
API# 30-015-35742

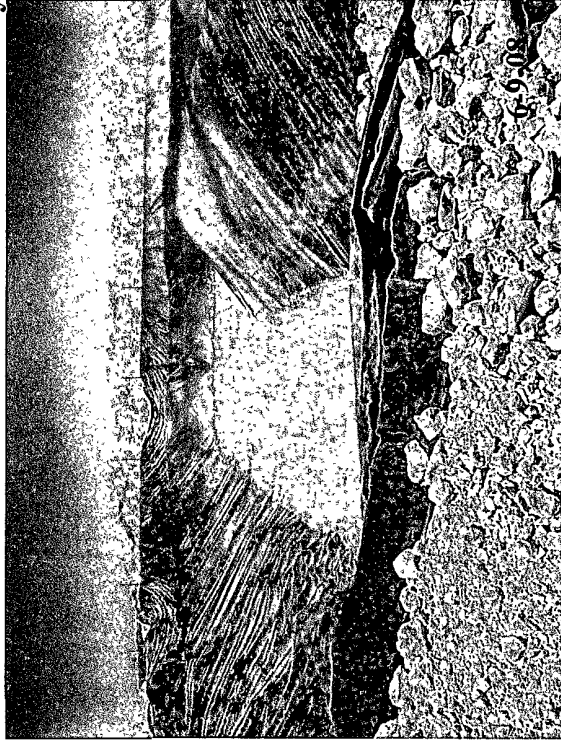
Drilling pit before closure.

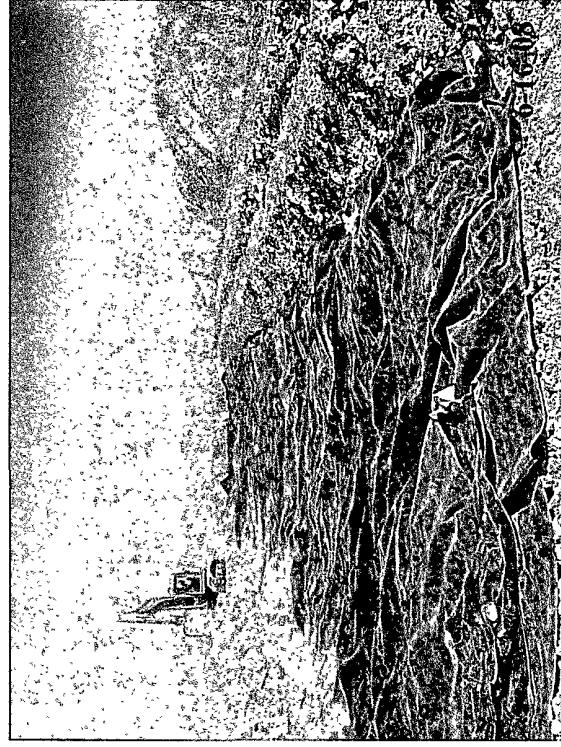
Burial pit capped with a 20 mil poly liner.

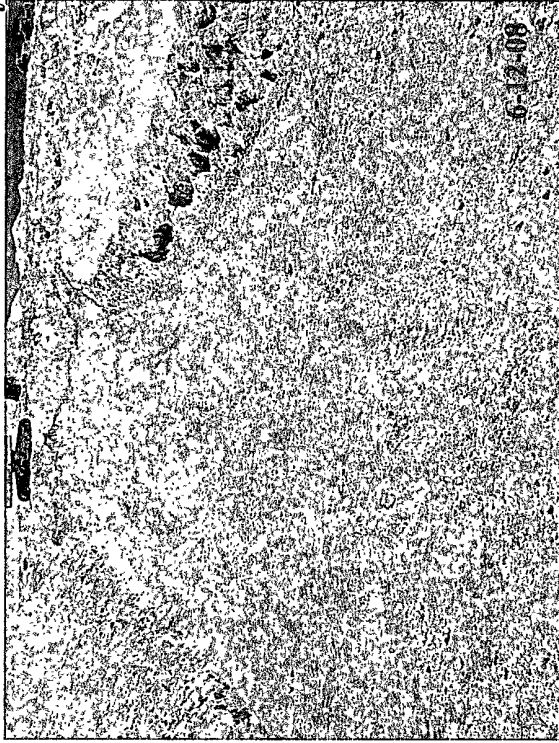
6-12-08

Drilling pit after removal of all drilling mud and liner.

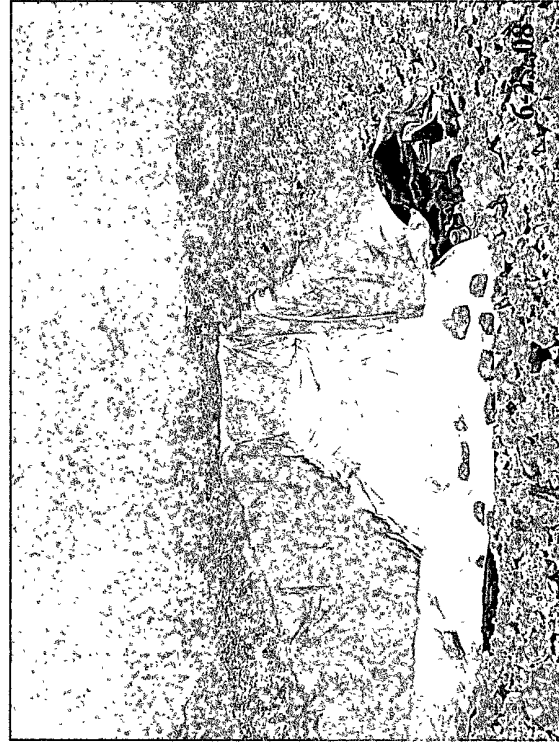
6-23-08

Burial pit #2 lined with a 12 mil poly liner.

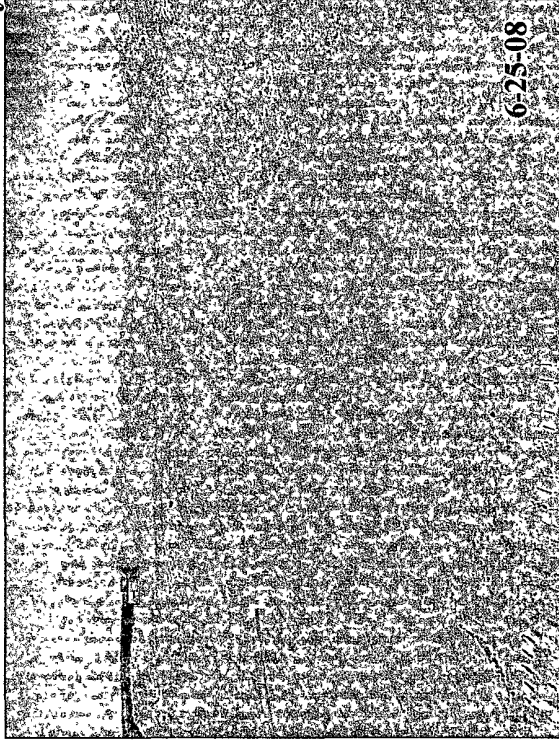
Drilling pit area after excavation of 6' of contamination.

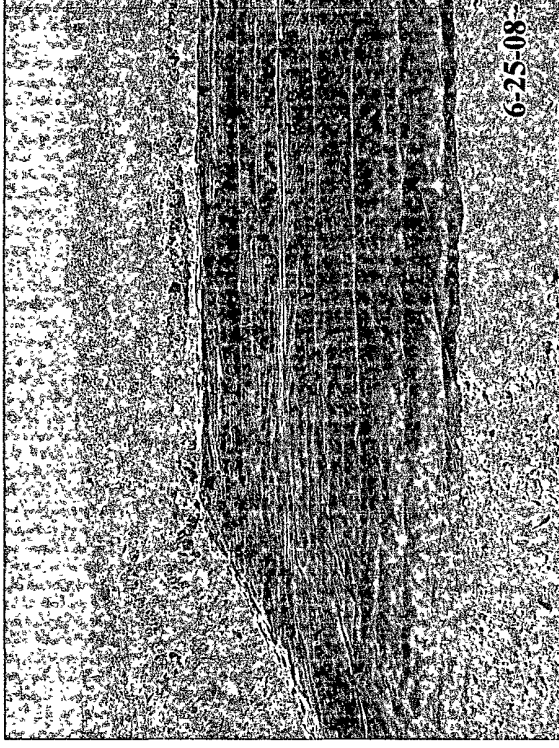
Drilling pit area capped with a 20 mil poly liner.

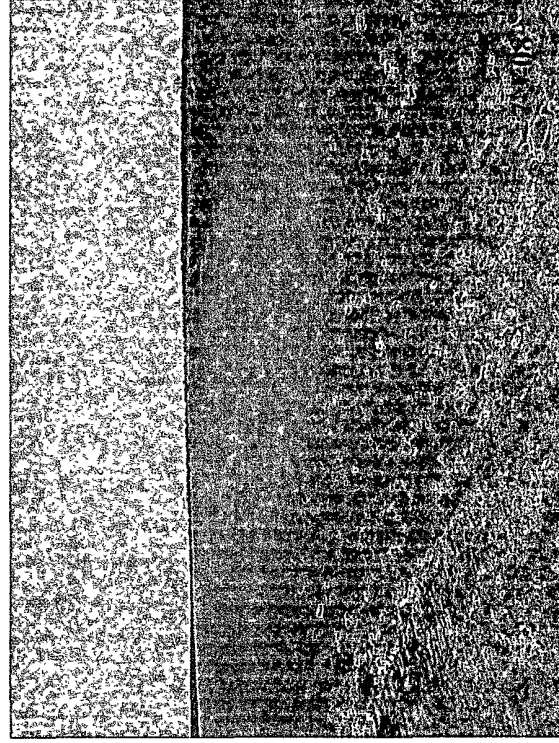
Drilling pit and burial pits after backfill of clean native soil and contouring to the surrounding area.
