# Final Closure Report

Fade Away Ridge 29 St. Com #1 Reserve Drilling Pit, API: 30-015-35030 Sec. 29 19S 28E – Eddy County, New Mexico (OCD Permit #0208229)

## Phoenix Environmental, LLC.

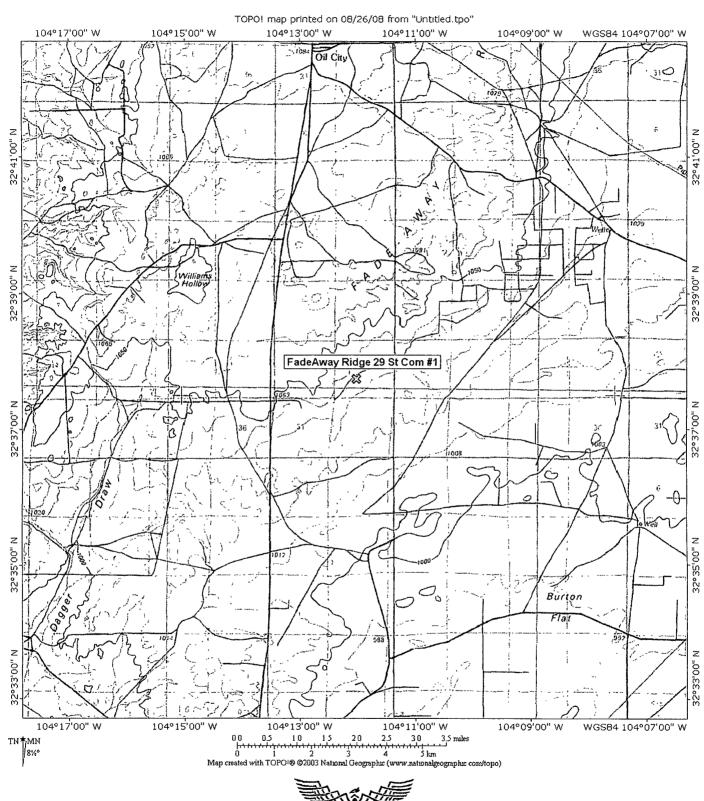
NW NE  ⊗  SW SE  Wellhead  □	Ŋ 	Cimarex Energy Fadeaway Ridge 29 St. Com #1 UL-K-SEC 29-T19S- R28E Eddy Co. NM API# 30-015-35030	1. SE - N32°37'44.5"-W104°12'01.4" 2. SW - N32°37'44.4"-W104°12'01.9" 3. NE - N32°37'45.0"-W104°12'01.5" 4. NW - N32°37'45.0"-W104°12'01.9" 5. BG - N32°37'43.9"-W104°12'03.6"
BG ⊗ Wellhead	•		NE ⊗
		sw ⊗	SE ⊗
