UNITED STATES
DEPARTMENT OF THE INTERIOR
BUREAU OF LAND MANAGEMENTFORM APPROVED
OMB NO. 1004-0135
Expires: July 31, 2010**SUNDRY NOTICES AND REPORTS ON WELLS**
*Do not use this form for proposals to drill or to re-enter an abandoned well. Use form 3160-3 (APD) for such proposals.***SUBMIT IN TRIPLICATE - Other instructions on reverse side.**5. Lease Serial No.
NMLC029426B

1. Type of Well
☐ Oil Well ☐ Gas Well ☒ Other: INJECTION8. Well Name and No.
H E WEST B 22Y2. Name of Operator
LINN OPERATING INCORPORATED E-Mail: tcallahan@linnenergy.com9. API Well No.
30-015-05950-00-S13a. Address
600 TRAVIS STREET SUITE 5100
HOUSTON, TX 770023b. Phone No. (include area code)
Ph: 281-840-427210. Field and Pool, or Exploratory
GRAYBURG

LOCATION HAS BEEN RECLAIMED AND READY FOR INSPECTION.

1. RICE ENVIRONMENTAL RECLAMATION REPORT WITH PHOTOGRAPHS
2. CARDINAL LABORATORIES REPORT

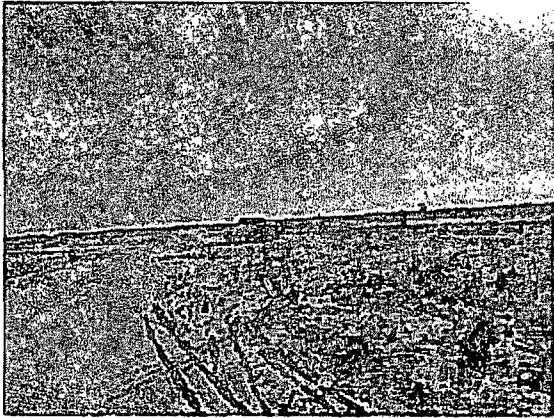
1/6/14

Initial site photo, facing east

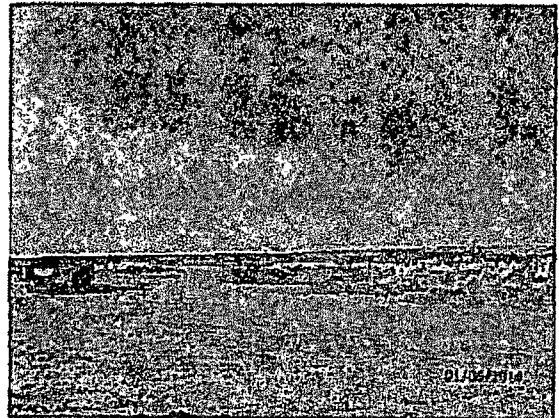
1/6/14

Initial site photo, facing west

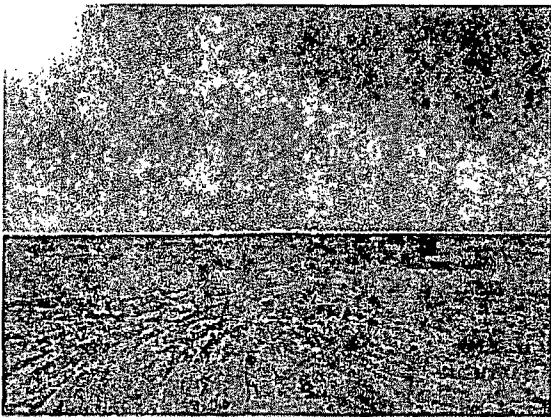
1/6/14

Initial site photo, facing southwest

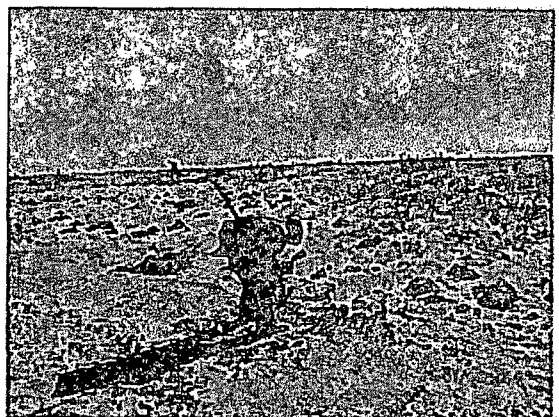
1/6/14

Sampling site, facing southeast

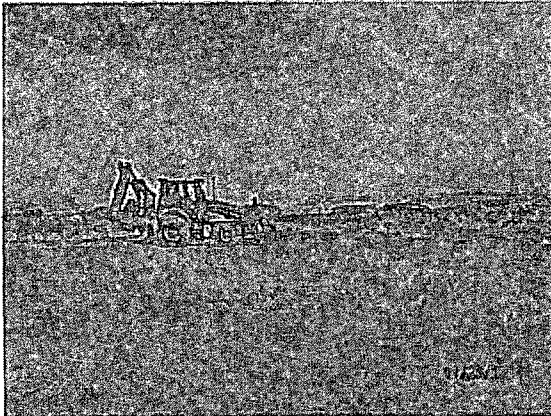
1/23/14

Scraping site, facing north

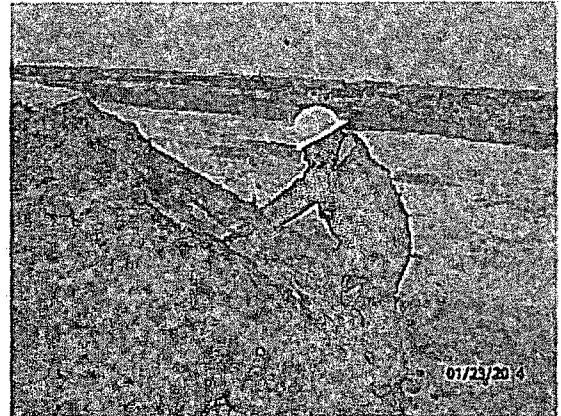
1/23/14

Sampling spoil pile

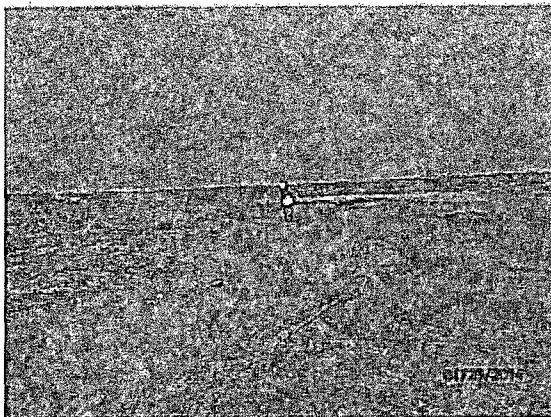
1/23/14

Spreading CA++Nhance, facing northeast

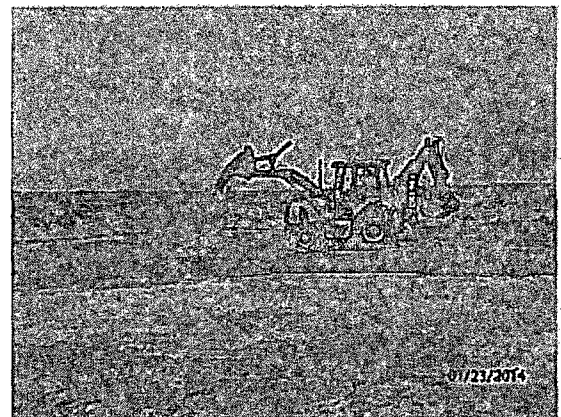
1/23/14

Spreading top soil, facing north

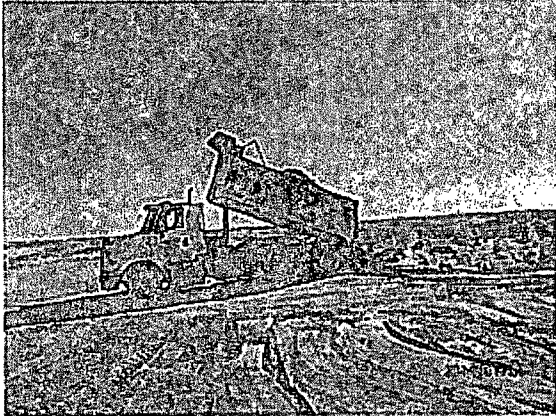
1/24/14

Importing soil, facing east

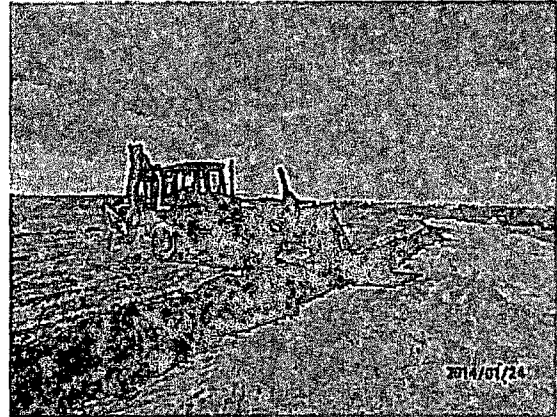
1/24/14

Building berm, facing southwest

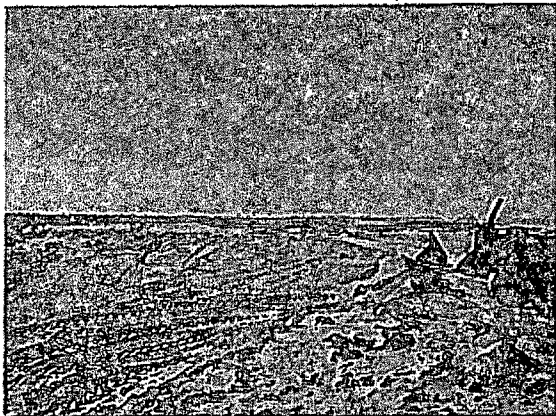
1/29/14

Site backfilled and berm built, facing west

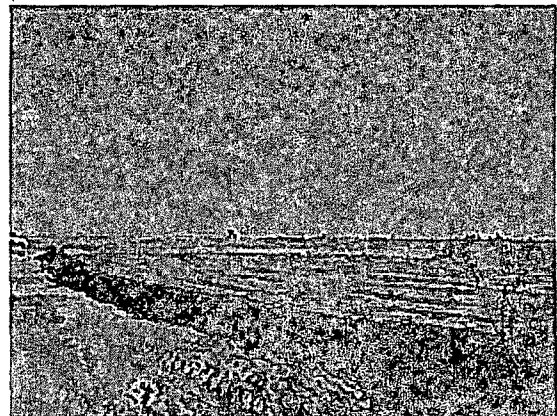
1/29/14

Site backfilled, facing southeast

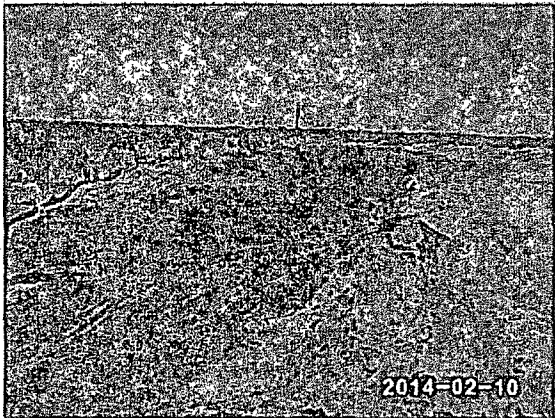
2/10/14

Site completed, facing east

2/10/2014 - RICE ENVIRONMENTAL CONSULTING & SAFETY, LLC DISC'D AND CULTIVATED THE SOIL, SPREAD 8 LBS OF BLM #2 AND 8 LBS OF BLM #4 SEED MIX.

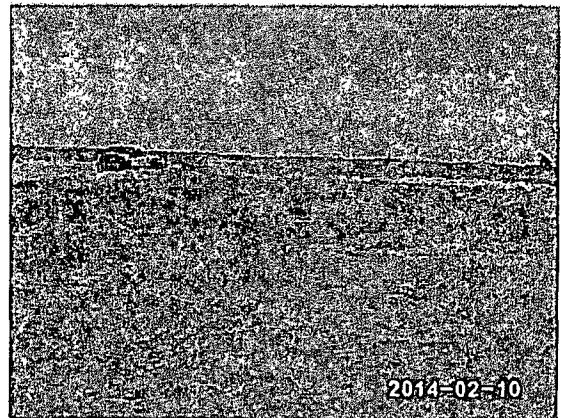
2/10/14

Site completed, facing east
