Pit or Below-Grade Tank Registration or Closure

Re: Drilling Pit Closure of Western Reserves – Lake McMillian 21 #1
UL 'C' Sec. 21 T19S R26E Eddy County
API # 30-015-35444

Closure Report

Lake McMillian 21 #1
API # 30-015-35444
Eddy County, NM

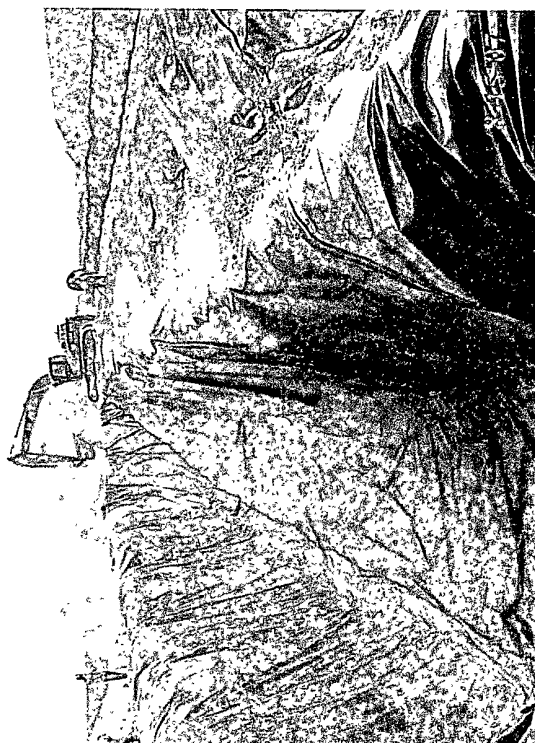
Burial pit with a 12 mil impervious liner.

Additional Comments: A burial pit was excavated and lined with a 12 mil impervious liner. Drilling mud was stiffened and placed in burial pit. The burial pit was capped with a 20 mil liner and backfilled with stockpiled soil. After drilling mud was removed the pit bottom was tested and meet NMOCD standards then backfilled with clean native soil. A plat map, analytical and pictures are attached.
